Rail Accident Investigation Branch

# Rail Accident Report

**Fatal accident to a track worker east of Reading station**

**29 November 2007**

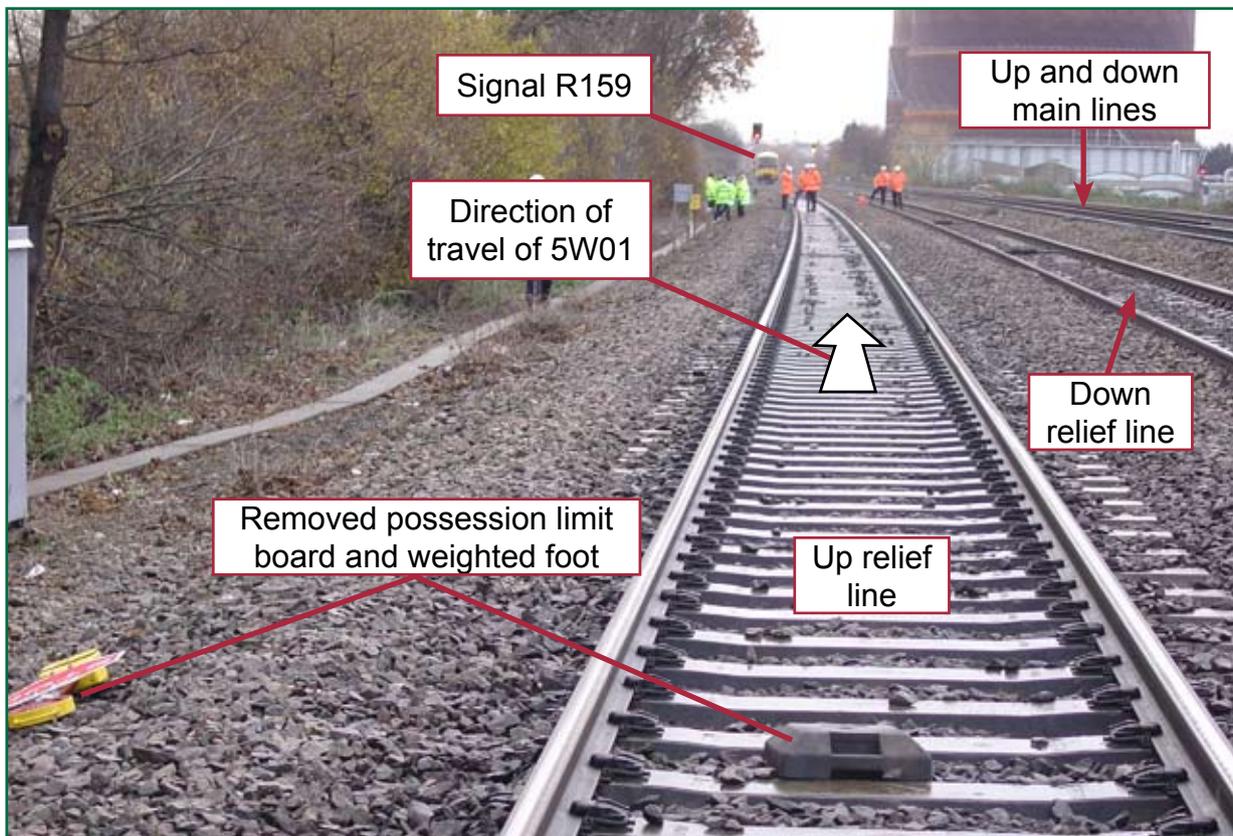
Figure 3: View east from the detonator protection position on the up relief line (35 miles 24 chains)

169 The position of the possession limit boards were not marked or otherwise indicated on site. The weighted feet remained in position between possessions (Figure 3), but these were not fixed down and were observed to move between site visits made by the RAIB. The lack of markings would make it difficult for a BRM, or a manager, to confirm that protection was being positioned in the correct place (**Recommendation 5**).

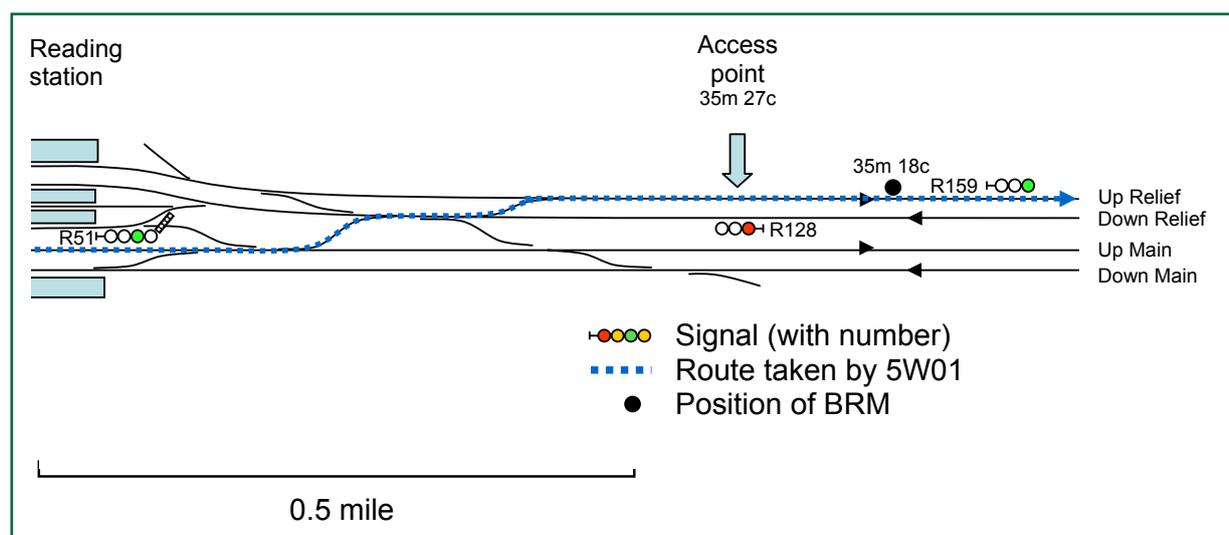
Figure 7: Route taken by 5W01

- 57 At 04:53:44 hrs, the driver of 5W01 sounded the horn after suddenly becoming aware of a person on the track an estimated one coach length in front of him. He moved the control handle from full power to emergency brake in a single movement. The OTDR shows that the train came to a halt after travelling a further 241 metres (264 yards), and experienced some wheel slip while braking. The driver sent an emergency message to Reading signal box using the *cab secure radio* as soon as the train had come to a stand. He stated that he had hit a track worker and requested the emergency services.
- 58 The Reading BRM did not become aware of the train in sufficient time to get fully clear and was struck a glancing blow by the front of the train.
- 59 The collision occurred at a speed of 48.6 mph (78.2 km/h).

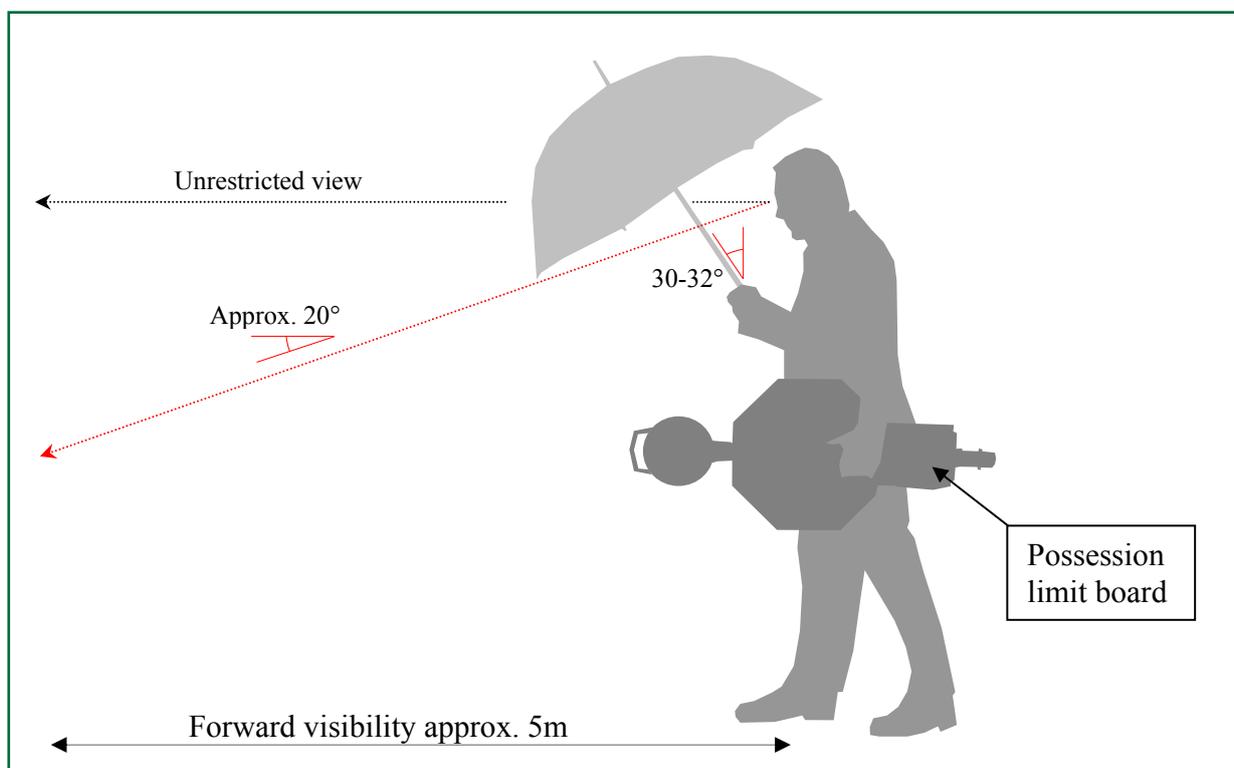
Figure 8: Diagram showing effect of 10 mph wind on forward sighting when using an umbrella

120 If the Reading BRM was using an umbrella, he would have needed to hold this in one hand as he was also carrying the down relief possession limit board and probably a torch. An umbrella user, facing into a 10 mph wind, would have to hold it at an angle and would therefore be less able to see approaching trains. Tests undertaken by the RAIB using a similar umbrella in a 10 mph headwind suggest that forward visibility could have been as little as 5 metres (Figure 8), which the train would cover in less than one second at 48.6 mph (78.2 km/h). He would have needed to see the train at a distance of at least 215 metres (235 yards) to meet the 10 second requirement made in the rule book (paragraph 119).

121 The Reading BRM did not observe the approaching train during the 20 seconds that it was visible to him, and the reflective properties of his high-visibility waistcoat were reduced by it being unfastened, making it less likely that the driver would see him. If the Reading BRM were using an umbrella, this would have affected his ability to keep an adequate lookout for approaching trains, and explains why he did not take avoiding action in sufficient time. The use of an umbrella in preference to waterproof clothing was therefore a causal factor in the accident.

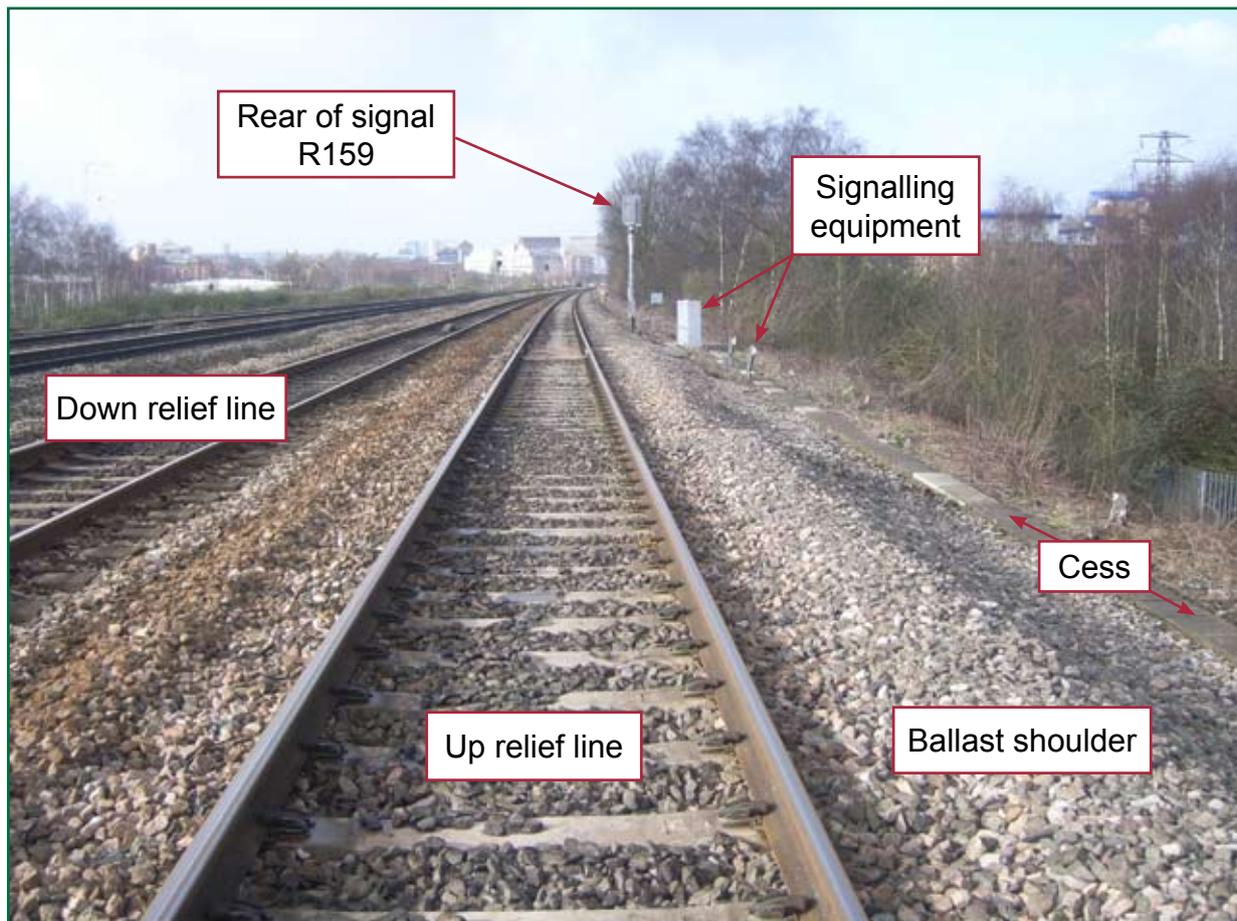
130 The Reading BRM commenced his return journey towards the access point at approximately 04:50 hrs, knowing that the possession was about to be given up. The choice of walking routes available to him at this stage comprised the four foot (ie walking on the track itself), the inclined ballast shoulder or, following the lineside cable route formed of abutting pre-cast concrete troughing units in the cess (Figure 9). The ballast shoulder was an unattractive option due to its angle, and Network Rail discourage staff from walking on the cess troughing route due to the risk of trips and falls due to a lid collapsing or springing up when stood upon. There was also signalling equipment located in the cess which could have been hazardous in the dark.

Figure 9: view west along the up relief line between detonator protection positions. The accident occurred beyond signal R159 in the centre of the photograph.
