Rail Accident Investigation Branch

Rail Accident Report

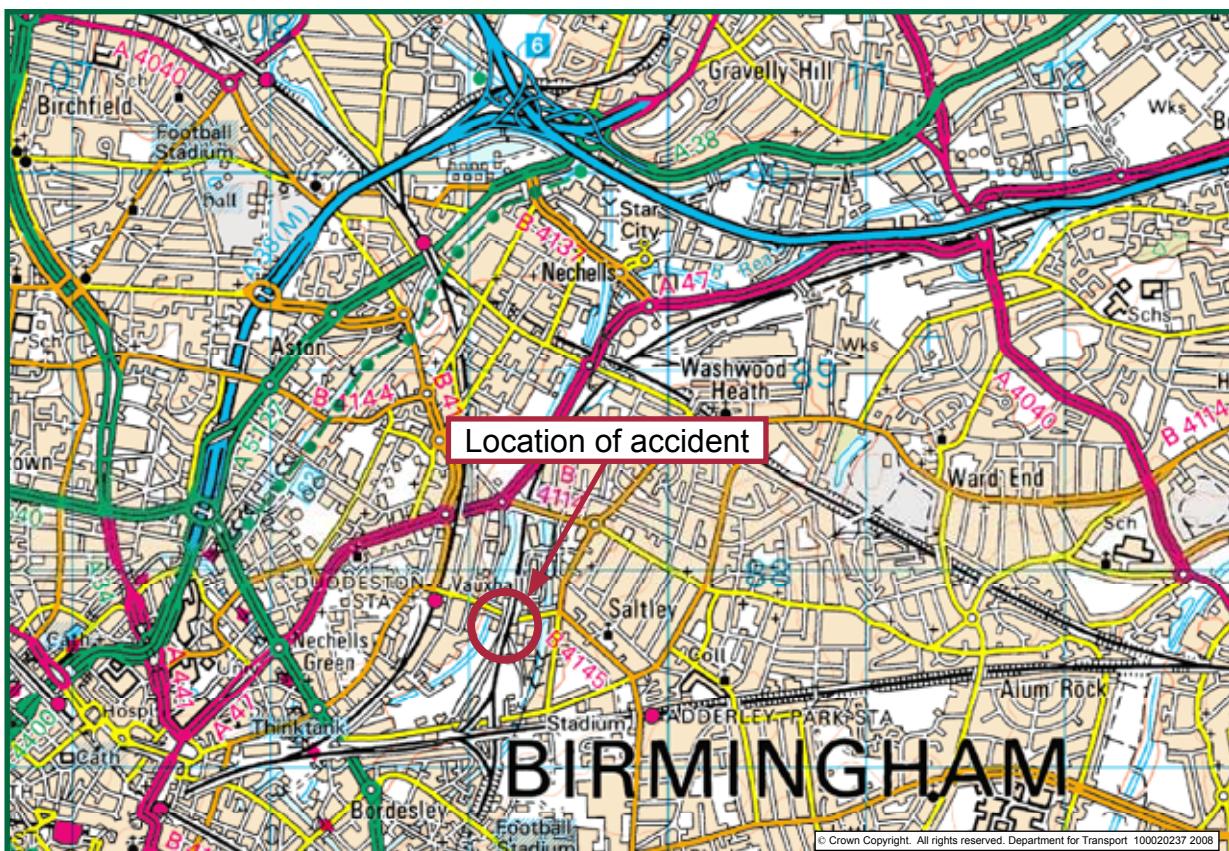
Figure 1: Extract from Ordnance Survey map showing location of accident

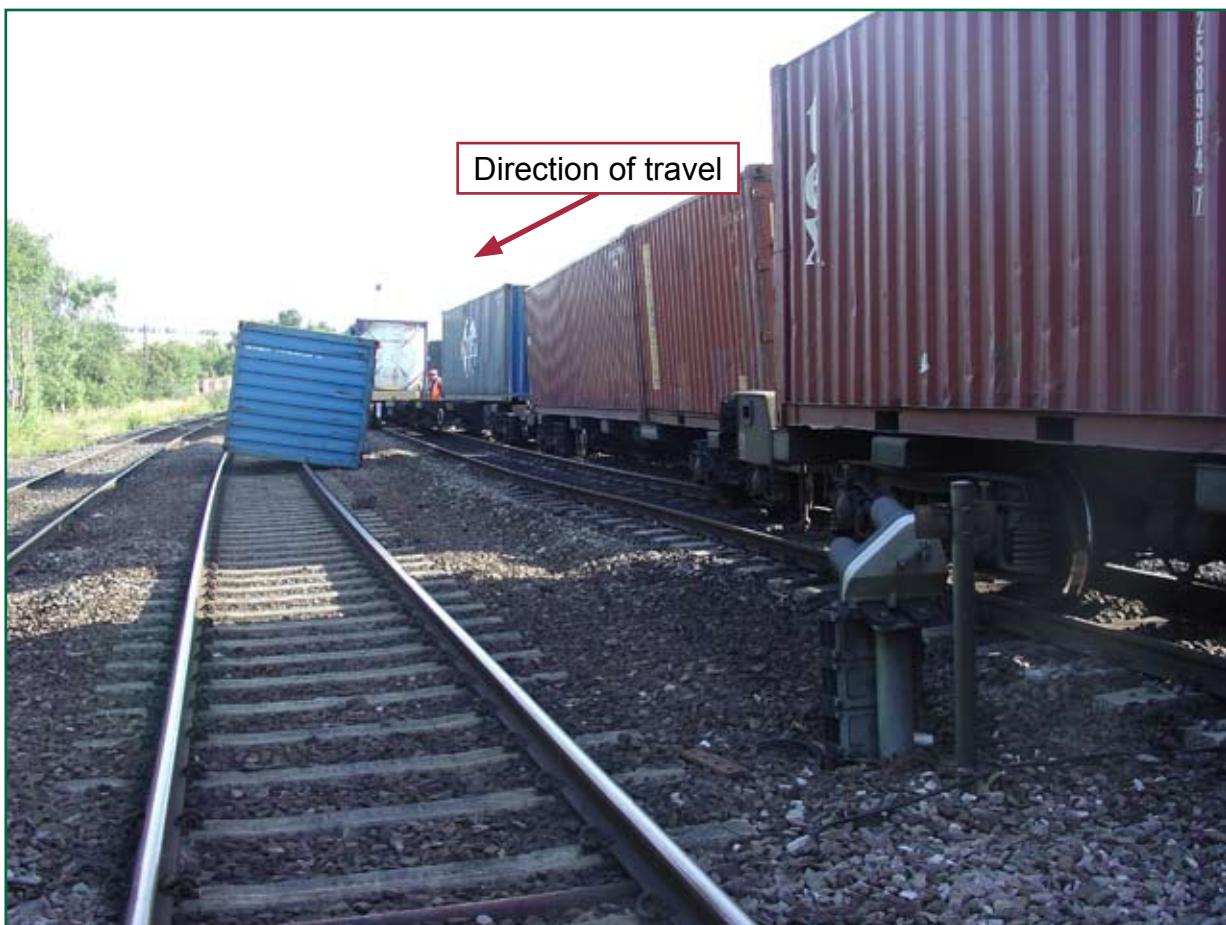
Figure 2: The seventh and eighth wagons of 4O84 derailed

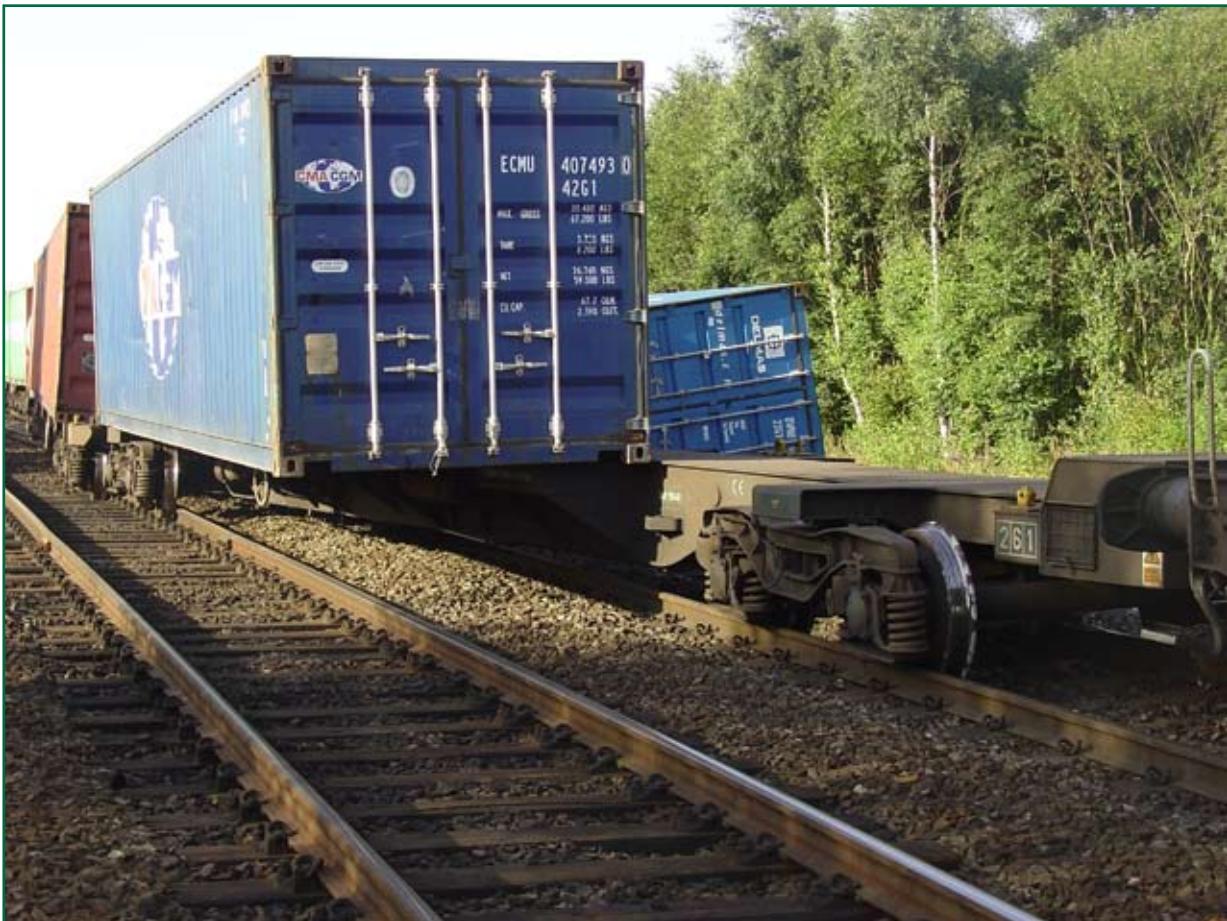
Figure 5: Wagon 640 261 with the fallen 20 ft and slewed 40 ft containers

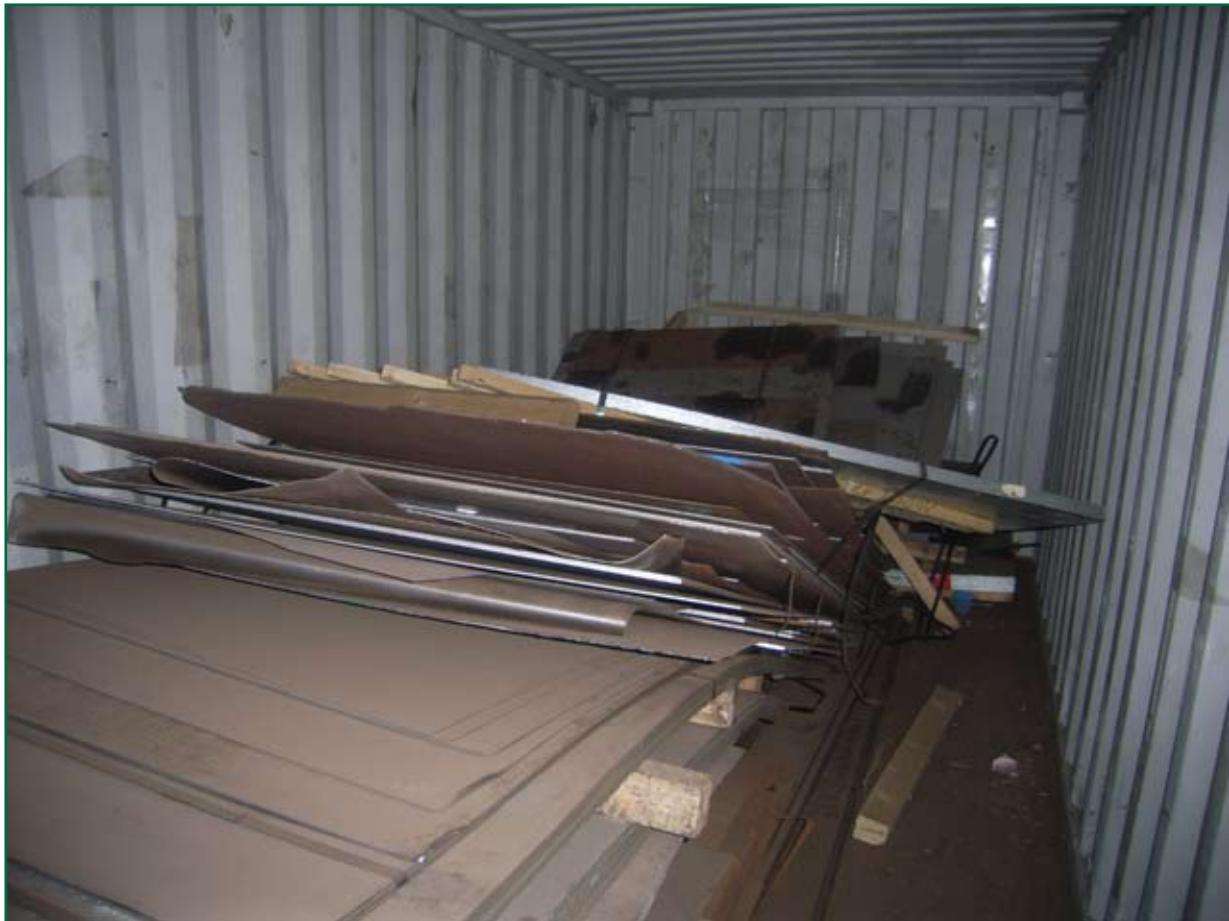
Figure 6: Wagon 640 262 rearmost (20 ft) container load as found after the accident

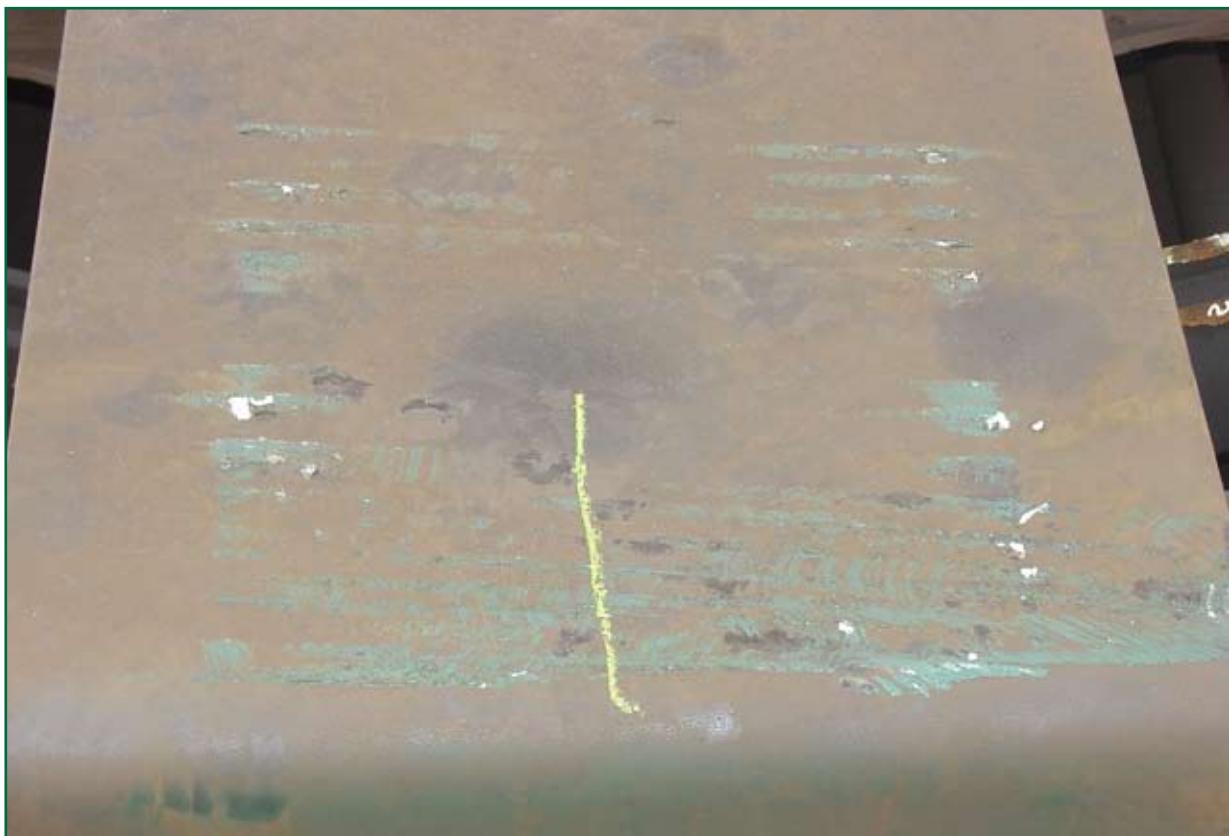
Figure 11: Marks on 640 261 paintwork adjacent to rear bogie indicating bouncing of rear container (the yellow chalk mark was added post-incident)

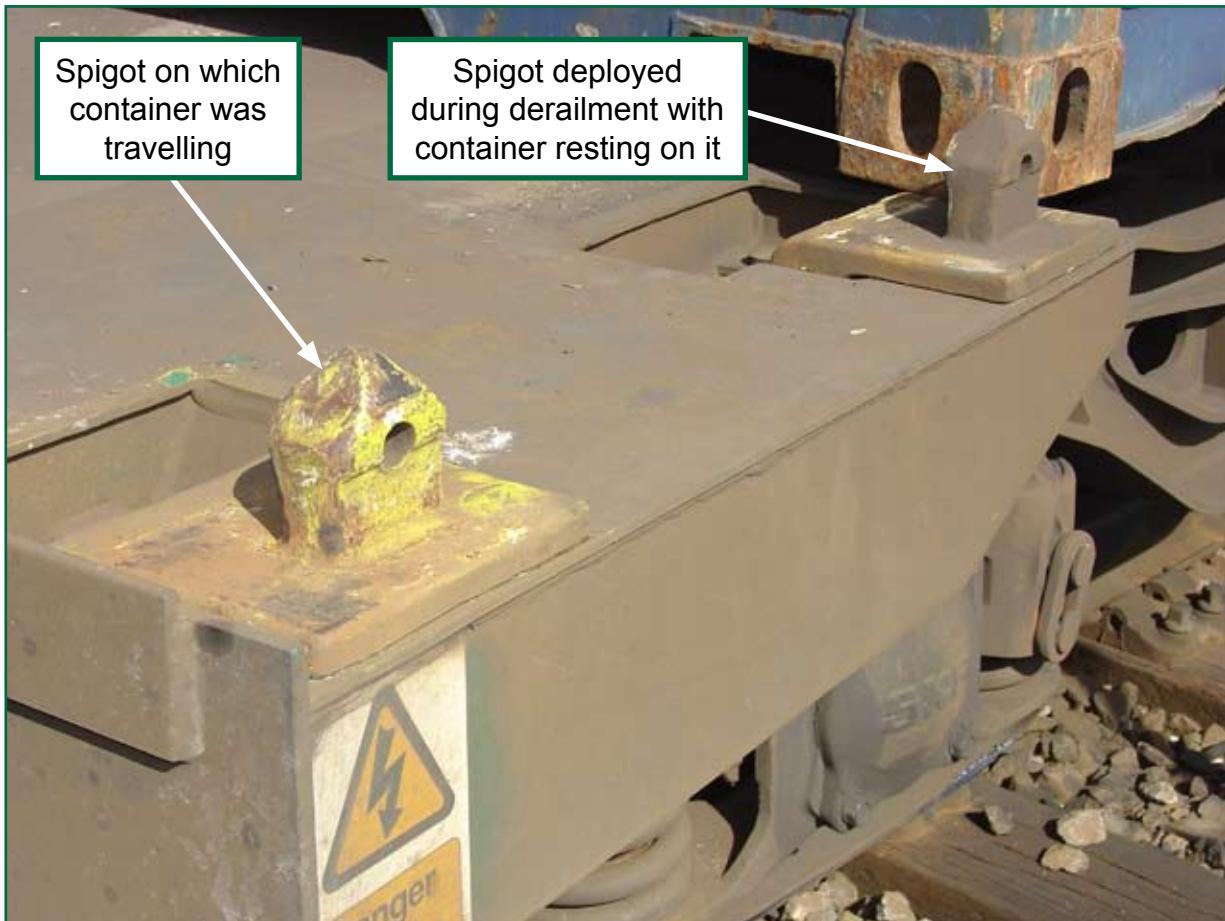
Figure 12: 640 261 front 40 ft container rear RH corner as found

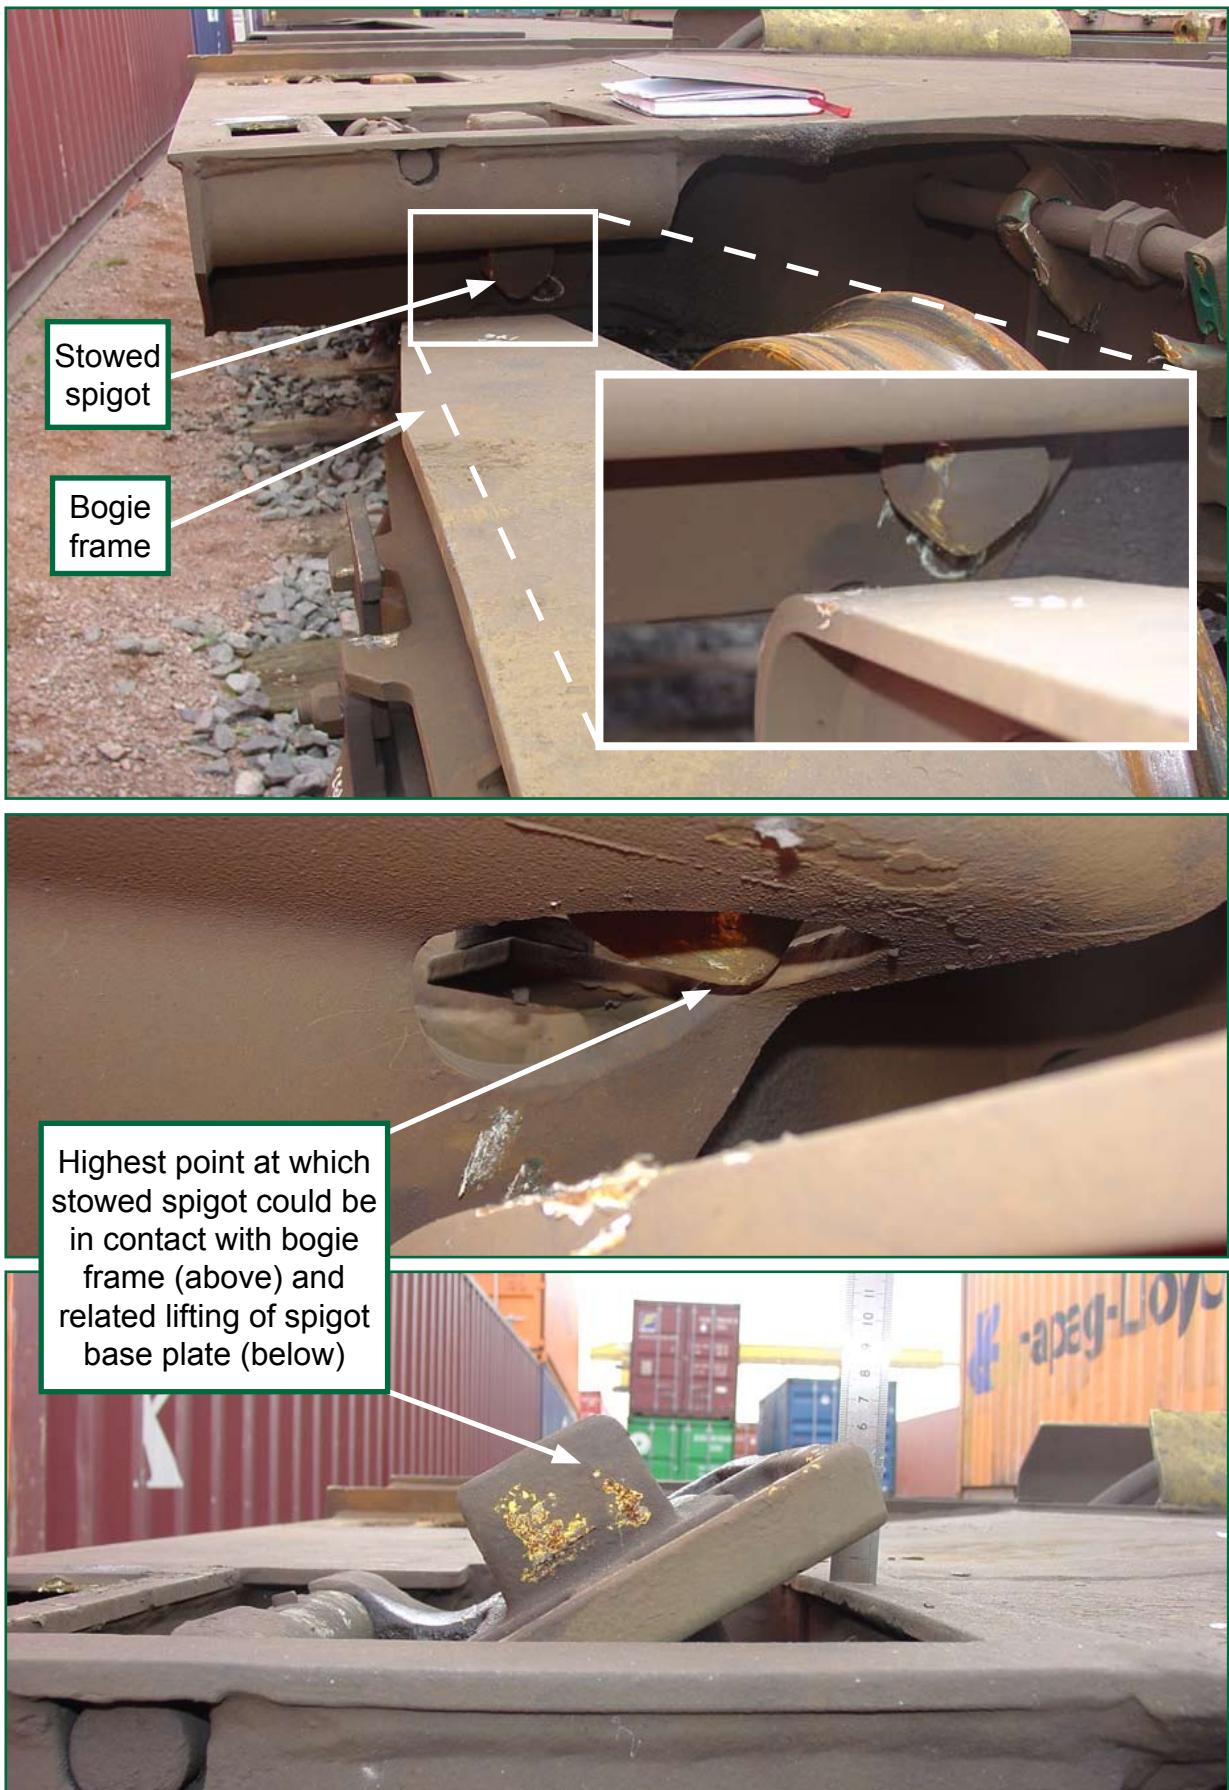
Figure 13: Wagon 640 261 - interaction of stowed spigot and bogie
