Rail Accident Investigation Branch

# Rail Accident Report

## Collision with the gates at Lydney Town level crossing 15 August 2007

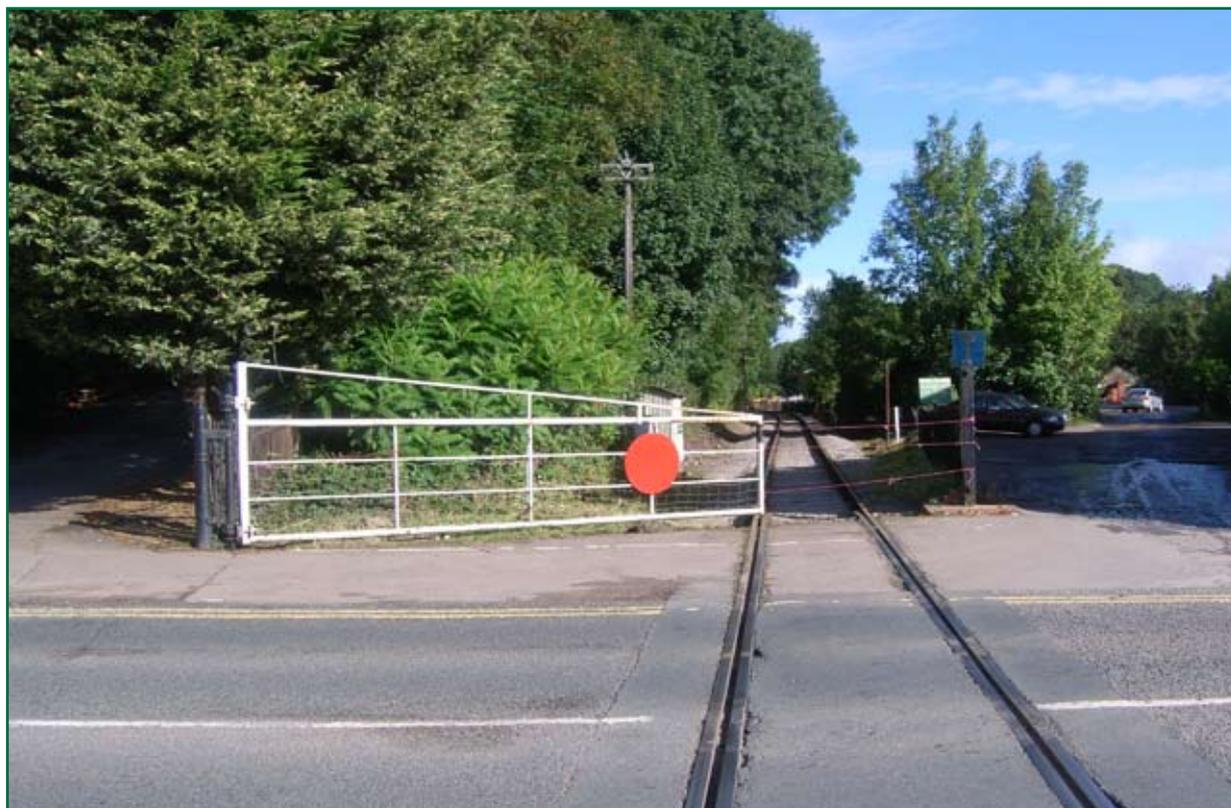
Figure 4: Lydney town crossing looking north (secondary gate missing following accident)

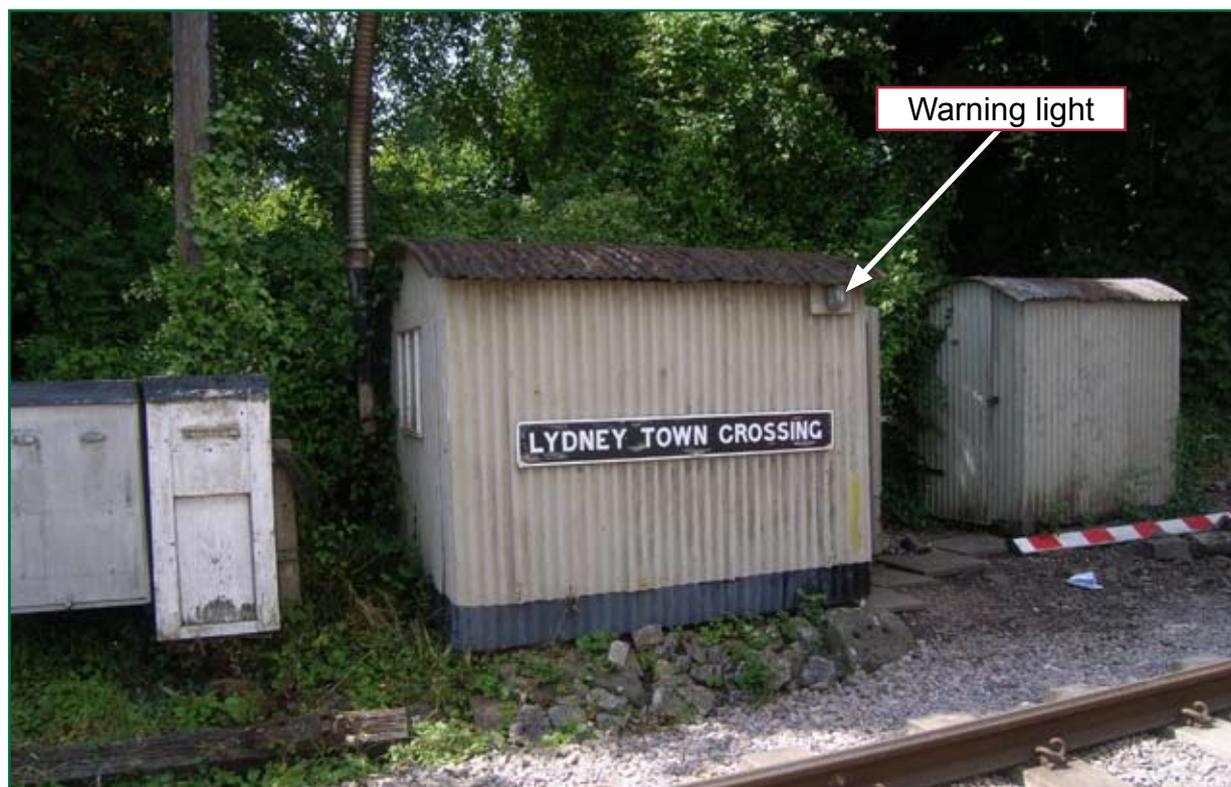
Figure 5: Crossing keeper's hut, showing warning light for approach of trains

- 84 Inspection of the system following the accident identified that the buzzer was faulty and not working at all. The treadle operated warning light was intermittent. The length of the warning given by the flashing light is a function of the train length and how long the treadle arm takes to return to the normal position once depressed by the wheel flanges of a passing train. The return motion is *damped* to extend the period of warning. At 20 mph, the wheels of the auto-train would depress the treadle arm for less than 3 seconds. If the arm is correctly adjusted, it should take between 6 and 8 seconds to return to its rest position. This gives a total length of warning of 9 to 11 seconds, which will be reduced if the arm is not set at the correct height (so that it is not fully depressed by wheel flanges) or if the damping not adjusted correctly.

- c. replaced the battery that powers the buzzer and the white light at the crossing;
  - d. moved the 'stop' board at Lydney Town to a greater distance from the crossing; and

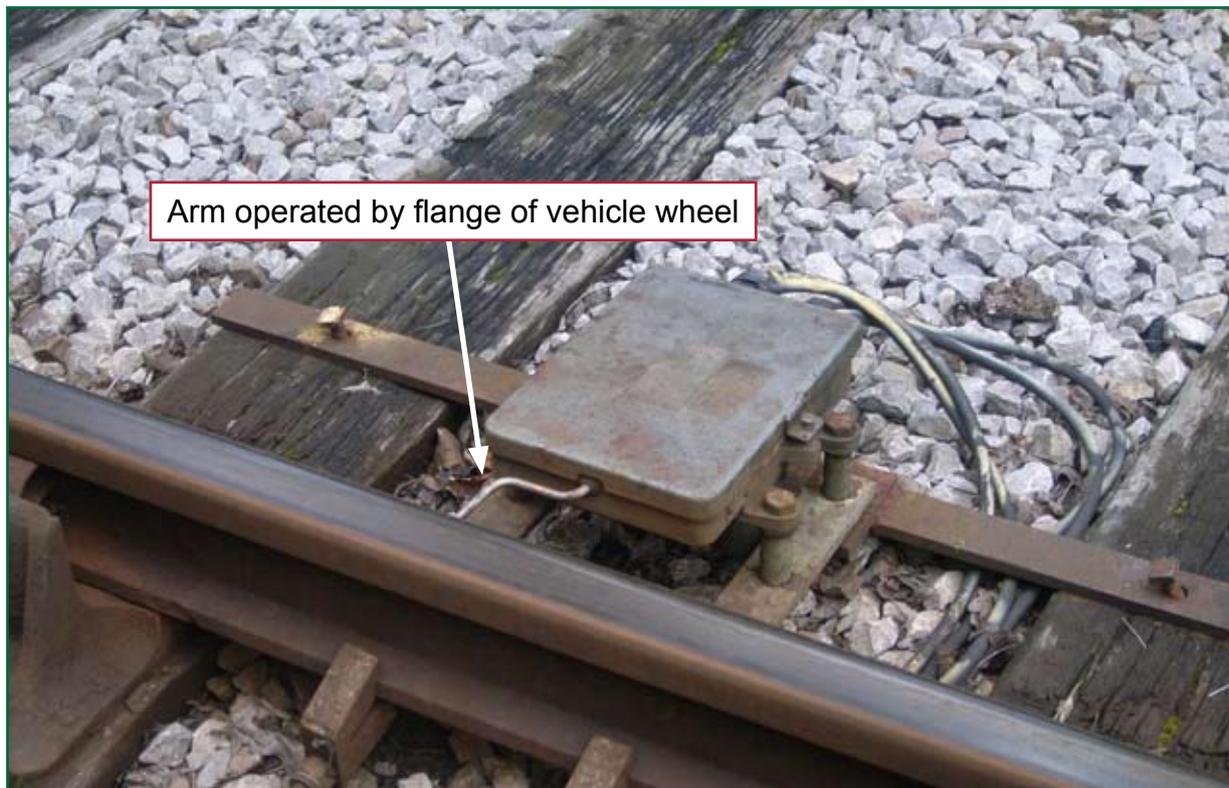
Figure 6: Treadle

- 32 In order to warn the crossing keepers of approaching trains there is a treadle placed 455 metres (500 yards) north of the crossing (Figure 6). Operation of this treadle by a train causes a buzzer to sound, and a light to flash, at the crossing keepers' hut.

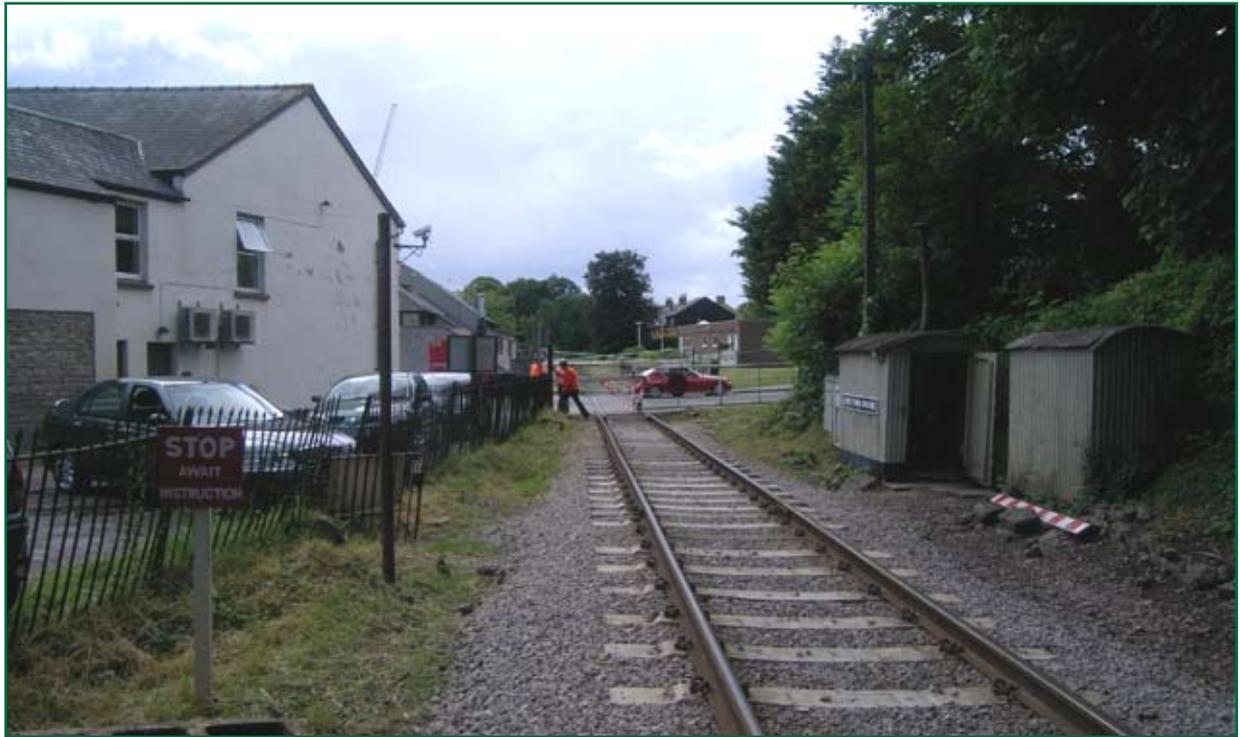
Figure 8: Approach to Lydney Town crossing, showing 'Stop' board

- Be prepared to stop at a board 24 metres before reaching the crossing, unless the crossing keepers give a proceed signal (Figure 8).

- 34 Vegetation to the left of the line obstructs the view of the stop board until the driver is some 40 metres from it, but for a train travelling at 10 mph on a dry rail this provides sufficient stopping distance.
- 35 Figure 9 shows schematically the position of the features in relation to the crossing gates.

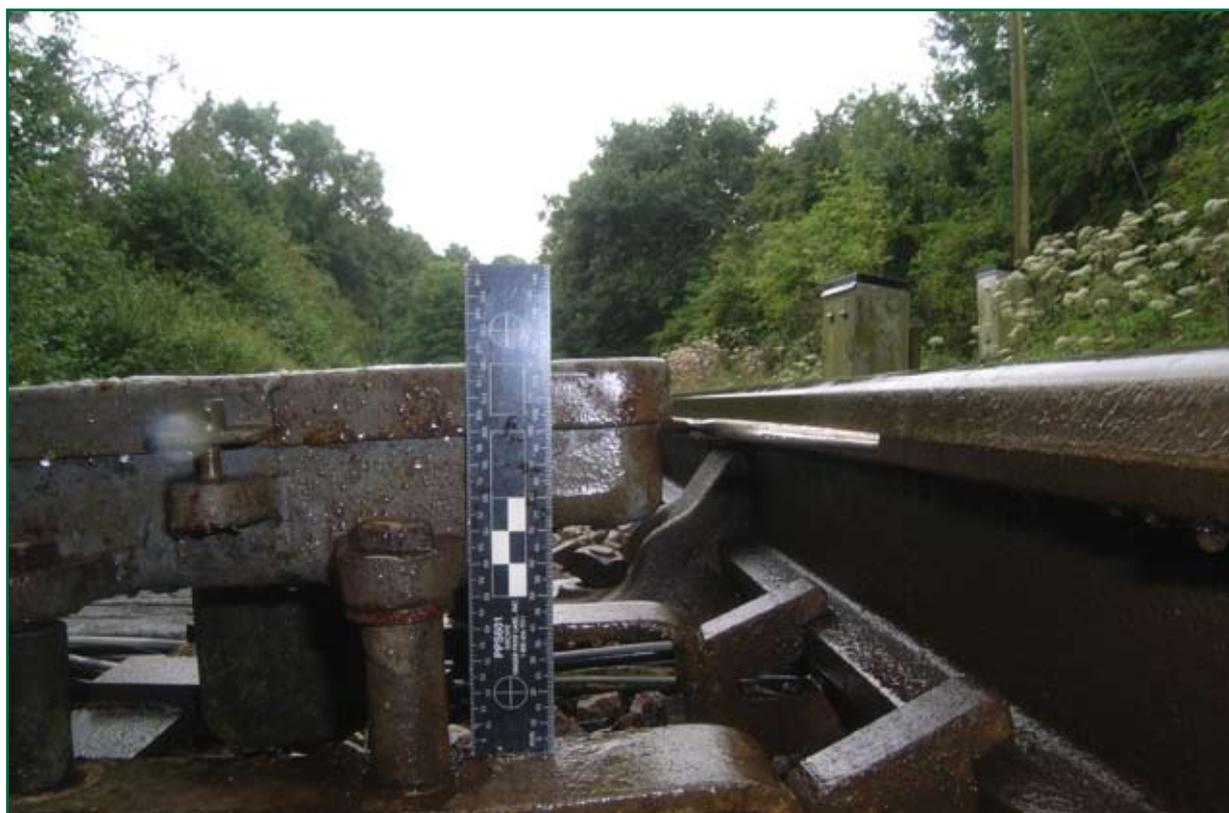
- 85 The treadle was found to be in working order. However, it was not functioning correctly, because its operating arm had been positioned or displaced about 22 mm below the rail head (Figure 14). Network Rail company standards NR/GN/SIG/19046 and RT/SMS/TEST/044 give guidance on the correct method for setting up treadles, and the correct distance of the arm below the rail head for this type of treadle is 16 mm (+/- 1 mm). The lower position of the arm meant that it was being depressed a small distance, or not at all, depending on the actual depth of the wheel flanges (which have a nominal depth of 24 mm). Therefore the warning light was showing for a very short time, or not at all.

Figure 14: Displaced treadle arm

- 86 The incorrect positioning of the warning treadle arm was contributory to the accident. The lack of corrective action by the DFR after it became aware of problems with the buzzer and warning light was also contributory to the accident.

- c. repair the warning treadle (the treadle has been temporarily replaced by a track circuit until it can be demonstrated to be reliable);
  - d. implement a reporting system for treadle malfunctions and ensure appropriate staff trained in its use (completed);
