Rail Accident Report

**Two trains in the same section at Aylesbury
27 August 2007**

Two trains in the same section at Aylesbury

27 August 2007

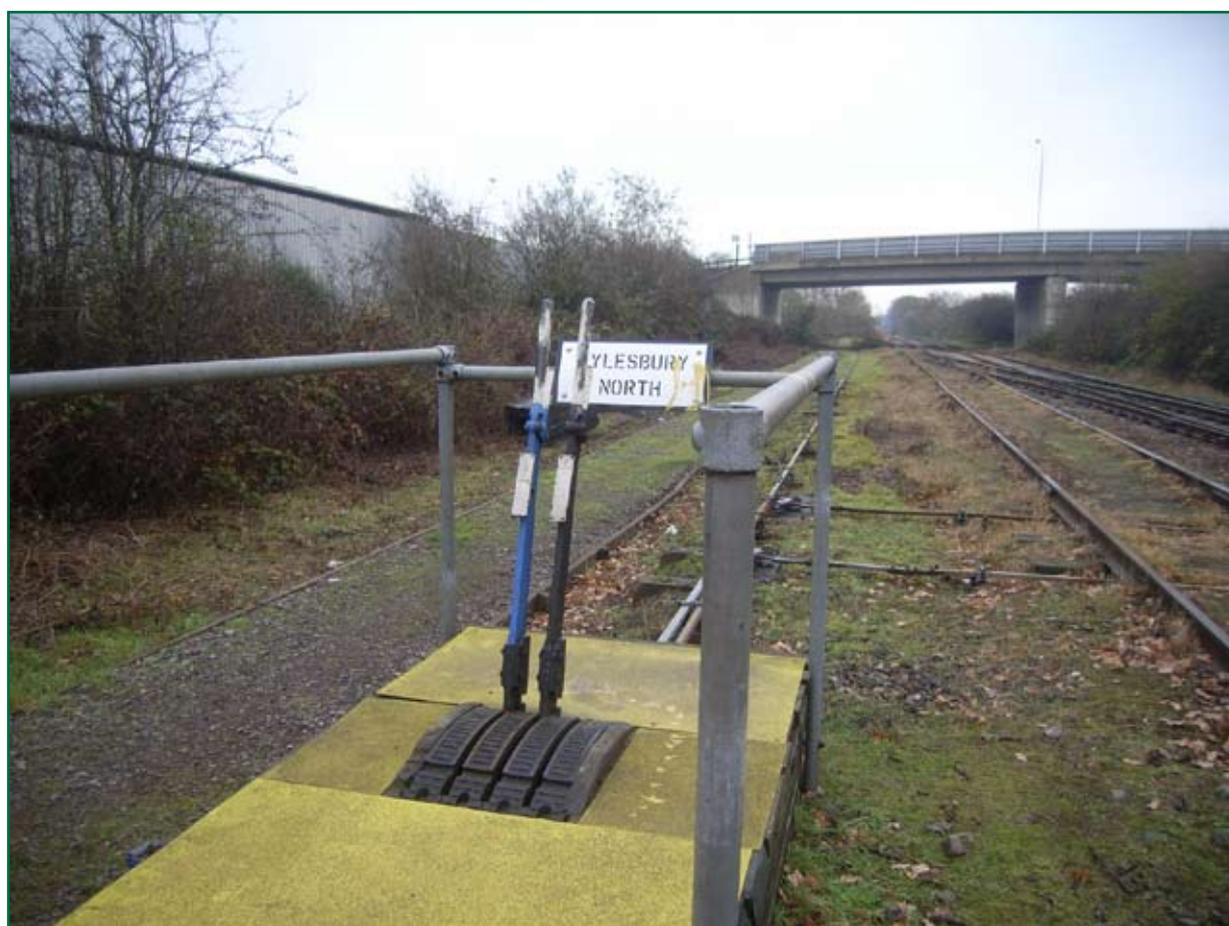
7 The train crew consisted of a driver and a shunter. The shunter obtained a *single line token* from the *token machine* at Aylesbury North *ground frame* (Figures 2 and 3), used it to unlock the ground frame, reversed the points and called the locomotive from the loop onto the running line. The shunter then returned the points to the normal position and returned the token to the token machine.

Figure 3: Aylesbury north ground frame

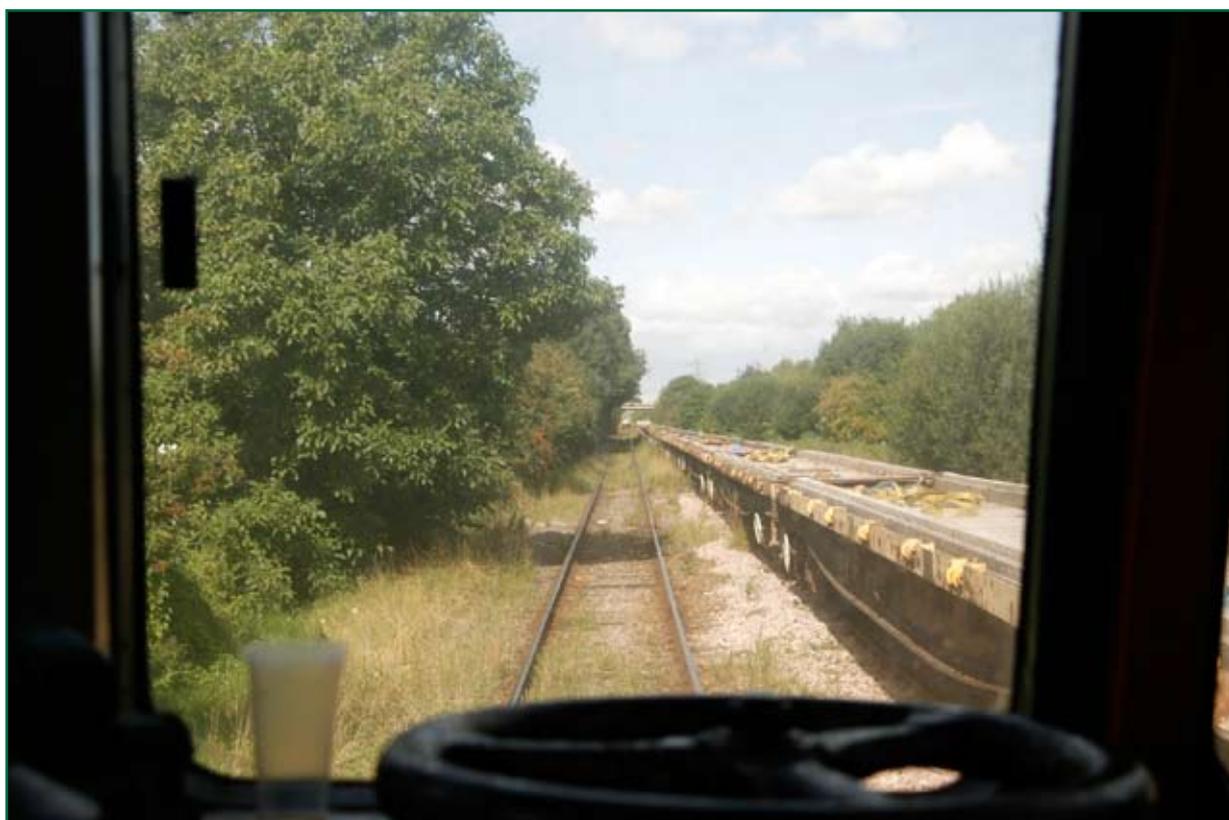
Figure 4: View from the front of train 1T80, showing locomotive 59102 in the distance and vehicles of train 6P27 on the right (photograph courtesy of David Paylor)

- 47 The train rounded a curve in the track and the locomotive from train 6P27 came into view. The driver stopped immediately and made an emergency call to Marylebone IECC.

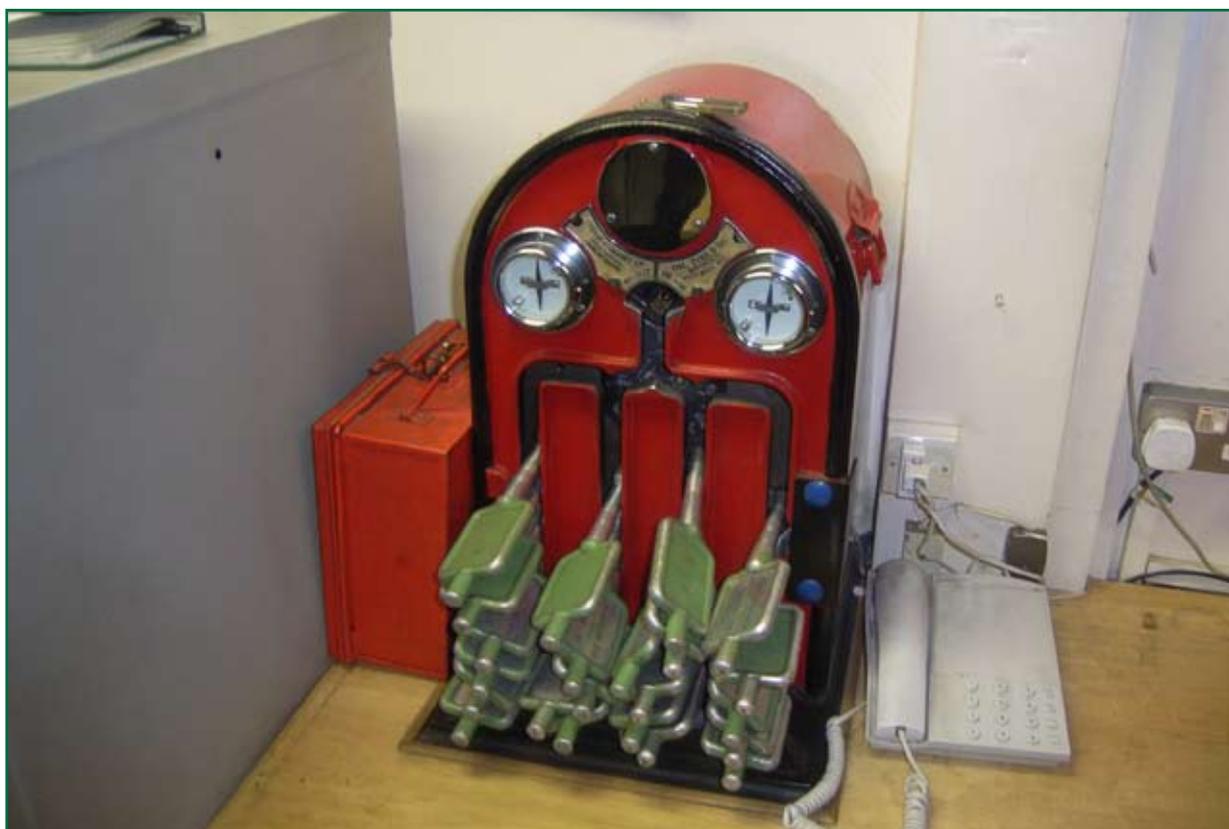
- 19 The token instrument at Aylesbury is located in the train crew supervisor's office (Figure 5). The release of tokens is controlled by Marylebone IECC and Claydon L&NE Junction signallers. The signallers both have to operate a token release control at the same time to release the token instruments.

Figure 5: Token instrument at Aylesbury traincrew supervisor's office

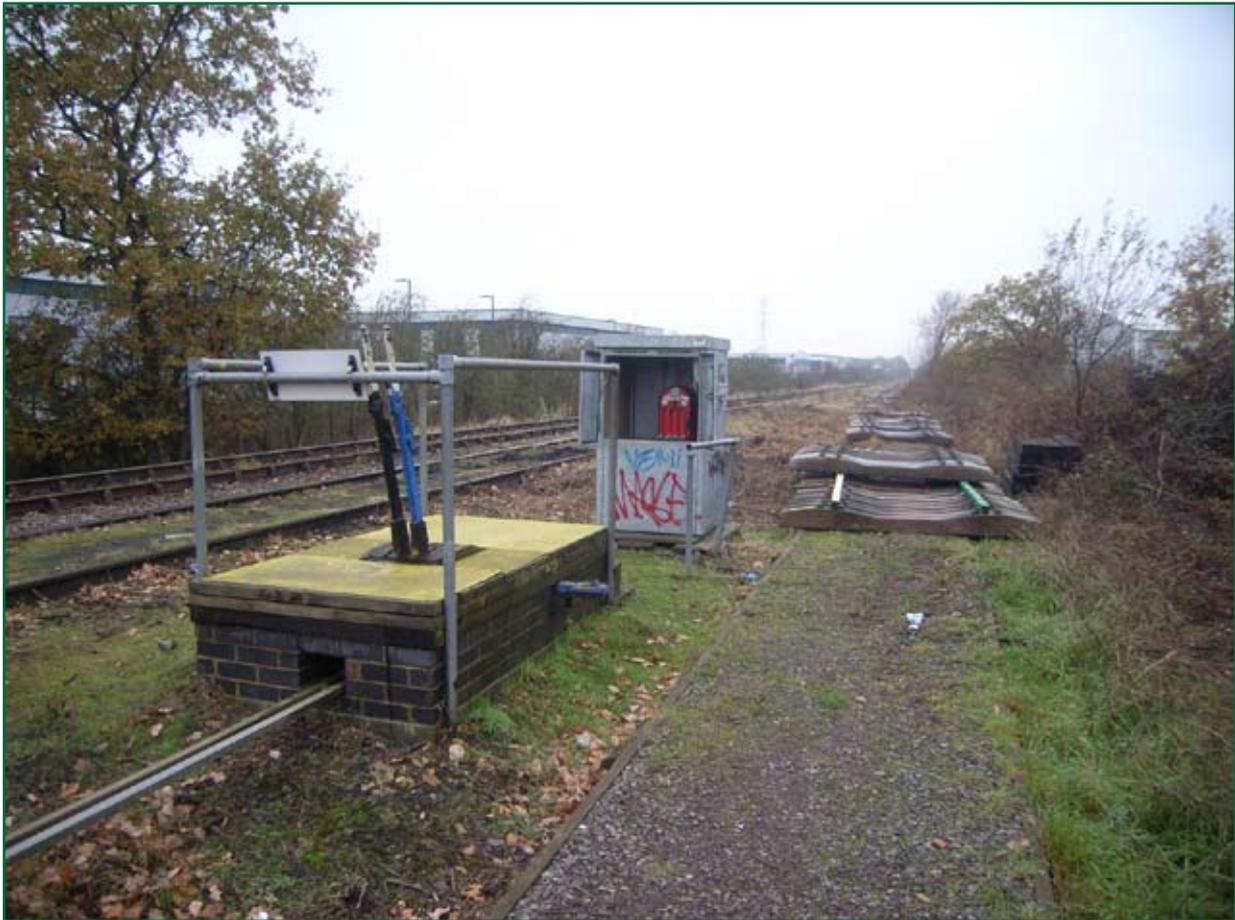
- 40 The shunter locked the ground frame with the crossover points set to the *normal position*, ie for the main line. The token can only be removed from the lock on the ground frame when the points are in the normal position. The shunter then removed the token from the ground frame lock and returned it to the token instrument. Figure 7 shows the ground frame and token instrument.

Figure 7: Ground frame and token instrument at Aylesbury north
