Rail Accident Investigation Branch

# Rail Accident Report

## **Collision between a train and tractor on crossing XL202 near Limavady Junction, Northern Ireland 2 August 2007**

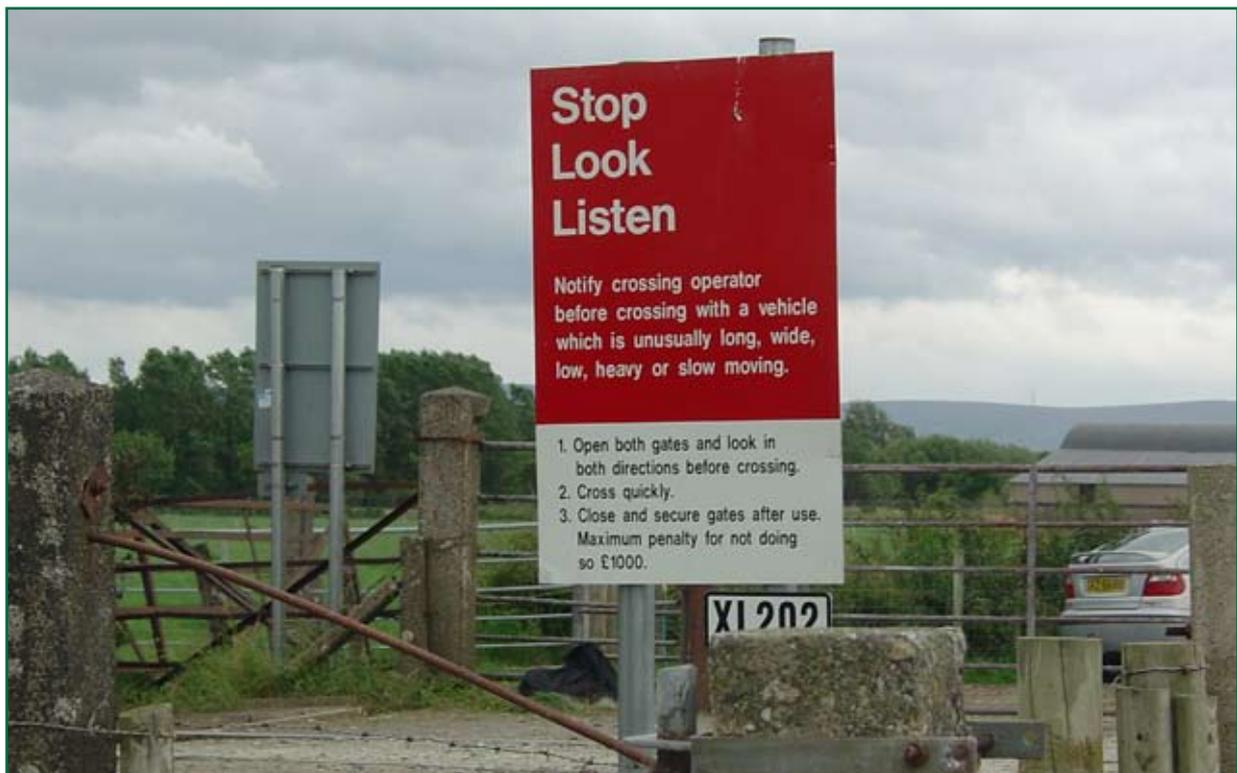
Figure 2: Signage at crossing XL202 (3 August 2007)

- 132 The existing sign does not include contact details for Castlerock signal box. In the event that a problem was encountered by a person not carrying the relevant telephone number with them, they would not know who to contact. A formal inquiry into a collision between a train and a car on a UWC at Woodtown (located nine miles east of crossing XL 202, between Bellarena and Castlerock) on 11 May 2004 recommended that NIR should review the signs at UWCs with one objective being to provide users with the most appropriate means of contacting the crossing operator.

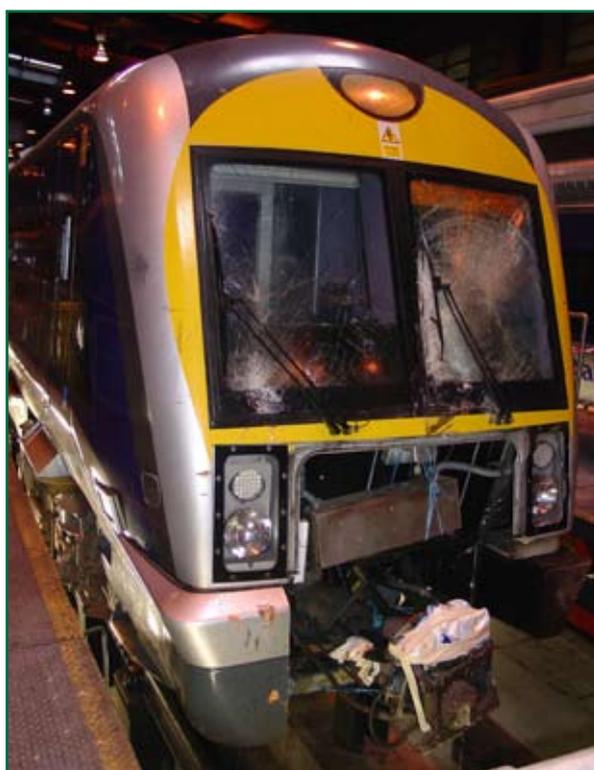
*Figure 3: Damage to the front of unit 3014 (3 August 2007)*

- 36 The tractor driver was thrown from the tractor on impact and suffered fatal injuries.
- 37 The train driver suffered shock and was taken to hospital.
- 38 The conductor and all the passengers were uninjured.
- 39 The tractor was destroyed in the accident.
- 40 The train was damaged during the collision (Figure 3). The damage affected the leading vehicle and comprised:
  - extensive distortion of the coupler;
  - damage to the panels on the front of the train;
  - both windscreens smashed (but the glass remained in the frame); and
  - various items of equipment dislodged, damaged or disconnected including flexible hoses and lighting boxes.

41 Following repair, the train returned to traffic on 7 September 2007.

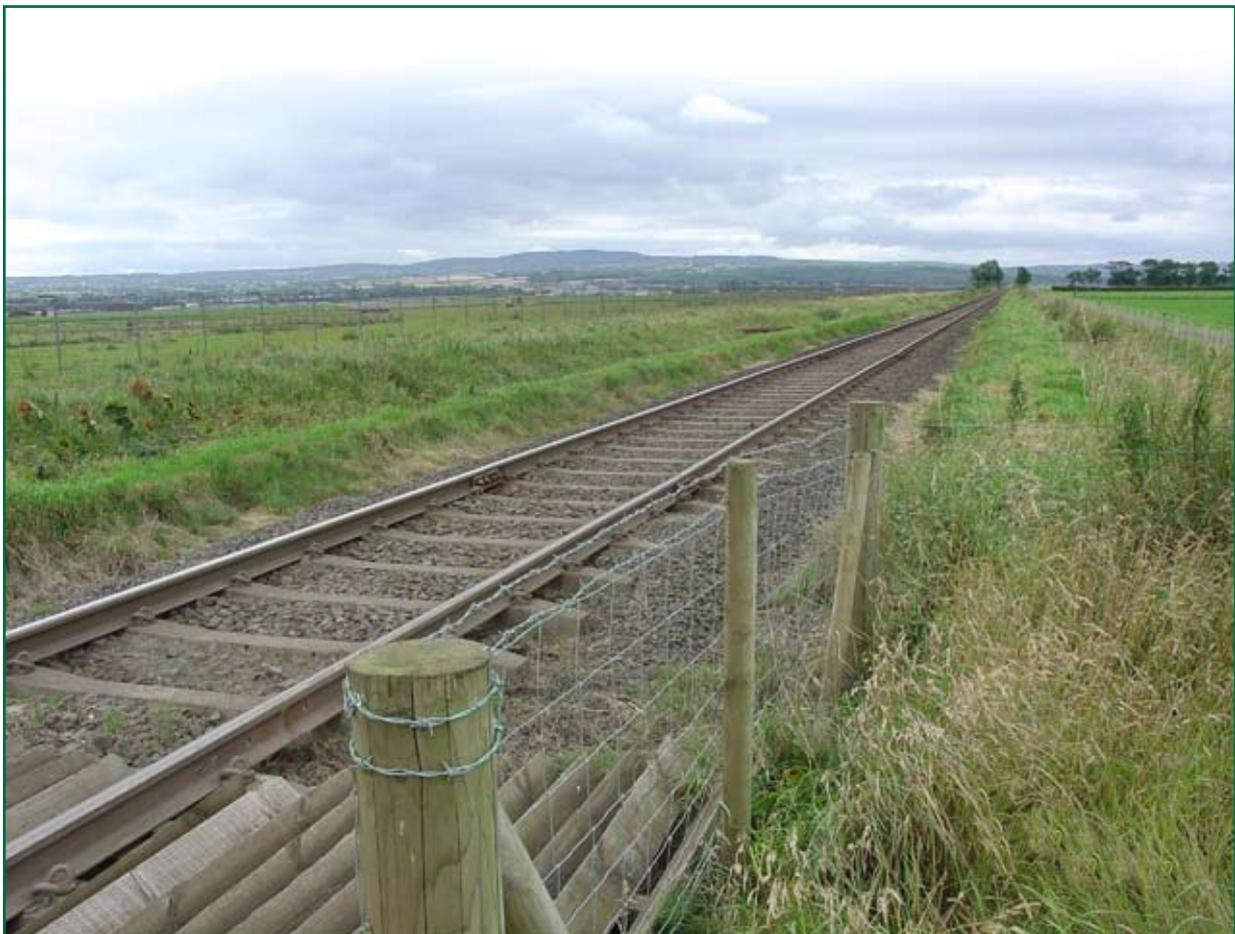
Figure 4: The view towards Londonderry from the north side of crossing XL202 (3 August 2007)

83 The signs at the crossing make reference to the need for users to look for approaching trains. For a tractor driver approaching the crossing from the north side, the view towards Londonderry is good, with no obstructions (Figure 4). The railway is straight at this point and affords a clear view over a significant distance (at least 1000 m) for a road user. The tree to the right of the line in Figure 4 is approximately 600 m from the crossing and train B413 passed the tree approximately 20 seconds before the collision occurred.

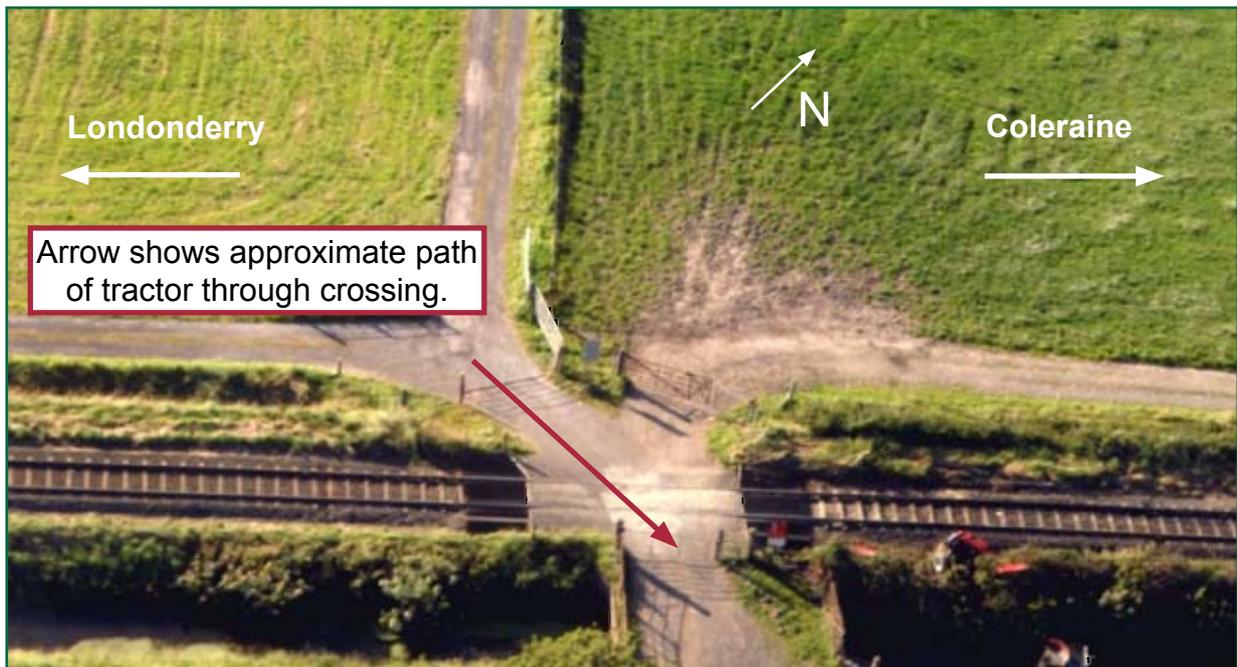
Figure 5: Aerial photograph of crossing XL202 showing 'dog-leg' (2 August 2007) (Photograph courtesy of PSNI)

- 88 When the roadway is running at right angles to the crossing, the tractor driver has a good view of trains approaching from the right. However, just before the crossing is reached, the roadway went through a 'dog-leg' (Figure 5). The gates on either side of the crossing were not directly opposite each other and the tractor driver crossed at an angle to the railway.

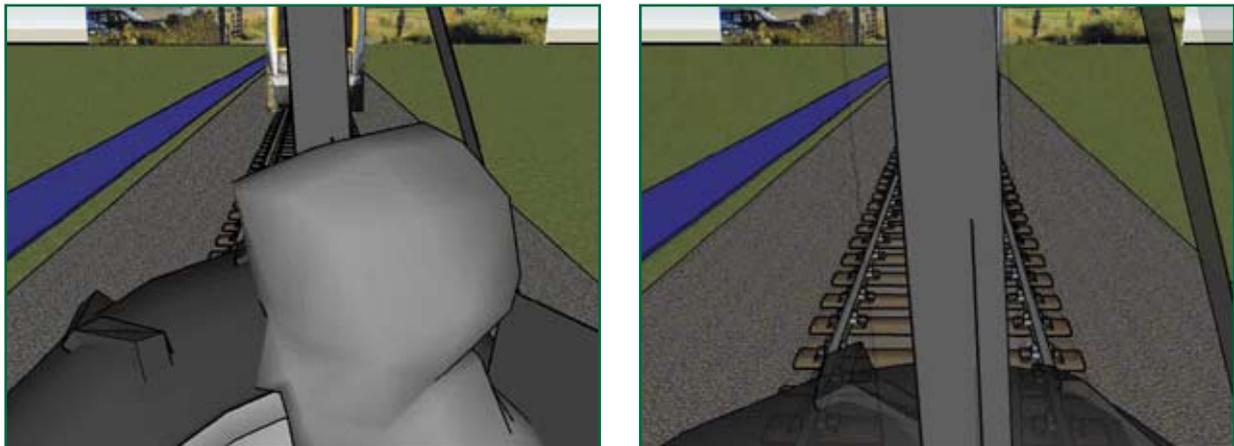
Figure 6: Graphic showing the possible effect of the roof support pillar on a tractor driver's vision at Crossing XL202

- 89 When crossing at an angle, the tractor driver's view to the railway on the right could have been affected by the tractor's roof support pillar when the tractor driver was sitting upright in the seat. This would have started to occur just as the tractor was approaching the railway (approximately three seconds before it reached the point where conflict with the train was inevitable and approximately six seconds before the time when impact occurred) and continued until the time of impact. The presence of the roof support pillar may have impeded the tractor driver's peripheral vision, preventing him becoming aware of the train until it was too late. Even if he had glanced quickly to his right, the presence of the pillar and the bright sunlight coming in through the tractor's right-hand window may have combined to make seeing the approaching train difficult.

90 Figure 6 illustrates the possible problem caused by the roof support pillar when the train is 19 m from the crossing and is based on the design and dimensions of the model of tractor involved in the accident and the dimensions of the Class 3000 DMU. The left-hand graphic shows the position of the tractor driver sitting upright in his seat with the train located 19 m from the crossing, while the right-hand graphic provides an indication of the peripheral vision available to the tractor driver in equivalent circumstances, and shows the roof support pillar obstructing the view of the approaching train. The skewed nature of the crossing, in conjunction with the position of the roof support pillar on the off side of the tractor are possible contributory factors for this accident.
