RAIB Bulletin 03/2008

Freight train derailed in July 2008

Description of the accident and findings of the RAIB

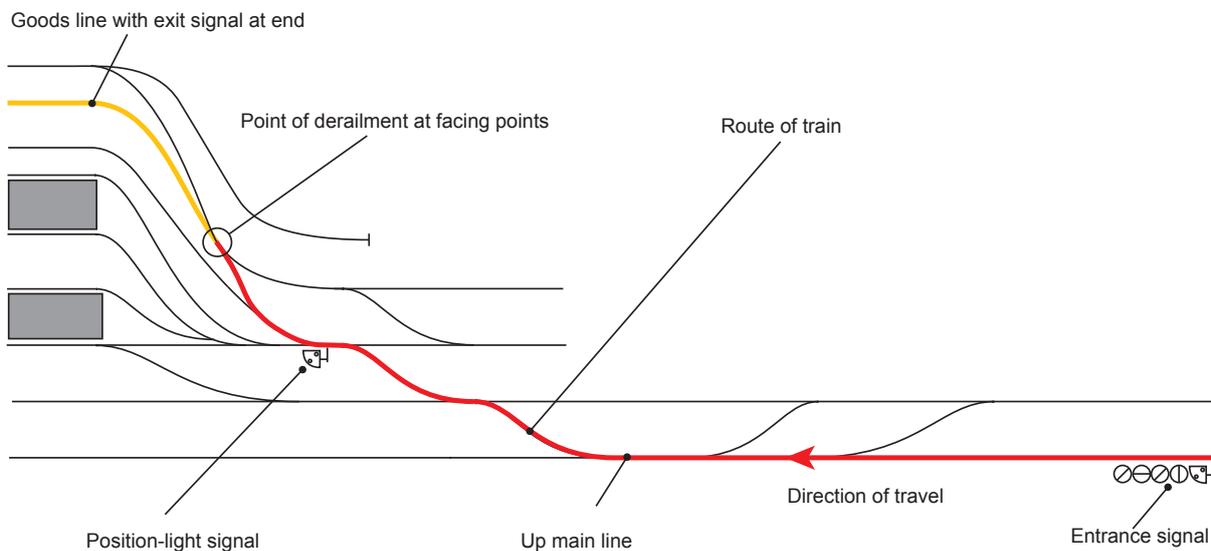
- 1 In July 2008, a freight train derailed at a set of points on the entrance to a goods line as it crossed over from a main line. At the time of the accident, a group of signal maintenance staff were working on these points.
- 2 The front of the train ran onto the points at approximately 15 mph (24 km/h) and all wheels on the front bogie of the locomotive derailed. The signal maintenance staff had moved quickly to a position of safety as it approached, but none were injured. However, the train driver suffered a minor back injury. The locomotive sustained damage to all of the front bogie gearboxes and minor damage to its front end skirt. The points and around 30 metres of track sustained damage.

Figure 1 – Path of train with point of derailment highlighted

- 14 The driver again sounded the train's horn for several seconds and began braking. Upon realising the train was travelling towards them, the signal maintenance staff quickly moved clear. As the points were still in a mid-position, they displayed a hand danger signal. The driver then saw the points were not set correctly and applied the emergency brake but was unable to stop. The front bogie of the locomotive derailed.

- 18 These learning points are:
 - the necessity of following the correct procedures when arranging protection to carry out work on railway infrastructure; the rule book defines all of the methods of protection that staff can use. This accident demonstrates why verbal arrangements to take local control of signalling equipment are not permitted; and

- if a position-light signal along the route between main running signals is not showing a proceed aspect when it should, and the driver sees it, despite there being no requirement to do so, this may indicate that there is a problem along the main route.
