Rail Accident Report

Derailment at Cromore, Northern Ireland 14 April 2007

Derailment at Cromore, Northern Ireland

14 April 2007

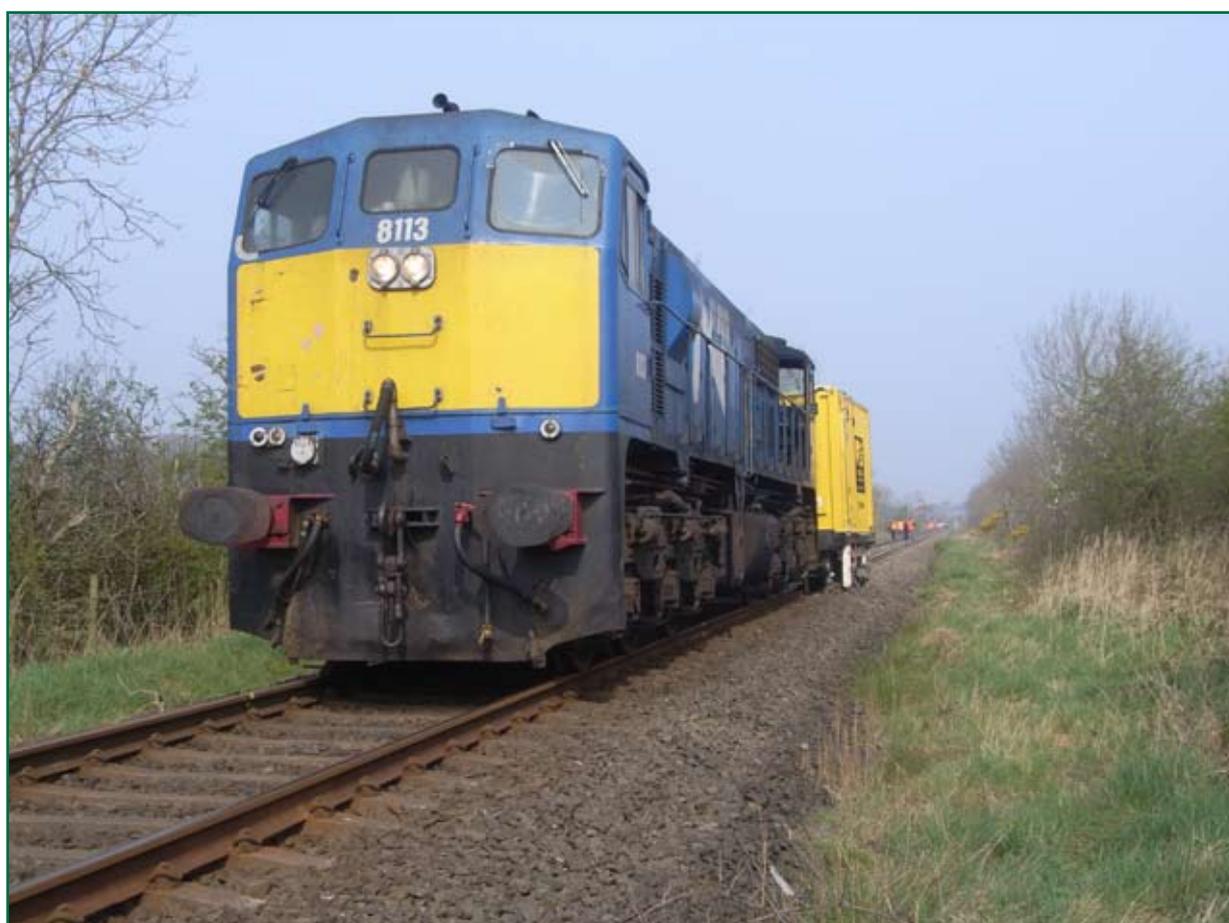
Figure 2: The train after the derailment

- 30 The departure from Portrush was uneventful. As the train approached Cromore it was travelling at about 49 mph (77 km/h), when the Sperry employees in the rear cab saw the test vehicle bouncing violently. It steadied briefly, and then derailed. One of the Sperry staff tried to use the locomotive's horn to attract the attention of the train crew, but without success.
- 31 At about the same time the driver and the guard became aware of a rumbling noise. They both looked out of the cab windows, and looking back could see a cloud of dust. The driver brought the train to a stop with an emergency brake application, and when the crew got out and examined the test vehicle they discovered that it was derailed all wheels to the left in the direction of travel (Figure 3).

- 32 About 400 m of track was damaged, and the running gear of the Sperry vehicle was distorted and some pieces of the brake rigging were detached. The ultrasonic test probes, fixed between the wheels, were destroyed.
- 33 No-one was injured.

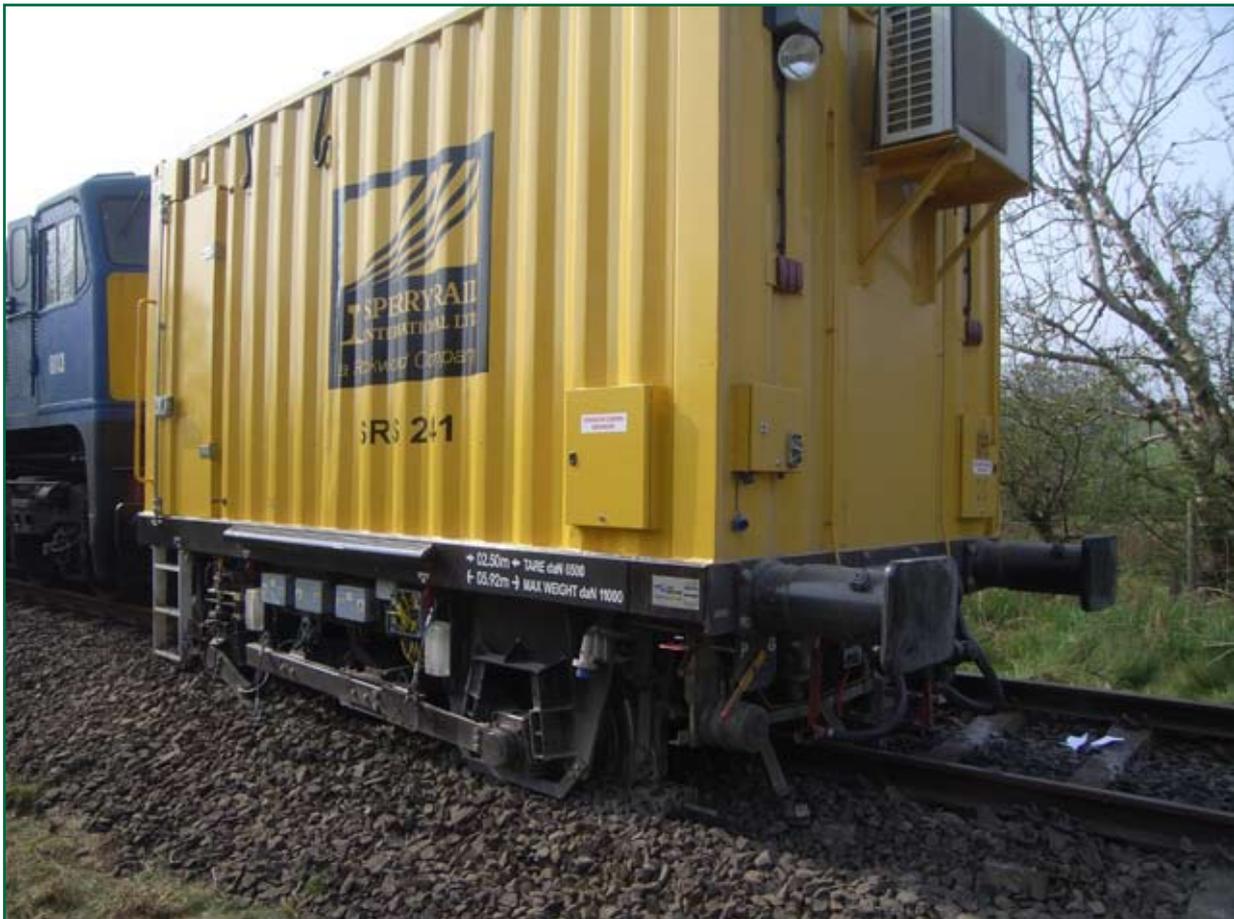
- 22 The test vehicle was built for Sperry International by Cometi of Italy in 2006. The lower portion is a Cometi 'CMT T15' type four wheel flat wagon with rubber suspension units, and has a wheelbase of 2.5 m and an overall length of 5.92 m (Figure 3).

Figure 3: The Sperry ultrasonic test vehicle after the derailment

98 As the wagon had such a short wheelbase, the design of the suspension meant that the wagon was highly sensitive to irregularities in the track, and liable to excitation by cyclic top when travelling at more than 40 mph. This had been recognised in the speed limits that NIR had set out for the wagon, although these were exceeded on 14 April. The design of the suspension was therefore a contributory factor in the derailment **(Recommendation 3)**.

- 121 Sperry have modified wagon SRS241 with softer rubber chevrons in the primary suspension, and the addition of hydraulic dampers. This work was done by the manufacturers, and calculations show that it should be beneficial to the ride of the vehicle and its response to cyclic inputs (**Recommendation 3**).

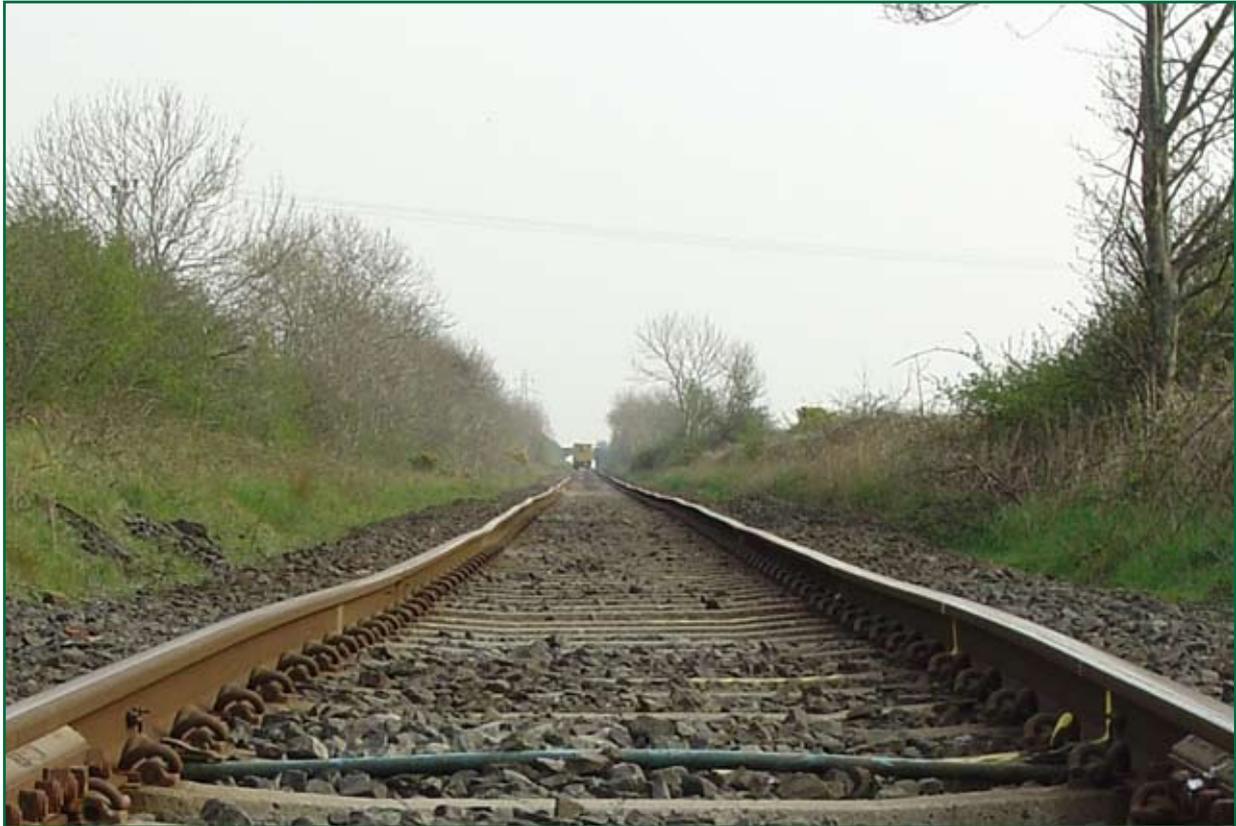
- 42 From the time that it was relaid the track exhibited ‘hogging’, in which each 15 m rail length has a convex vertical profile between the welds at either end. NIR believe that this has got worse in the seven years since relaying, because the dip at the weld results in an increased dynamic load on the formation at this location each time a train passes, and leads to the crushing of ballast and loss of support at that spot, causing the dip to become more pronounced.

- 43 NIR have attempted to correct this effect by *tamping*, but these efforts have not been successful. The result of this is that the track geometry on the Portrush branch now exhibits cyclic top on a 15 m wavelength, for the whole length of the line, and as far as vehicle ride is concerned, it has similar characteristics to jointed track and is sometimes referred to as ‘virtual jointed’ track. The track near the point of derailment is shown in Figure 5 (the derailed train can be seen in the distance).

Figure 5: Track near point of derailment, showing cyclic top

99 The track had been relaid with cyclic top present, and subsequent maintenance had not reduced this: the condition had probably become worse in the seven years since renewal took place (paragraph 42).

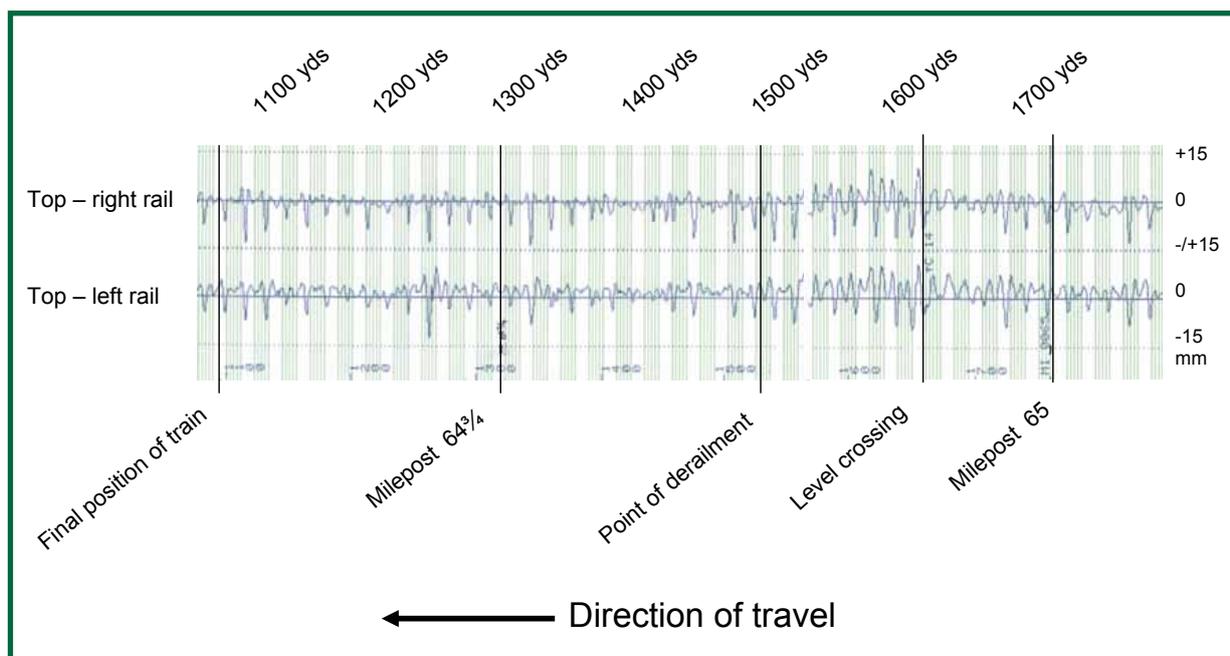
- 45 The TRC run over the Portrush branch in 2006 confirmed the presence of cyclic top along the whole route. Part of the trace covering the area of the derailment is at Figure 6. Distances on the trace are in miles and yards. It can be seen that the left and right top are closely matched, and exhibit peaks every 15 m, corresponding to the length of the cascaded rails that the branch is laid with.

- 46 Shortly after the TRC run this printout was reviewed by the Infrastructure Engineer (Track) and the District Engineer (North). The District Engineer (North) arranged for the line to be tamped during late 2006 to try and correct the cyclic top, but RAIB's site survey after the derailment showed that the track was in a similar condition to that which existed at the time of the TRC run in 2006.

Figure 6: Track recording coach output for area of derailment on 26 August 2006
