Rail Accident Investigation Branch

Rail Accident Report

**Fatal accident at Bronwydd Arms station,
Gwili Railway
19 July 2006**

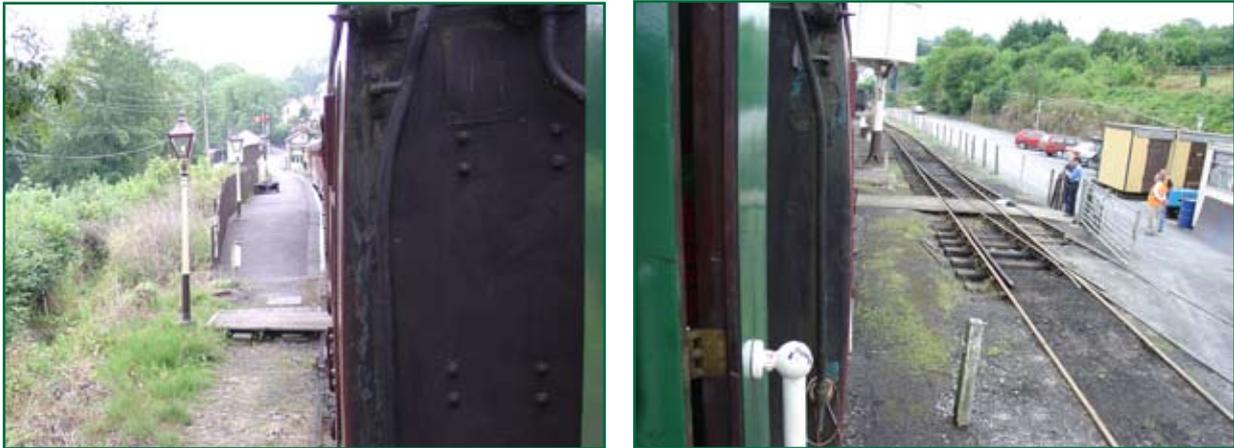
Figure 4: The views from the locomotive cab windows showing the slight curvature of the track at the north end of the station

- 18 The platform is on a very slight curve from west to east as a train approaches the station from the north. This curve is visible in the photographs in Figure 4.
- 19 The station area is fully signalled with semaphore signalling, typical of that found in the 1960s at a country station. The signal box is opposite the platform, adjacent to the level crossing. The fixed signalling system played no part in the accident.
- 20 The Gwili Railway is operated by volunteer staff.

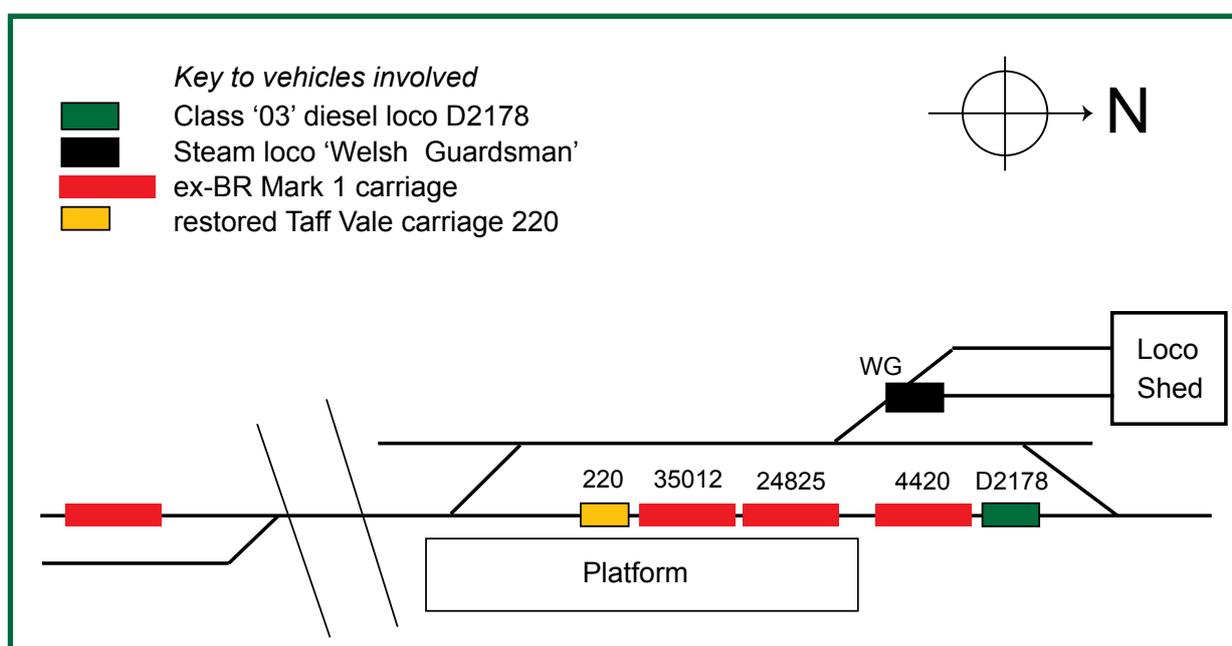
Figure 6: Location of relevant rail vehicles during the during the shunting manoeuvre, immediately prior to the accident occurring

- 40 When the locomotive and carriage had passed the points at the north end of the station, the signaller set the route and cleared the signal for the vehicles to propel back towards the platform line. The driver then commenced the propelling move (Figure 6).

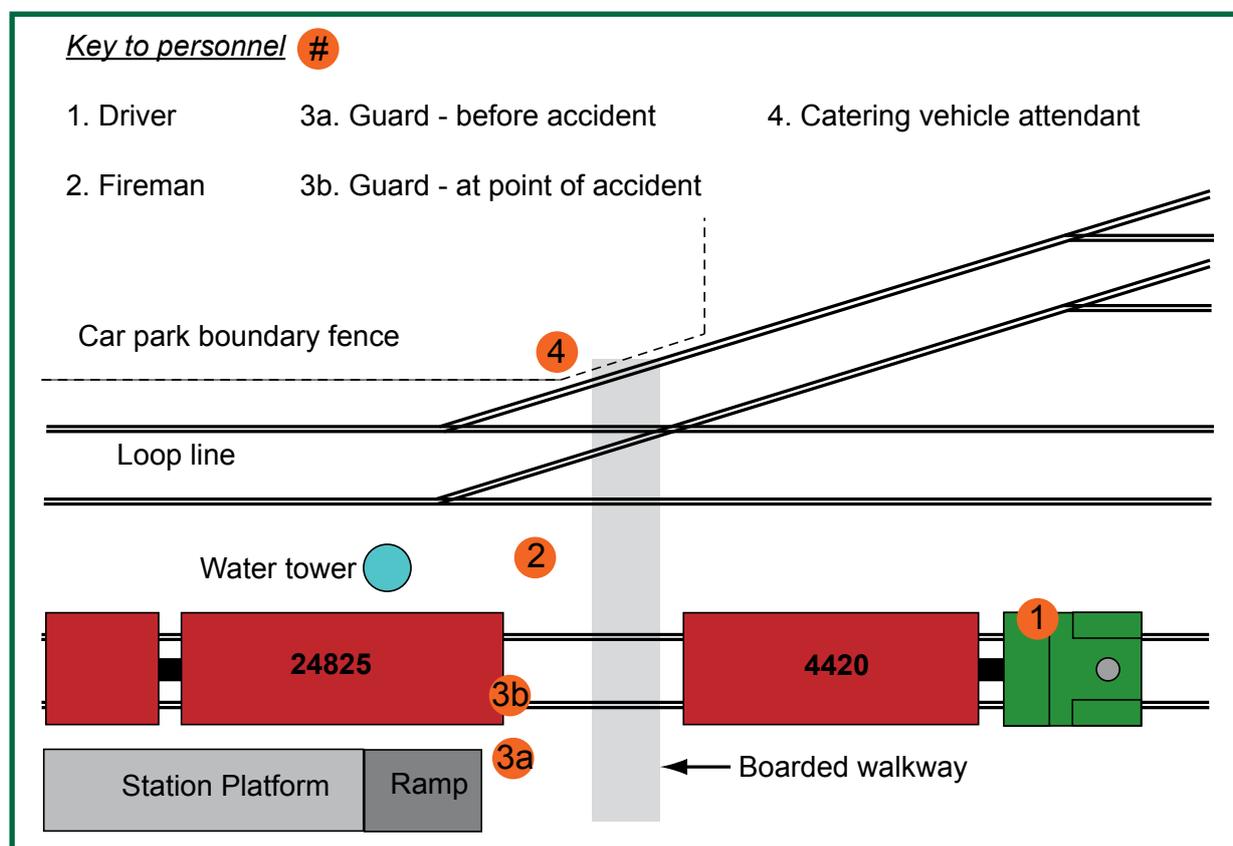
Figure 7: Location of relevant staff during the shunting manoeuvre, immediately prior to and at the time of the accident

- 43 The fireman saw the guard arrive at the bottom of the ramp (position 3a on Figure 7) and advised the guard that he (the fireman) would stop the carriage and attend to the connection on carriage 4420. The fireman did not specifically inform the guard that he had adopted the role of shunter.

- 46 At the same instant the train driver (position 1 on Figure 7) saw a hand signal from the fireman which he interpreted as an 'ease-up' or 'couple-up' instruction and started the movement forward at low speed.

- 64 A reconstruction was undertaken to determine the viewing lines of the driver, the fireman and the guard, based on their positions as denoted in Figure 7. The results of this were:

- the driver could clearly see the fireman in position 2;
 - the driver could not see the guard in either of positions 3a or 3b;
 - the fireman, when looking towards the carriages could see the guard clearly in positions 3a and 3b;

- when the fireman turned to face the driver he was no longer able to see the guard in either position 3a or 3b;
 - the guard could not see the driver from either of his positions;

- the guard could see the fireman from position 3a, but not from position 3b because he was facing the stationary carriage. From position 3b he would not be able to see the carriage moving towards him as it was directly behind him; and

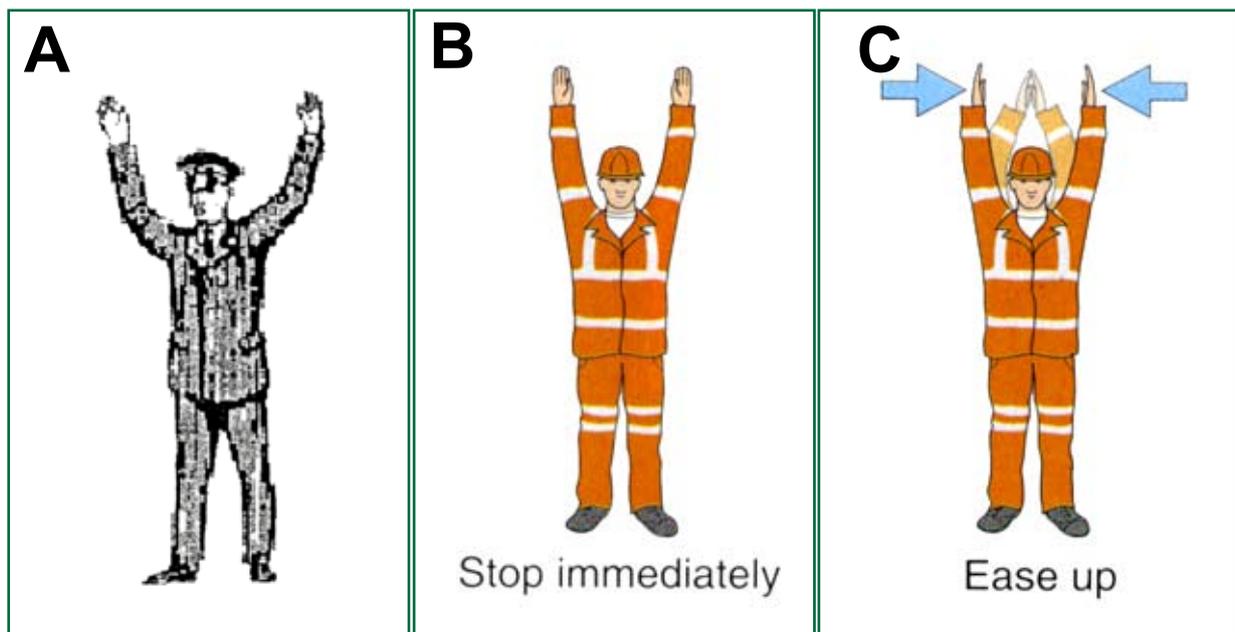
Figure 8: Relevant shunting hand signals described in the Gwili Railway rule book and national rail network rule book GE/RT 8000

- 74 The hand signals applicable on the Gwili Railway are defined in its 1992 rule book amendment No.2, section J4. There is reference to the 'move away', 'move towards', 'slow down' and 'stop immediately' hand signals, with accompanying pictures. That for 'stop immediately' is shown here in figure 8 as 'A'. For comparison with GE/RT8000 module SS2 4.2a the 'stop immediately' hand signal is referred to in Figure 8 picture as 'B'.

- 75 Nowhere in the Gwili Railway documentation is there any reference to the 'ease-up' / 'couple-up' hand signal. However, both the driver and fireman, and other operations staff interviewed were aware of and demonstrated such a signal. 'Ease-up' is an action generally undertaken before physically coupling vehicles in order to close the gap. 'Couple-up' is pushing the vehicles closer together in order to get the coupling made. The hand signal for both actions requires the same response from the driver. This hand signal is described as both hands raised above the head and palms clapped together two or three times, and is the same signal found in GE/RT8000 module SS2 4.2a. It is referred to there as the 'ease-up' signal. The accompanying picture is shown in figure 8 as 'C'.

- 86 The Gwili Railway Rule Book is incomplete in its description of permissible hand signals and also on the restriction on starting or continuing when a hand signal is incorrectly given or not understood. Drivers and shunters routinely use a hand signal that is found on the national rail network but not in the Gwili Railway rule book (paragraphs 73 to 76). **Recommendation 4 refers.**

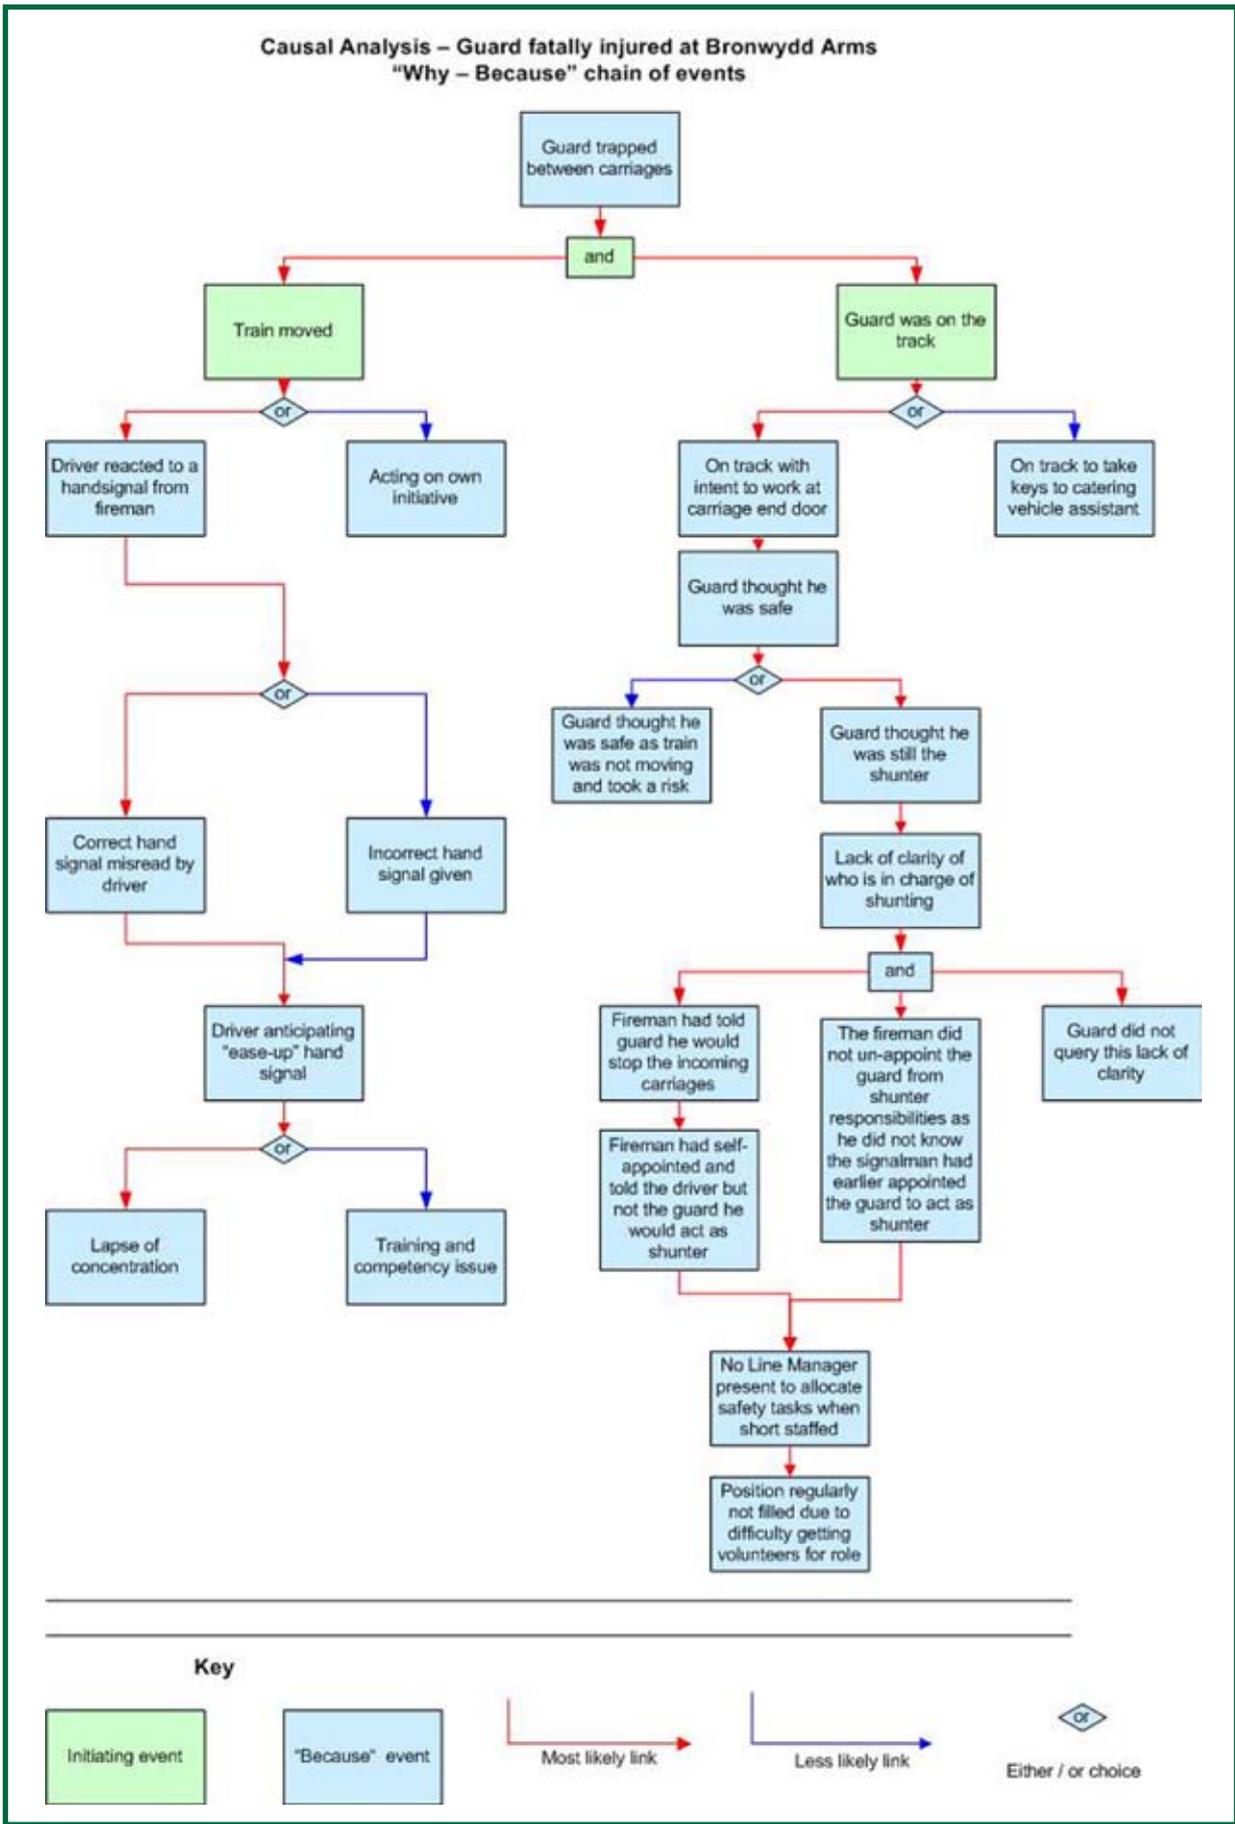
Figure 9: Causal analysis diagram

106 The chart in Figure 9 shows the causal analysis of the accident on a 'why - because' chain of events, starting from the accident event and working backwards. The two initiating events are highlighted, both of which had to happen at the same time for the accident to have the consequence of the guard being trapped between the carriages.
