Rail Accident Report

Derailment at Ropley (Mid Hants Railway) 25 July 2006

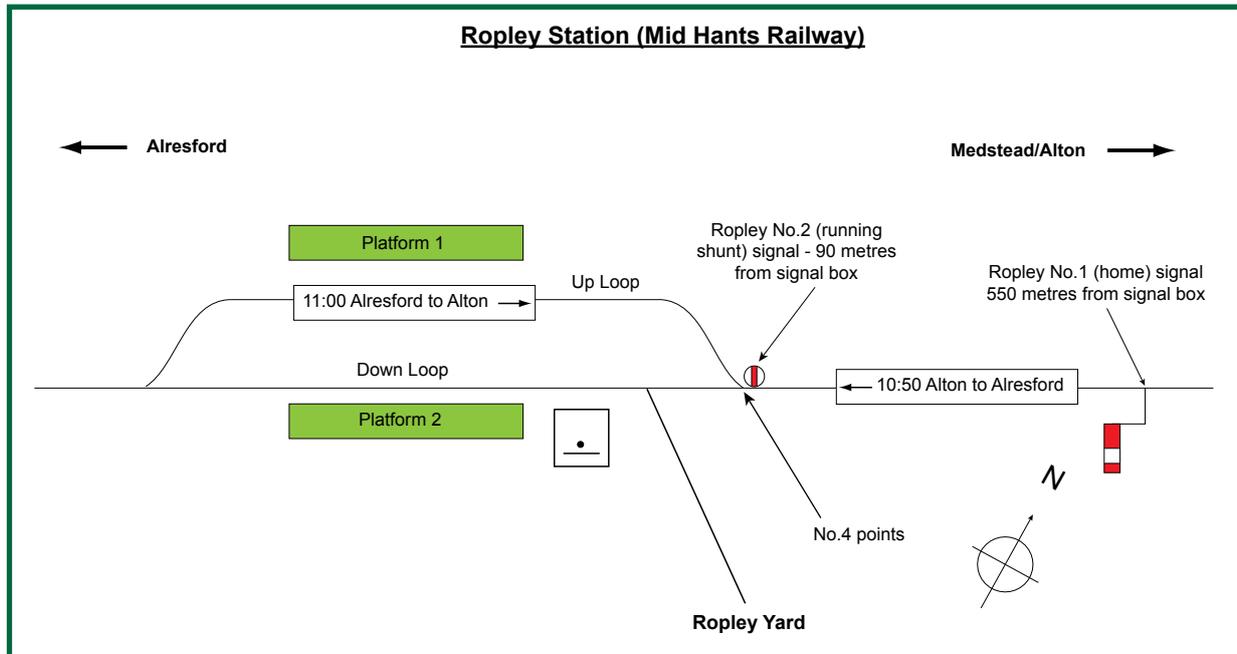
Figure 3: The track layout at Ropley

- 18 At approximately 11:15 hrs on Tuesday 25 July 2006, the leading bogie of the 10:50 hrs MHR service from Alton to Alresford derailed on No.4 points (see Figure 3) approaching Ropley station. There were no injuries to passengers or staff as a result of the accident. The train and track suffered only limited damage. Train services were suspended for the remainder of the day.

- 22 Soon after the leading bogie of the train passed the *switch toes* of No.4 points, it derailed. The derailed bogie followed a path midway between the routes to platforms 1 and 2, while the second bogie remained on the track, but followed the route towards platform 1.
- 23 The derailment became apparent to the trainee driver and instructor almost immediately because of the severe jolting that occurred as the leading bogie left the rails and ran over sleepers. The instructor applied the emergency brake and the train stopped within 20 metres of the point where the front bogie derailed.

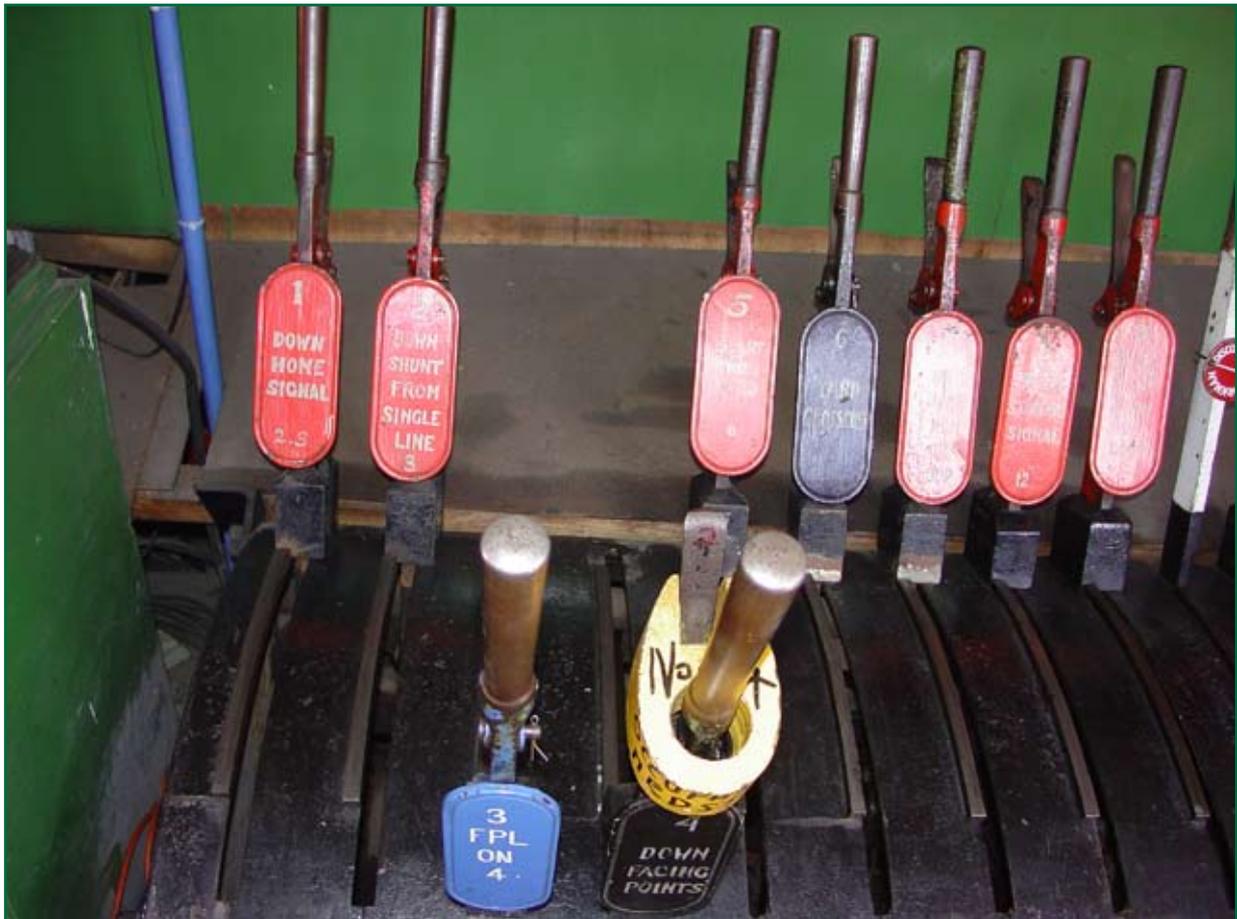
Figure 4: The lever frame in Ropley Signal Box

- 90 Another possible explanation is that having replaced signal No.1 and signal No.2 to danger and unlocked the facing point lock, the signaller realised that the down train had not arrived and, being concerned about the passage of the train over unlocked points, returned to the frame to lock the points again. The levers for the facing point lock and No.4 points are adjacent (see Figure 4). If the signaller accidentally pulled the lever for the points instead of that for the facing point lock, the fact that the facing point lock was already unlocked would allow No.4 points to be moved.
