Rail Accident Investigation Branch

Rail Accident Report

Unauthorised train movement at High Street Kensington 29 April 2006

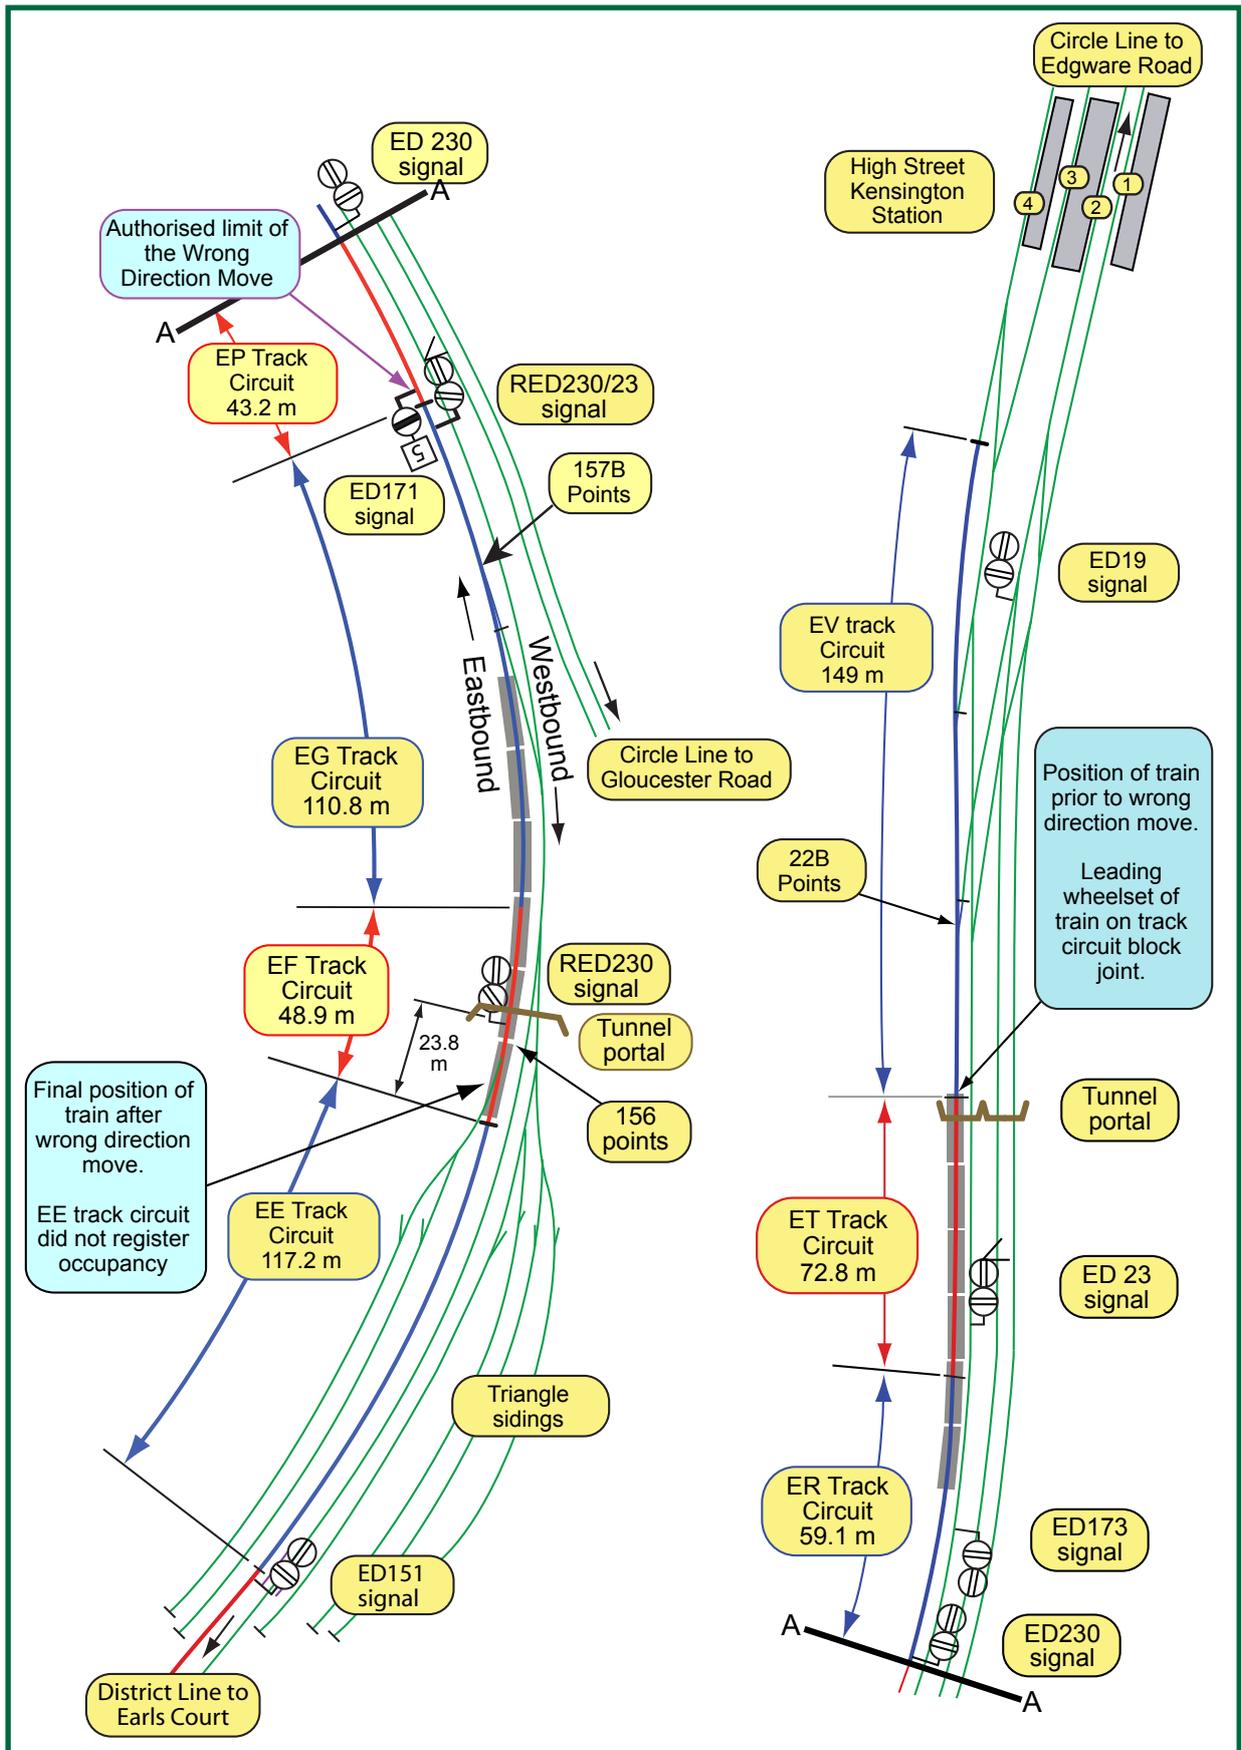
Figure 3: Detailed diagram of track and signal layout between Triangle Sidings and High Street Kensington

- 65 Initially the diagram showed that train 73 had not passed ED23. This indication reflected the condition of track circuits; EP, ER and ET that were occupied, whilst EV was clear (Figure 3). A decision was made in the control room that the Service Operator should take a release for the route currently set for train 73. After the mandatory time delay for the route release, train 73 would be able to enter one of the bay platforms and train 204 would be able to use platform 2. They would only experience the minimum of delay.

- 112 The change of occupancy of EV track circuit (Figure 3) can only be explained by train 73 having stopped with its first wheelset over the IBJ. Initially EV track circuit did not register the presence of the train, however a slight movement of the train or track by just a few millimetres was sufficient to cause EV to register that the section was occupied. There is no evidence to indicate that the train was deliberately moved by the Train Operator at this time. Because no defect was found with the track circuit or IBJ, no other plausible explanation has been found for this occurrence. The position of the train reported by the Train Operator, Station Supervisor – Days and Duty Station Manager validates the likelihood of the first wheel resting on top of the IBJ.

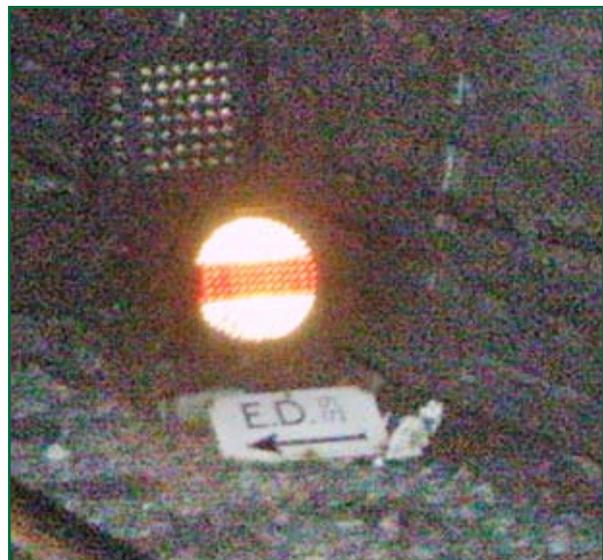
Figure 12: Signal ED171

- 86 The Train Operator continued to drive the train up to and past ED171 which was displaying a STOP aspect. The Train Operator did not advise the Duty Station Manager about the approach to this shunt signal. The train was not *tripped* at the signal because the tripcock had been cut out (see paragraph 113). There is conflicting information about what recognition those in the cab had of this signal. The Duty Station Manager, as the person-in-charge of the WDM, did not instruct the Train Operator to stop the train.

102 The immediate cause of the incident was the failure by the person-in-charge of the WDM to correctly locate and identify the position of ED171 signal and to stop the train at it, The Train Operator also failed to identify ED171 and proceeded past a signal displaying a STOP aspect. The consequence was that train 73 did not stop at the authorised limit of the move. Under slightly different circumstances this could have resulted in a collision with another train travelling in the opposite direction. With the protective measures taken during the incident the risk of such a collision was exceedingly low.

161 The immediate cause of the incident was that train 73 did not stop at the authorised limit of the move (ED171) due to the person-in-charge of the WDM not recognising that limit and not stopping the train at it. The Train Operator also did not identify ED171 and proceeded past a signal displaying a STOP aspect.
