Rail Accident Report

Two near misses at Crofton Old Station No.1 Level Crossing, near Wakefield, West Yorkshire 1 and 18 May 2006

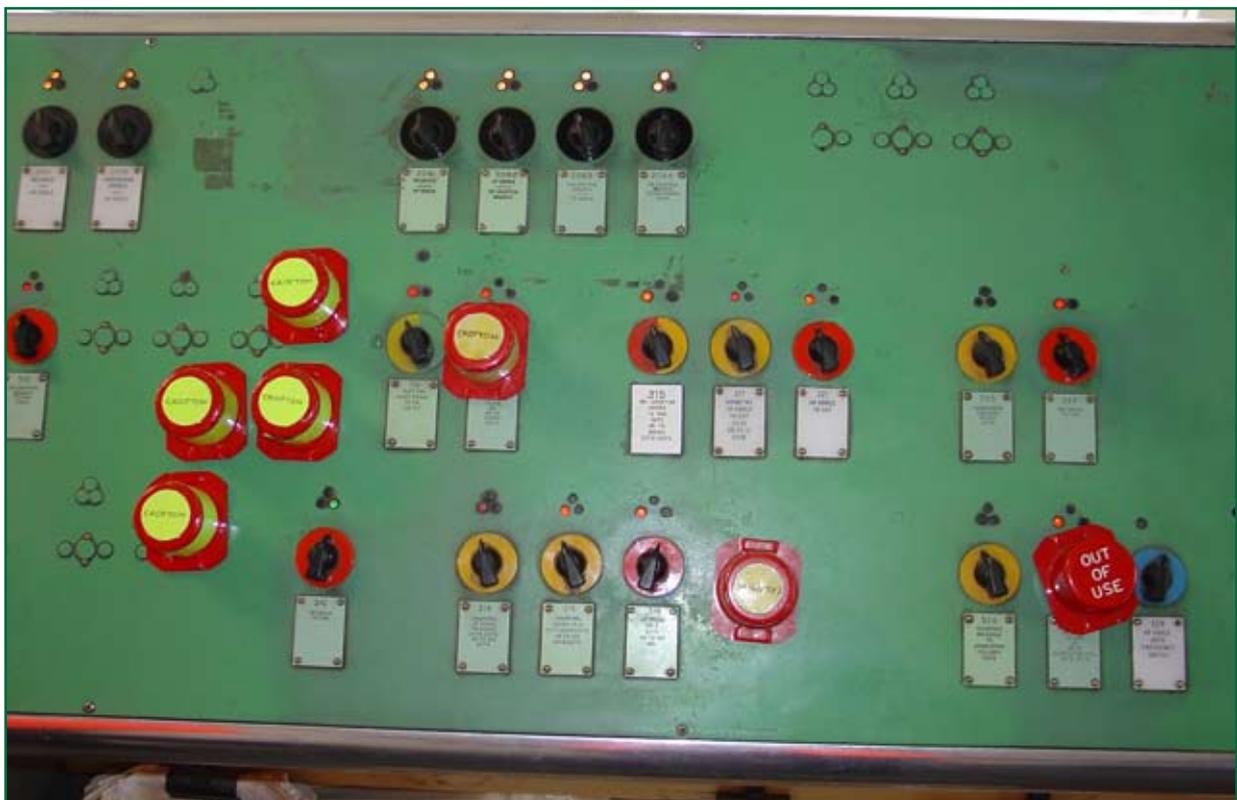
Figure 4: Oakenshaw signal box switch panel showing special crossing reminder appliances

- for incident 2, distraction led to the *special crossing reminder appliance* not being replaced over the switch for Signal O313 the last time it was used.

- 167 The distraction in the duties of Signaller 2 is considered to be contributory to incident 2 in that it led to the omission of the special crossing reminder appliance not being replaced over the switch for Signal O313 following its earlier use.

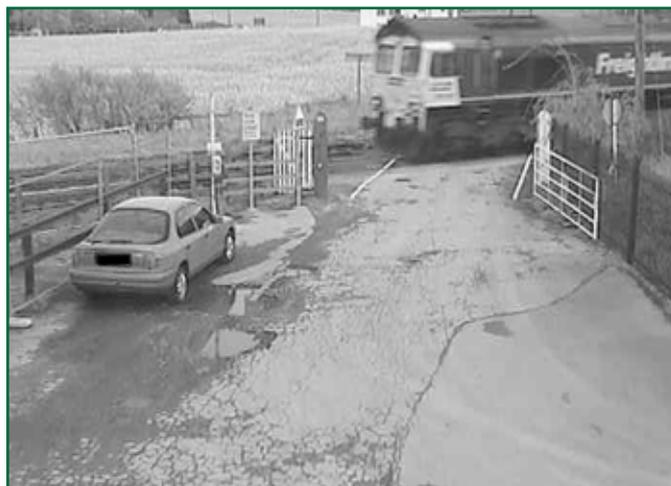
Figure 5: CCTV image of 0D52 passing over the crossing during incident 1

- 45 At around 12:42 hrs, after train 2F71 had passed over the level crossing, Crossing Keeper 1 left the crossing keeper's cabin and opened both level crossing gates to the road.
- 46 Between 12:41 hrs and 12:43 hrs, Signaller 1 cleared Signal O313 for train 0D52 to pass over the crossing on the down line.
- 47 At around 12:44 hrs, a car, driven by Crossing Keeper 2, crossed over the crossing. Crossing Keeper 2, who was about to commence his shift of duty, parked his car close to the cabin and entered the cabin to sign on. The changeover duty occurred and was recorded in the cabin occurrence book.
- 48 At around 12:45 hrs, train 0D52 passed over the crossing with the gates open to the road (Figure 5).

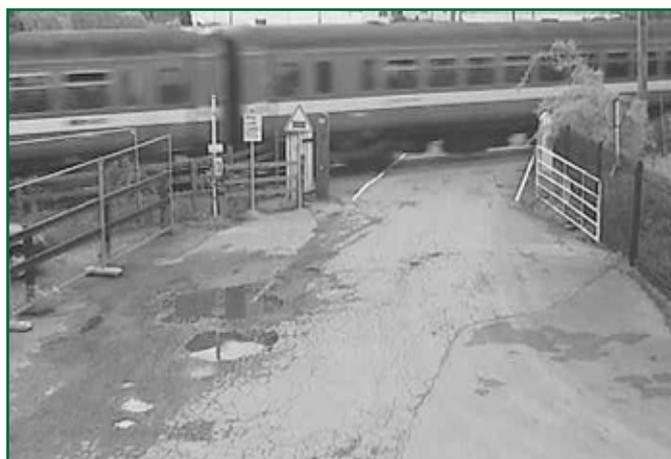
Figure 6: CCTV image of 2F65 passing over the crossing during incident 2

- 69 Train 2F65 passed over the crossing as Crossing Keeper 3 had just locked the up side line gate. He was between the gate and the running lines as the train passed. The gate closest to the down side line was still open to the road (Figure 5).

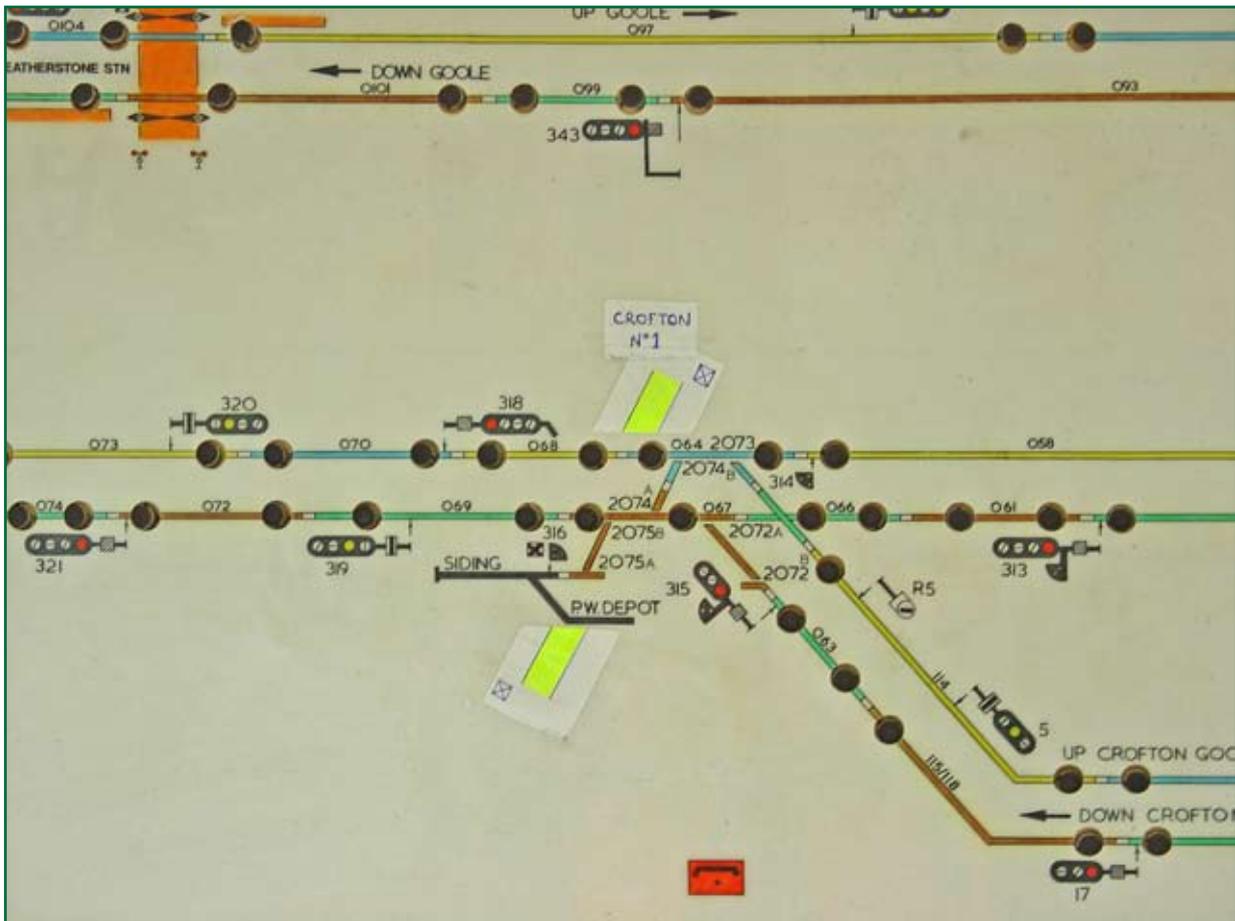
Figure 7: Crofton crossing graphic added to Oakenshaw signal box diagram

- 77 Documentary evidence indicates that Network Rail made a visit, as part of a signalling safety tour, to Oakenshaw signal box on 3 March 2006. This identified the action to place a graphic on the signal box diagram to indicate the position of Crofton Old Station level crossing. This was intended to serve as a visual reminder to the signaller to request that the crossing gates be closed to the road prior to the clearing of the protecting signals. This had previously been identified as an 'essential' action on 27 May 2004 when concerns over the level of traffic were first documented. The graphic was added to the signal box diagram by a local signalling manager on 19 May 2006 after the two incidents (Figure 6).

- The recording of the decision to add the graphic of the crossing to the signal box diagram, which was done on 19 May 2006.
- A reversal of the decision to implement the additional special crossing reminder appliances that had been delivered to the signal box on 19 May 2006. Although these were required for compliance with the level crossing order, the meeting notes recorded that the use of too many may diminish their significance in situations where they were needed for other signal box operations.
