Rail Accident Investigation Branch

Rail Accident Report

Collision between train and buffer stops at Sudbury 27 January 2006

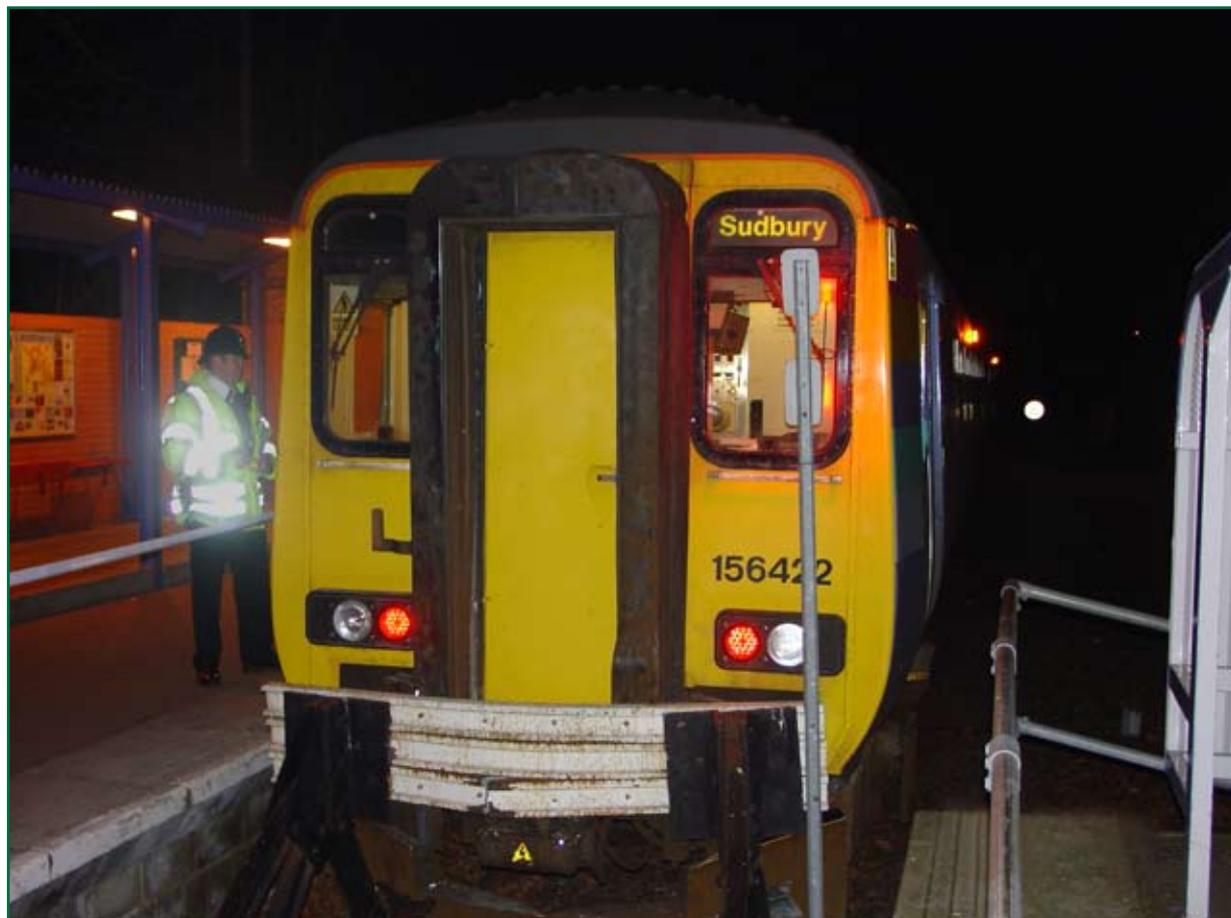
Figure 2: 156422 at the buffer stops at Sudbury immediately after the collision

- 11 On 27 January 2006 at 18:27 hrs a passenger diesel train, reporting number 2T28, ran into the buffer stops at Sudbury Station (Figure 2). It was formed of two coach unit 156422, comprising vehicles 57422 (leading) and 52422 (trailing). Both the train and the station were operated by 'one'. The collision occurred at about 6.4 mph (10.2 km/h) as the train was braking to a stand. Approximately 100 passengers were on board at the time; a number of them received minor injuries as a result of falls caused by the rapid deceleration of the collision. Minor first aid attention was given by other passengers and shortly afterwards by paramedics who were called to the scene. One passenger sustained suspected fractured ribs. No passengers were conveyed to hospital.

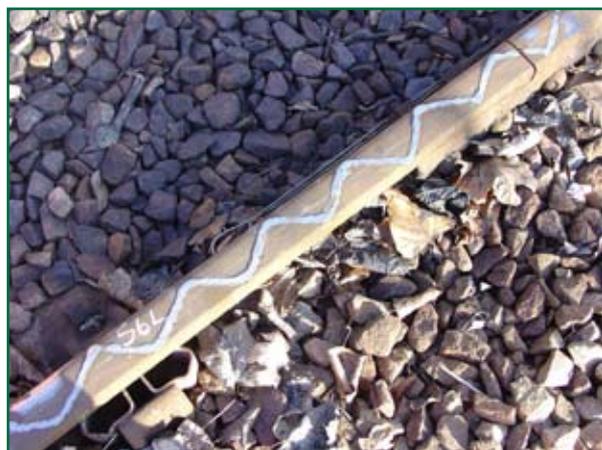
- 17 The track in the platform at Sudbury comprises of 95 lb Bullhead rail held in cast iron chairs with wooden keys on softwood sleepers. The rail heads have *rumble strip* welds added to them (Figure 5); these ensure a good electrical contact between the rail and wheel for *track circuit* purposes. Rumble strips are commonly used where the train service is insufficient to ensure that rust, detritus and contaminants do not build up on the surface of the rail and thus inhibit *train detection*. Although the branch is operated on the single train principle, confirmation has to be received by the signaller that the train has *berthed* at Sudbury before authority is issued for it to depart for Marks Tey. The track circuit at Sudbury, and hence the rumble strips, are provided for this purpose.

Figure 5: Track in Sudbury platform. Example of railhead with rumble strip

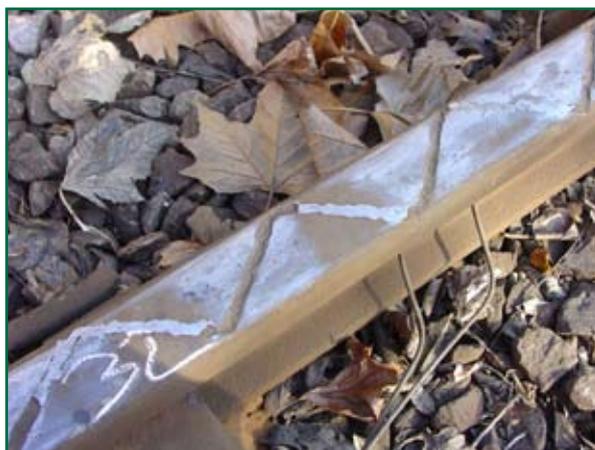
- 18 Certain parts of the rumble strips at Sudbury are nearing the end of their life. Along the length of platform track various examples of defect were found:

- flattened weld;
 - worn down weld with an unusual triangular wheel contact pattern with the normal head of the rail;
 - *spalling* of the weld from the head of the rail.

Figure 6: Track in Sudbury platform. Example of spalling of rumble strip

- 19 Some time prior to the incident, Network Rail had started work to replace the welds. This involved grinding the weld off the head of the rail, grinding out any corrosion from spalling, and re-profiling the head prior to laying down a new zigzag weld pattern. Some parts of the rail head were already awaiting the attention of specialist welders who would apply new weld strips. Figure 8 shows a section of ground rail head.

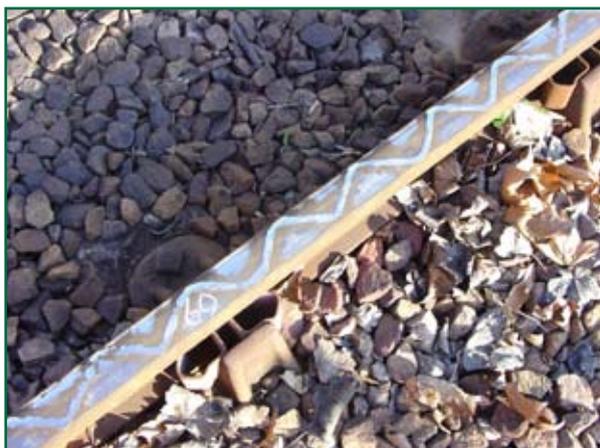
Figure 7: Track in Sudbury platform. Example of worn rumble strips and triangular rail head contact

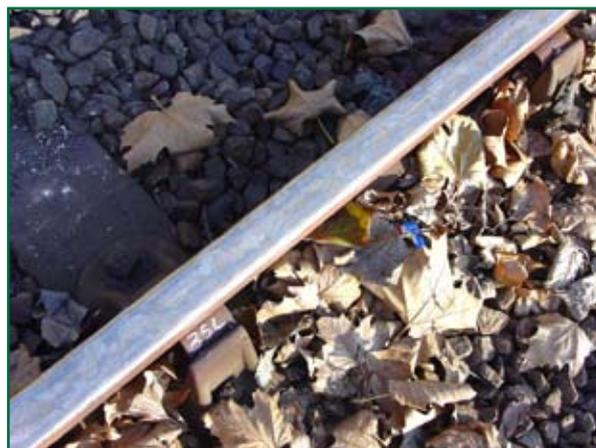
Figure 8: Track in Sudbury platform. Example of smooth rail head

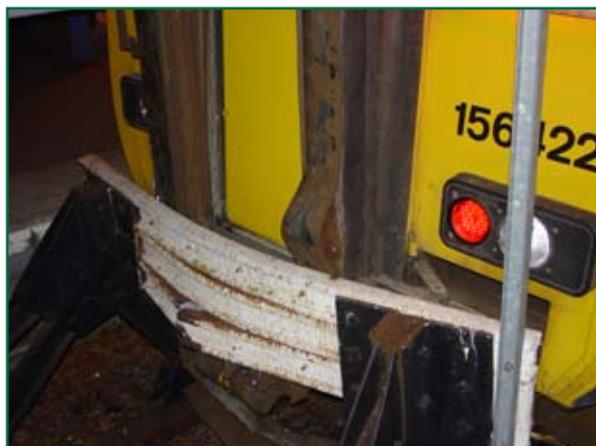
- 44 The collision significantly damaged the buffer stops which suffered severe bending and the fracture of one of the cross bars. The train suffered damage to the obstacle detector, coupler and gangway connection.

Figure 15: Damage to buffer stop with 57422 in its final position

- 105 The buffer stops are of a traditional design, fabricated from second-hand bullhead rail. Many examples of this design can be found all over the Network Rail network, often at the end of sidings. There are two failings of the type that is provided at Sudbury:

- a) There is no buffing or seating block that mates with the centre coupler.
 - b) It does not offer any form of controlled retardation.
- 106 The absence of a centre buffing block resulted in the tongue of the coupler on the train taking the initial brunt of the impact as it hit and fractured one of the buffer stop cross rails.

- 107 The energy of the collision was dissipated by the bending and fracture of the buffer stop and by bending of various parts of the train. Even with the low speed and deceleration experienced it is possible that a different design of buffer stop may have beneficially altered the jerk experienced by the passengers that caused them to be thrown forward. The provision of a more modern design of buffer stop would enable these forces to be focused into defined areas with more predictable results for the train deceleration.

- 108 Replacement of the buffer stop by a more modern design that includes a retardation mechanism would be an advantage; however these designs invariably require an additional length of track on which to fit them. At Sudbury fitment of such a design would almost certainly require the platform to be lengthened and for the TPWS loops and other electrical systems to be altered. The service pattern and likelihood of a repeat incident may make the expenditure difficult to justify. Nevertheless Network Rail should investigate the provision of an alternative design of buffer stop that should be fitted if it is practical to do so (Recommendation 2).

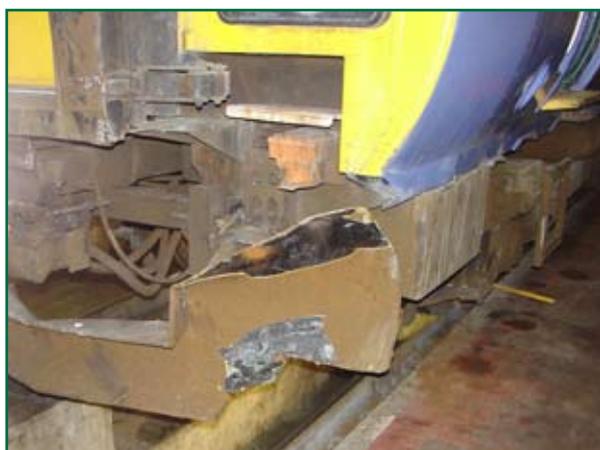
Figure 16: Damage to 57422 (left-hand side)

- 109 The damage to the train was relatively minor. The coupler, gangway connection and obstacle deflector all required remedial action prior to the train re-entering service. There was no evidence that caused concern regarding the train's crashworthiness.

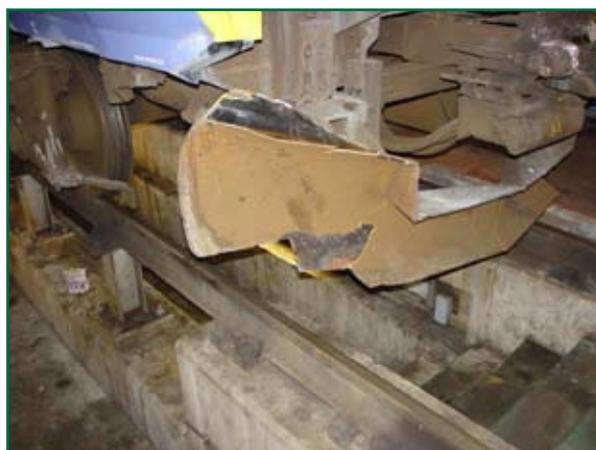
Figure 17: Damage to 57422 (right-hand side)

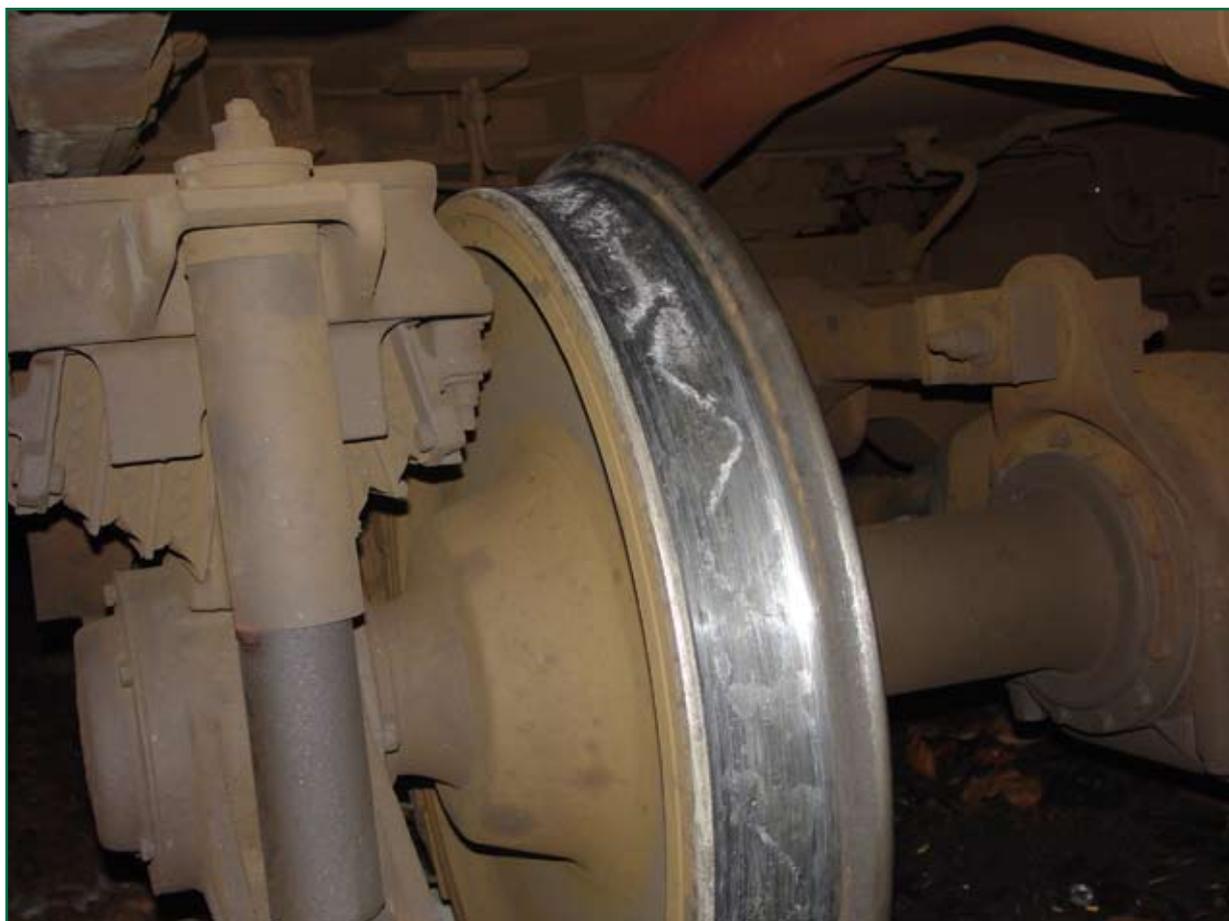
Figure 18: Sand pattern on wheel

- 75 Areas of sand deposit unaffected by any rolling wheel were also found on the rail head immediately below the sand pipes. This was caused by residual sand continuing to flow down the delivery pipes after the sand demand had been switched off due to the train being stationary.
