Rail Accident Investigation Branch

Rail Accident Report

Derailment near Moy, Inverness-shire on 26 November 2005

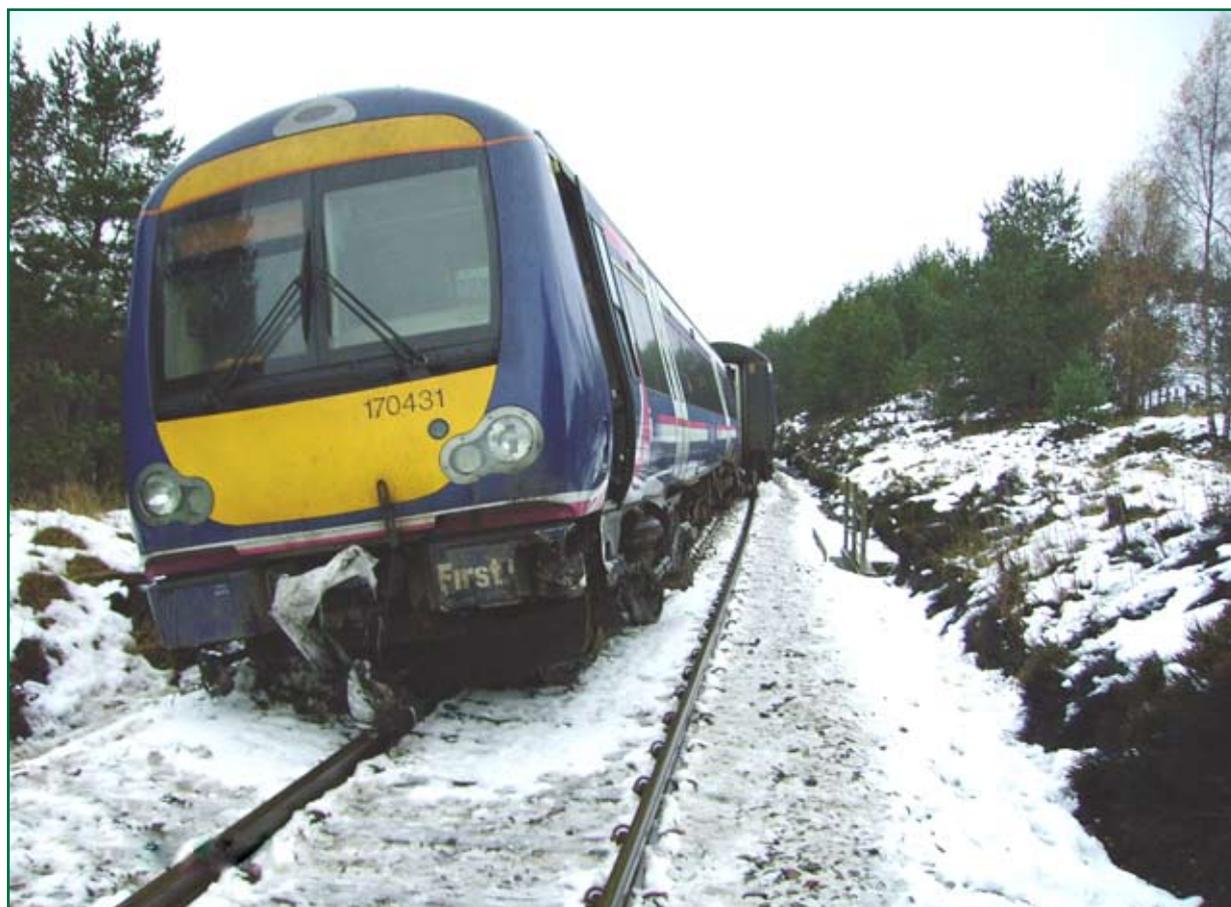
32 At approximately 07:02 hrs the train encountered a landslip in the cutting north of Moy. All wheels on both bogies on the leading vehicle derailed to the right, the down cess. No other wheels were derailed. The train came to rest upright after travelling a further 122 m, Figure 2. (There was found to be timing mis-match between recording equipment fitted on the train; it is possible that the time of encountering the landslip was up to four minutes later).

Figure 2: The derailed train.

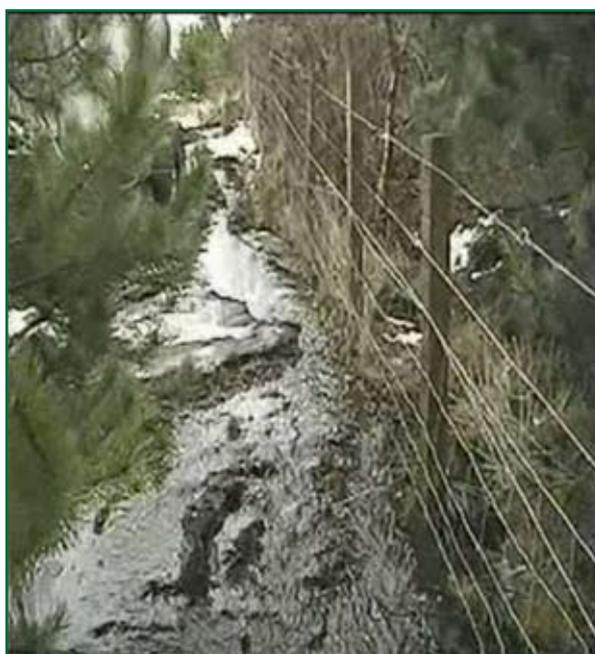
- 63 Some surface water runs off the northern end of the Parking Area. There is evidence that a portion of the run-off then breaches the boundary fence and enters the Network Rail crest drain, as shown diagrammatically on Figure 4 and also on the video image at Figure 5. Just north of this location, a tree was found growing which blocked the drain. No water flowed past the blockage; it was observed to infiltrate into the ground via an apparent 'sink hole' in the drain invert. There was no evidence of ponding due to the blockage or water then overspilling onto the cutting slope. (A portion of the remaining run-off was observed to enter the 3rd party V-drain indicated on Figure 4. Water overflowed from this drain and entered the Network Rail crest drain via an additional breach of the boundary fence north of the tree blockage. However, at this location both drains appeared to be free-flowing and therefore effective in taking the water away from the cutting slope).

Figure 5: Still image from the site video showing water breach through the boundary fence and into the Network Rail crest drain (Image: Network Rail).

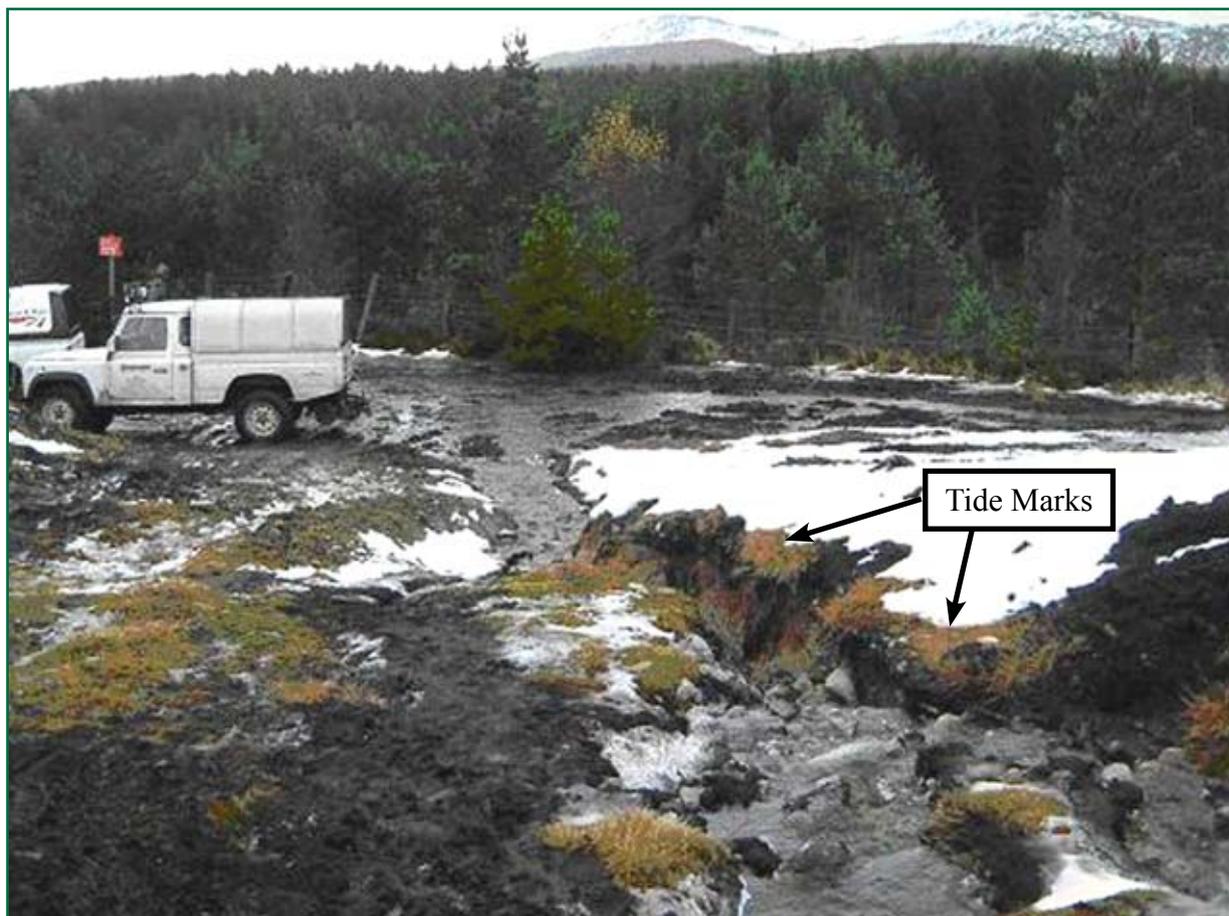
64 Site photographs taken by the Site Witness immediately after the incident show a significant amount of water flowing onto the Parking Area (Figure 6). The presence of tide marks in the snow can also be seen again indicating that the flow had been higher.

Figure 6: Water observed flowing onto the Parking Area.

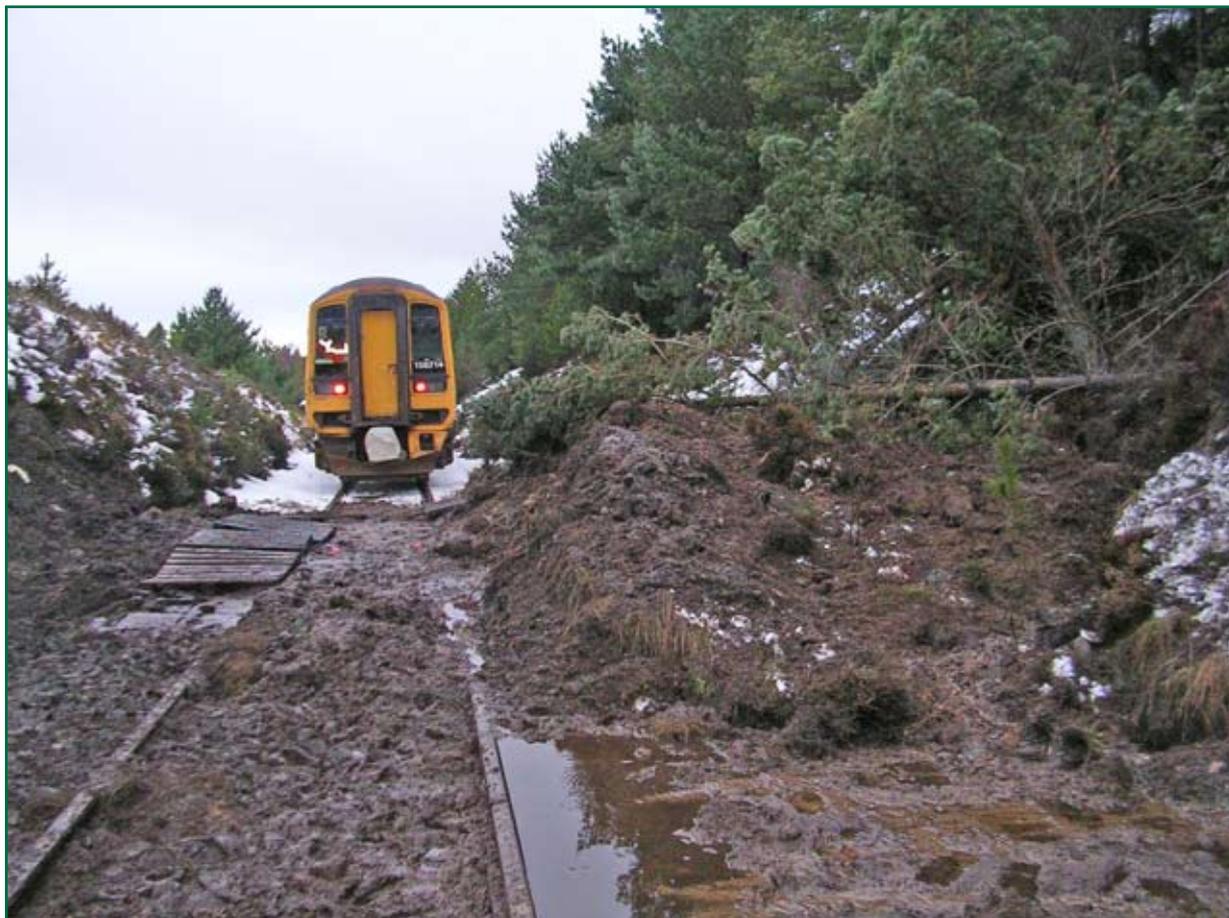
77 A fan shaped debris pile was observed spreading out from a slip bowl. This resulted in the deposit of a pile of mixed soil material between 1.5 and 2 m high across the track, Figure 7. The observed landslip is typical of an initial deep rotational failure followed by an *earthflow*.

Figure 7: Debris pile from landslip (the train shown is the one sent to site for rescue). (Photograph: Network Rail)

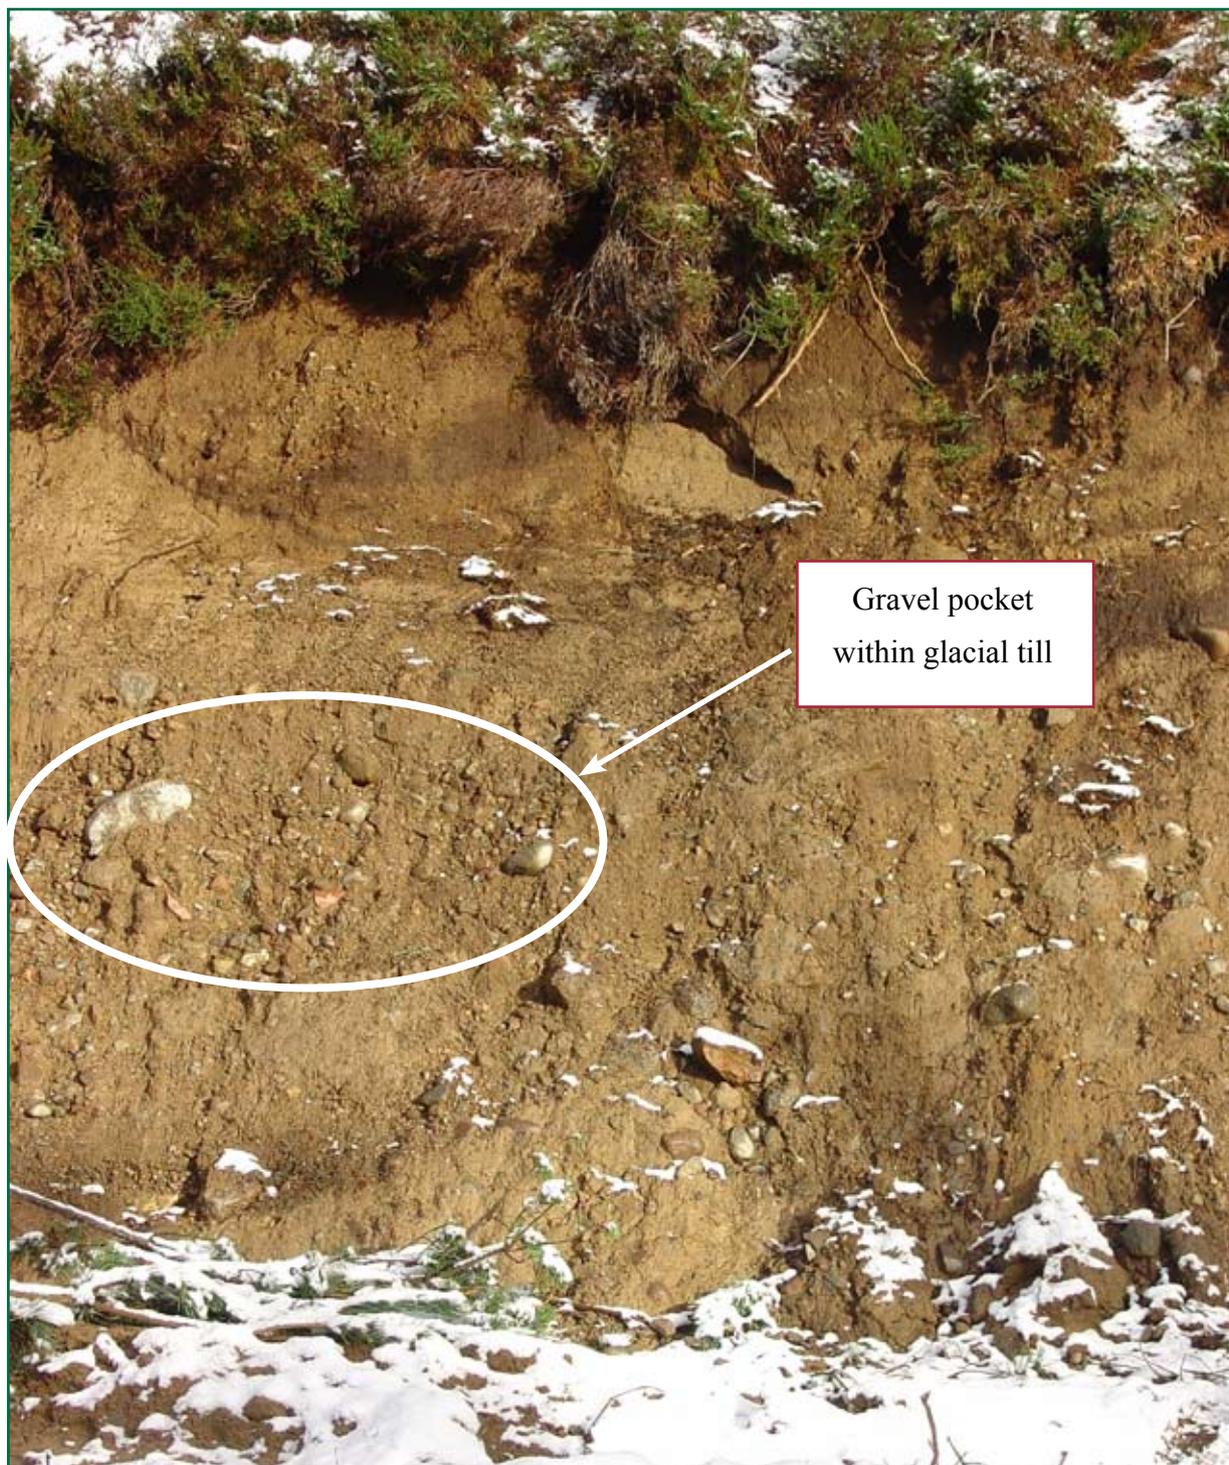
78 Site photographs taken on 28 November showed significant local variation within the glacial till exposed in the backscar; this included the presence of pockets of sand/gravel in the uppermost 3 m band, Figure 8.

Figure 8: Backscar resulting from the landslide.

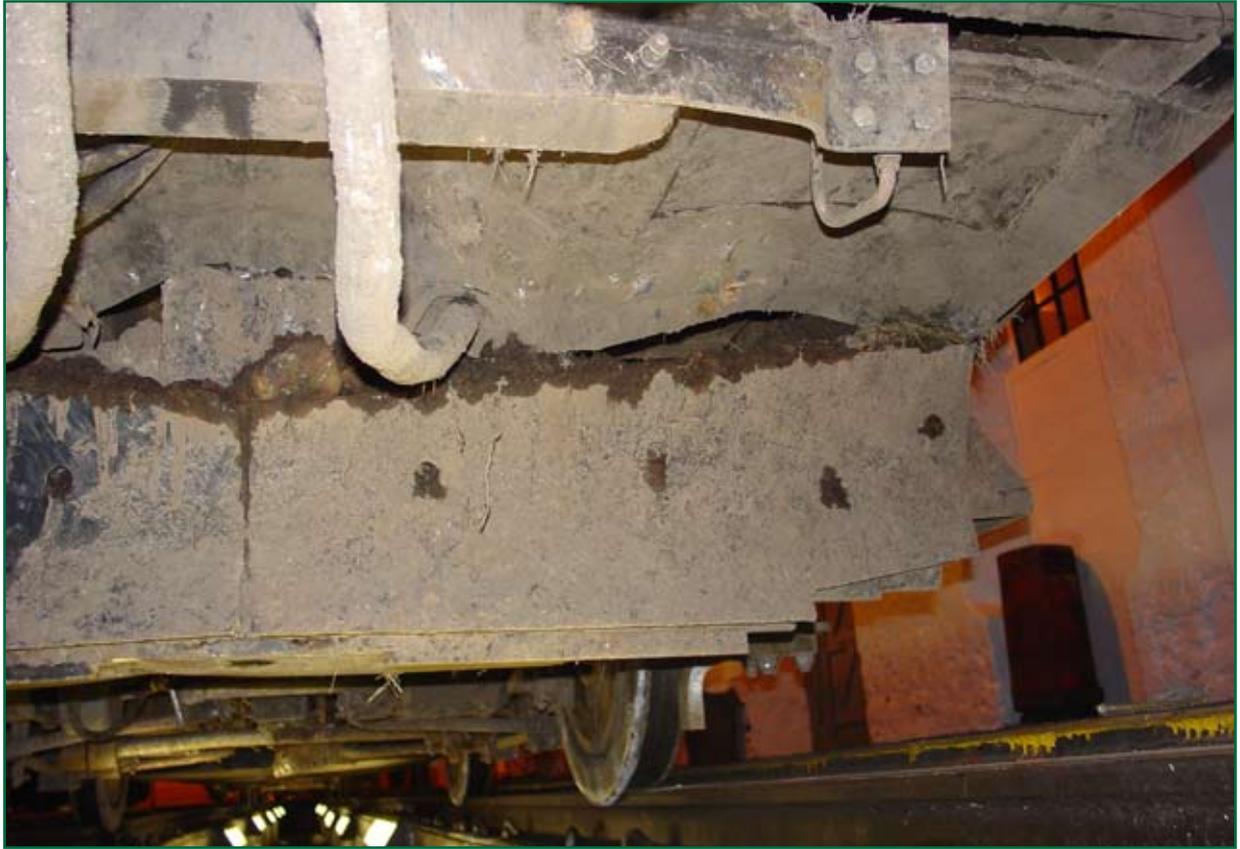
Figure 10: Underside of leading cab showing damage as a result of encountering the debris pile.

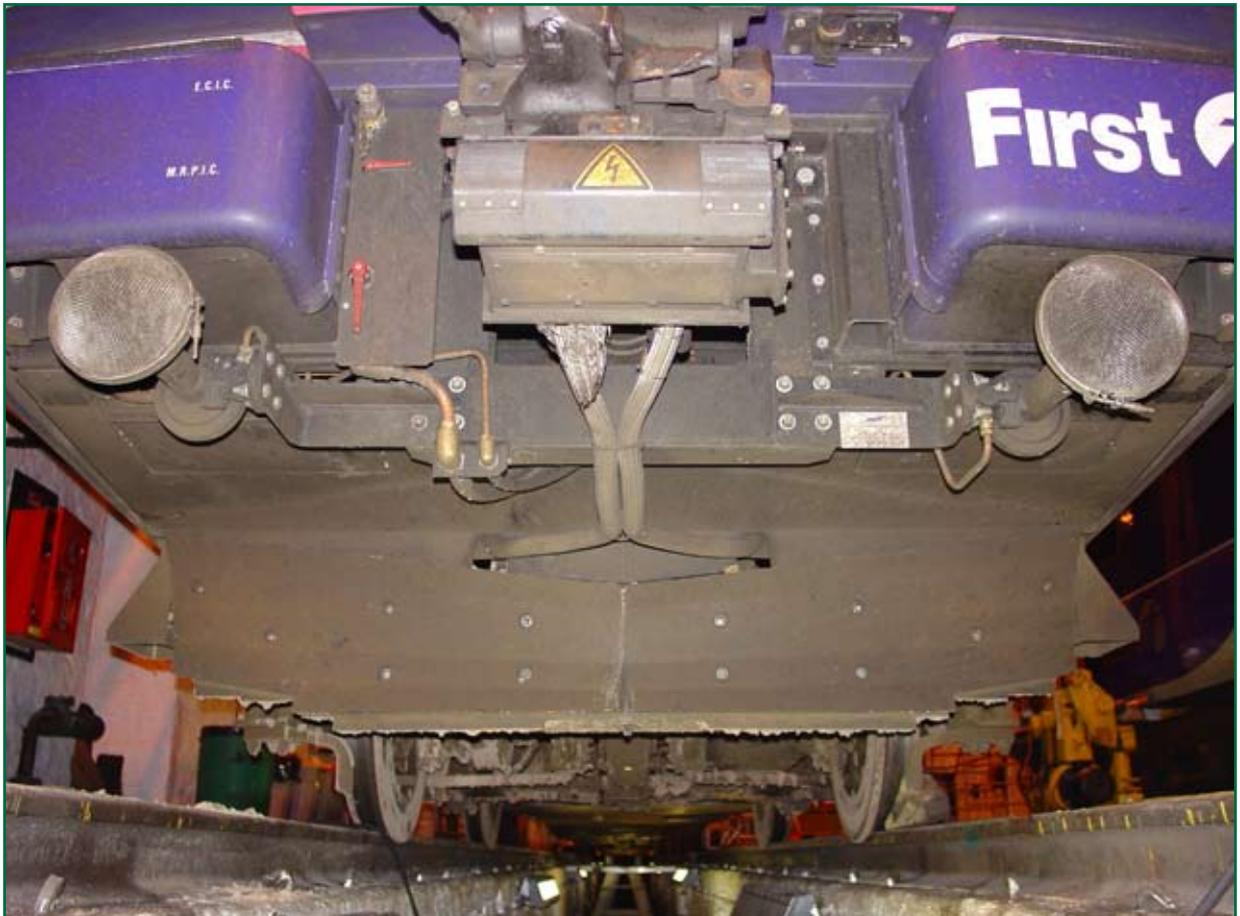
- contact marks and corresponding underframe structure damage showing that the coupler connecting the leading vehicle to the following vehicle had been subjected to high lateral forces which caused it to *yaw* to the right hand side; the coupler remained connected.

Figure 11 : Underside of trailing cab.

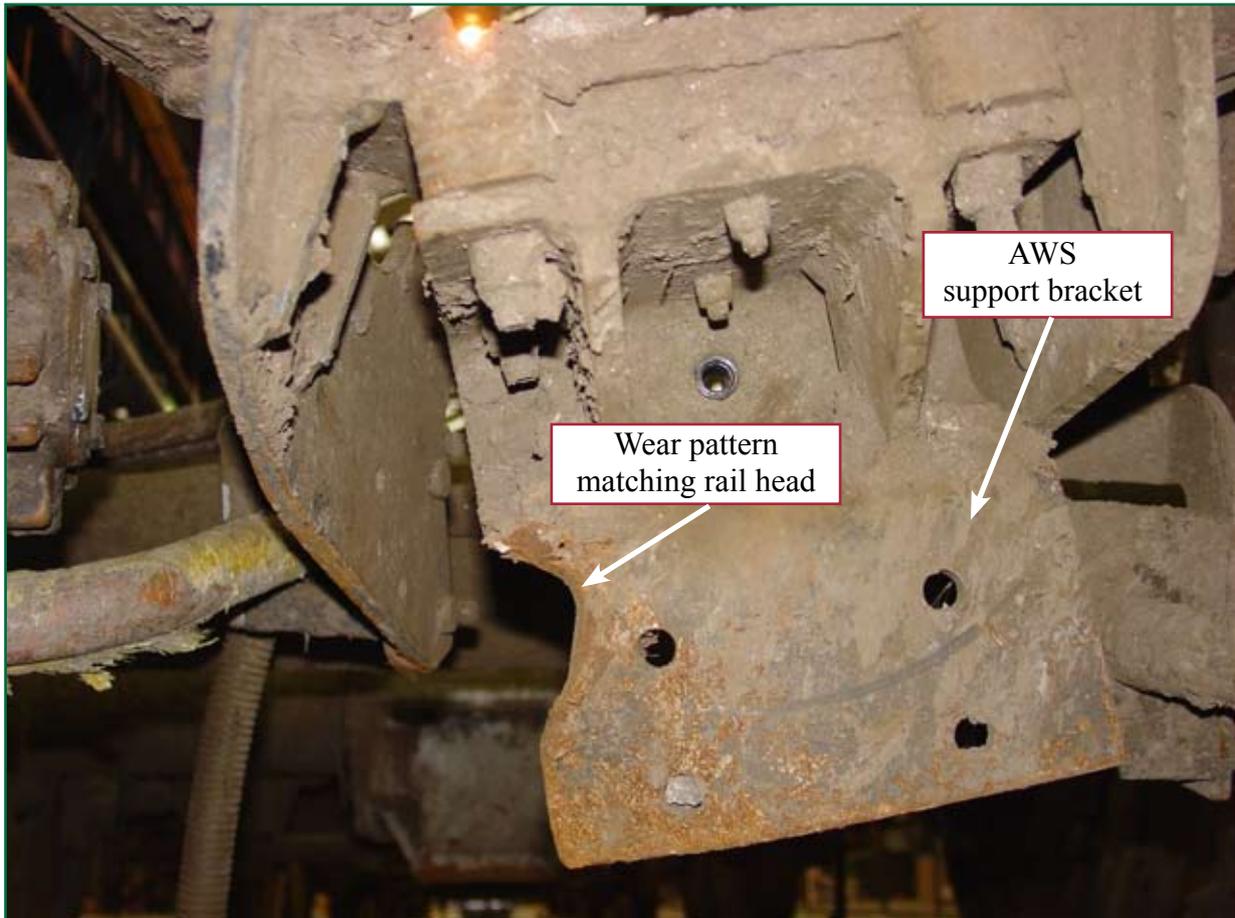
- deposition of soil and distortion of a *secondary traction link* on the trailing bogie;
 - deformation of the AWS support bracket on the leading bogie indicating that it ran pressed against the inner face of the down cess rail, Figure 12;

Figure 12: AWS support bracket on leading bogie.

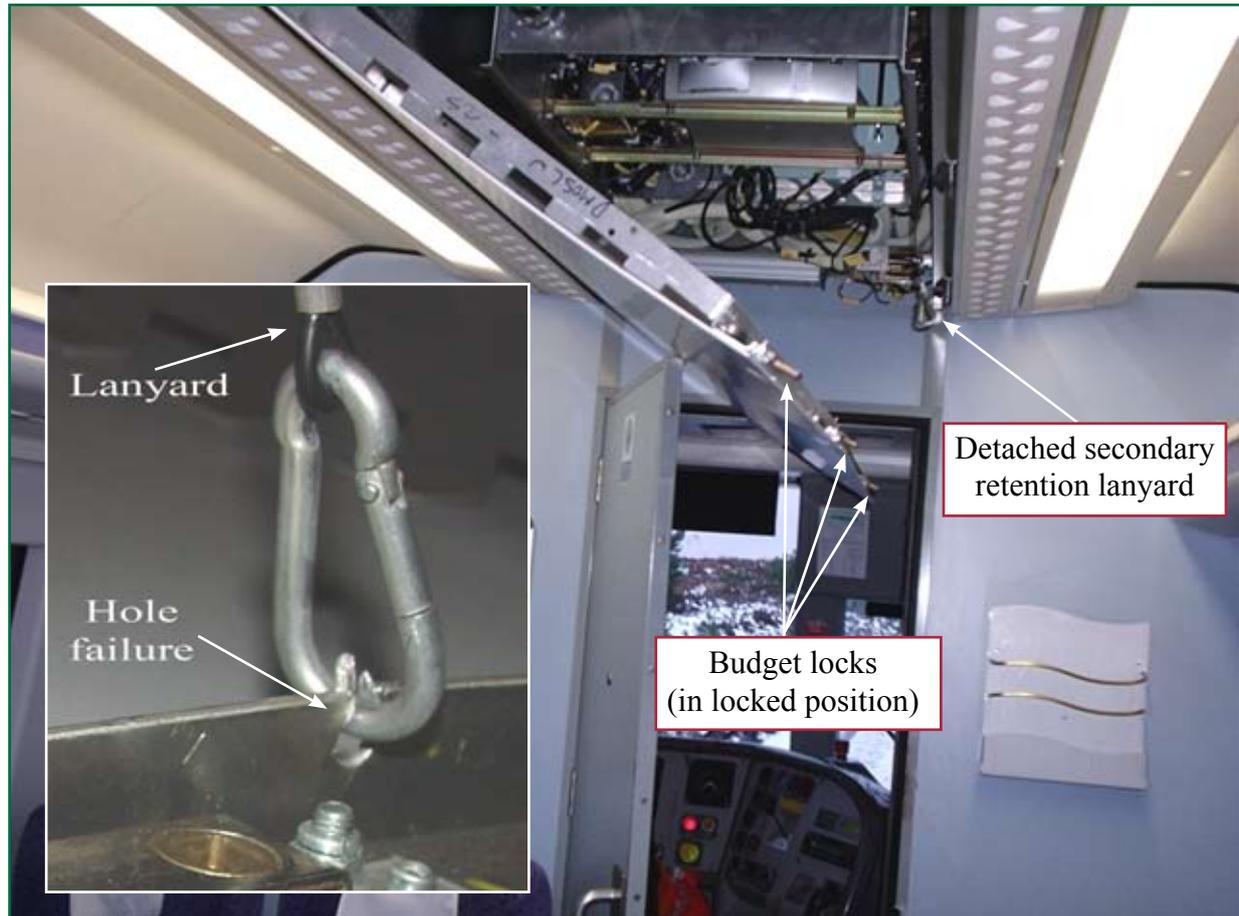
171 Site photographs taken after the incident showed that the primary system (key operated budget locks) used to retain the released passenger saloon ceiling panel had been correctly operated. The lanyards which provide secondary retention had also been fitted. However, the metalwork surrounding the holes used to anchor the lanyards had fractured causing the lanyards to break free, Figure 13.

Figure 13: Ceiling panel showing failed secondary retention facility.

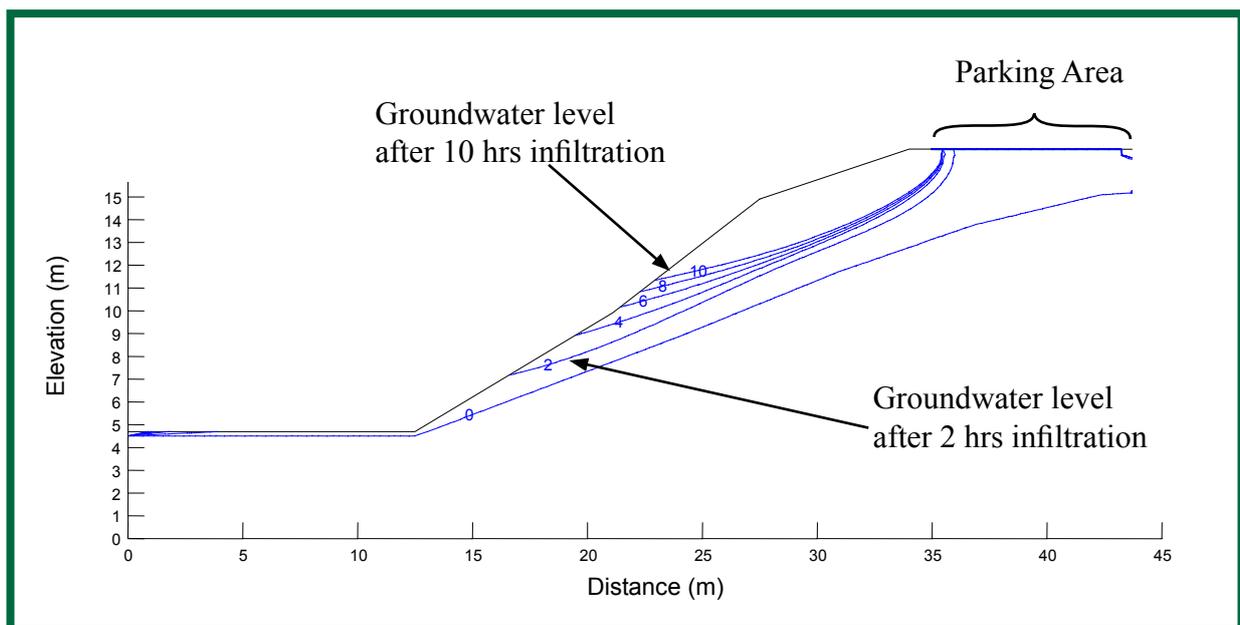
190 The groundwater seepage calculations demonstrate that, for permeability values in the upper range (for this type of glacial till), the groundwater profile would rise rapidly in response to infiltration into the Parking Area, Figure 14. Even at the lower end of the range, there would be a significant rise in groundwater level.

Figure 14: Seepage calculation showing rise in groundwater level in response to infiltration on the Parking Area.

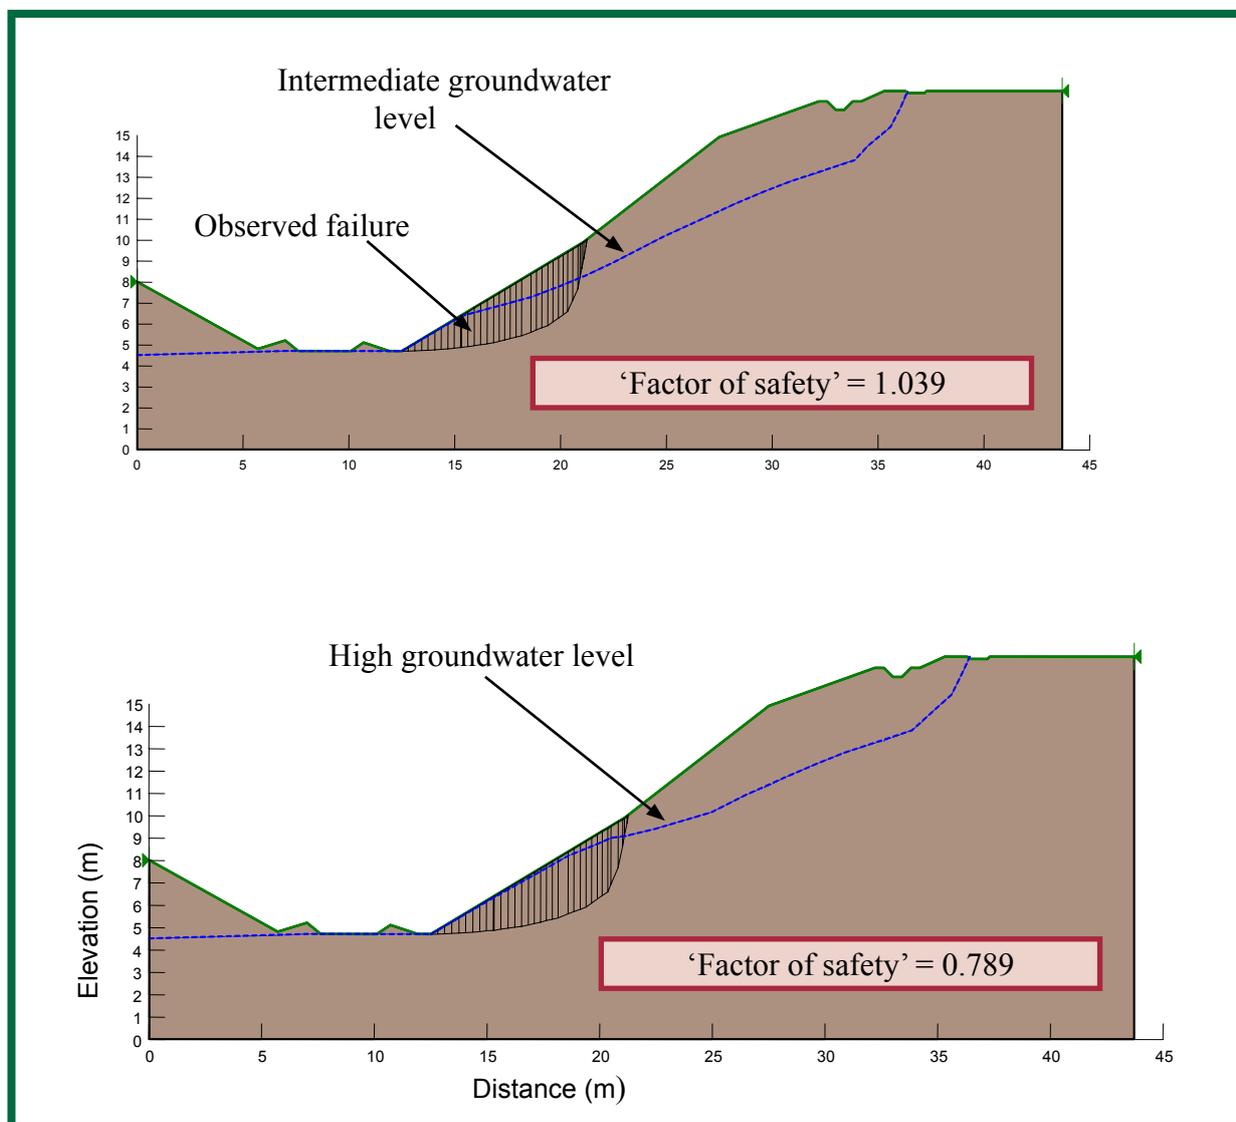
213 Evidence from the Special Examination indicates that a deep failure occurred, similar in nature to a rotational failure. The slope stability analysis shows that a failure of this magnitude would require a high groundwater level, see Figure 15.

Figure 15: Slope stability calculation for the observed failure with assumed high and intermediate groundwater levels. Factor of safety of less than 1 indicates instability.

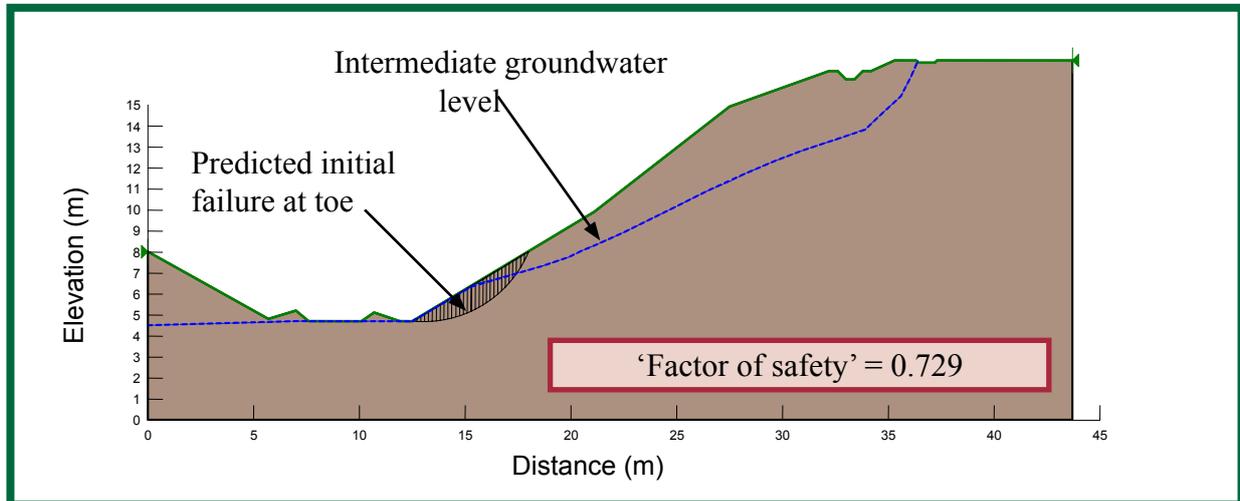
215 The slope stability analysis indicates that as the groundwater level rises, a small rotational failure would be expected at the toe of the cutting slope before the groundwater level reached a height sufficient to result in a failure of the magnitude observed. This is shown in Figure 16. Additionally, the predicted small failure would not have exhibited the steep backscar found at the site.

Figure 16: Slope stability calculation indicating likelihood of a small failure on the cutting slope toe at an intermediate groundwater level.

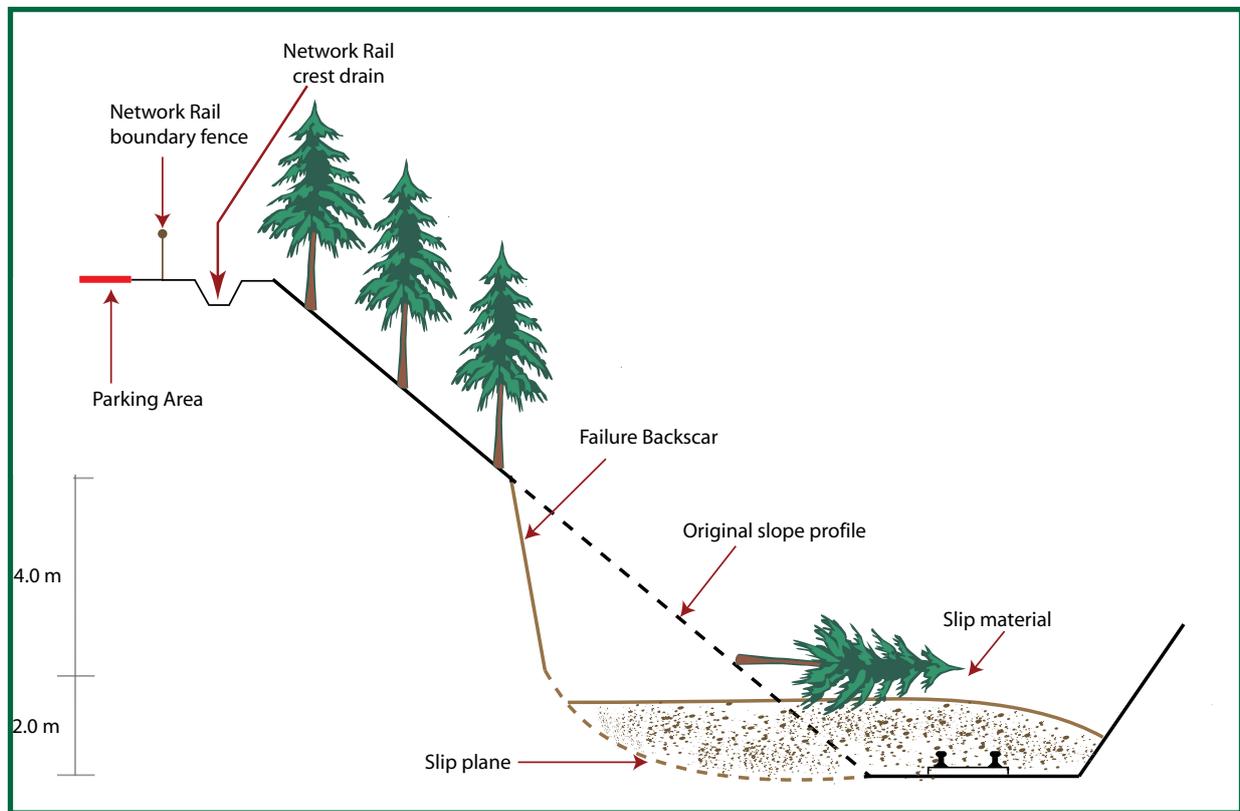
218 The soil continued to flow across the cutting until it reached the toe of the opposite cutting slope. Once the flow movement stopped the water within the material was able to drain leaving a mixture of granular and cohesive material on the track up to a height of between 1.2 and 1.5 m. The orientation (crowns predominantly toward the track) of the trees remaining within the debris pile, indicates that the only obstruction that they may have presented to the train would have been their upper branches and light foliage, Figure 17.

Figure 17: Observed landslide.

219 This mode of failure is consistent with the trees falling forward down the bank – i.e. due to the earthflow. A pure rotational failure would have resulted in them falling backwards against the bank.
