Rail Accident Investigation Branch

Rail Accident Report

**Collision at New Addington on
Croydon Tramlink,
23 November 2005.**

Report 11/2006
July 2006

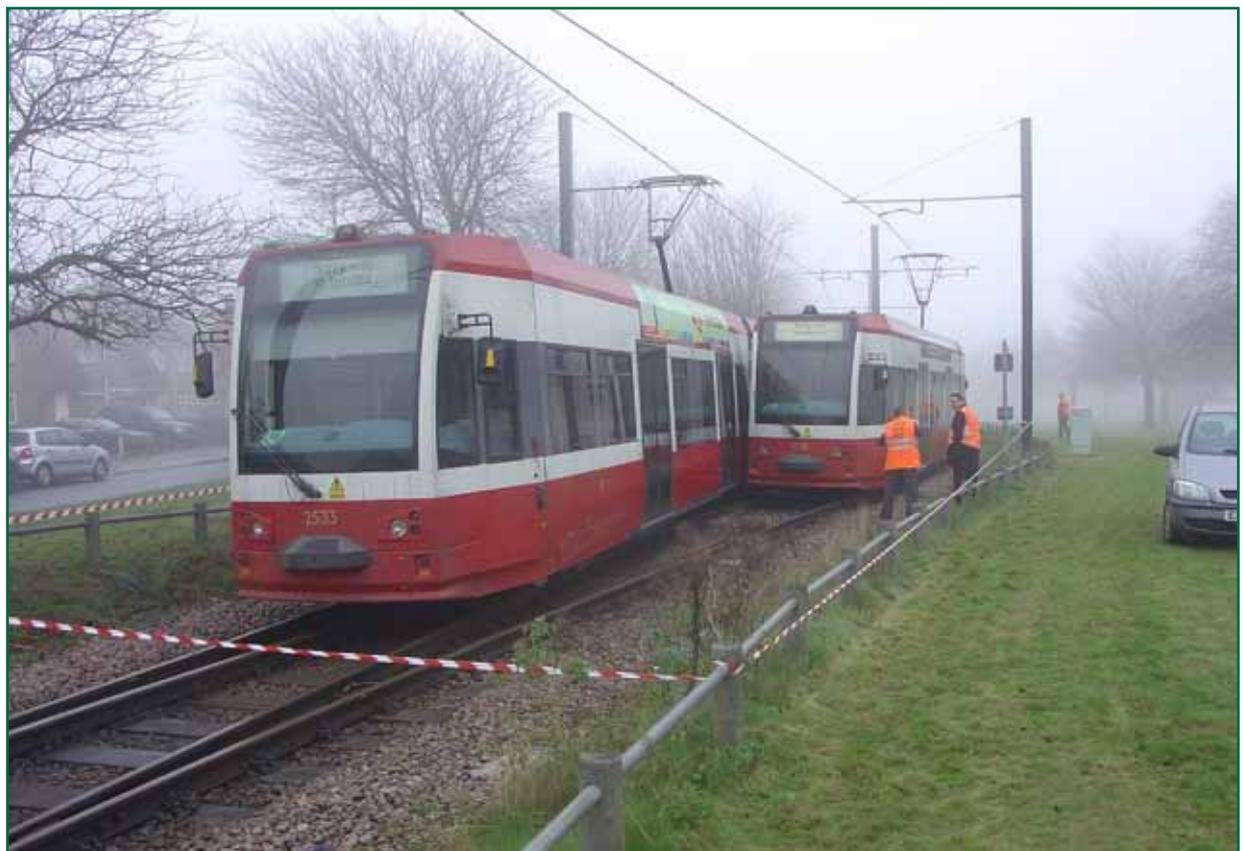
Figure 2: Site of the collision looking towards King Henry's Drive tramstop, showing the rear of tram 2533 (on left) and the front of tram 2538 (on right). The rear of KHD02 signal is on the shorter post to the right of tram 2538.

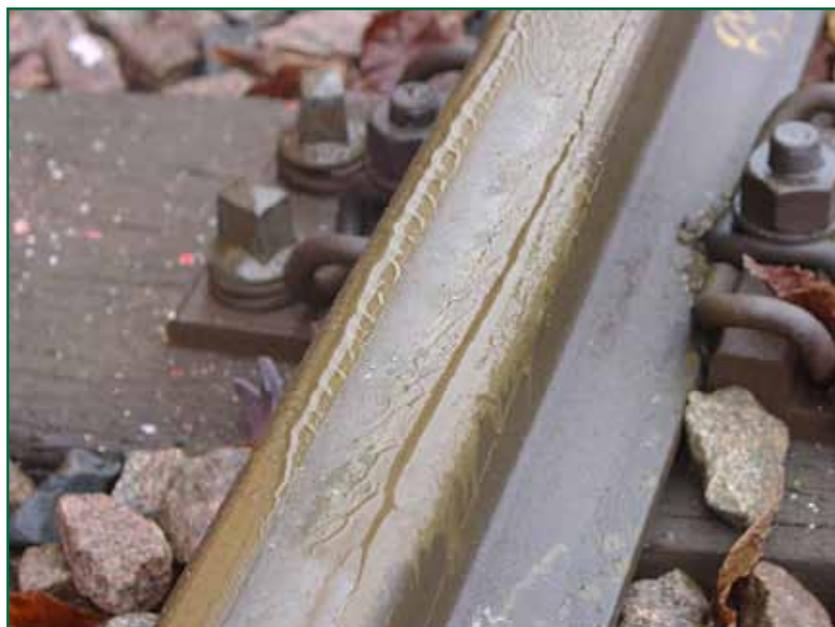
- 29 On the morning of 23 November, trams 2533 and 2538 were operating on the Line 3 service from Croydon to New Addington (Figure 3). Thick fog had descended during the night and remained in the area until late morning reducing visibility to approximately 70 m (this is estimated from witness commentaries and CCTV records). Rail conditions were very damp and the southbound line adjacent to KHD02 signal was visibly contaminated with a rusty sludge or paste. There is no evidence of poor wheel-to-rail adhesion which would have adversely affected the braking capability of the tram. Consequently the presence of this sludge does not appear to have had any bearing upon the accident.

Figure 5: Rail condition in the vicinity of KHD02 signal

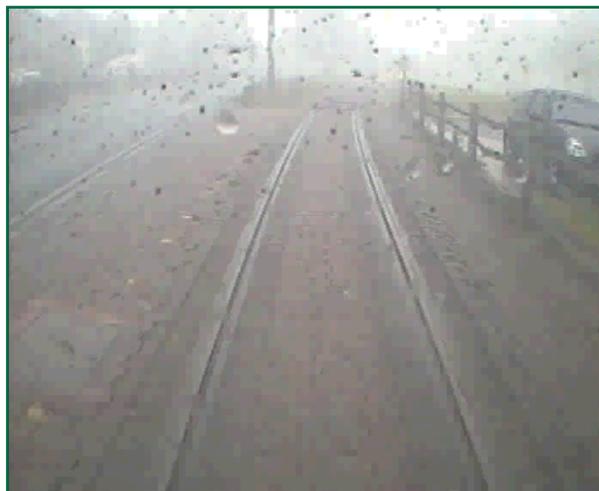
Figure 6: CCTV record from Tram 2533.
Tram 2538 not visible.

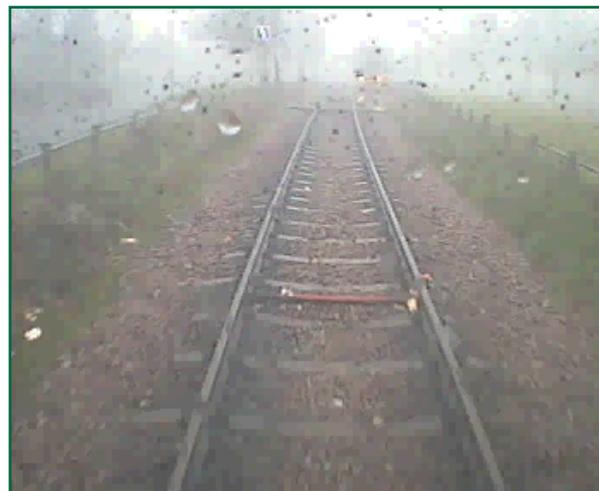
Figure 7: CCTV record from tram 2533.
First sighting of headlights of tram 2538.

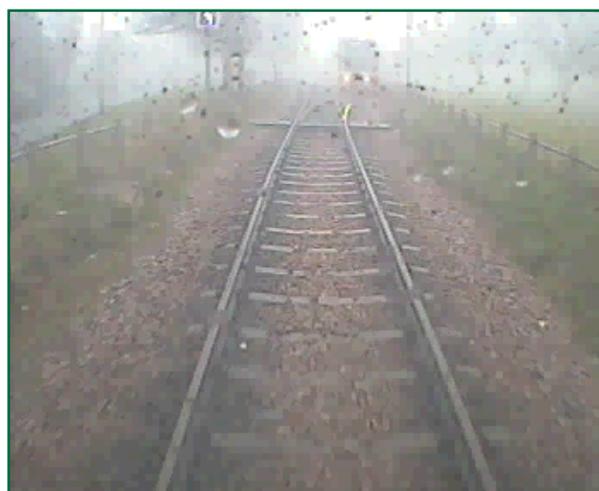
Figure 8: CCTV record from tram 2533.
Tram 2538 outline and headlights just visible

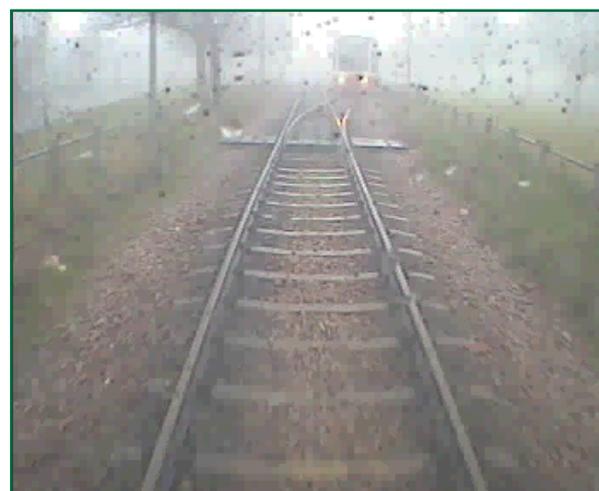
Figure 9: CCTV record from tram 2533.
Tram 2538 clearly foul of running line

48 The driver of tram 2533 departed normally from New Addington after a slightly shortened layover. From inspection of the CCTV record, at 10 m from the toe of points, even with the poor visibility then present, tram 2538 can clearly be seen to be foul of the line. Had a hazard brake application been made here, the tram would have come to rest about 15 m from tram 2538. If the hazard brake application had been made still later, at the toe of the points, a collision would still have been avoided. The driver did not take any action until the distance between the trams was only 1.5 m, only then applying a full service brake.

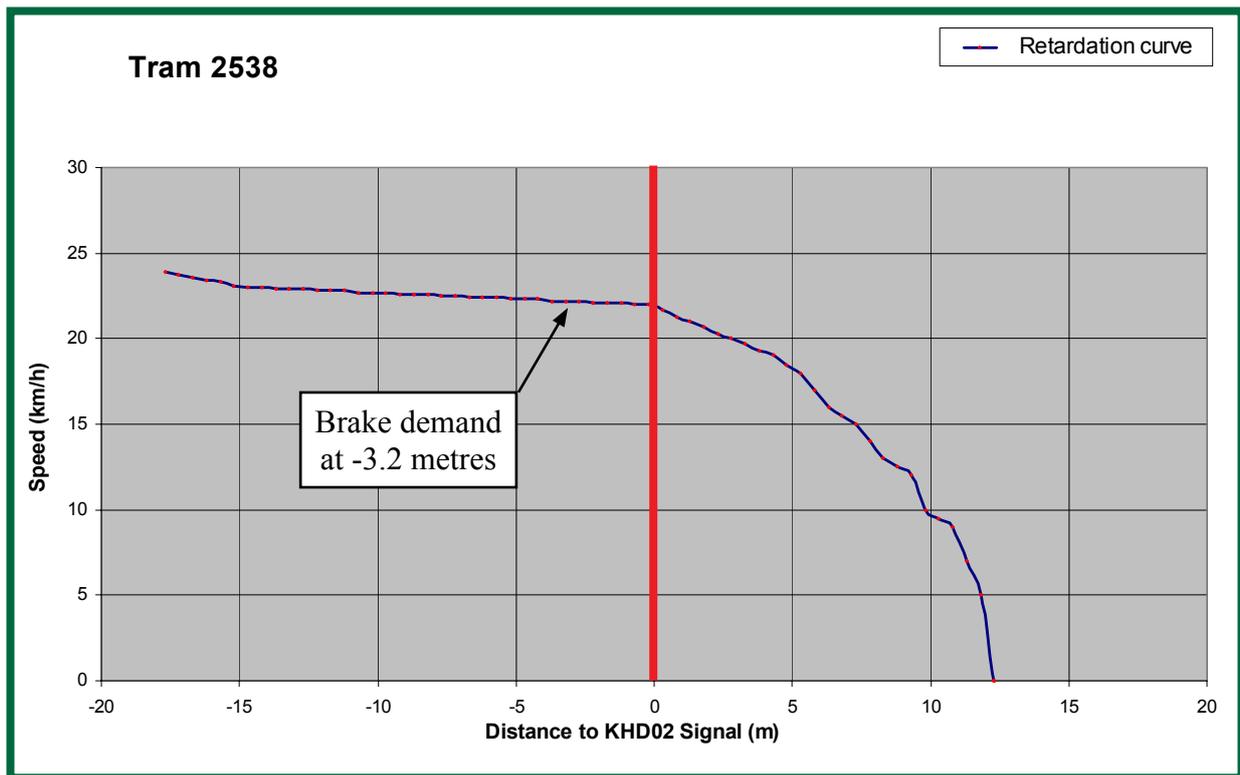
Figure 15: Speed - Distance record for tram 2538, (Negative distances are on approach to signal)

Speed at signal	=	21.9 km/h (6.1 m/s)
Retardation rate	=	2.75 m/s ²
Retardation distance	=	$\frac{(\text{entry speed})^2}{2 \times \text{retardation}} = \frac{(6.1)^2}{5.5} = 6.8 \text{ m}$
Brake application distance	=	4.6 m
(assuming a hazard brake application time of 0.75 seconds)		
Total stopping distance	=	11.4 m
Predicted over-run of KHD02	=	(11.4 - 3.2) m = 8.2 m
(assuming same location for application of the brake)		
Predicted distance short of fouling point	=	(10.0 - 8.2) m = 1.8 m

Figure 16: Calculation of hazard braking Distance for tram 2538. For further details of assumptions see paragraph 49.

- 50 Both drivers applied only a service brake. No explanation has been forthcoming of why the hazard brake was not used. Commentary from other drivers during later cab riding by an RAIB inspector confirmed a cautious use of the hazard brake to preclude injuries being caused to passengers. This conditioning of driver reaction to potentially hazardous events may have been initiated or reinforced by the need for drivers to request that any passengers injured during the hazard brake application make themselves known immediately to the driver, as described in paragraph 18. Use of the hazard brake is covered thoroughly during the initial training of drivers, and is included as a specific item during subsequent performance monitoring. Feathering of the brake (easing back from hazard to service just before the tram stops) to ease the jerk as the tram halts is also covered by initial training and drivers are monitored to ensure that they use this technique. A number of operating staff expressed the view that regular use of the hazard brake was inappropriate due to some (undefined) technical limitation. Whilst there is a limit (due to long term energy and thermal constraints) this is not a factor for limiting regular and repeated use of the hazard brake during training and performance monitoring. Drivers appear to be reluctant to use the hazard brake, and this reluctance, in the case of tram 2538, is a contributory factor to the collision (Recommendation 1).

- 1 Tram Operations Ltd should carry out a programme to re-train all their drivers on the necessity to use the hazard brake in an emergency. Training and routine assessments should include understanding and demonstration by the driver in the operation of the hazard brake. The process of ‘feathering’ to avoid the final jerk should be retained (paragraph 50).

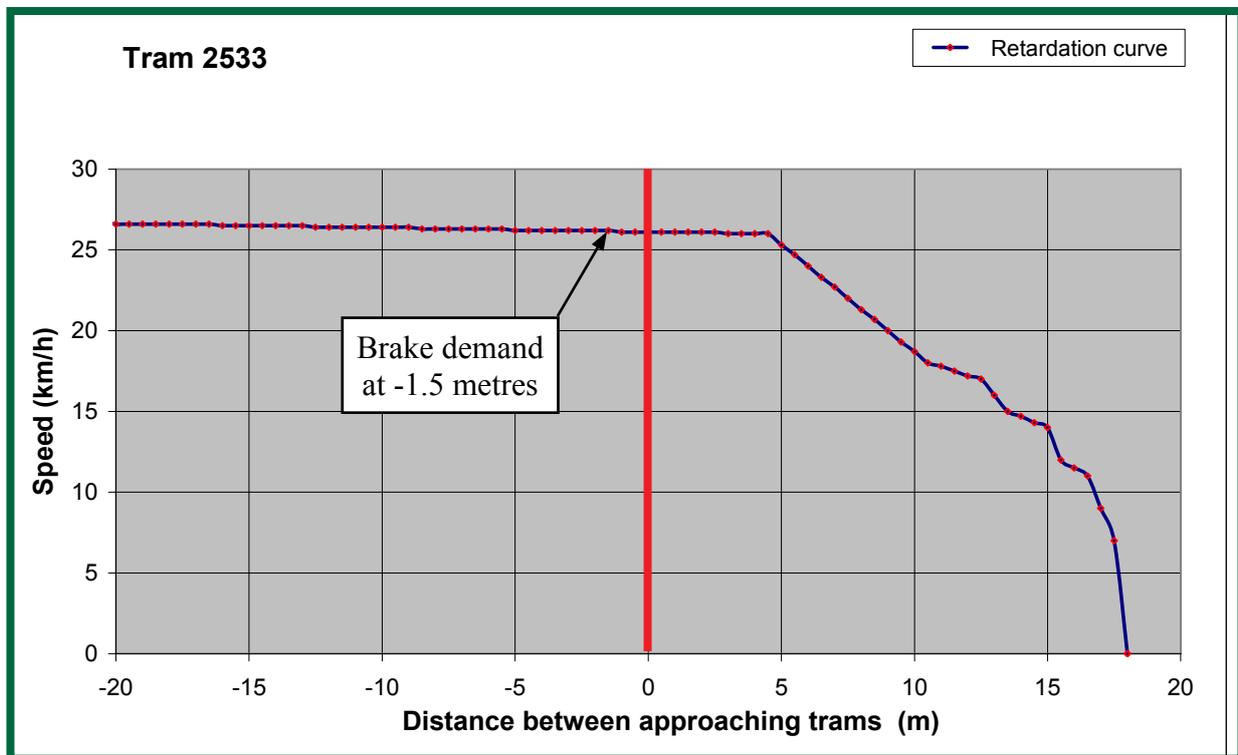
Figure 17: Speed - Distance record for tram 2533 (negative distances are on approach to point of collision)

No explanation has been found of why the other tram was not recognised as an obstruction. Action was only taken when it was already too late to avoid the collision. It is possible that the effects of a cold and the warm atmosphere generated by the cab heater could have slowed reaction, but there is no evidence to support or discount this idea.

Speed at toe of points	= 26.7 km/h (7.4 m/s)
Retardation rate	= 2.75 m/s ²
Retardation distance	= $\frac{(\text{entry speed})^2}{2 \times \text{retardation}}$ = $\frac{(7.4)^2}{5.5}$ = 10.0 m
Brake application distance (assuming a hazard brake application time of 0.75 seconds)	= 5.5 m
Total stopping distance	= 15.5 m
Distance, toe of points to front of 2538	= 20.9 m
Predicted distance between trams	= (20.9 – 15.5) m = 5.4 m

Figure 18: Calculation of hazard braking distance for tram 2533. For further details of assumptions see paragraph 49.
