Rail Accident Report

**Runaway and subsequent collision near to
Loughborough Central station, Great Central
Railway
12 May 2014**

Report 04/2015
May 2015

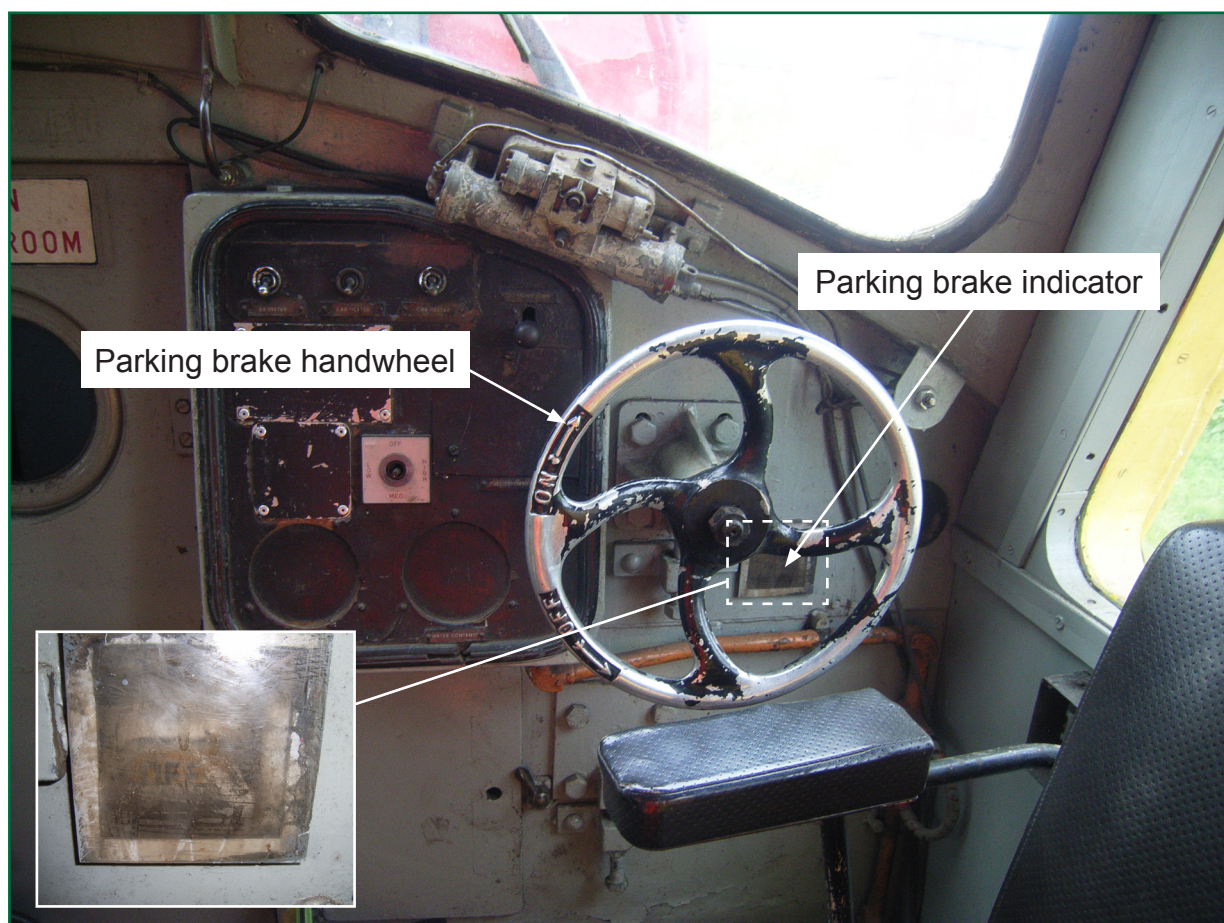
Figure 4: Class 37 handbrake hand wheel and indicator

- 35 Damage to locomotive 37198 meant that only the No. 2 end handbrake (which would have been the trailing cab on the incident train) could be tested by the RAIB following the accident. During this test, the brake blocks were observed to have become fully applied to the middle wheel on the secondman's side after 60 turns of the hand wheel and on the driver's side after 80 turns. This indicated that the No.2 end handbrake was not correctly adjusted. The maintenance of the locomotive is discussed further in paragraphs 123 to 134.

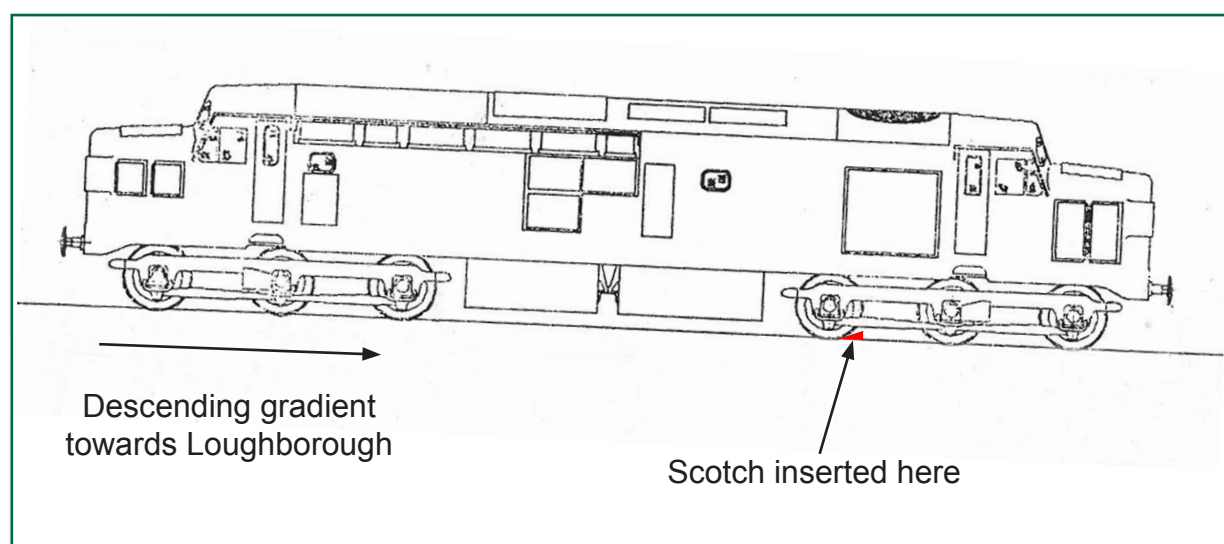
- 59 As the PICOP was shutting down the locomotive, the permanent way team started to disembark from both cabs. Trackworker A descended from the cab and was passed a scotch. He stated that he positioned this scotch against the leading (downhill) face of the right-hand (secondman's) side wheel of the rear axle of the locomotive's leading end bogie (figures 6 and 7) and drove it home against the wheel tread using his boot (figure 8). The POS coach (which was downhill of the locomotive) was not secured with a scotch.

Figure 6: The position on the locomotive where Trackworker A placed the scotch

- 75 To be effective, a scotch has to be positioned squarely on the rail head and snugly against the face of the wheel tread. Failure to do this may allow the scotch to fall out or reduce its available holding force. Trackworker A stated that, when he placed the scotch, he was certain that it was 'well in place' and that he was 'very conscious' of the need not to leave a gap between the wheel and the scotch.

- a. Trackworker A probably positioned the wheel scotch in a way that made it ineffective (**paragraph 75, Recommendation 1**); and
- b. the PICOP did not apply the train's handbrakes and believed that using scotches would be an appropriate alternative (**paragraph 85, Recommendation 1**).

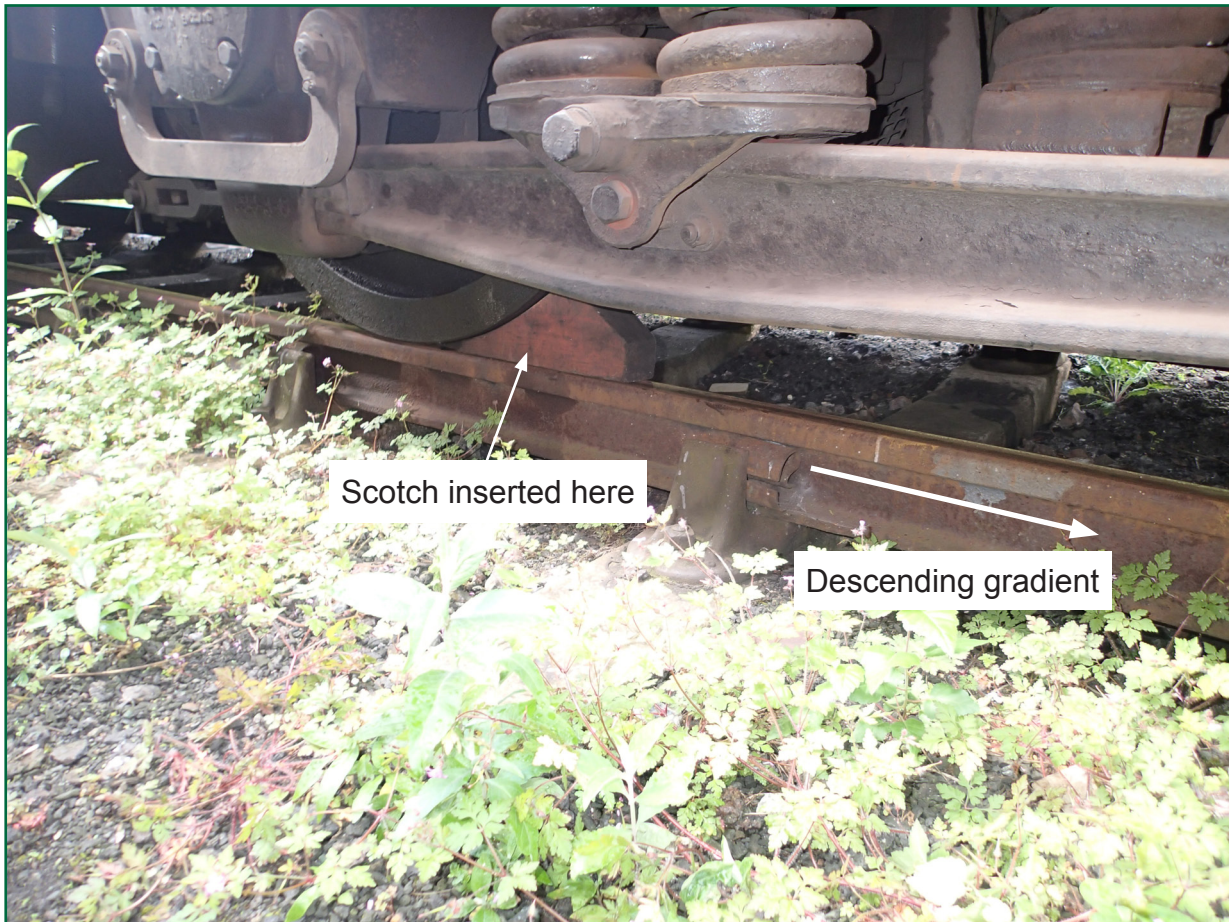
Figure 7: The position of the scotch as it was placed during a post-incident reconstruction

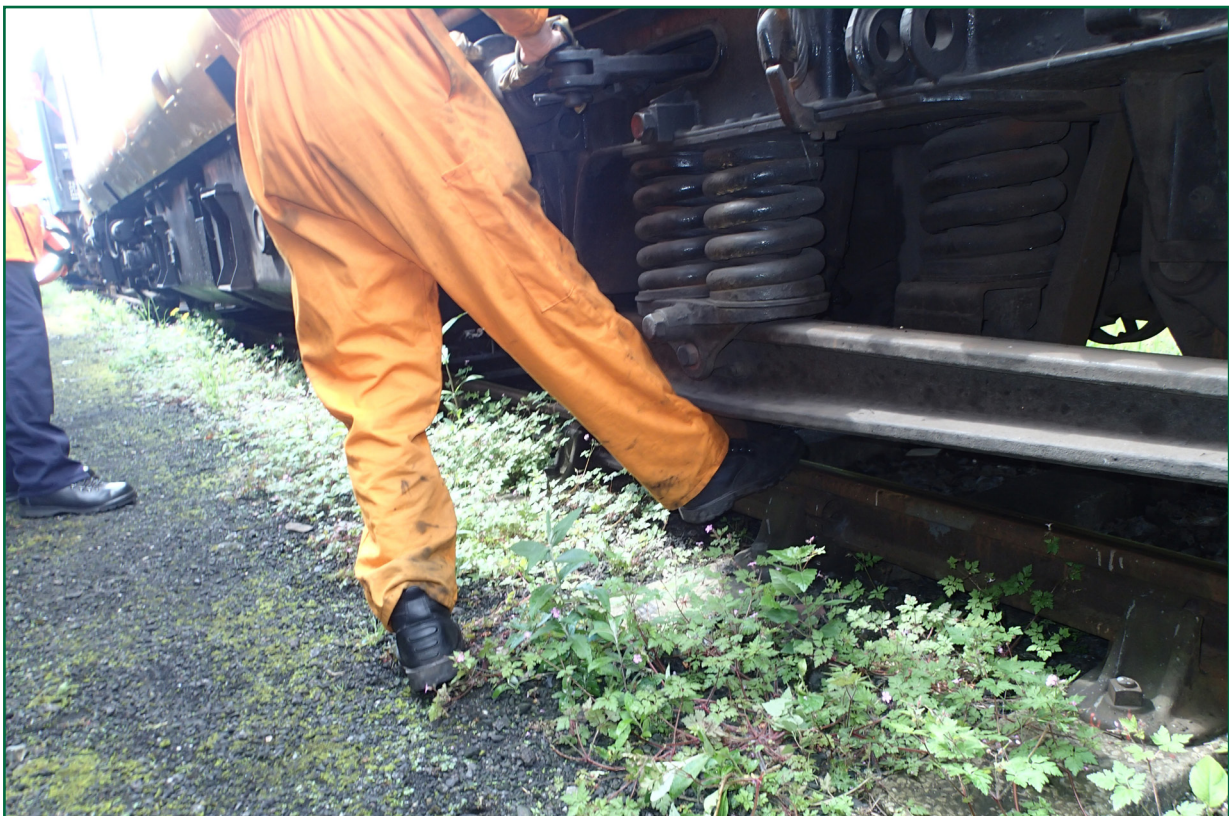
- GCR staff training and competency records;
 - a reconstruction of how the incident train was stabled at Quorn and Woodhouse on 12 May 2014;
 - technical data and schematics relating to the Class 37 locomotive;

Figure 8: A post-incident reconstruction of how the scotch was driven against the wheel tread

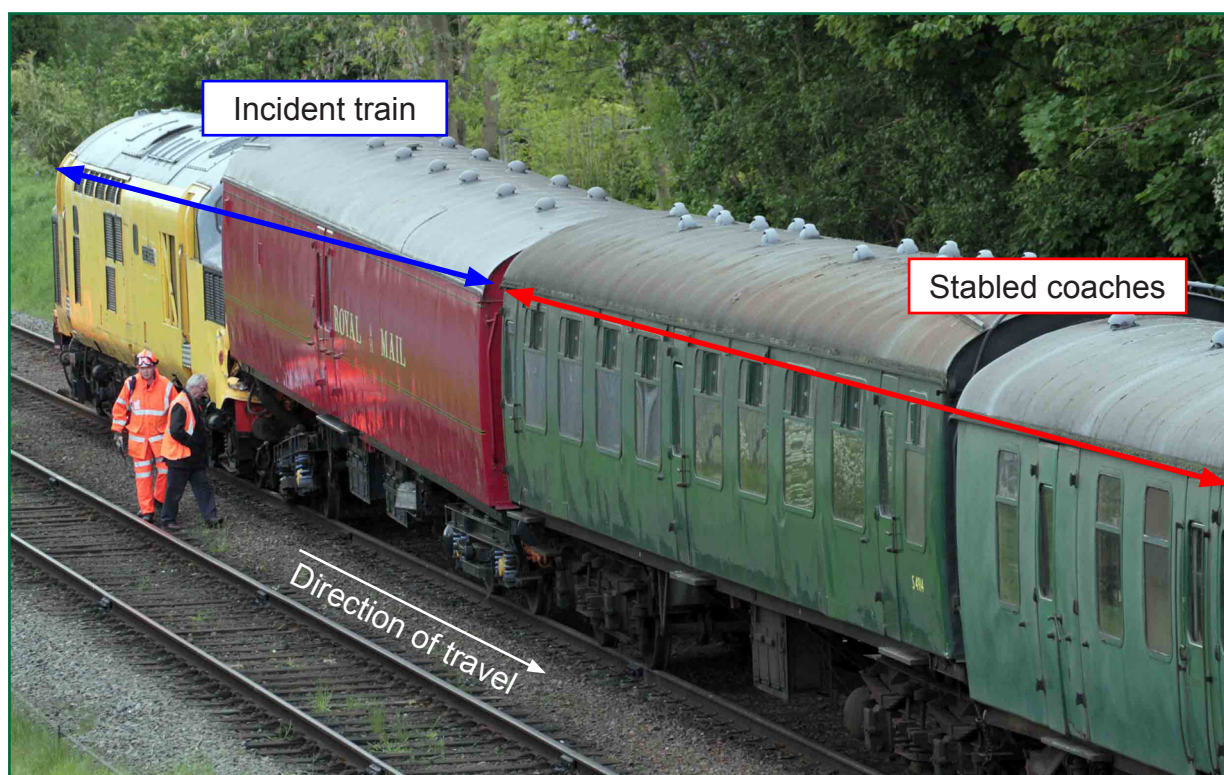
- 62 The PICOP telephoned the operations manager, who was at Loughborough, in order to warn him about the runaway. The operations manager asked a signaller to go to Loughborough North signal box in order to check the status of the track circuits. The signaller concluded from the indications within the signal box that the stabled set of coaches had moved and that a collision had occurred (figures 9 and 10).

Figure 9: The positions of the incident train and stabled set of coaches following the collision (image courtesy of Chris Milner, *The Railway Magazine*)

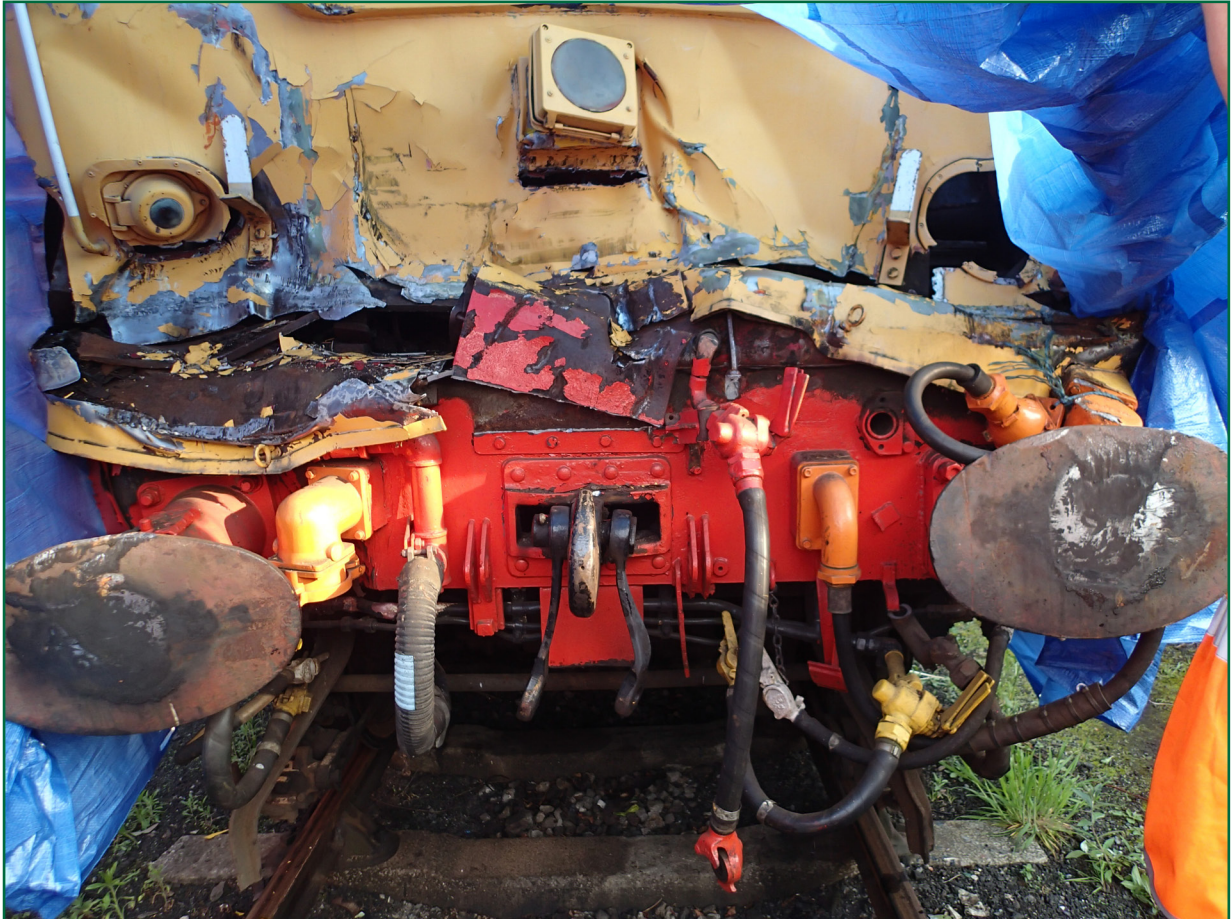
- 7 Nobody was injured as a result of the collision. Significant damage was sustained by some of the rail vehicles involved.

Figure 10: Damage sustained by locomotive 37198 following the collision

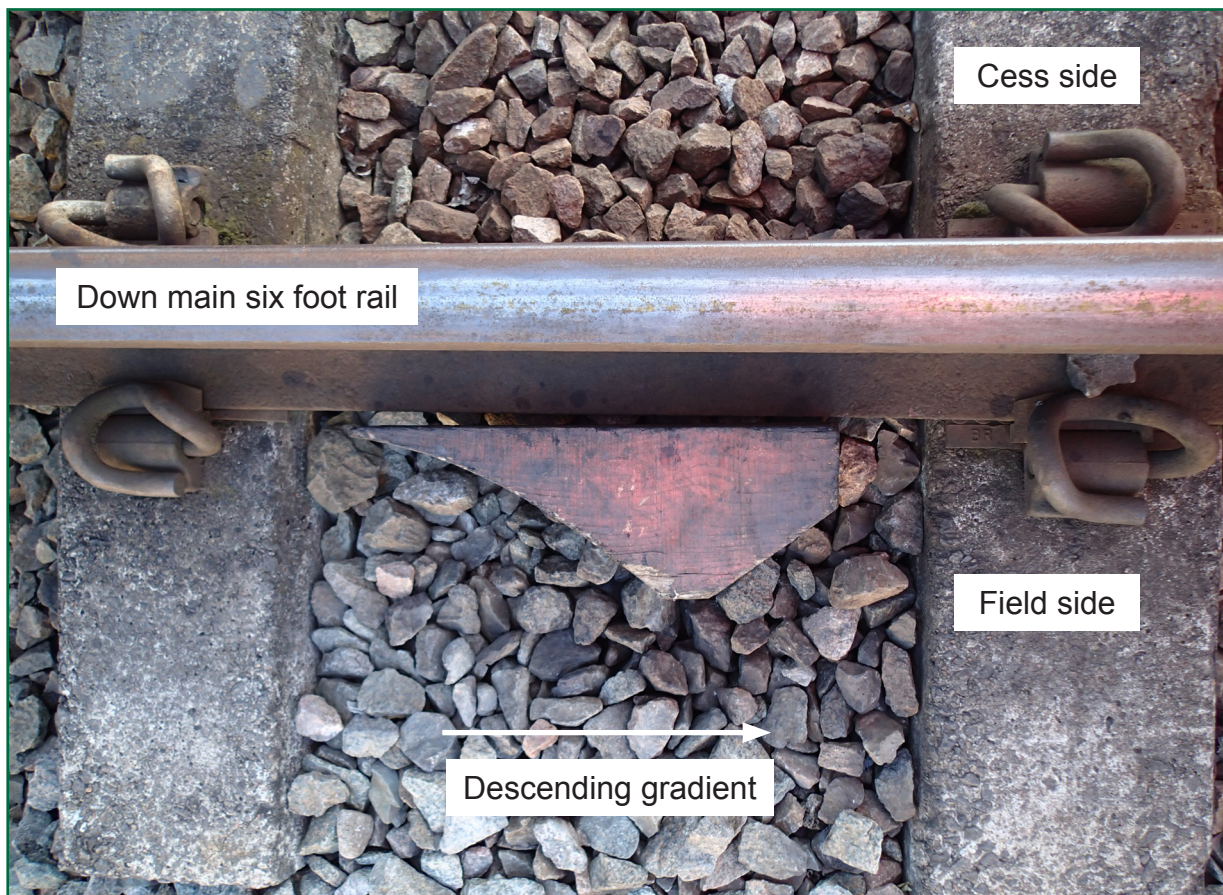
- 64 There is witness evidence that, following the runaway, members of the permanent way team found a scotch on the *field side* of the six foot rail of the down main, a short distance north of where the incident train had been stabled. The RAIB subsequently recovered this scotch during its post-incident examination of the railway at Quorn and Woodhouse (figures 11 and 12).

Figure 11: Position of the scotch as found post-incident by the RAIB at Quorn and Woodhouse

- 82 The RAIB examined the scotch which was recovered post-incident (paragraph 64). This showed that the scotch was in a reasonable state of repair and that it had not been crushed or over-ridden by rail wheels. It was also evident that the base of the scotch was not heavily contaminated with either oil or grease.

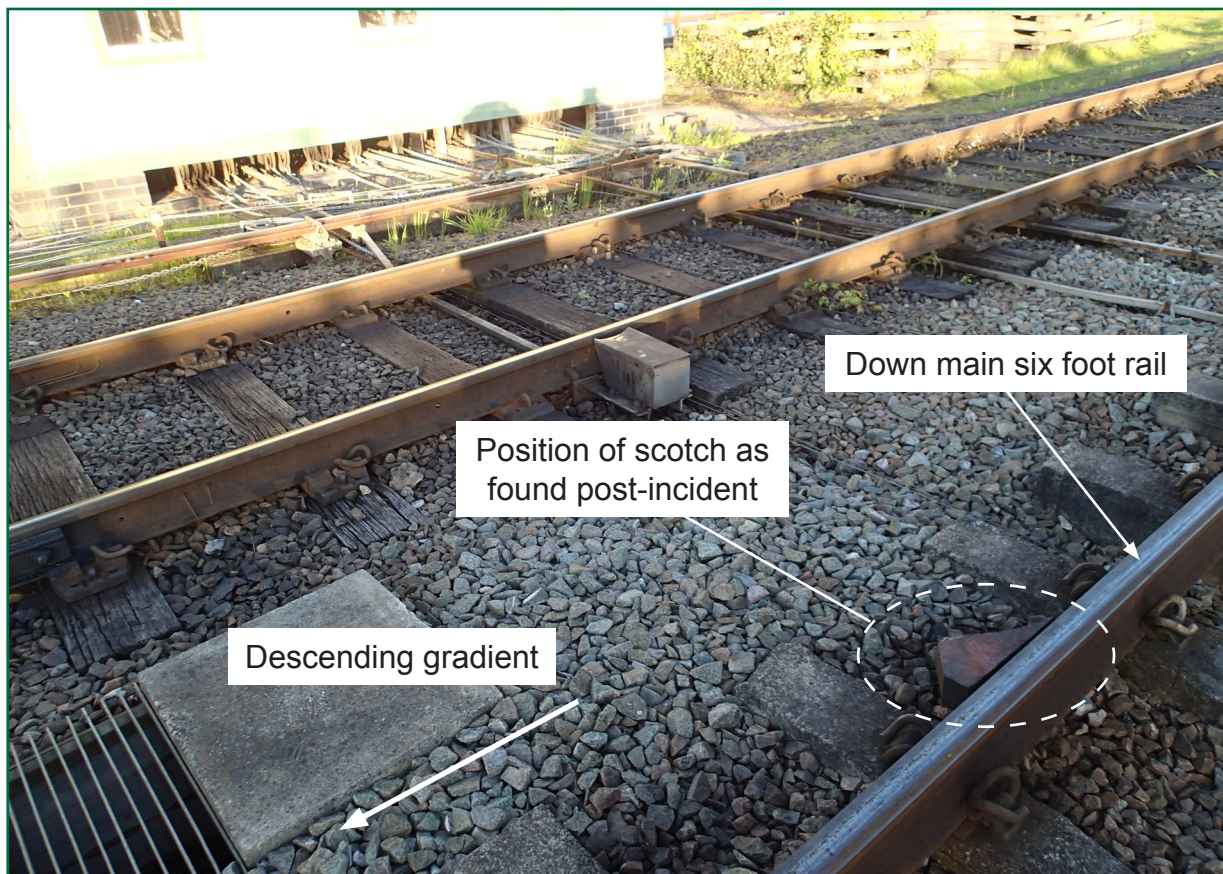
Figure 12: Position of the scotch as found post-incident by the RAIB at Quorn and Woodhouse
