Investigation Report
Aggregate Supplies to Whitwell Quarry Concrete Plant
'Pop-Outs' External Slab & M1 Extruded Barrier

June 2014

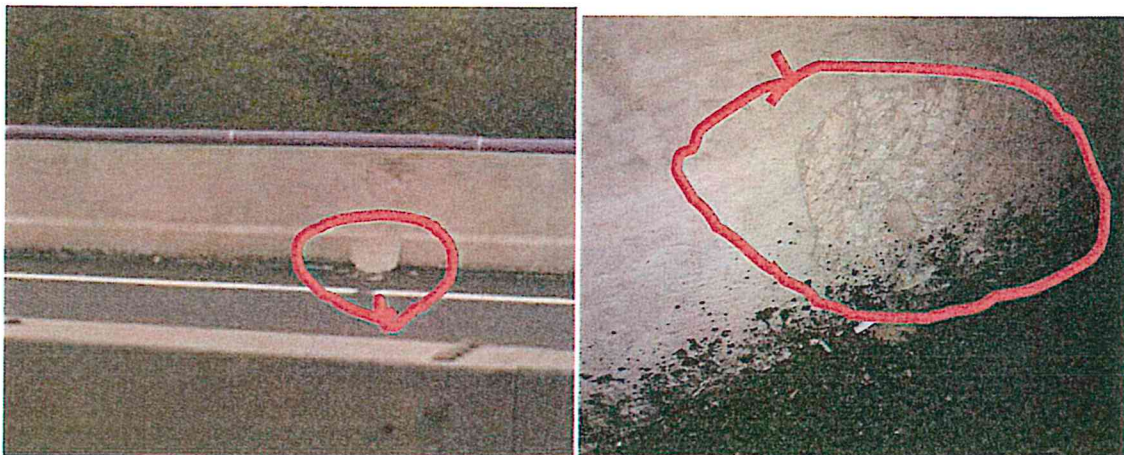
XRF analysis of material taken from the surface 'pop-outs' confirmed the material to be calcined dolomite, that is 'burnt' or 'partially burnt' dolomite. When exposed to water 'calcined dolomite' is subject to an expansive reaction which causes characteristic surface blemishes as manifested in the Sites supplied by Whitwell Concrete plant.

The surface 'pop outs' varied in size and shape, but were typically 10 - 100mm in diameter as displayed in photographs (Fig 1).

Fig (1) Photographs of spalled concrete area or surface 'pop-outs'

Typically an aggregate particle could be observed at or near the base of the surface pit, which had apparently induced the pop-out. The aggregate particle remained wholly embedded in the concrete, sometimes being fractured, with some of the particle having detached from the surface. These particles which ranged in size from 3 to 10mm in diameter were typically white coloured, granular and relatively soft and friable. Importantly, there was no evidence of secondary deposits or staining of the surrounding concrete matrix adjacent to the 'pop-out' formation.

Where they occurred, the pop-outs were limited to 100mm diameter and were typically just a few millimetres deep, associated with a single particle of calcined dolomite.

There is no evidence of any deterioration of the concrete barrier matrix beyond the pop-outs and the incidence of these surface blemishes appears to be limited and finite. Localised repair of pop-outs would seem to be the most practicable remediation solution.
