# ***AAIB Bulletin***

***7/2015***

<b>Aircraft Type and Registration:</b>	Hawker Sea Fury T Mk 20, G-RNHF	
<b>No &amp; Type of Engines:</b>	1 Bristol Centaurus XVIII piston engine	
<b>Year of Manufacture:</b>	1949 (Serial no: ES3615)	
<b>Date &amp; Time (UTC):</b>	31 July 2014 at 1601 hrs	
<b>Location:</b>	RNAS Culdrose, Cornwall	
<b>Type of Flight:</b>	Private	
<b>Persons on Board:</b>	Crew - 1	Passengers - None
<b>Injuries:</b>	Crew - None	Passengers - N/A
<b>Nature of Damage:</b>	Engine internal disruption, right wingtip, flap and minor fuselage abrasion damage	
<b>Commander's Licence:</b>	Military	
<b>Commander's Age:</b>	44 years	
<b>Commander's Flying Experience:</b>	3,545 hours (of which 232 were on type) Last 90 days - 54 hours Last 28 days - 35 hours	
<b>Information Source:</b>	AAIB Field Investigation

<b>Aircraft Type and Registration:</b>	Jetstream 3102 31, G-GAVA
<b>No &amp; Type of Engines:</b>	2 Garrett Airesearch TPE331-10UGR-516H turboprop engines
<b>Year of Manufacture:</b>	1987 (Serial no: 785)
<b>Date &amp; Time (UTC):</b>	15 August 2014 at 1836 hrs
<b>Location:</b>	Doncaster Sheffield Airport, Yorkshire
<b>Type of Flight:</b>	Commercial Air Transport (Passeng

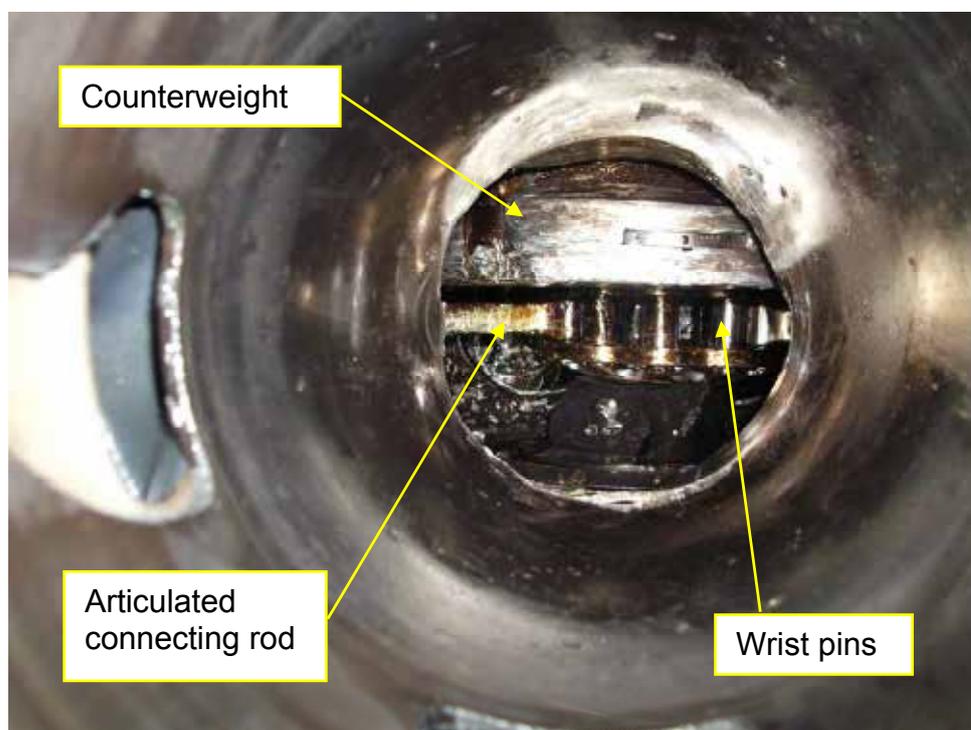
**Figure 2**

Master con-rod wrist pins viewed through the No16 cylinder

The localised heat evidence on the master con-rod suggests that one or more adjacent wrist pin and con-rod bearings overheated, leading to material failure and resulting in a piston, and the remains of its con-rod, stopping in its sleeve. The clearance of the crankshaft counterweight is such that anything in its path would be struck with massive force. It appears that the No16 con-rod was caught and dragged out of its cylinder and this resulted in it being knocked around the inside of crankcase, causing further damage. The counterweight and knuckle joint clearance is very small, so damage caused by high-energy loose debris impact would quickly lead to sleeve valve de-synchronisation.

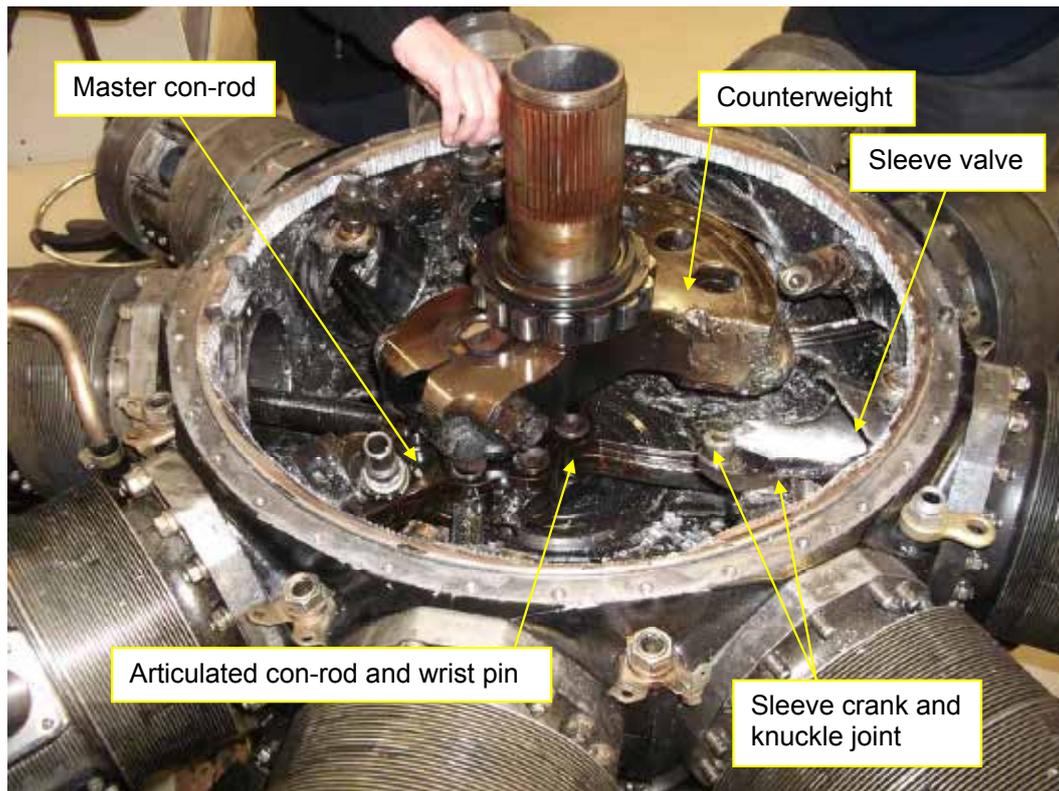
**Figure 3**

Front row crankcase component damage

The majority of the components within the crankcase were severely damaged. All the sleeve driveshafts showed signs of torsional overload and some of the driveshafts had failed. The majority of the knuckle joints, which attach the drive crank to the sleeve, were damaged and in some cases had detached. Several of the sleeves had been severely damaged, in particular where they had extended out of their respective cylinders into the path of the crankshaft counterweight. Multiple impact marks were also present as a result of increasing amounts of churned-up debris. The front row sleeve valve gear trains were generally intact and meshed, except for one of the valve crank drive and idler gears which had damage indicative of gear tooth overload.

Closer examination of the debris removed from the crankcase identified forged steel con-rod and aluminium piston material. The remains of No16 piston were found loose and had the appearance of a pulverised and flattened sphere. The con-rod material, particularly from the wrist pin ends, showed signs of extreme heating and appeared to have been splattered with molten copper. Examination of the wrist pins and their associated holes in the master con-rod showed similar evidence and one of the broken con-rod wrist pin ends exhibited the characteristics of plastic deformation leading to failure. Lubricating oil was present throughout the crankcase but showed evidence of overheating and had lacquered various surfaces. It was also observed that the gear carrier diaphragm outer surface was discoloured with hot oil lacquering. Normally this surface would be a bright silver grey.

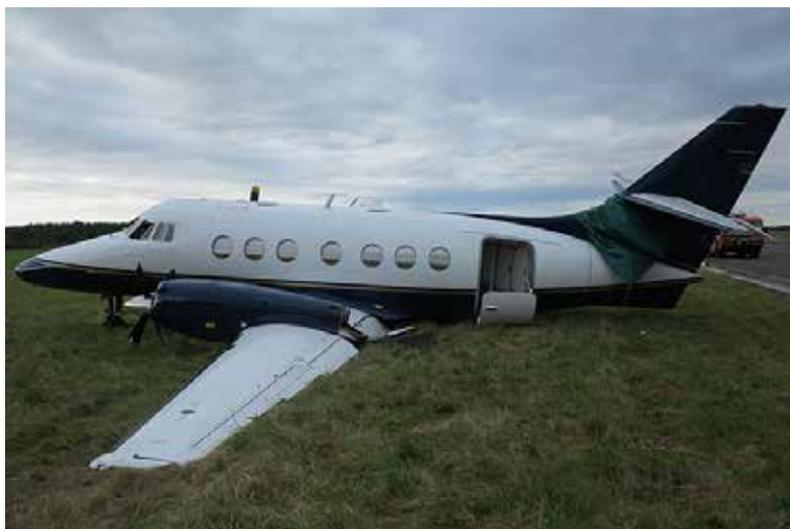
**Figure 1**

The aircraft touched down at 1836 hrs with an IAS of 102 kt and a peak normal acceleration of 1.3 g, and the commander moved the power levers aft to `GROUND IDLE` and then to `REVERSE`. As the aircraft decelerated, the commander moved the power levers forward to `GROUND IDLE` and asked the co-pilot to move the RPM levers to `TAXI`. At an IAS of 65 kt, eight seconds after touchdown, the left wing dropped suddenly, the aircraft began to yaw to the left and the commander was unable to maintain directional control with either the rudder or the nosewheel steering tiller. The aircraft ran off the left side of the runway and stopped on the grass having turned through approximately 90°. The left landing gear had collapsed and the aircraft had come to a halt resting on its baggage pannier, right landing gear and left wing (Figure 1).

The aircraft as it came to rest

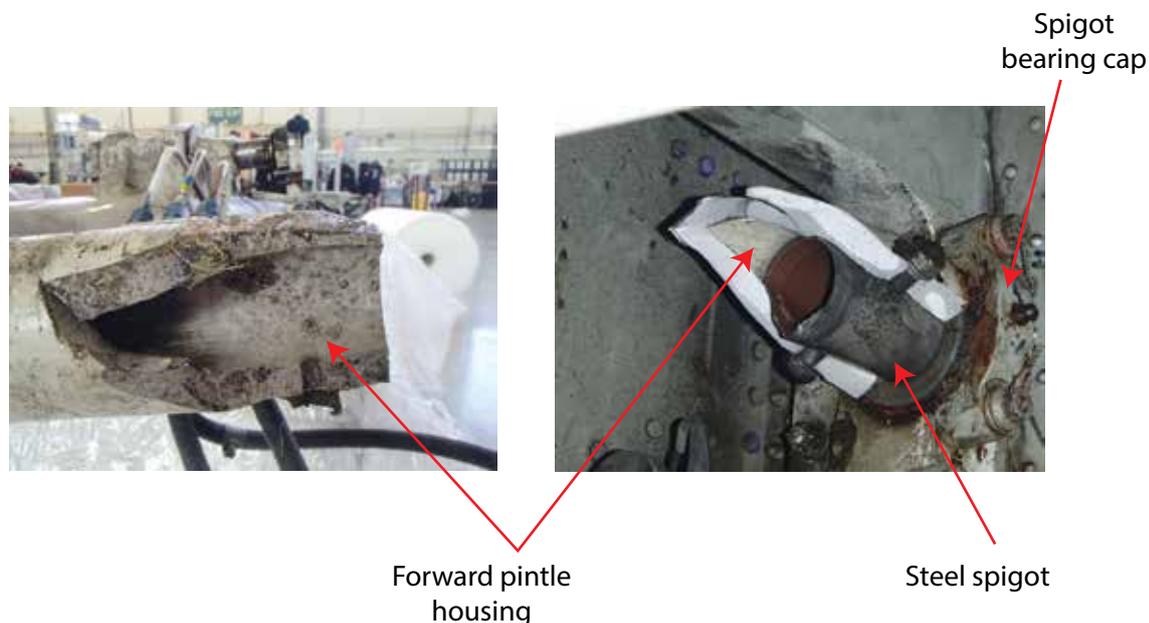
**Figure 3**

The left landing gear had broken away from its mounts as a result of the failure of the forward pintle housing. Two sections of the pintle housing stayed attached to the pintle spigot (Figure 3). However, the landing gear remained attached to the aircraft by the radius arm (retraction jack) and hydraulic pipelines.

Left main landing gear forward pintle housing

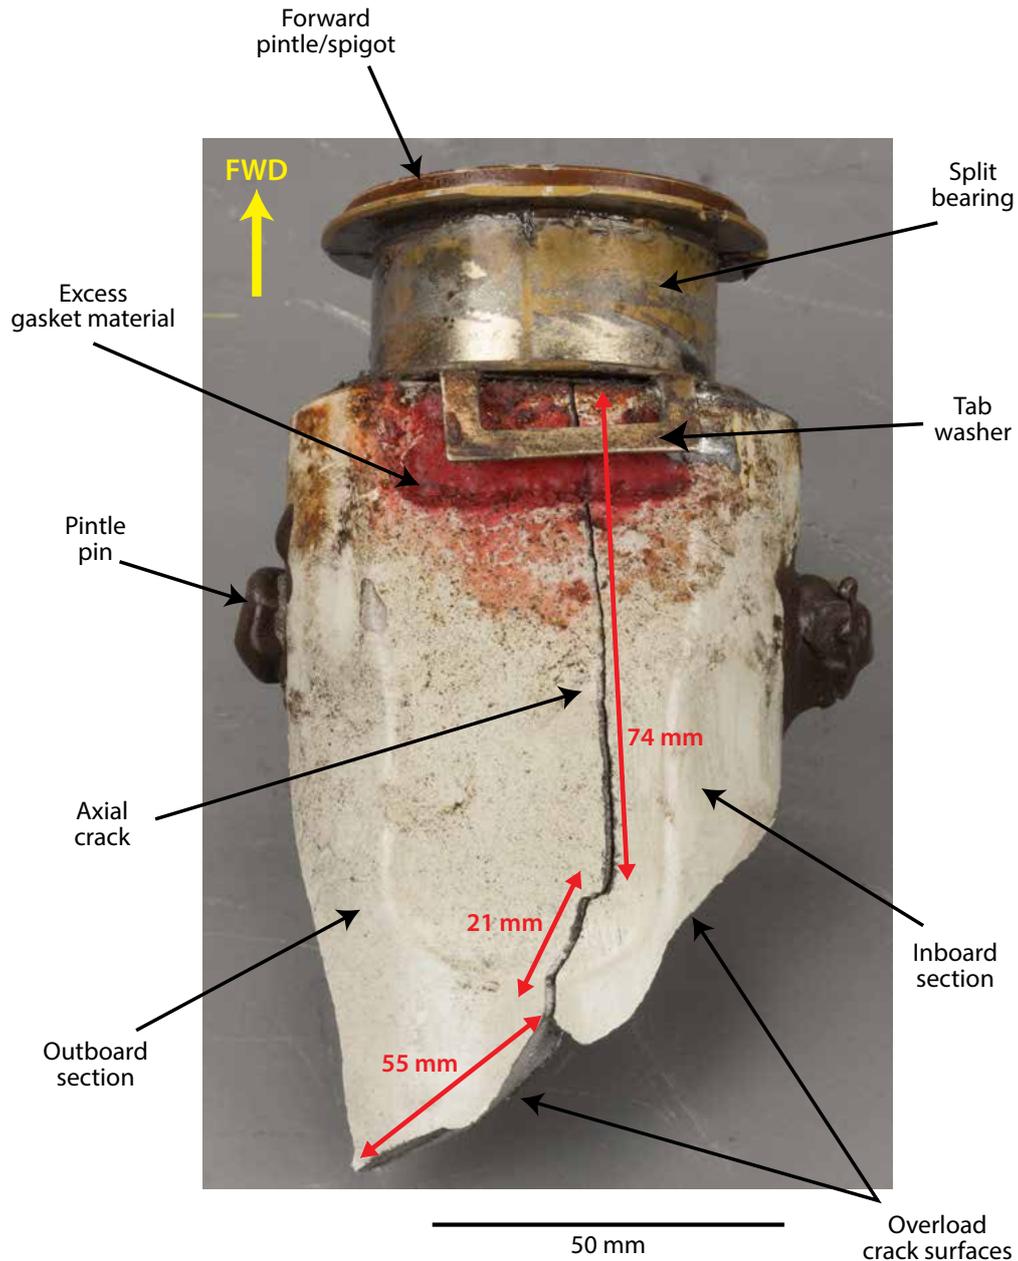
**Figure 5**

The axial crack propagated aft for 74 mm, before extending a further 76 mm in a downwards and outboard direction (Figure 5).

Both fracture surfaces of the axial crack had a 'woody' appearance, characteristic of SCC. Smearred gasket material was present on the top of the fracture surfaces, towards the start of the crack. Examination of the inboard fracture surface showed that corrosion was present within the first 35 mm, extending rearwards and downwards. A narrow band of corrosion along the top of the fracture surface extended for a further 40 mm. Figure 6 shows the corrosion staining in the area bounded by the dashed red line.

Scanning electron microscopy of the fracture faces, showed a small flat fracture region, measuring 2.4 mm x 1.5 mm, extending from a corrosion pit on the forward face of the pintle housing, close to the top surface. Within this flat fracture region, the surface showed extensive corrosion and the crack growth appeared intergranular, typical of SCC. Beyond the flat fracture region, the corrosion staining was less severe but the fracture surface was still intergranular in nature. Approximately 14 mm from the crack origin, ductile features start to become evident in the corrosion-stained area. The remainder of the fracture surface within the corrosion-stained region exhibited a combination of intergranular features and ductile dimples, with ductile features becoming more prevalent and corrosion less severe as the crack progressed. Although DTD 5094 fracture surfaces are difficult to interpret, the prevalence of ductile features on some areas of the fracture surface suggests that overload failure also contributed to the later stages of the axial

Left landing gear forward pintle housing showing crack

The smeared gasket material on the machined flat, on the top surface of the pintle housing, visible in Figure 5, did not fluoresce under UV light and its consistency confirmed that it had only partially cured. After removing this gasket material from the machined flat, it was noted that the paint in this area was blistered.

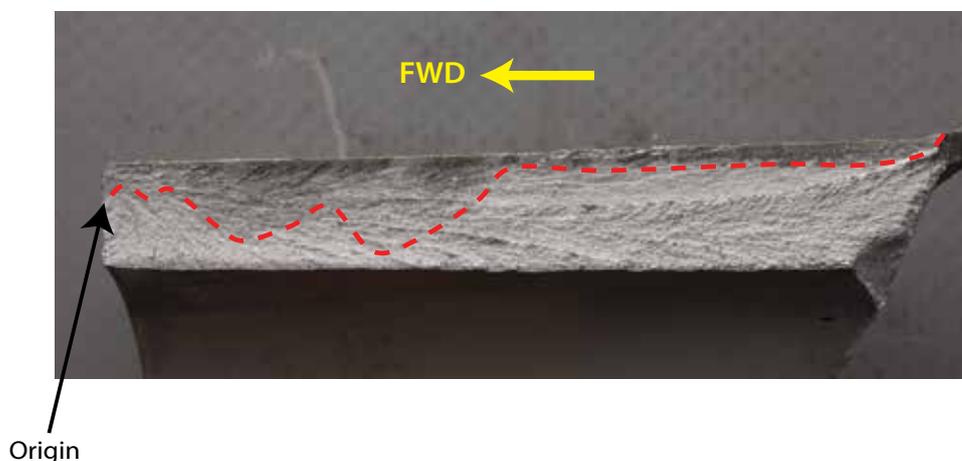
**Figure 6**

crack progression. The severity and depth of the corrosion staining towards the start of the crack suggest that this part of axial crack had been open for some time prior to final failure, although it was not possible from the metallurgical analysis to determine for what length of time the crack may have been present. The reduced severity and depth of the corrosion band in the later stages of the axial crack suggest that this part of the crack was open for a shorter period of time.

Left landing gear, inboard half of axial crack fracture surface after cleaning, showing corrosion staining

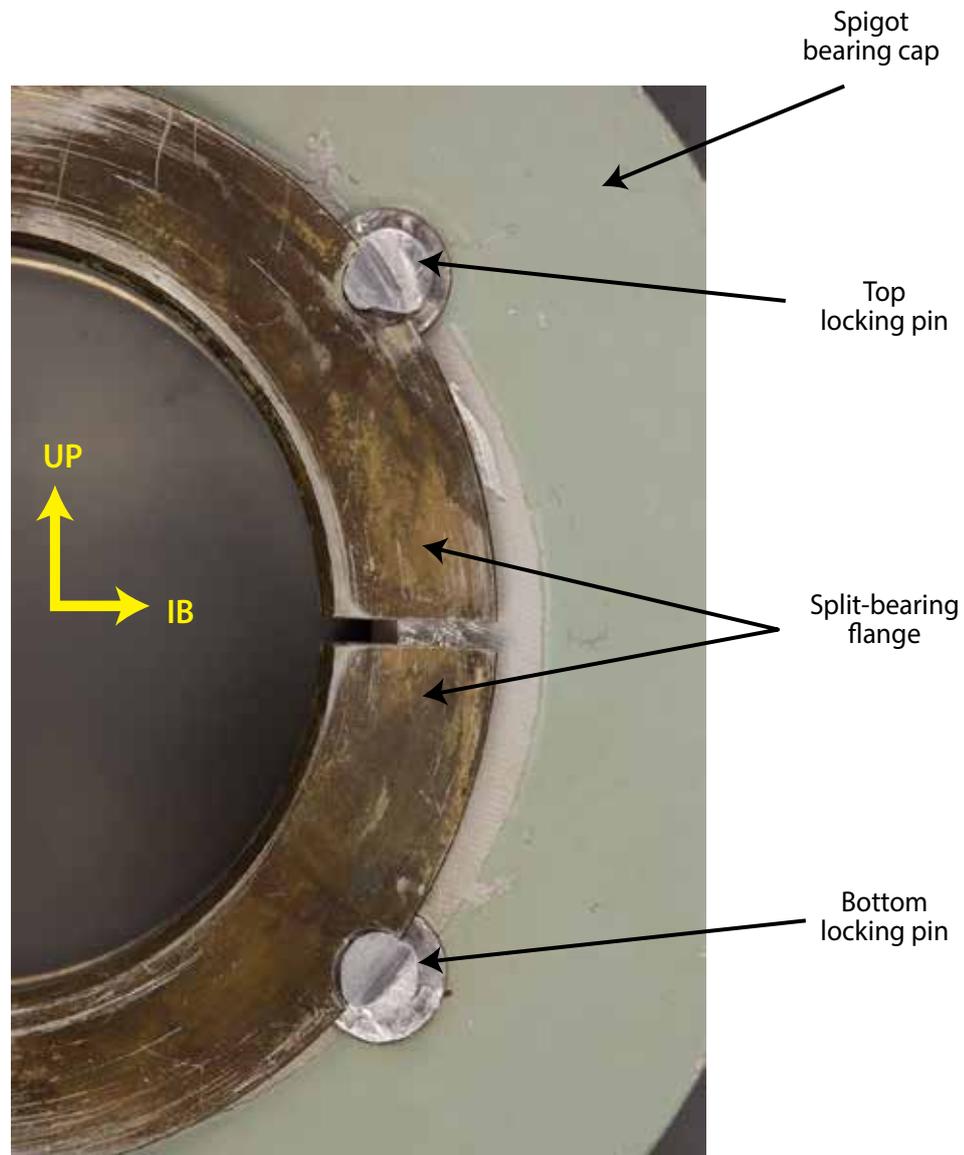
**Figure 7**

The washer tab was distorted and rotational wear marks were evident on the forward face of the washer, around the inboard edge. This wear is consistent with contact between the washer and the bearing locking pins in the spigot bearing cap. Substantial wear was evident on the bearing locking pins, including a distinctive notch on each pin, created by the outer edge of the washer (Figure 7). The top and bottom pins protruded 1.95 mm

and 2.03mm respectively, from the surface of the spigot bearing cap. The bearing flange measured 1.64 mm thick.

Left landing gear, wear on bearing locking pins

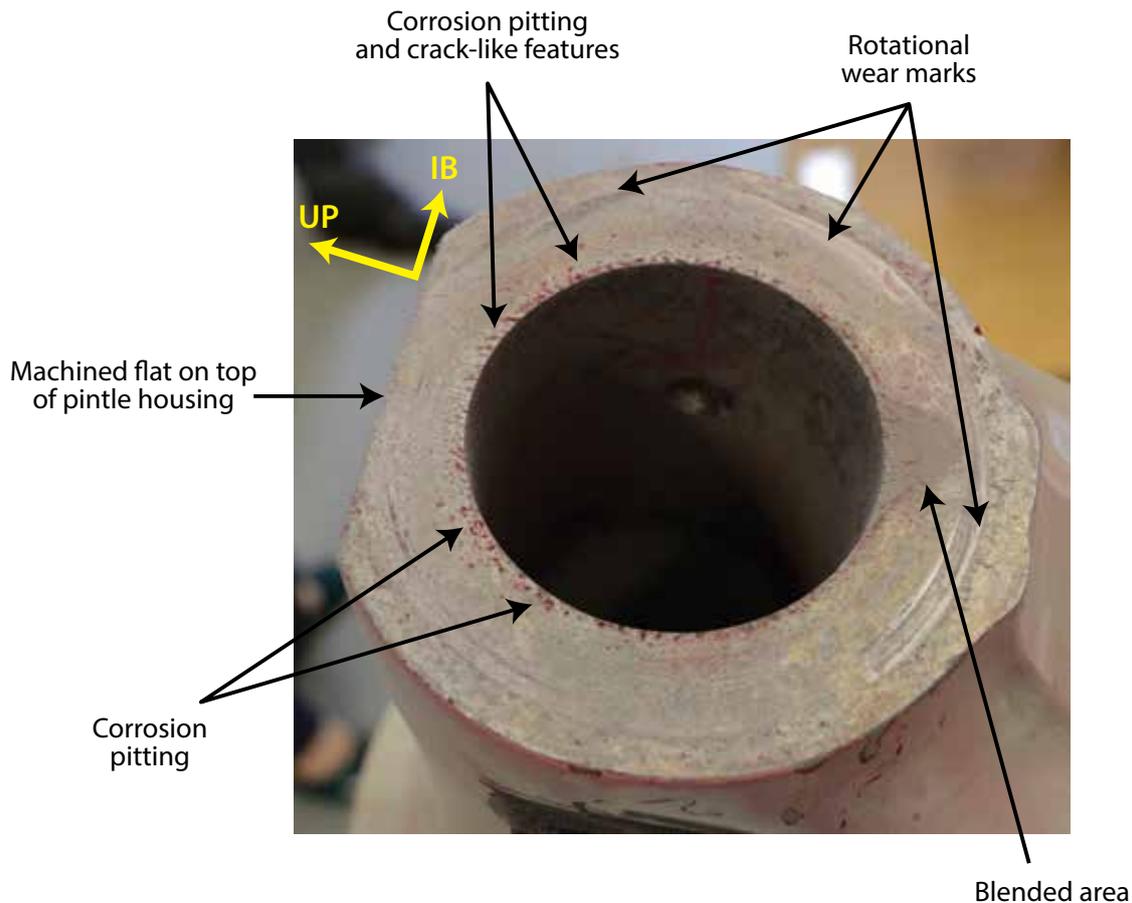
**Figure 8**

There was extensive corrosion pitting on the forward face of the pintle housing, most prevalent around the bore, with crack-like features appearing to emanate from the corrosion pits. A HFEC inspection using the technique called up in SB 32-A-JA851226, Revision 6 and SB 32-19 Revision 6, identified defect indications which exceeded the maximum permissible limit. A dye-penetrant inspection was conducted to highlight these defects; the results are shown in Figure 8. The damage was determined to be outside permissible repair limits and the right landing gear cylinder was deemed to be 'scrapped'.

Right landing gear, forward face of pintle housing after dye penetrant examination

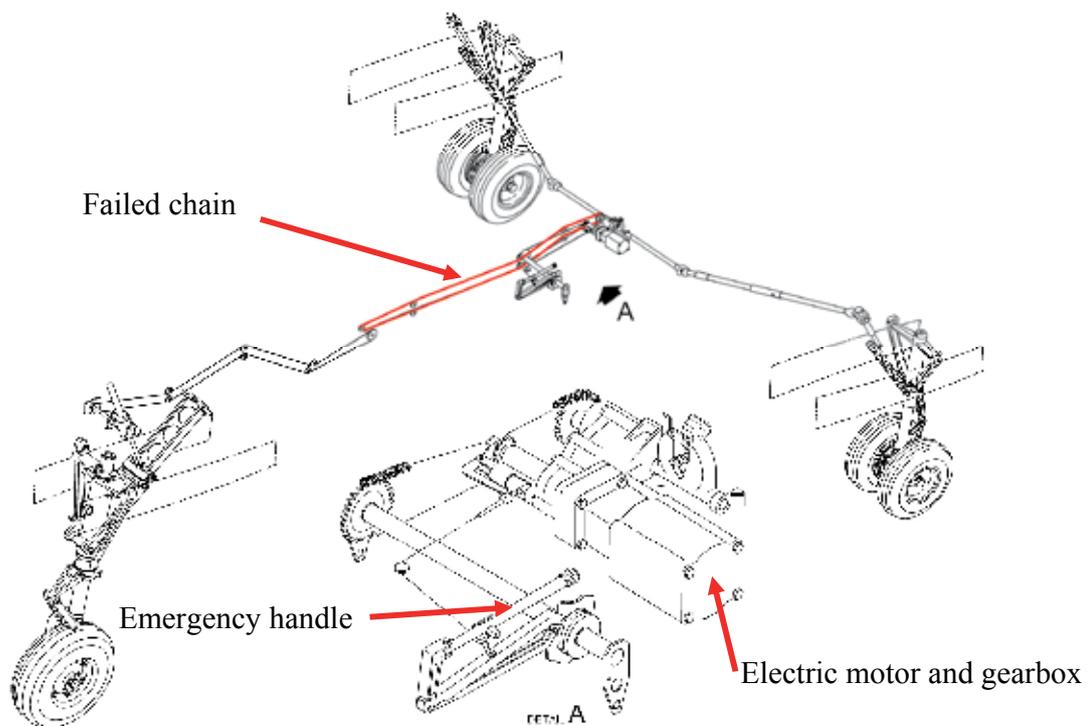
**Figure 1**

Investigation by the operator's maintenance organisation revealed that the forward segment of the chain (the portion within the area bounded by the red line in Figure 1) was found broken at the master link following a failure of the master link itself. This effectively isolated

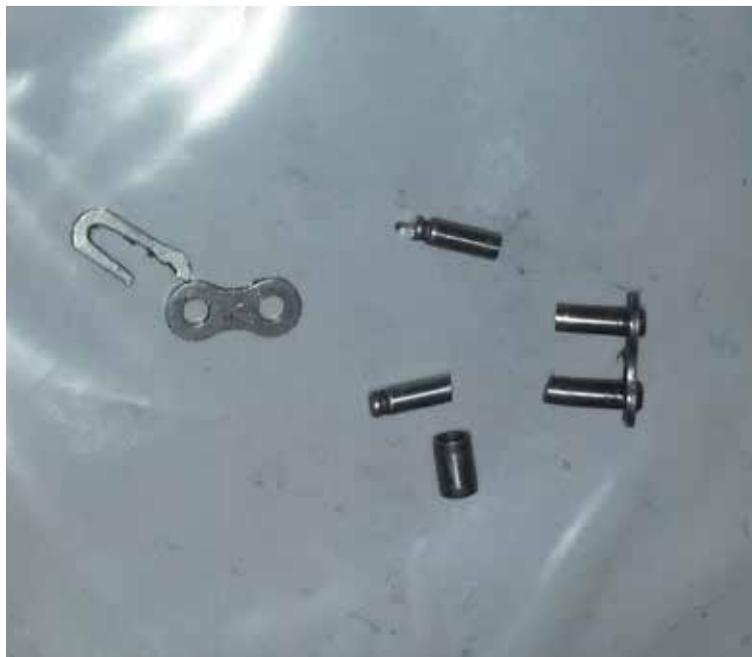
**Figure 2**

the nose gear from the rest of the system, such that operation of the emergency handle (intended to be used in the event of a failure of the motor or gearbox) would only operate the main gear. Figure 2 shows a photograph, taken by the maintenance company, of the master link components.

Master link components

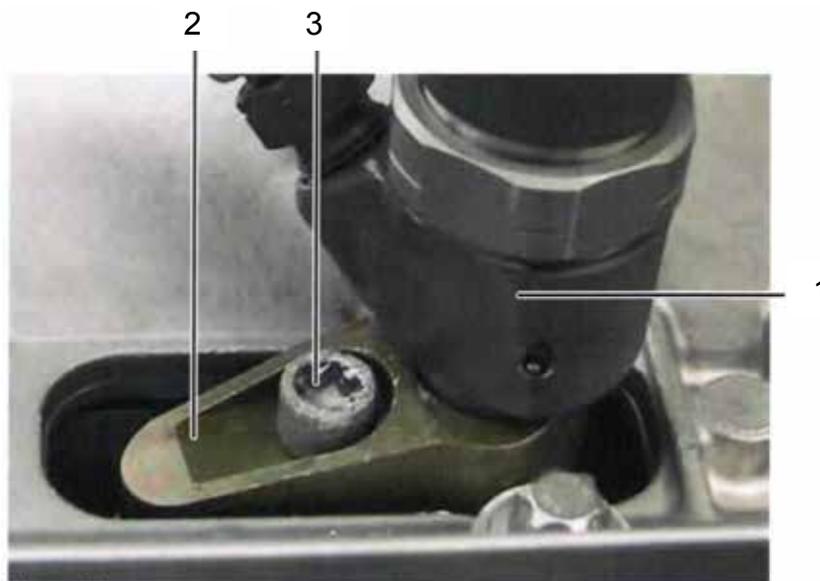
**Figure 1**

Engineers from the aircraft's maintainers arrived at the site and checked fluid levels and downloaded the data from the engine FADEC (Full Authority Digital Engine Control) unit. Although at first it visually appeared that nothing was wrong with the engine, the data for the accident flight showed a series of alerts for low fuel rail pressure. The next day, upon closer inspection, it was found that No 2 cylinder injector securing screw and injector support were missing, the injector itself was out of position by about 50 mm and the associated fuel pipe unions had loosened (Figure 1).
