Rail Accident Investigation Branch

Rail Accident Report

Derailed at Porthkerry, South Wales 2 October 2014

Report 10/2015
August 2015

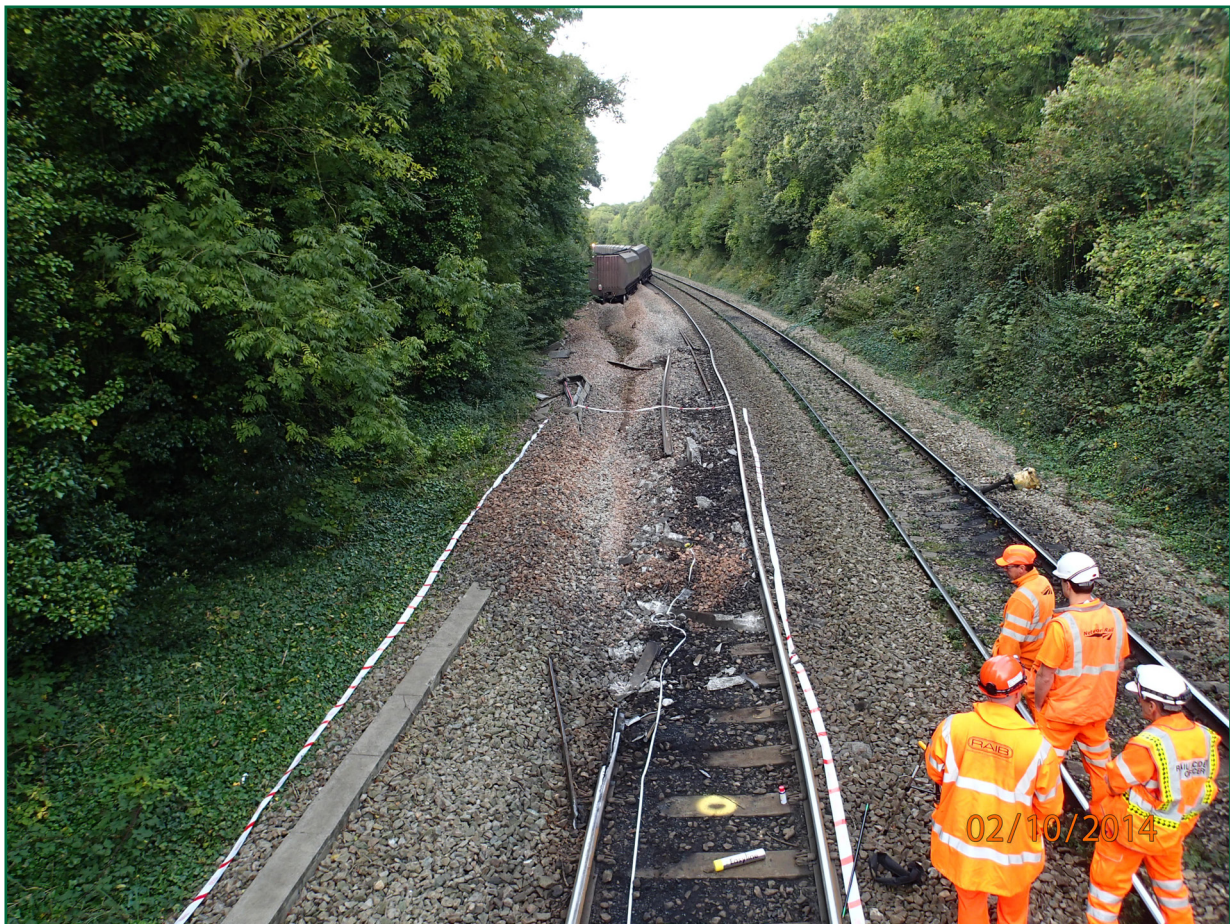
- 3 At 02:30 hrs on Thursday 2 October 2014, a loaded coal train derailed at Porthkerry, between Barry and Rhoose on the Vale of Glamorgan line in South Wales (figure 1). The last two wagons in the train were derailed when the rail beneath them collapsed (figure 2).

Figure 2: Overview of derailment site

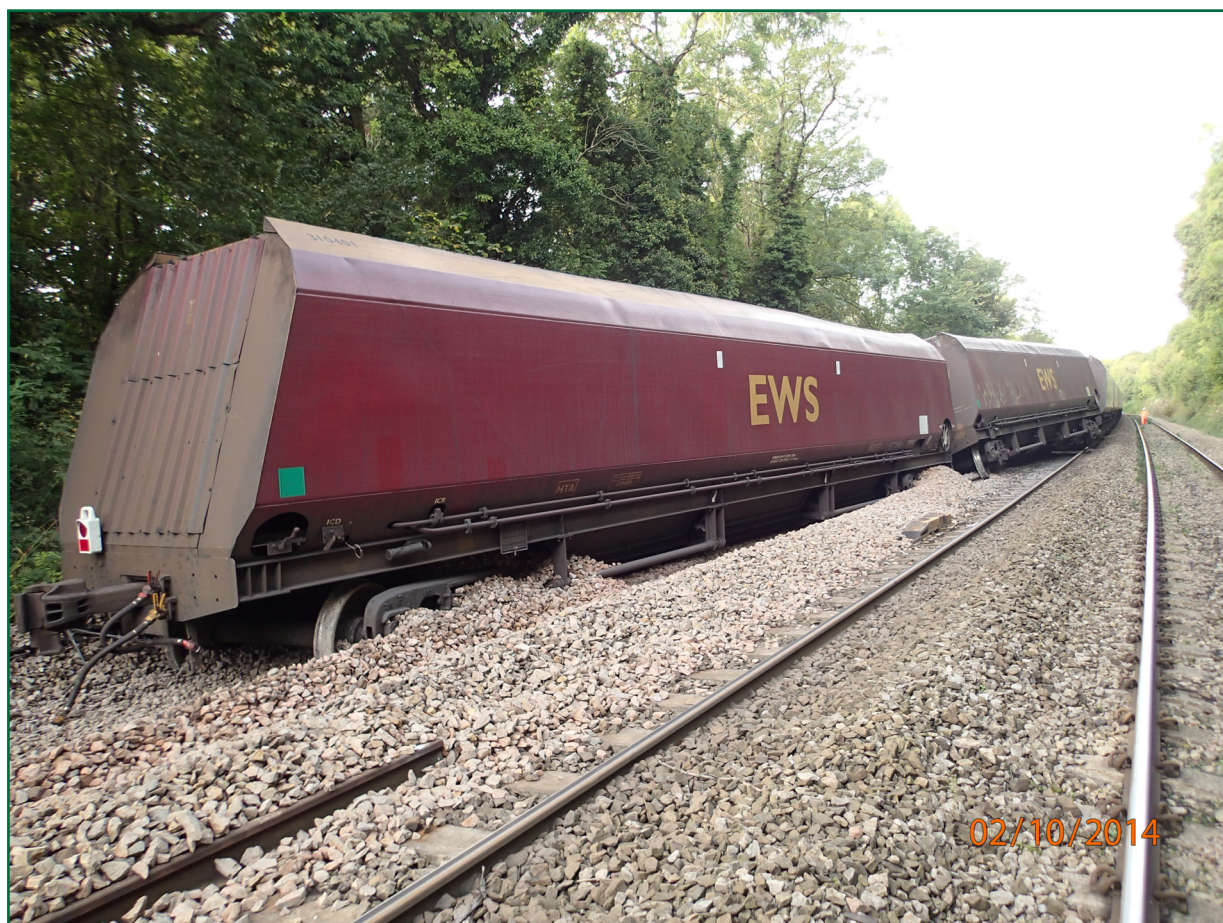
Figure 4: Derailed HTA wagon

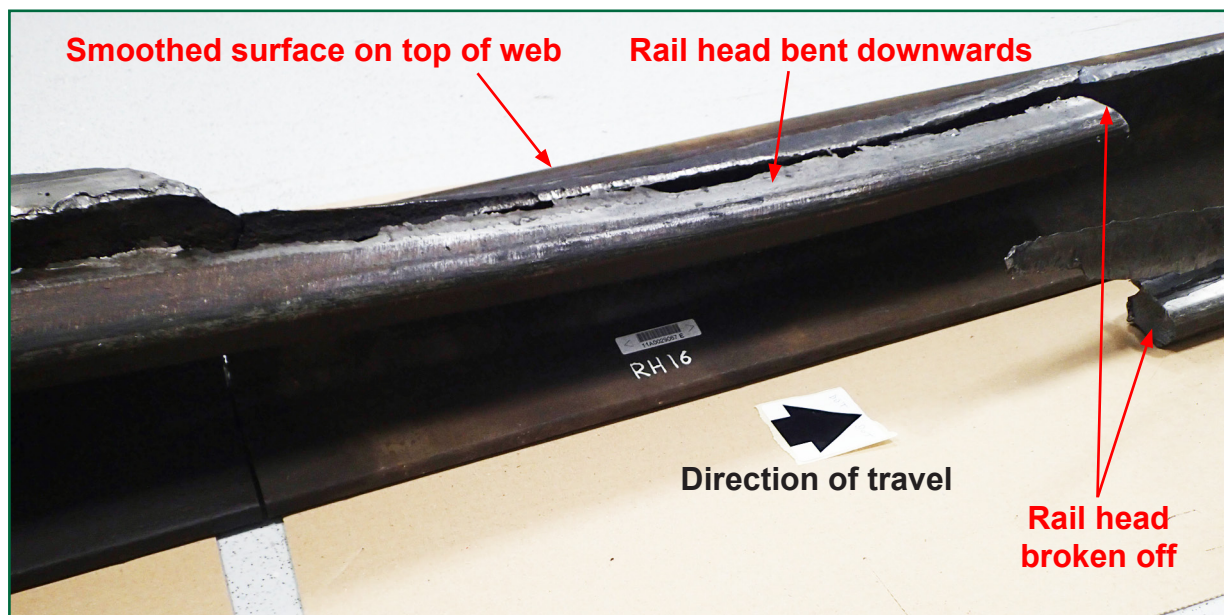
- 26 As the wheels ran on the exposed web of the rail, it was left with a smooth surface (figure 6) and the gauge side of the rail head was bent downwards. At the end of this section of rail, the gauge side of the head broke away in several pieces. The whole rail section failed at this point and some wheels struck the exposed end of the next piece of rail, breaking off three more pieces.

Figure 6: Fractured section of rail, showing smoothed surface of fractured web

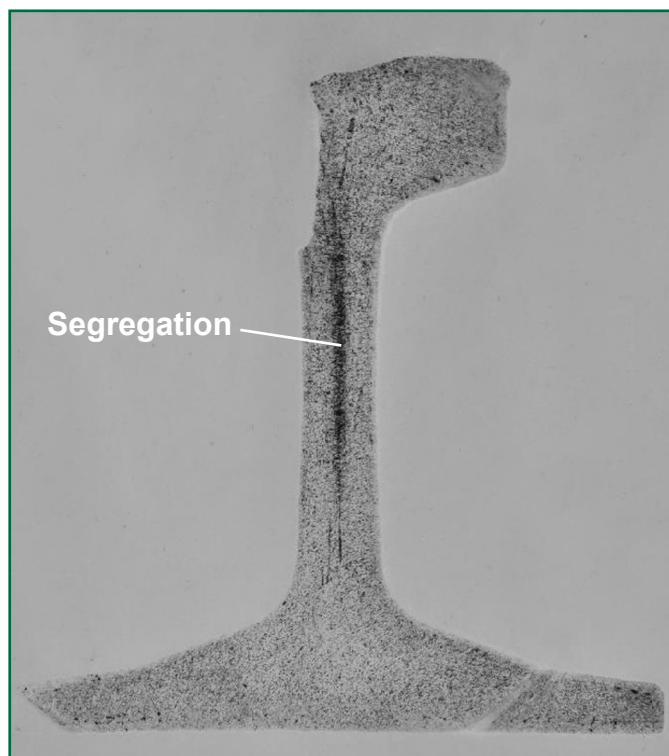
- 70 The presence of impurities in steel can be revealed by making a *sulphur print* of the surface of a cut section. This shows sulphide compounds in the steel which can reveal *segregation* within the metal. The metallurgist produced a sulphur print of a section of this rail (figure 9) which showed that there were distinct signs of segregation of the metal in the centre of the web which extended up into the head.

Figure 9: Sulphur print of rail showing segregation in web extending up into head (image courtesy of Serco Rail Technical Services)

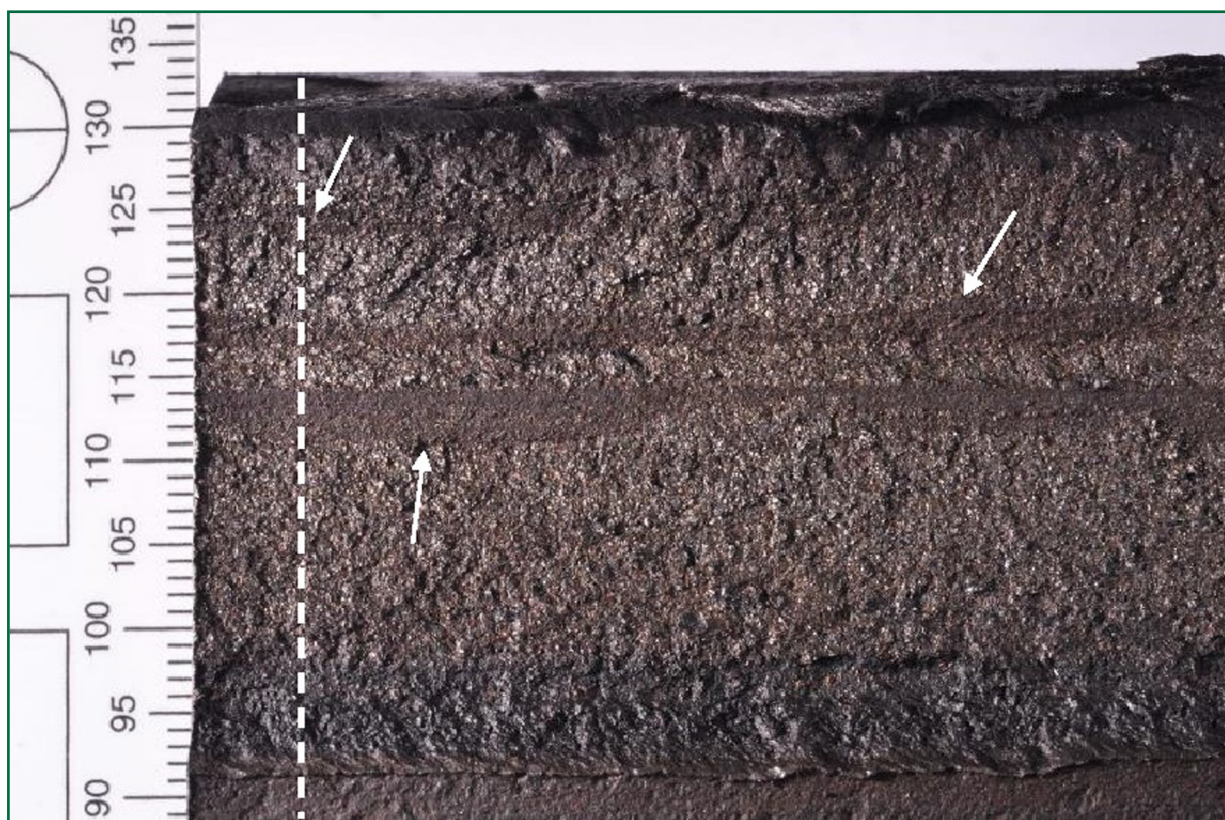
- 71 Examination of the fracture face of one of the sides of the VLS fracture showed indications of multiple defects in the steel oriented in the rolling direction of the rail (figure 10). This is consistent with impurities in the steel at manufacture being elongated along the rail as it was rolled.

Figure 10: Fracture face of VLS crack showing multiple defects (arrowed) oriented in the rolling direction (image courtesy of Serco Rail Technical Services)

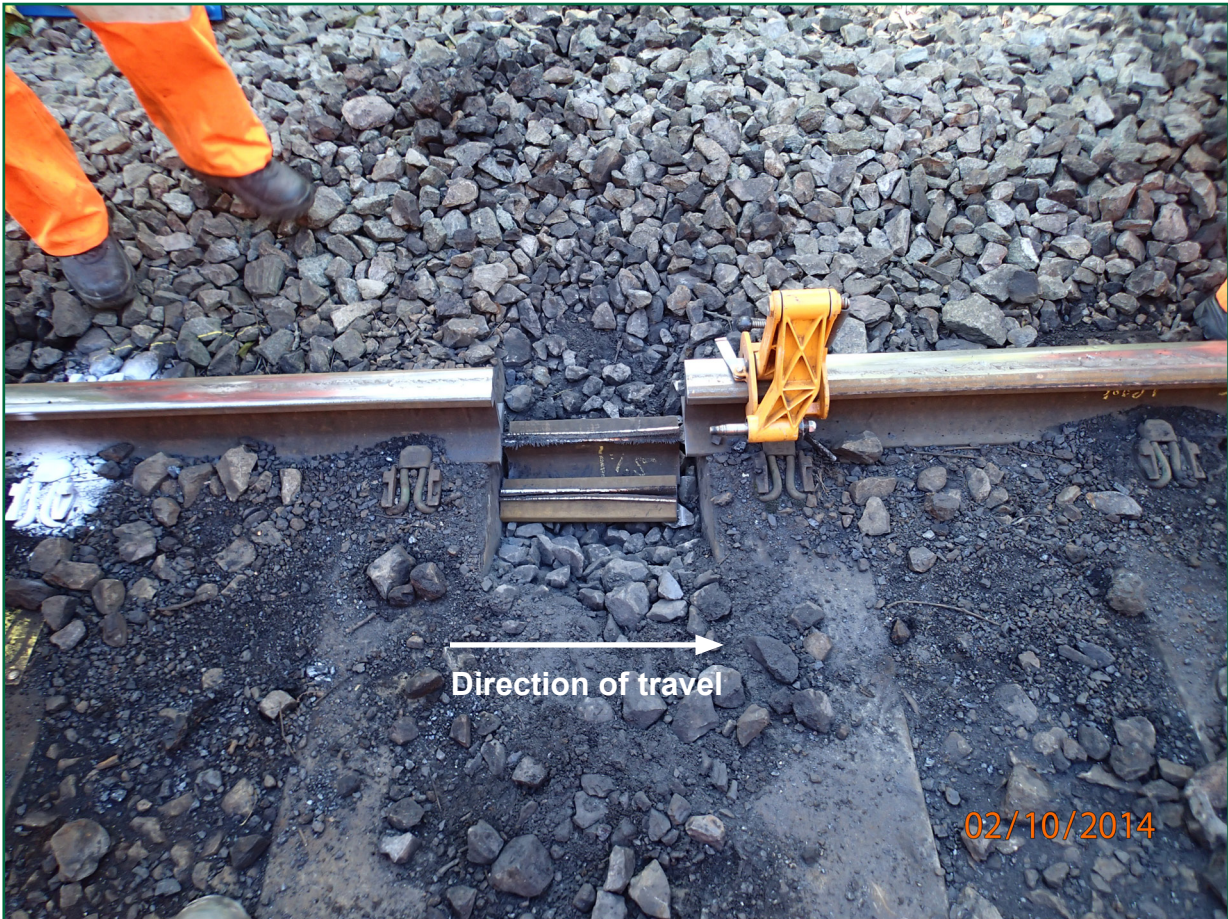
72 The position of the split within the rail cross section was evident in several places where the rail had completely broken. In addition to these breaks, there was a length of rail each side of the broken area where the split had opened up within the rail head but had not yet led to complete failure. The RAIB asked Network Rail to cut out a short length of apparently undamaged rail on the approach to the point of derailment (figure 11). This revealed that the piece of rail cut out was in two pieces, with fractures between the head and web at the *upper fillet radius* (figure 12). The cut ends of the rail revealed the extent of the split in the head (figure 13).

Figure 11: Apparently intact rail on the approach to the point of derailment

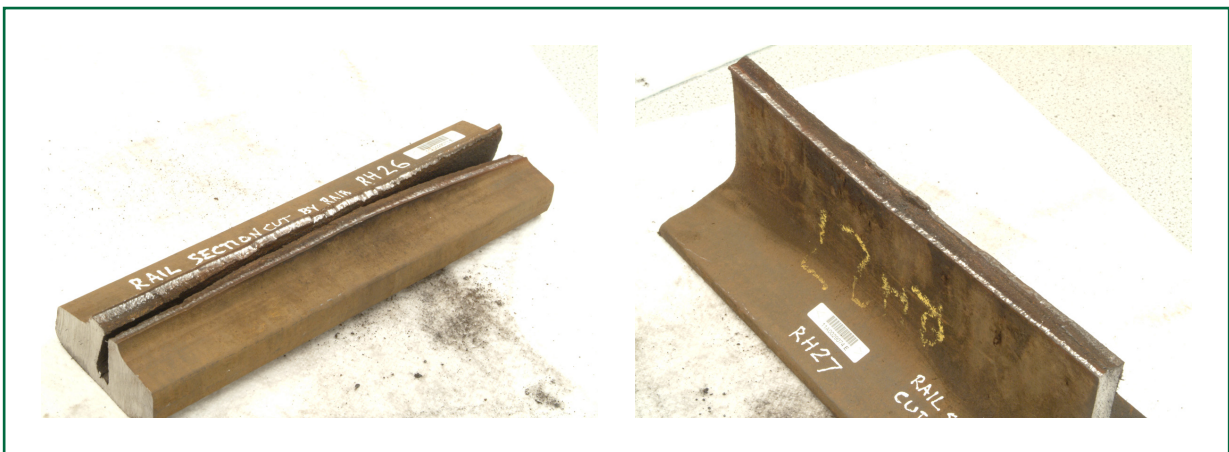
Figure 12: The two pieces of rail seen in figure 11

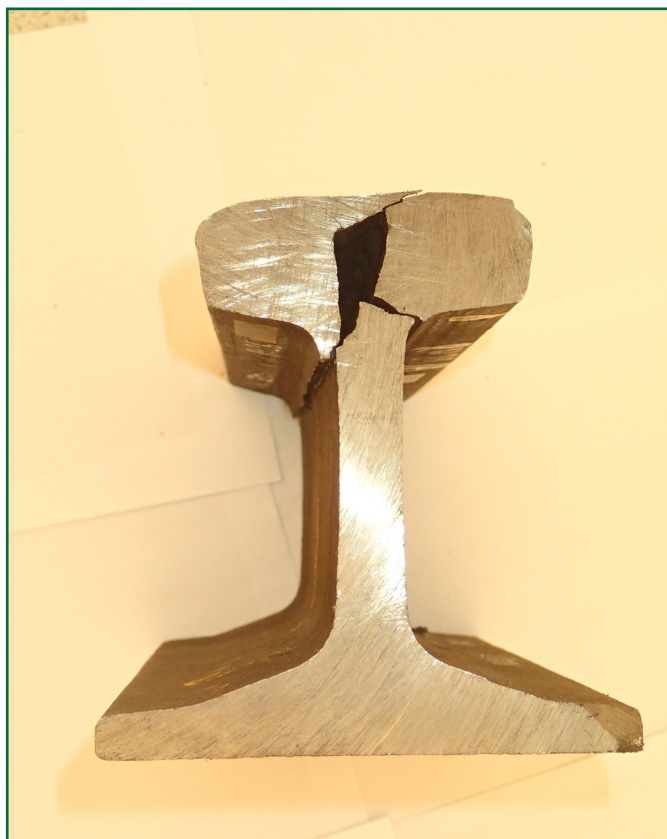
Figure 13: Cross-section of rail showing extent of VLS

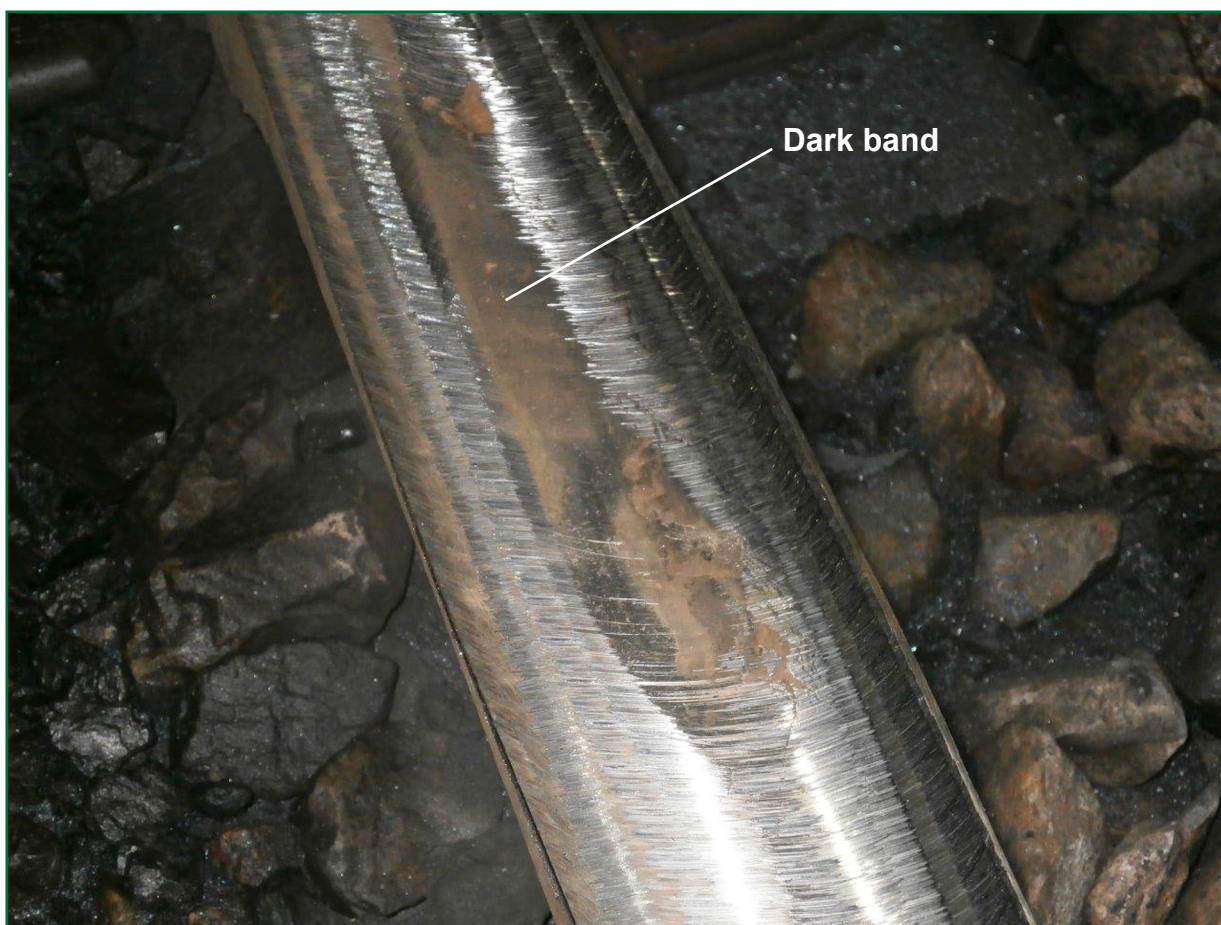
- 110 The RAIB obtained copies of the photographs taken by Harsco and they show the condition of the rail after the grinding work. One of the photographs (figure 16) shows a dark band in the centre of the rail head which is a sign that the head was starting to collapse into the void formed by the VLS.

Figure 16: Photograph of left-hand rail taken by Harsco after grinding on 30 August 2014 (dark area shows where rail had started to collapse)

- 111 It is not possible to determine from the evidence available precisely when the VLS had developed to the extent that the crack broke through the surface or the head became bulged by 2 mm. However, the photograph taken after the grinding on 30 August shows that the head had started to collapse at that time.

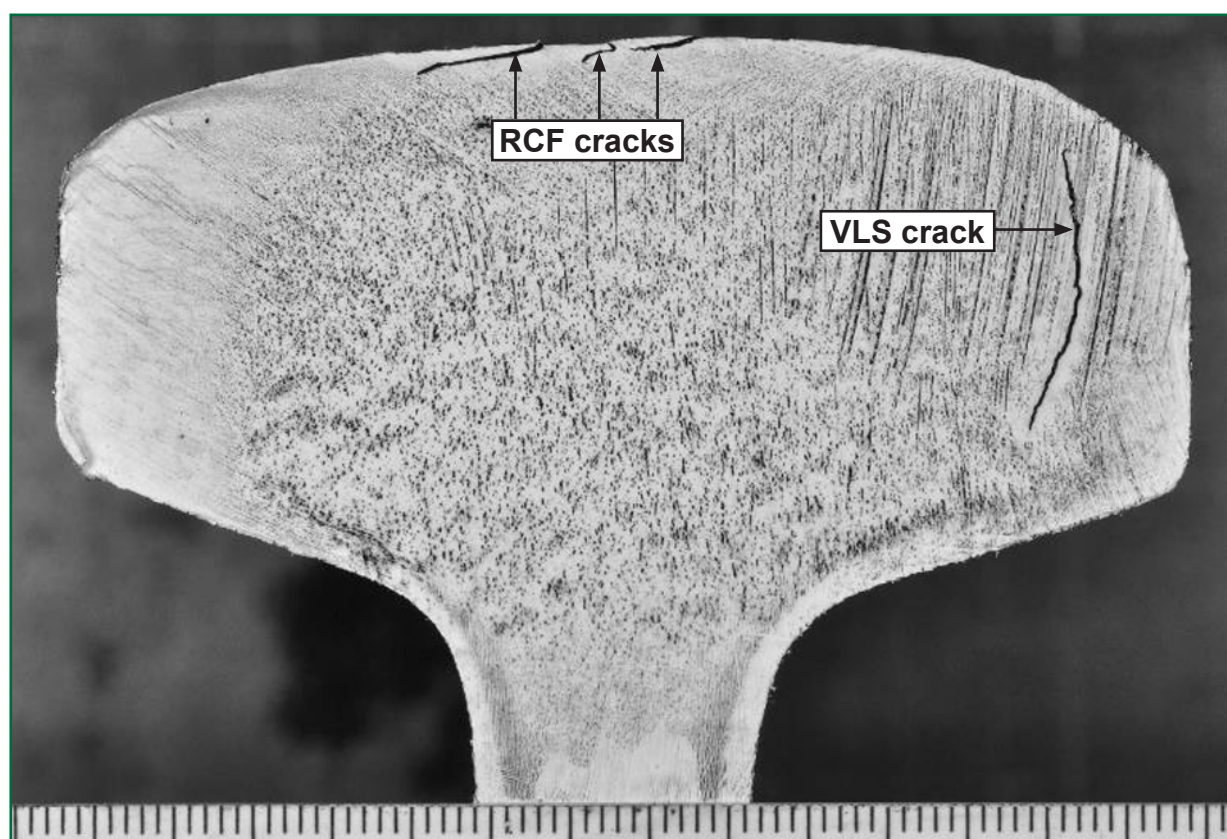
Figure 17: Magnetic particle inspection of the rail cross section at the start of the VLS section (image courtesy of Serco Rail Technical Services)

- 113 The rail samples recovered by the RAIB only contained one piece of 'unbroken' rail where the crack had reached the surface. This crack was difficult to see with the naked eye and was only evident after magnetic particle inspection had been carried out.
