Rail Accident Investigation Branch

# Rail Accident Report

## Freight train derailment at Angerstein Junction 2 April 2014

Report 11/2015  
August 2015

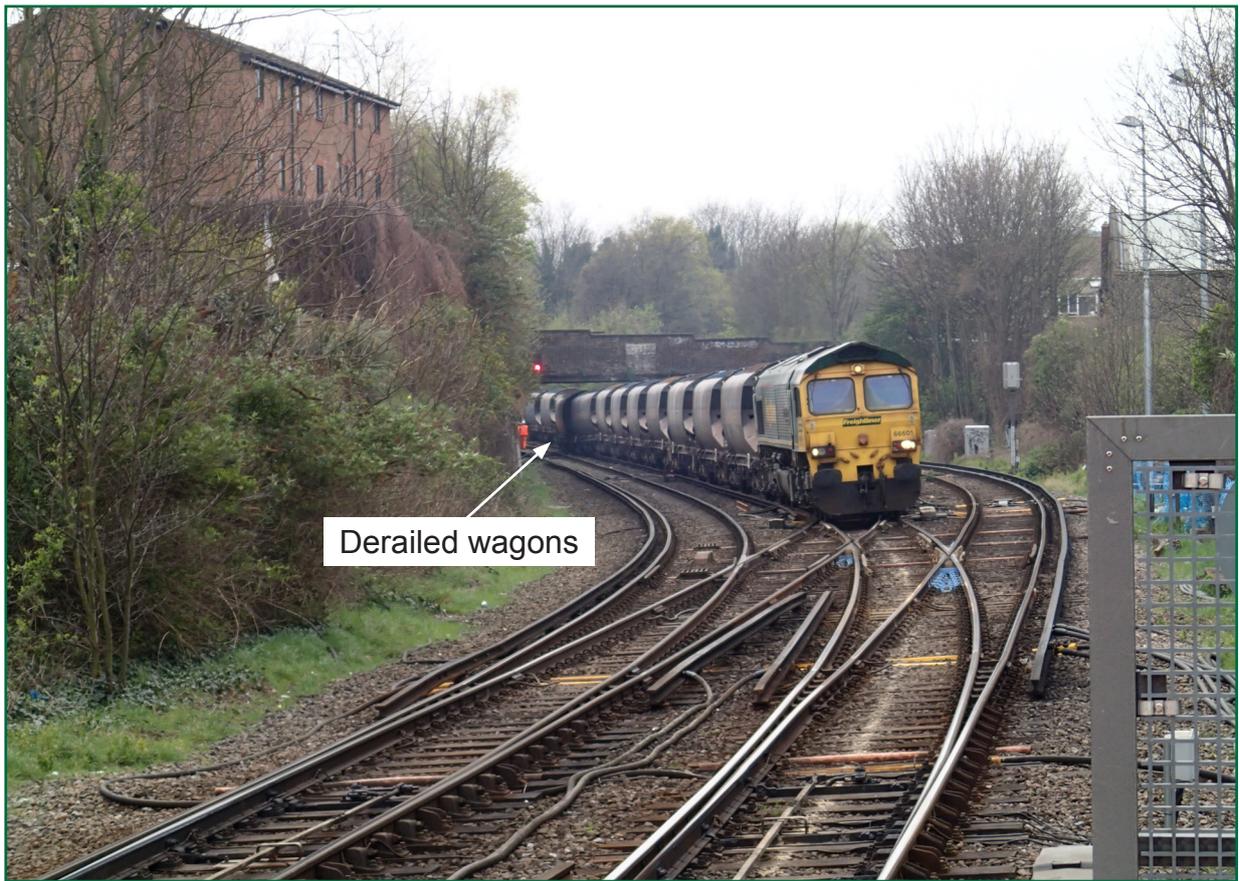
Figure 2: Derailed train after stopping, showing derailed wagons at the bridge

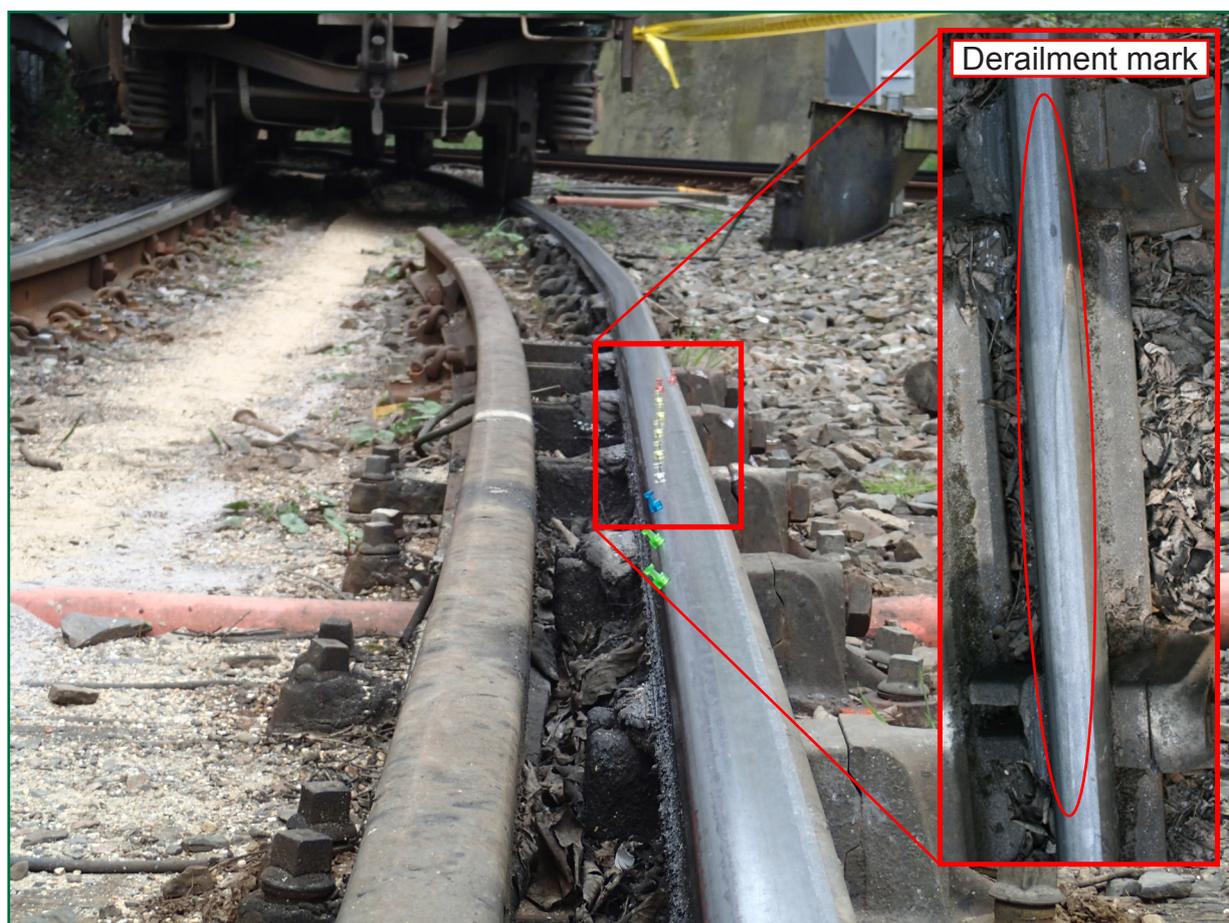
Figure 9: Derailment mark (position marked by coloured magnets placed on the rail) (Inset courtesy of Network Rail)

- 58 **The immediate cause of the accident was that there was insufficient load on the front right-hand wheel of the leading bogie on wagon 546 to counteract the lateral forces at the wheel-rail interface, and thus to prevent the flange climbing over the railhead in the vicinity of trap points 851A.**

- i) **Support of the rails:** there was an orange pipe containing electrical cables crossing the track at the point of derailment (figure 9). This was positioned between sleepers, and near to the surface, and so would not have affected the vertical track support at that location.

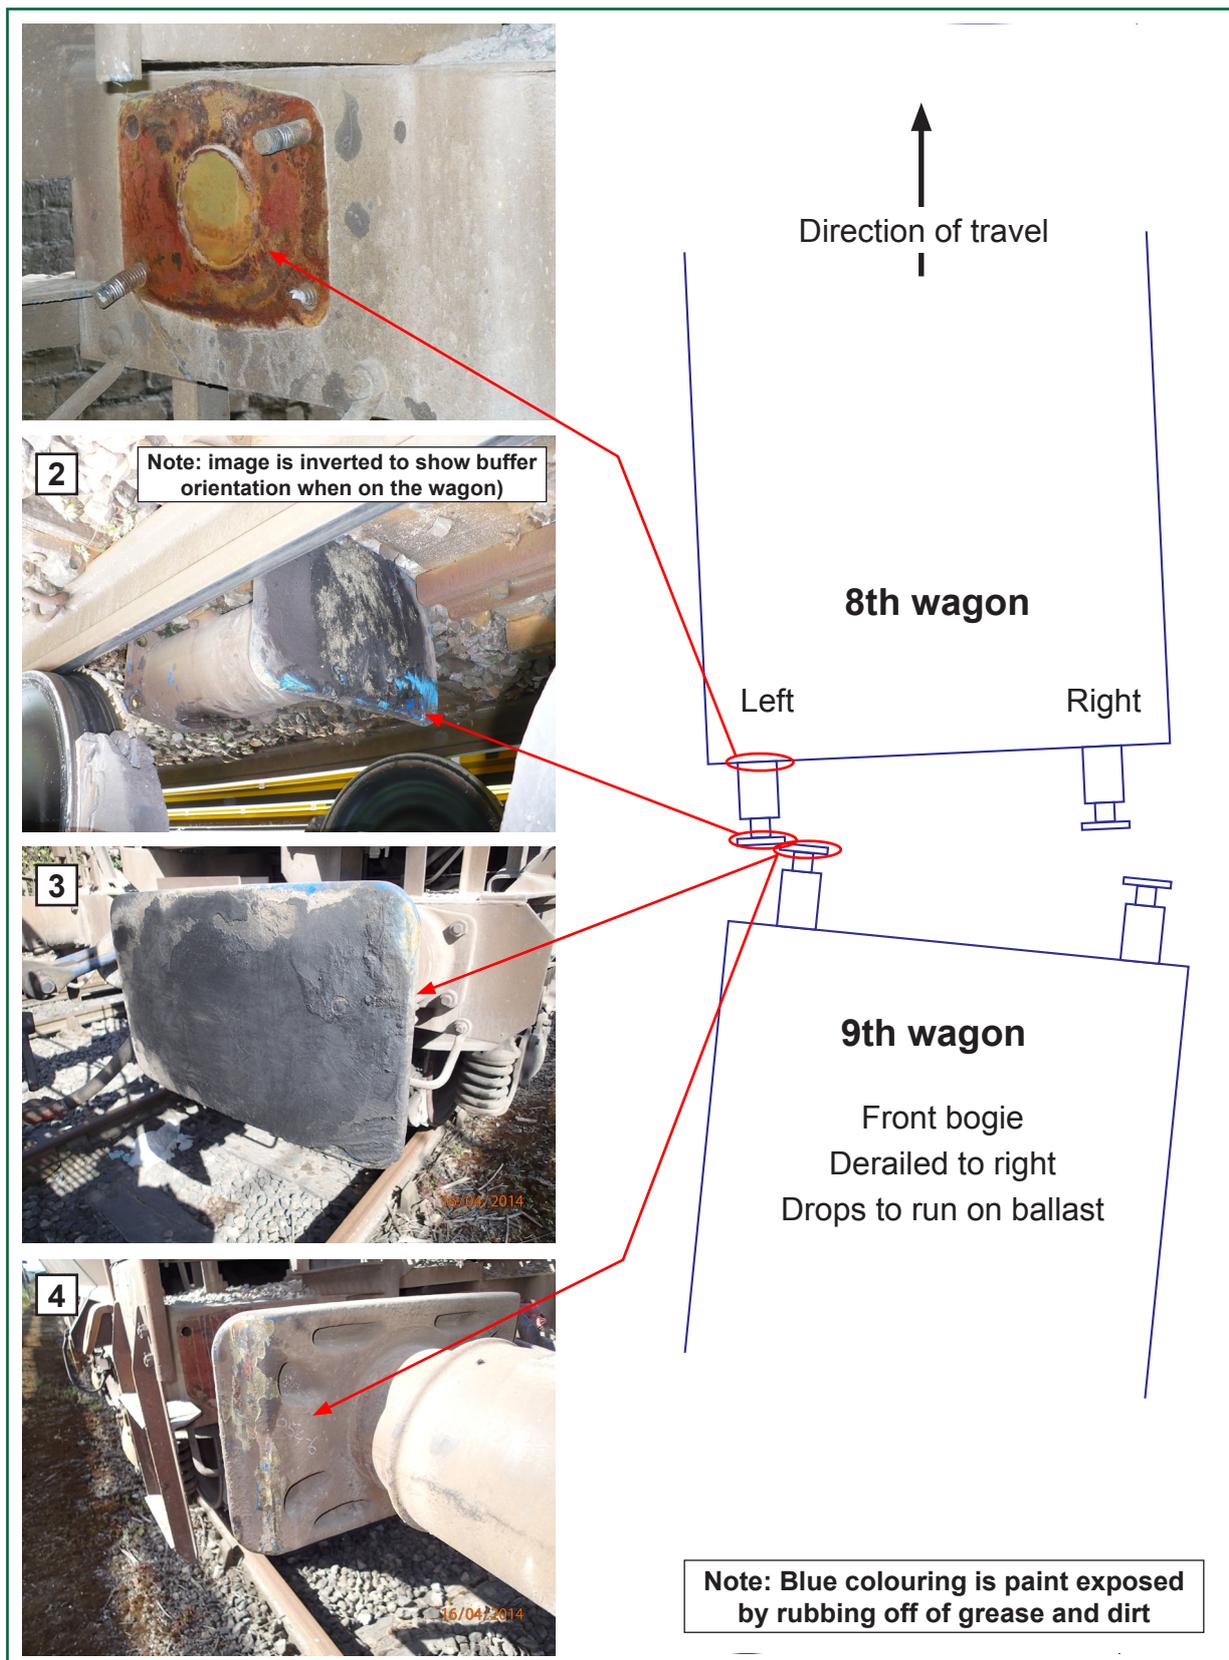
- 63 Marks on the back of the left side buffers on both the 8<sup>th</sup> and 9<sup>th</sup> wagons indicate that these locked together (image 4 in figure 10). This is discounted as a cause of the derailment because the marks on the front faces of the buffers show that the buffer on the 9<sup>th</sup> wagon dropped relative to that on the 8<sup>th</sup> wagon (ie the 9<sup>th</sup> wagon derailed) before locking occurred (paragraph 61). The *buffer locking* resulted in the rear left buffer on the 8<sup>th</sup> wagon being levered off to the left by the front left buffer on the 9<sup>th</sup> wagon (image 1 in figure 10). This buffer was found upside down between the running rails, about 70 metres after Angerstein Junction (image 2 in figure 10).

Figure 10: Buffer marks on 8th and 9th wagon (1st and 2nd insets courtesy of Network Rail)

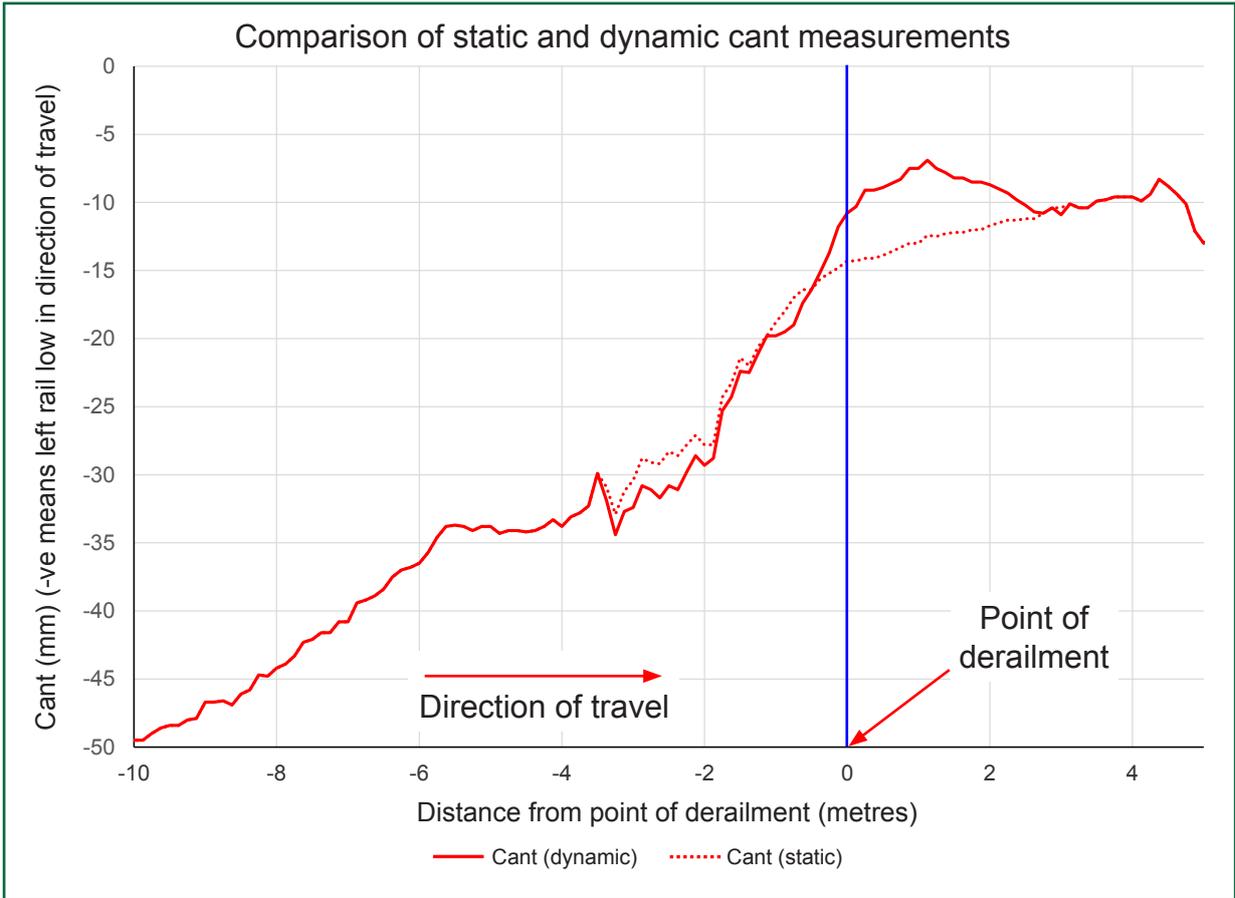
Figure 13: Track cant in the vicinity of the derailment location

- 70 The survey data showed that over the 10 metres on the approach to the point of derailment, the average cant gradient was close to the maximum design limit of 1 in 400 (7.5 mm change in cant every 3 metres) that is allowed by railway group standard GC/RT5021 (Track System Requirements) for new track. This design limit was significantly exceeded at some locations, including in the immediate vicinity of the point of derailment, probably due to track bed deterioration.

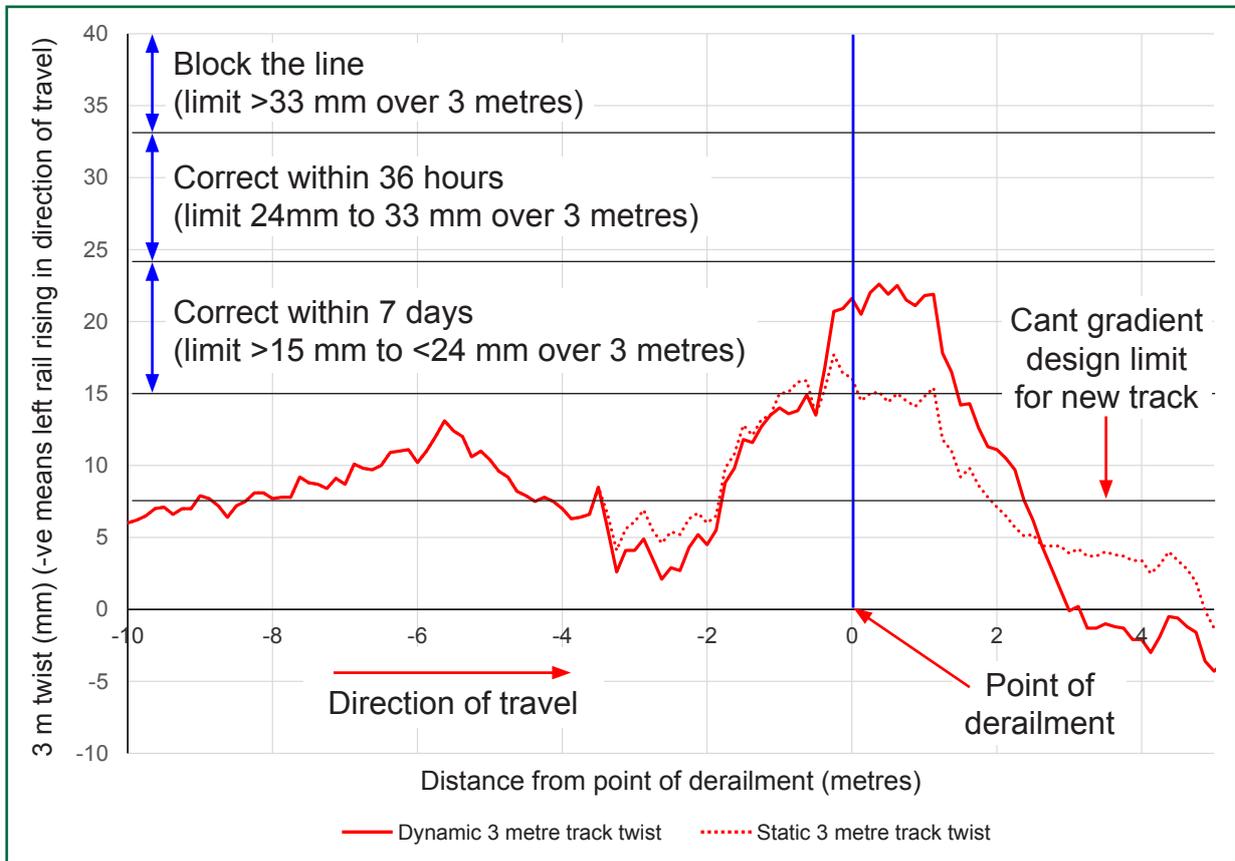
Figure 14: Track twist in the vicinity of the derailment location

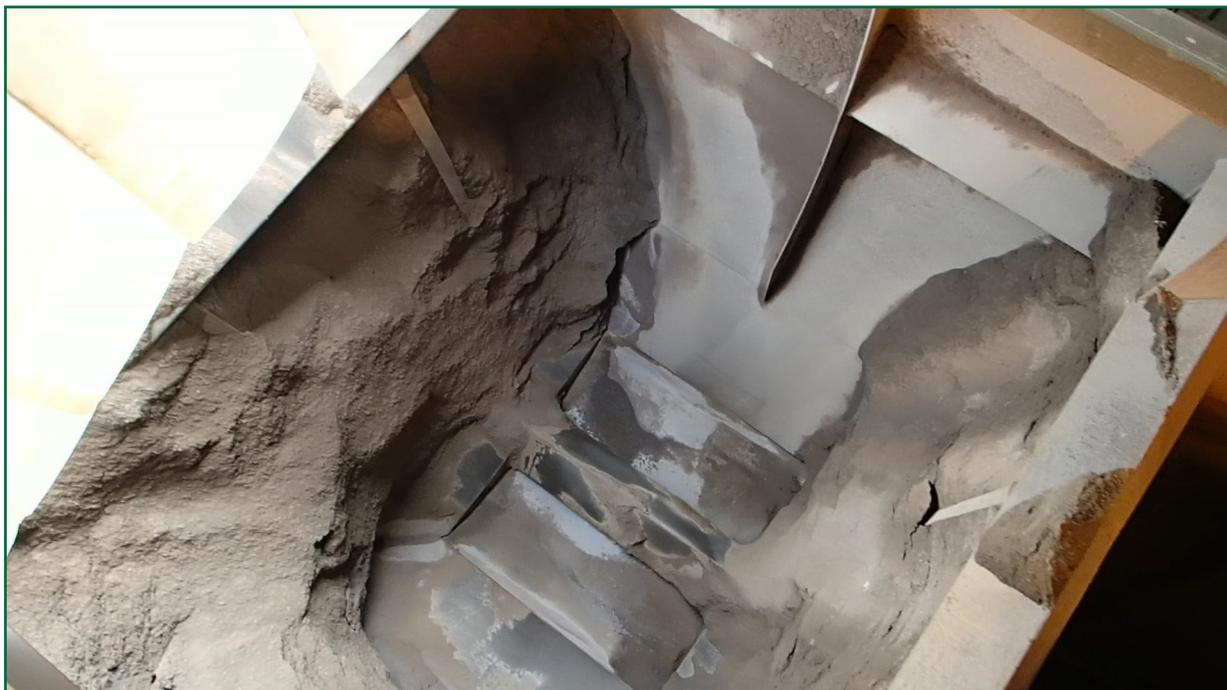
Figure 16: Crushed rock fines hanging up in a similar hopper wagon

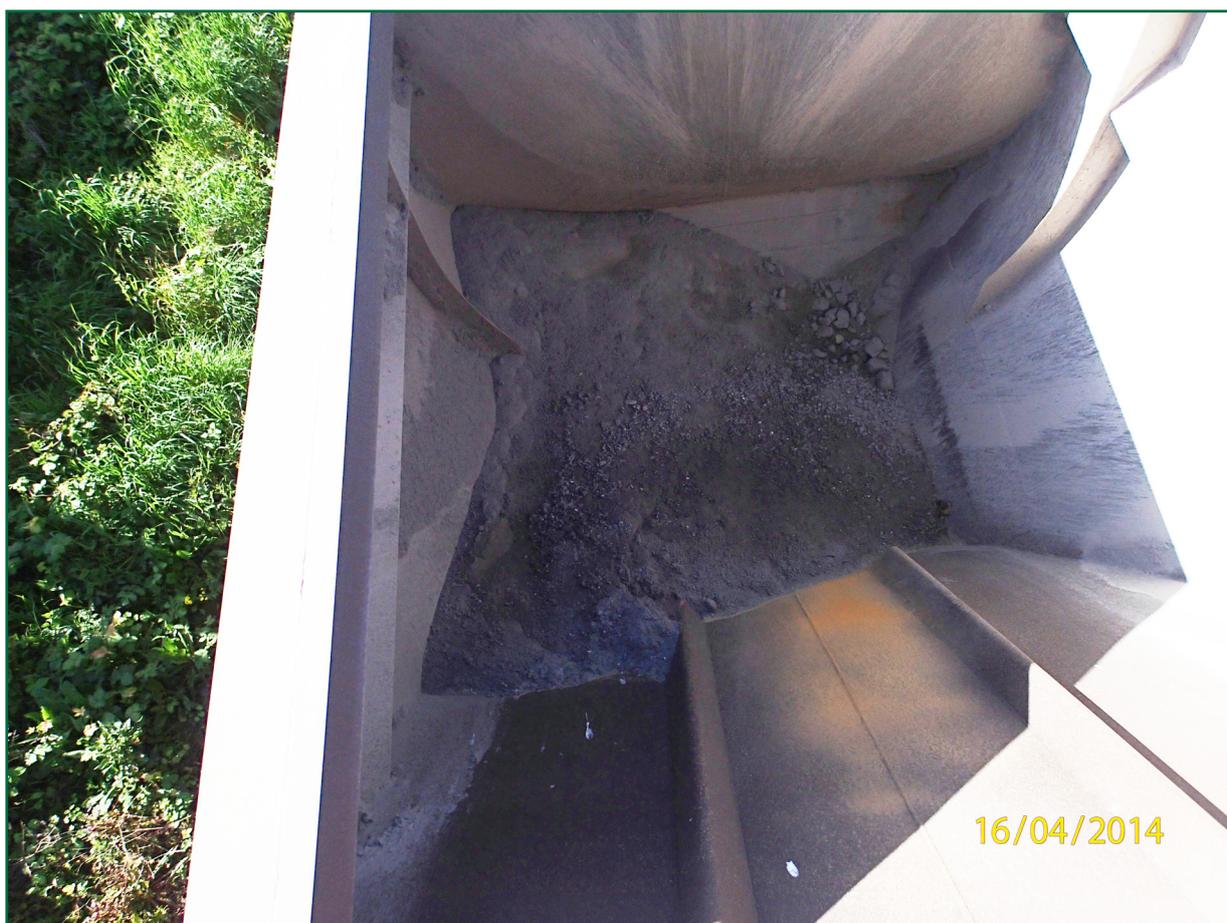
- 97 The actual distribution of the retained payload of 11.7 tonnes of crushed rock fines (paragraph 94) at the time of derailment is not known, as it was displaced during the derailment (paragraph 95). In the absence of better information, the RAIB has assumed that the load distribution at the time of the derailment was similar to the distribution of the 13.3 tonnes of material recorded by WheelChex when the wagon passed Thurmaston on 1 April 2014. The wheel loadings at the time of derailment, with the residual load, are estimated to have been as shown in appendix E.

Figure 17: Retained material in the wagon (after derailment)

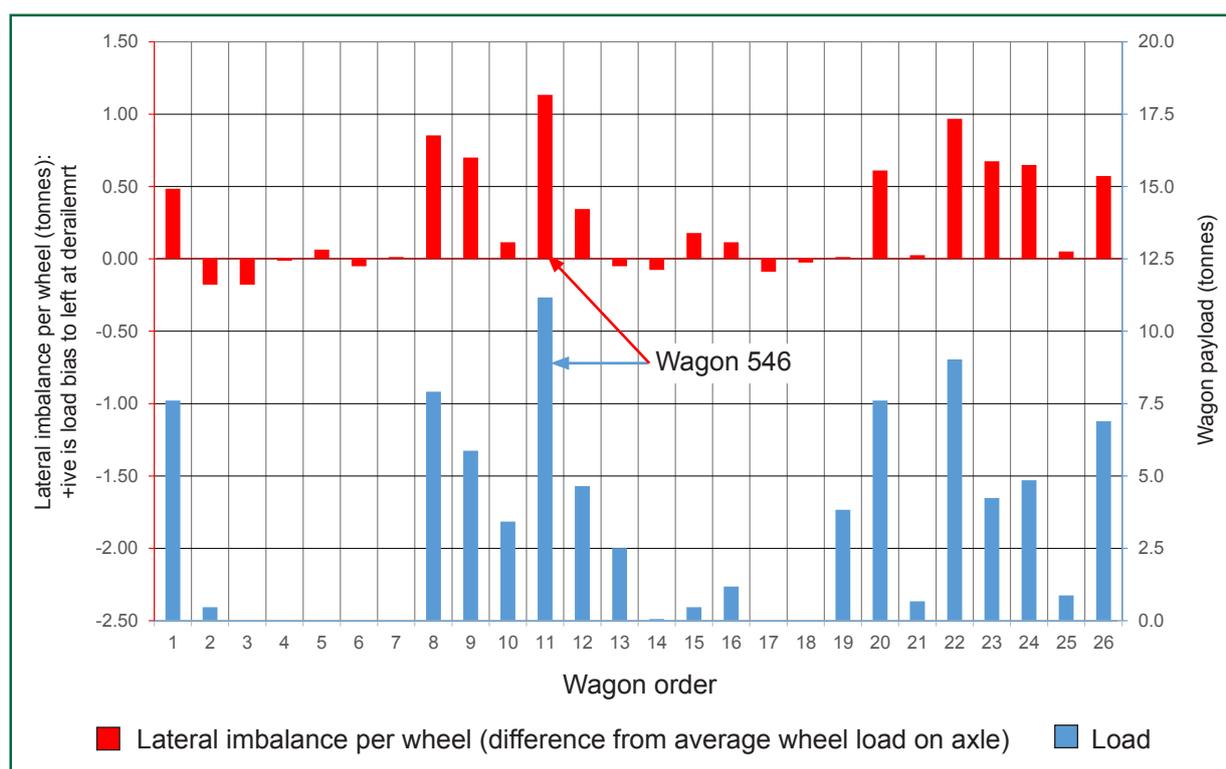
112 The WheelChex data for the nominally empty train that included wagon 546 and passed Thurmaston WheelChex site on 1 April 2014 (when travelling from Tinsley to Bardon Hill quarry), is shown in figure 18. This shows the lateral imbalance (per wheel)<sup>11</sup> of most of the wagons is less than 0.2 tonnes, but exceeds this value on ten wagons. In all ten instances, the load is biased to the same side (the left side when related to the direction of travel at the time of derailment), and is associated with wagons that are carrying residual loads in excess of 4 tonnes. RAIB analysis of additional WheelChex data for two earlier nominally empty trips between Tinsley terminal and Bardon Hill quarry shows that between 40% and 85% of the wagons in each train contained a residual load in excess of 1 tonne, and that this load was always significantly biased towards the same side.

Figure 18: Graph of unbalanced loads in other wagons (from Thurmaston WheelChex on 1 April 2014)

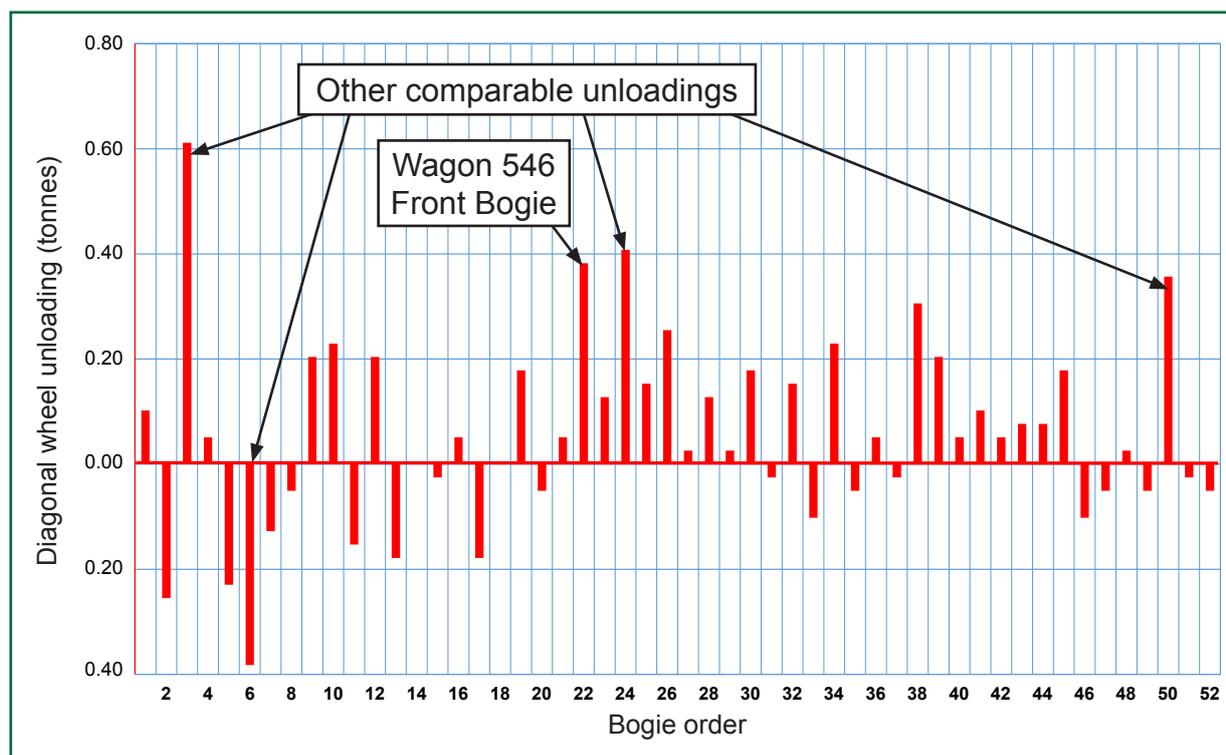
144 Figure 24 shows the diagonal wheel unloadings for the train containing wagon 546 at Thurmaston on 1 April 2014. This shows that four other bogies in that train had comparable or greater diagonal wheel unloadings to that on wagon 546. Three of these had the effect of unloading the leading right wheel, while the fourth would have unloaded the leading left wheel.

Figure 24: Bogie diagonal wheel unloading for train containing wagon 546 (from Thurmaston WheelChex on 1 April 2014)

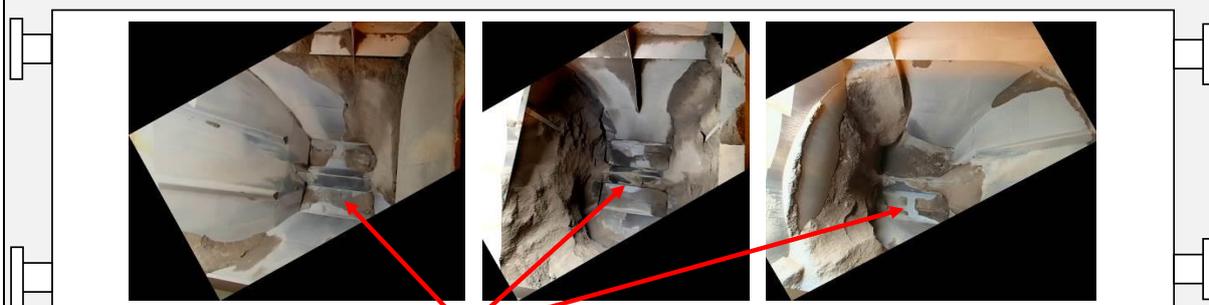
*Crushed stone adhering to the sides of the three hoppers in a wagon after unloading on 20 June 2014 at Angerstein wharf.*
