# Post-incident reporting for reservoirs Annual report 2014

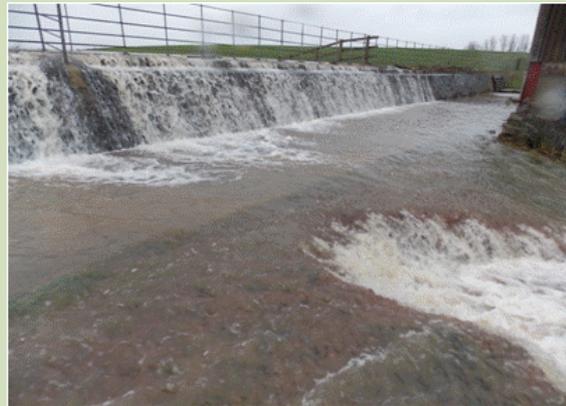
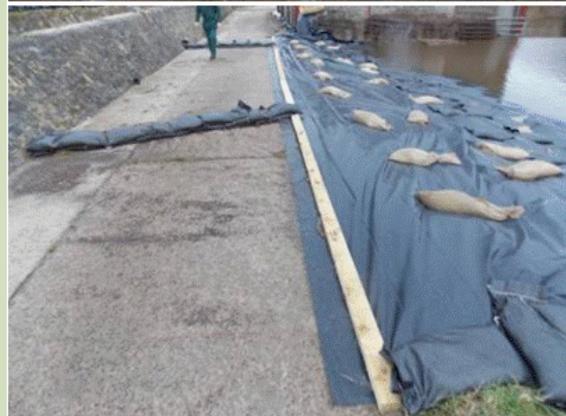
Incident 409	
Dam type	Earthfill embankment
Reservoir legal status	Statutory impounding reservoir
Dam height (m)	2.2
Incident type	Inflow flood, erosion by overtopping
Incident severity	3

A flood storage reservoir filled and spilled over a reinforced embankment spillway section causing erosion of natural ground immediately downstream of the dam. There was a low spot on the crest of the spillway which is thought to have contributed to the extent of the damage. Emergency works were carried out to reduce any perceived threat to the embankment. The erosion hole was filled and covered using sand bags and plastic sheeting. Subsequent inspection of drawings showed that there were toe piles at the base of the wall which substantially reduced any risk of a breach. Works are planned to level the spillway crest.

Photos show erosion of natural ground downstream of the dam and the temporary protection works.

This incident demonstrates the need to monitor crest levels on spillways regularly, not just during the 10 yearly inspection or the annual supervising engineer visits, and to carry out works to correct any significant deformations. During flooding, design conditions can be exceeded if flows are concentrated due to low spots and it is advised to have an inspection carried out after heavy periods of rainfall or a flood event.

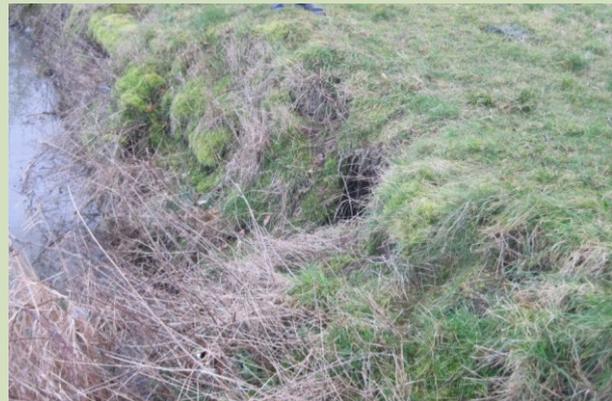
Incident 391	
Dam type	Earthfill embankment
Reservoir legal status	Statutory impounding reservoir
Dam height (m)	4.5m (nearby dam embankment)
Incident type	Embankment stability, internal erosion
Incident severity	3

Following a very wet period, a sinkhole was noted on the upstream face of a feeder canal embankment approximately 25m from one of the dam embankments forming the reservoir. Failure of the feeder canal embankment would have resulted in the uncontrolled escape of part of the reservoir volume.

A precautionary drawdown of the reservoir water level was carried out. Water was observed emerging from a nearby culvert outlet and running along the toe of the dam embankment. Dye testing confirmed that this water was connected with the sinkhole. Repairs to the canal were successful in sealing the leakage.

It is thought that poor quality of the materials used to form the canal embankment, together with the unusually high and sustained water levels, led to the internal erosion and leakage occurring.

Photo, courtesy of the Canal and River Trust, shows sinkhole on the feeder embankment.

This incident highlights the need to inspect all structures which affect reservoir safety regularly, especially during wet periods when high water levels can initiate internal erosion.

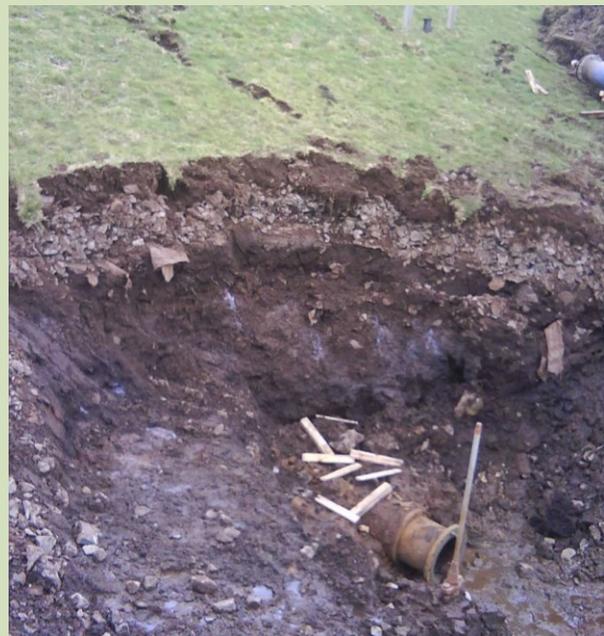
Incident 407	
Dam type	Earthfill embankment
Reservoir legal status	Statutory impounding reservoir
Dam height (m)	8
Incident type	Human error
Incident severity	2

A contractor was carrying out works to a supply main. The dam embankment was excavated at the downstream toe to expose the pipework. The excavation was left unsupported which threatened the stability of the embankment. The reservoir was not partially drawn down before the works started and the scour outlet pipework had been disconnected as part of the same contract. When the situation was discovered, the excavation was secured but it was not possible to lower the reservoir level.

Photo, courtesy of Scottish Water, shows unsupported excavation into the dam embankment.

The contractor started excavation into the dam without submitting method statements for review by the client and the supervising engineer. Any works carried out at reservoir sites should be referred to the supervising engineer. A qualified civil engineer should oversee any works that could affect reservoir safety.

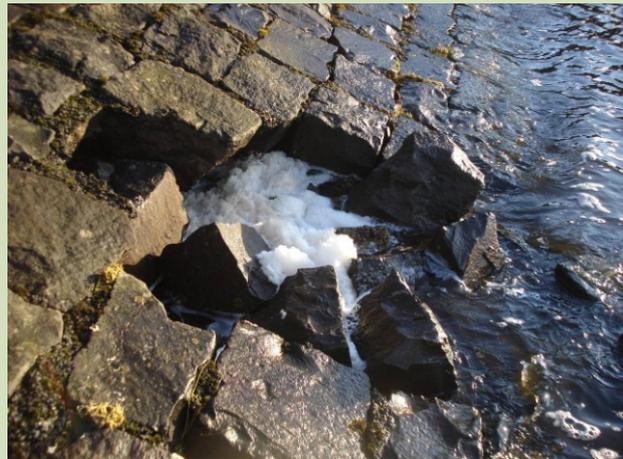
Incident 396	
Dam type	Earthfill embankment
Reservoir legal status	Statutory impounding reservoir
Dam height (m)	11
Incident type	Wind, waves, damage to upstream face protection
Incident severity	3

The dam has a history of problems with the face protection, and concrete slabs had been used to replace the pitching in some areas. Following a severe gale, damage was noted to the masonry pitching on the upstream face of the embankment just below the wave wall. Further damage could have led to the undermining and collapse of the wave wall and overtopping of the embankment. A temporary repair was undertaken using sandbags until a permanent repair could be completed.

The gaps between the pitching blocks were filled periodically with granular material until about 20 years before the incident when the practice stopped. Pointing with no-fines concrete about 3 years before the incident failed to prevent the progressive loss of bedding material through the joints in the pitching. The incident demonstrates the need to review the effectiveness of maintenance activities on a continuous basis.

Photo, courtesy of Scottish Water, shows damage to face protection.

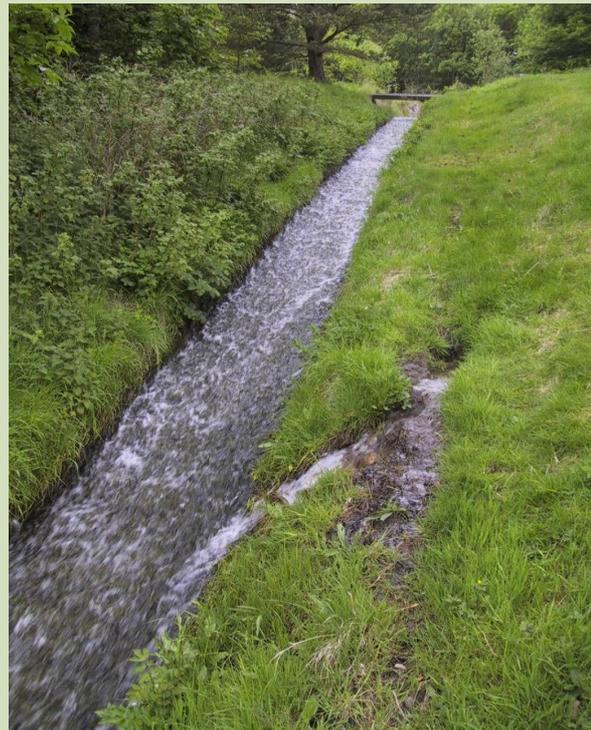
Incident 397	
Dam type	Earthfill embankment
Reservoir legal status	Statutory impounding reservoir
Dam height (m)	13
Incident type	Internal erosion adjacent to spillway structure
Incident severity	3

Leakage was identified on the embankment downstream mitre adjacent to the masonry spillway chute. A precautionary drawdown of the reservoir level was carried out. Grouting works were carried out to the floor of the masonry spillway and were successful in arresting the leakage. This showed that the leakage originated from the masonry-lined spillway, further up the spillway channel, not from the reservoir dam embankment.

Photo, courtesy of Scottish Water, shows leakage which was coming from the masonry-lined spillway chute.

Masonry spillway channels are prone to deterioration which can lead to leakage paths developing close to the spillway. Regular surveillance is important to identify any signs of spillway deterioration.

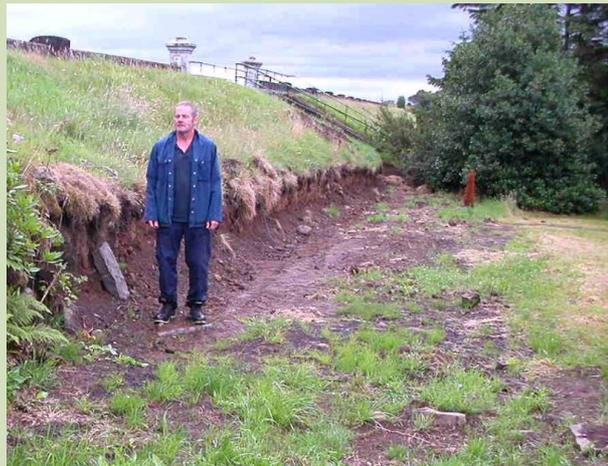
Incident 405	
Dam type	Earthfill embankment
Reservoir legal status	Statutory impounding reservoir
Dam height (m)	10
Incident type	Human error, unauthorised excavation into dam fill
Incident severity	3

An excavation of dam fill material along the downstream toe was carried out by a private landowner who believed he had the right to improve his access by carrying out the excavation. The owner had recently bought the property and the deeds appeared to indicate that he owned the toe area. The reservoir owner carried out a precautionary drawdown of the reservoir and monitored the downstream shoulder for instability using survey pegs. The excavated area was reinstated shortly afterwards to preserve the stability of the dam.

Photo, courtesy of Scottish Water, shows excavation along the toe of the embankment.

Where areas adjoining a dam structure are not in the ownership of the undertaker, it is important to engage with landowners to make them aware of basic reservoir safety matters. In this case, there was no fence marking the property boundary at the downstream toe and a new owner believed he had the right to excavate into the dam structure.
