AAIB
Air Accidents Investigation Branch

AAIB Bulletin

9/2015

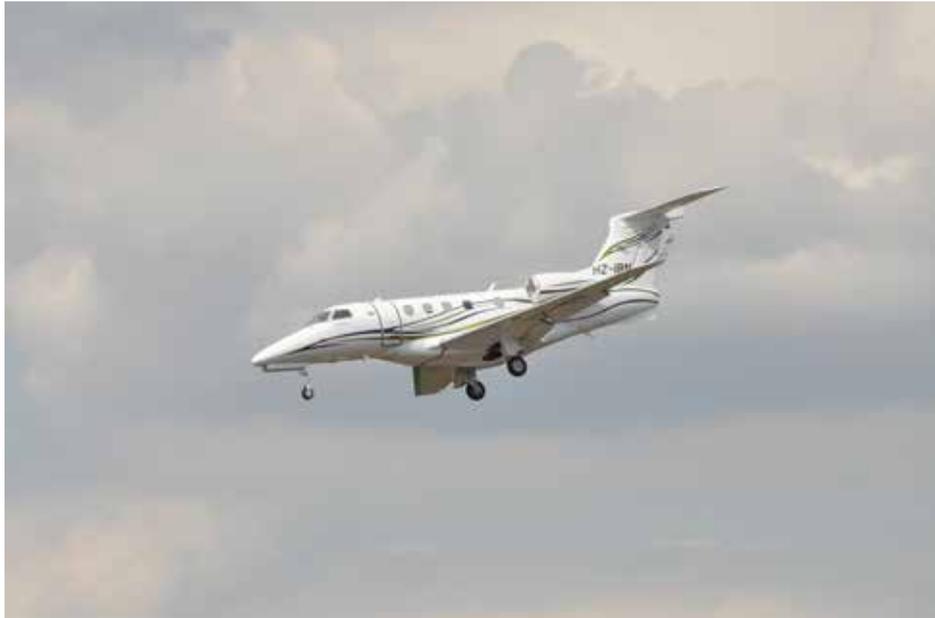
Figure 1

HZ-IBN on approach to Runway 25 shortly before the accident
(photograph taken by Geoff Pierce)

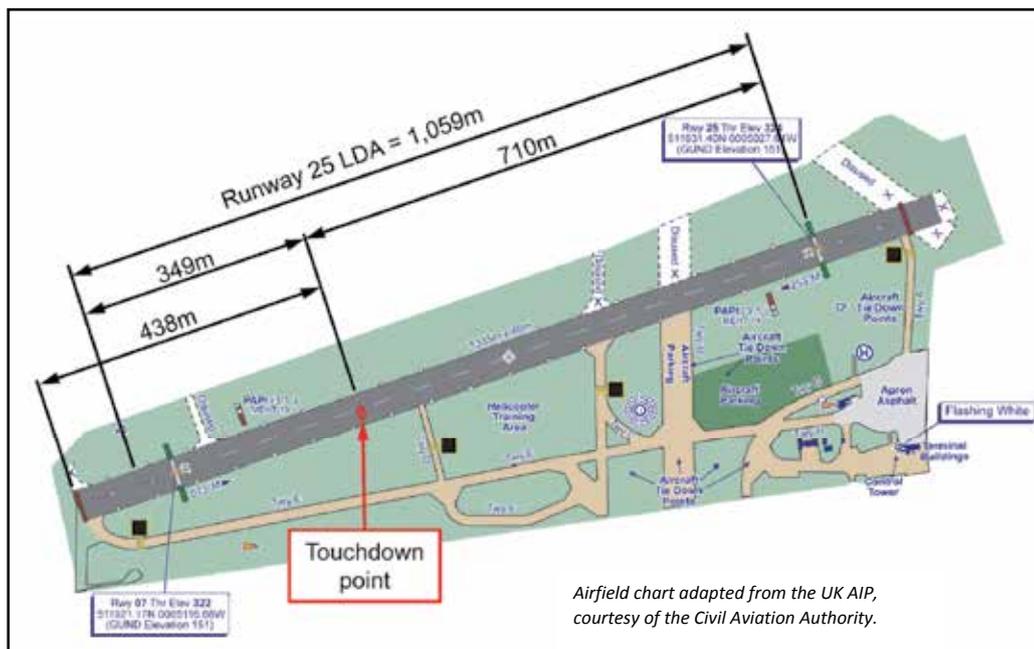
Figure 2

Tyre marks made by the aircraft at touchdown indicated that it landed approximately 710 m beyond the Runway 25 threshold. Runway 25 has a declared Landing Distance Available (LDA) of 1,059 m; therefore the aircraft touched down approximately 349 m before the end of the declared LDA, 438 m before the end of the paved runway surface.

Blackbushe aerodrome chart, showing LDA and approximate touchdown point

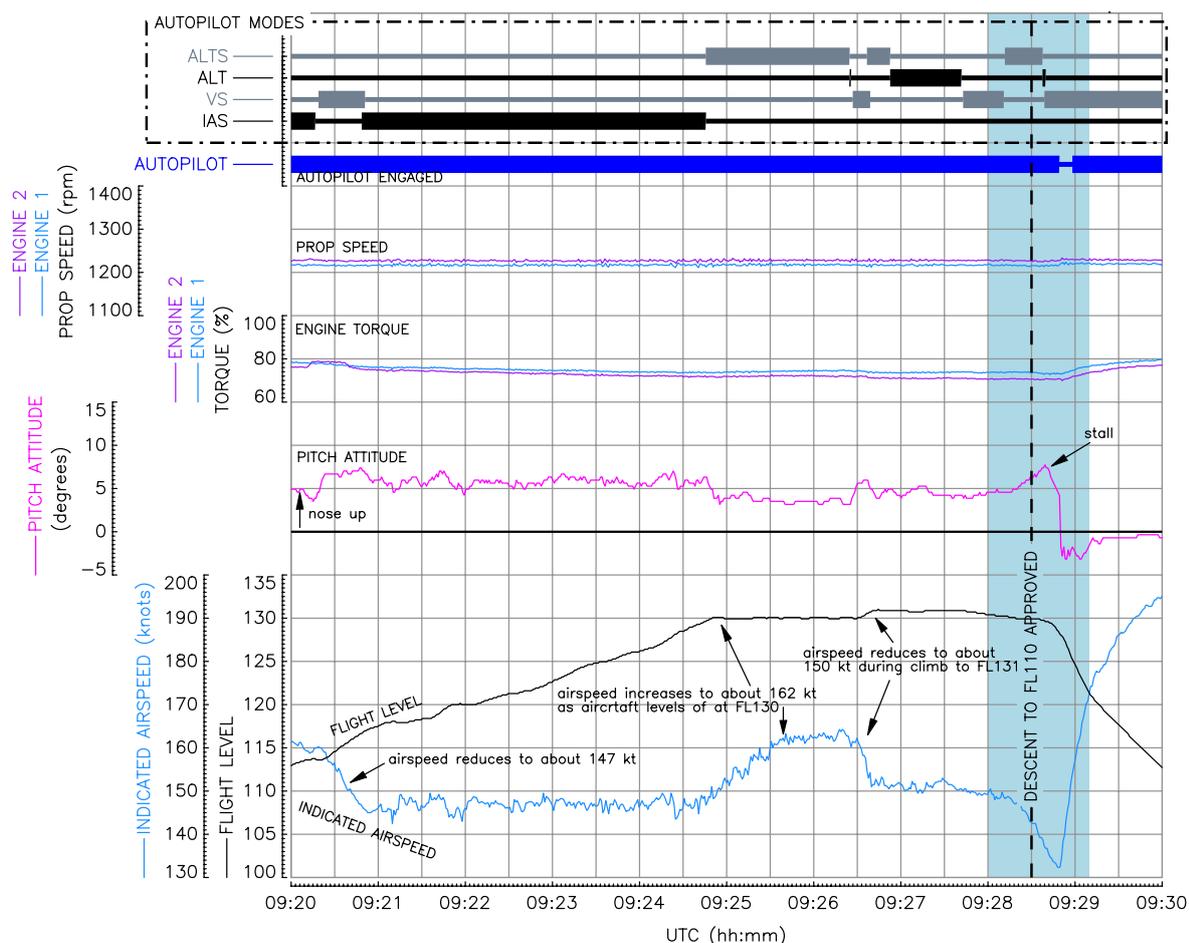
Figure 1
FDR data overview of event
(shaded area to the right is detailed in Figure 2)

At 09:28:26, the airspeed had slowed to 145 KIAS, reaching 140 KIAS 10 seconds later as the increasing angle of attack (AOA) exceeded 5.9° . The shaded blue area under the AOA curve illustrates the period when the AOA was 5.9° or more, when a stall warning would have occurred if the 'Ice Speed function' had been operative⁵.

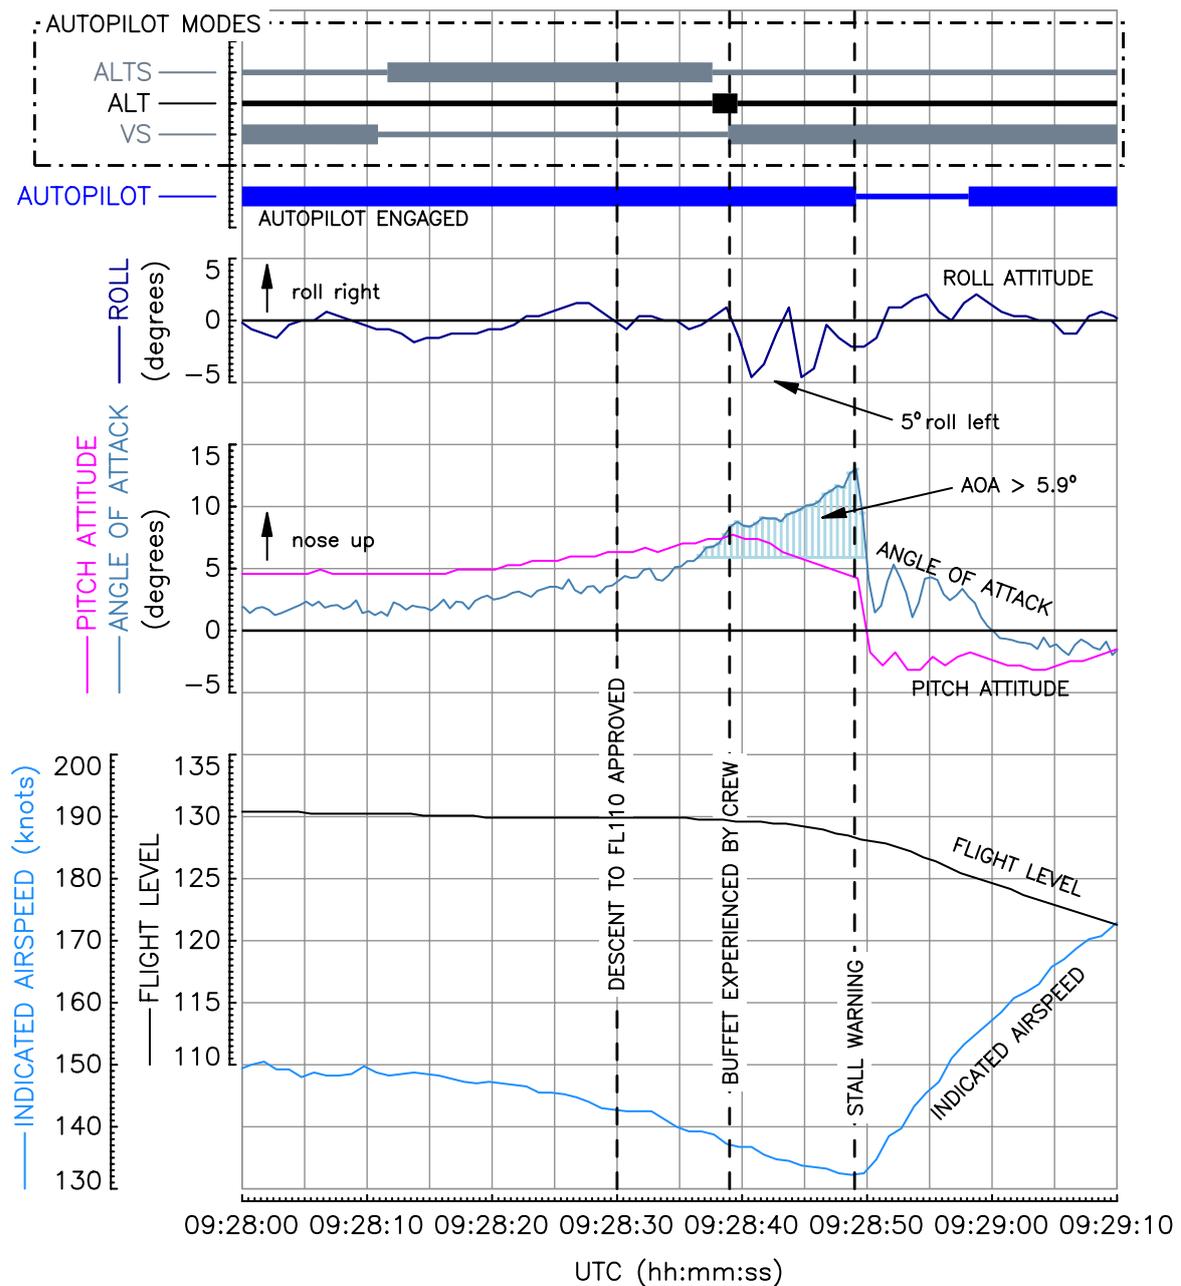
Figure 2
FDR data at the time of the event

The aircraft also rolled left, twice in quick succession, to 5° angle of bank (AOB). At 09:28:49, as the AOA reached 13° (with the pitch attitude at 4°), the stall warner sounded and the autopilot disengaged. The airspeed at this point was 132 KIAS. Subsequently, the AOA reduced, the airspeed increased and the autopilot was re-engaged.

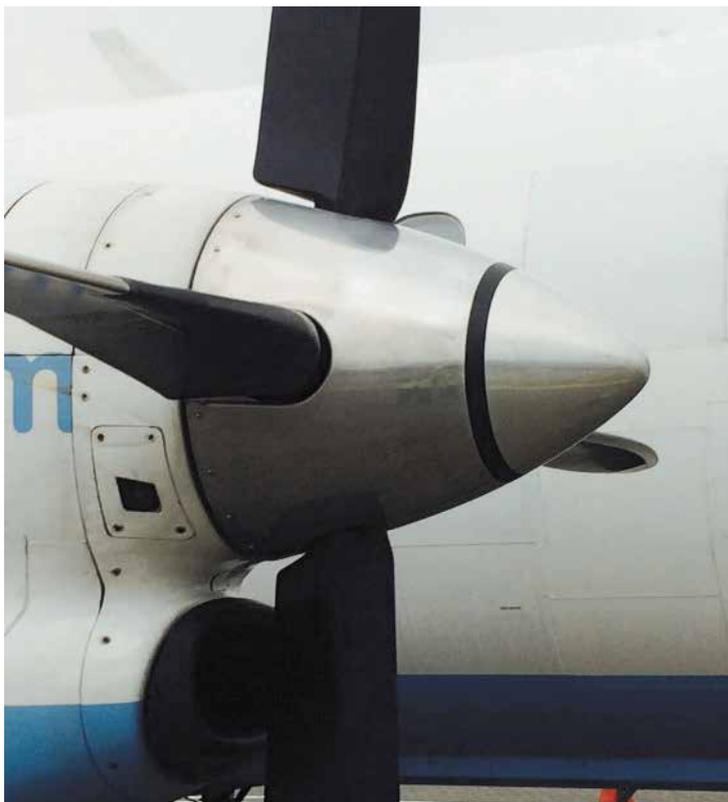
Figure 3

Both spinners on G-LGNM's propellers, in common with those on many of the operator's other aircraft, were painted with black rings (see Figure 3). The rings were not mentioned in any guidance material and the manufacturer stated that they had been incorporated on certain aircraft as part of a trial. The intention, which was not advised to operators, was that if ice was seen to accrete aft of this line it could indicate that the conditions were beyond the aircraft's certified limits ie a severe icing encounter. However, the manufacturer later determined that this was not an accurate cue for severe icing and was more conservative than the certified visual cue (see *Ice detection* section earlier in this report). The manufacturer has

Propeller spinner showing black-painted ring

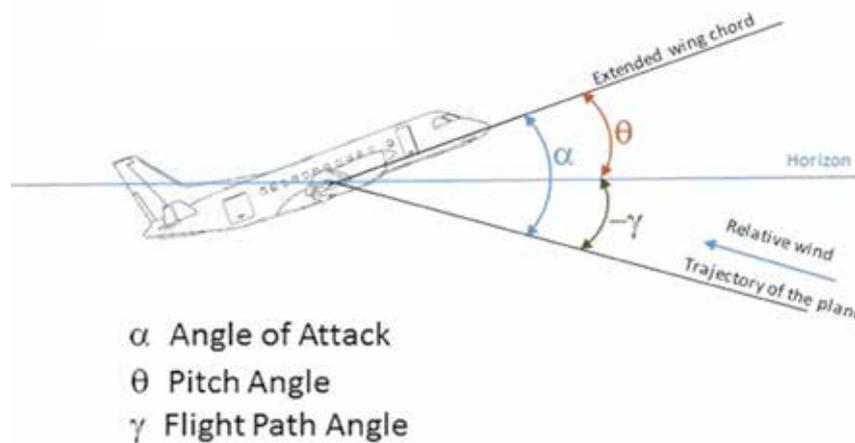
Figure 4

Manufacturer's illustration of AOA greater than pitch angle in descent

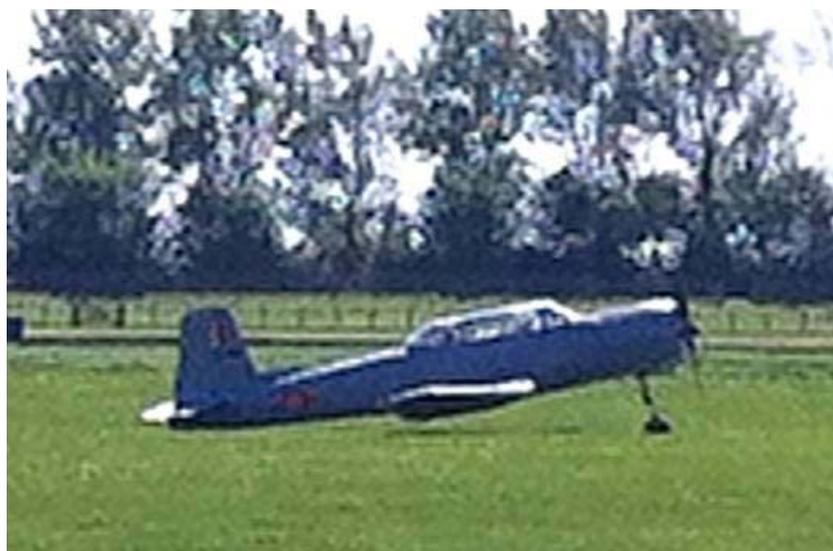
Figure 1

Following a normal touchdown the right main landing gear collapsed, quickly followed by the left and then the nose landing gear. The pilot submitted a photograph taken during the landing roll showing the aircraft with both main landing gears retracted but the nose landing gear still extended (Figure 1). The pilot and passenger were uninjured and exited the aircraft without difficulty.

View of the landing roll showing the main landing gear retracted and the nose landing gear extended
