Rail Accident Investigation Branch

Rail Accident Report

Freight train derailment at Heworth, Tyne and Wear 23 October 2014

Report 16/2015
September 2015

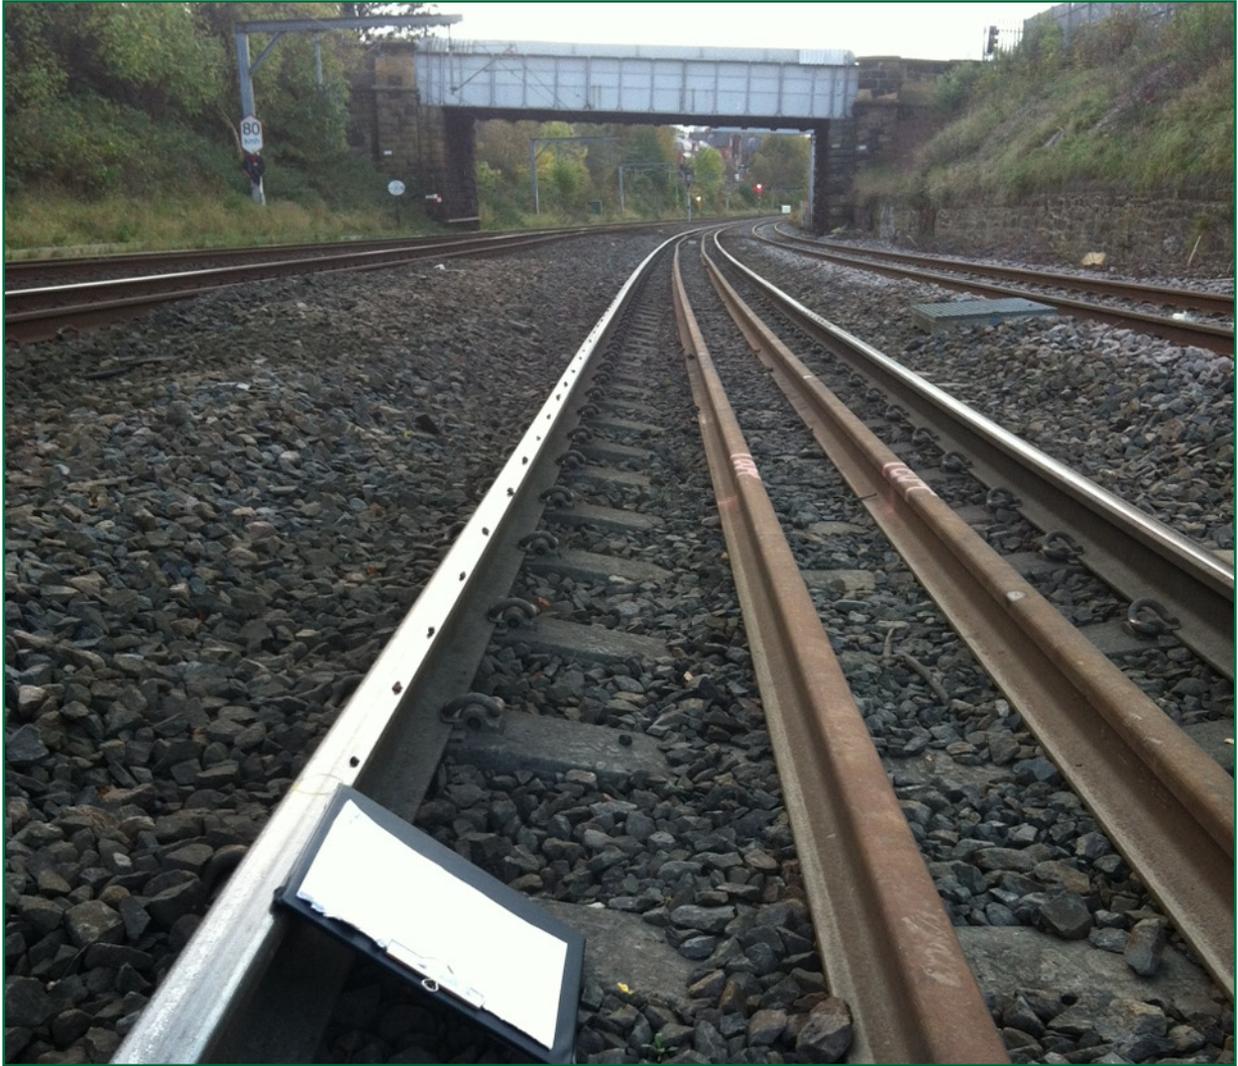
Figure 5: The path of the flange marked out on the head of the left-hand rail (image courtesy of Network Rail)

- 18 Marks found on the head of the left-hand rail show that the flange of a wheel had climbed onto the top of this rail at 99 miles 253 yards (figure 5). The flange ran along the head of the rail for 10.3 metres before the wheelset derailed to the left. At this point the right-hand wheel derailed into the *four foot*.

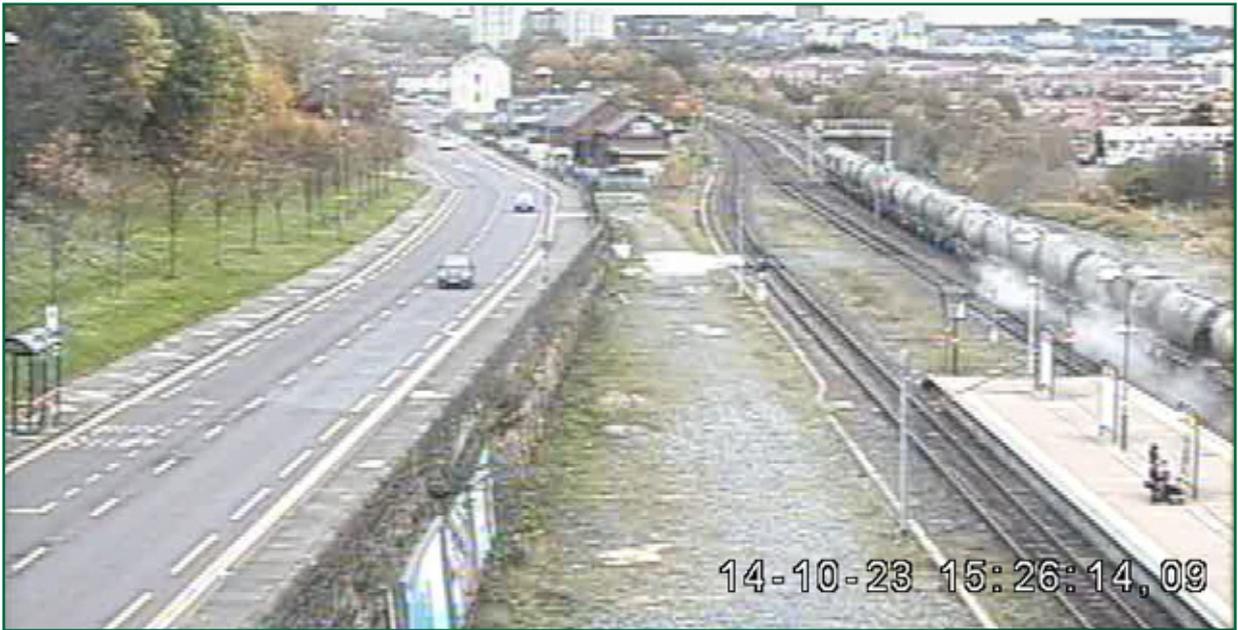
Figure 6: CCTV image of the derailed wagon passing Felling Metro station (image courtesy of DB Regio Tyne and Wear Metro)

- 20 The derailed wagon was kept generally in line by the couplings of the adjacent wagons. The wheels were running on top of the concrete sleepers (evidenced by the closed circuit television (CCTV) footage of the train passing through Felling – see figure 6). The derailed wheels struck a set of *points* at St James Bridge junction at 100 miles 506 yards while travelling at about 13 mph (21 km/h), causing damage to the points and also to the wagon's suspension.

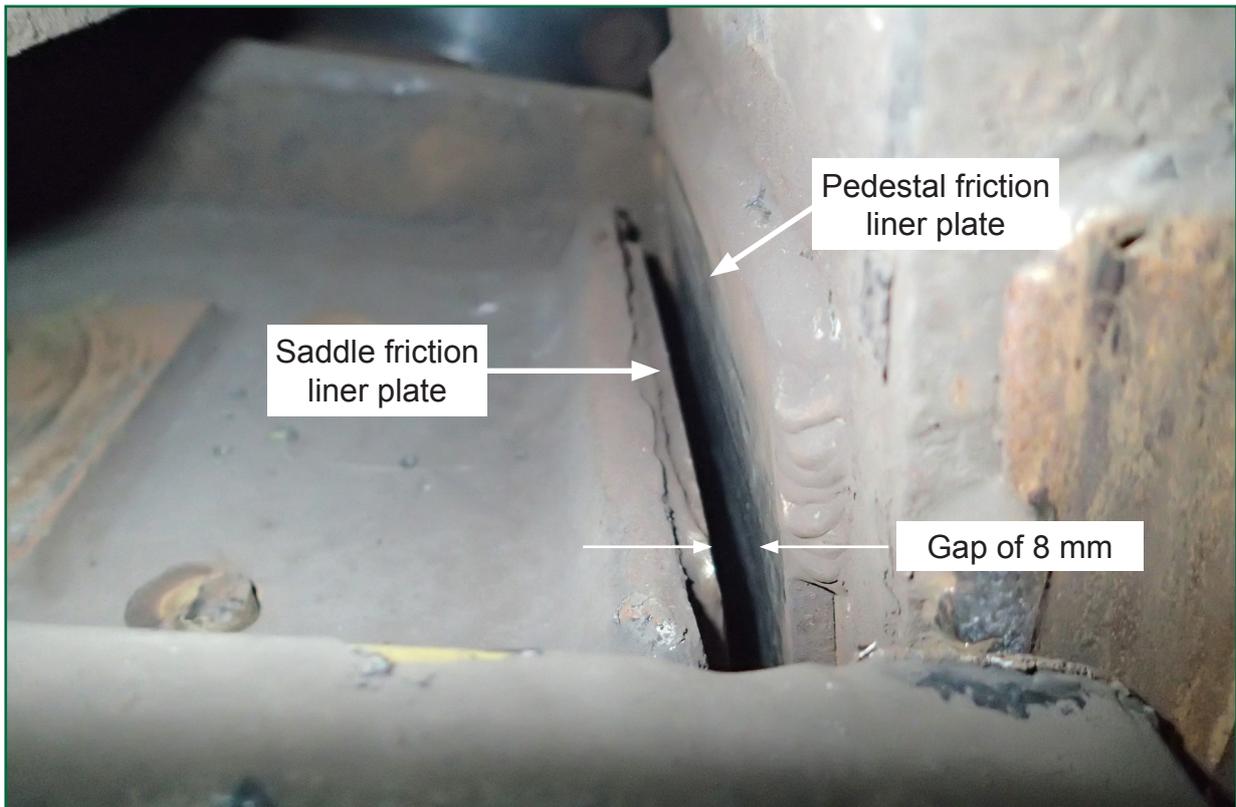
Figure 9: The gap in the suspension on the leading right-hand corner

- 49 The suspension component measurements on the leading right-hand corner were checked against the limits defined in Freightliner's vehicle maintenance instruction for PCA wagons. Two suspension components exceeded the limits:
- the depth of wear on the damper pot liner plate was 1.4 mm, exceeding the limit of 1.0 mm; and
 - the damper pad was worn to a length of 57.2 mm, exceeding the wear limit of 65.0 mm.
- 50 The damper pads from the other three corners of the wagon were all inside the permitted wear limit. Figure 10 shows the damper pads from the leading left and right-hand corners, highlighting the difference in the amount of wear.

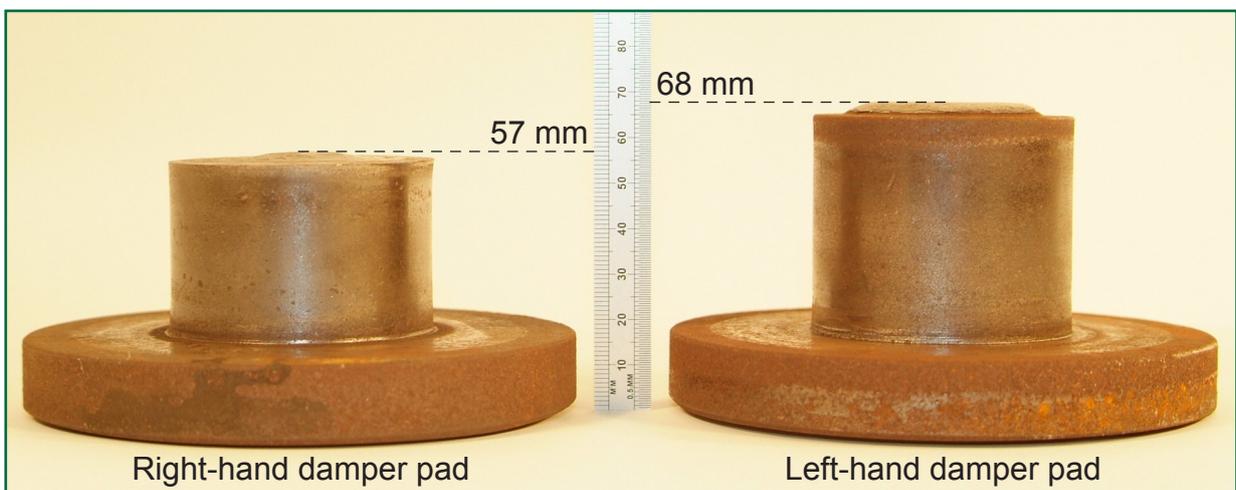
Figure 10: The damper pads from the leading right and left-hand corners

- 51 The worn damper pad and the gap found between the friction liner plates indicated that there was a loss of damping within the suspension on the leading right-hand corner of this wagon. This in turn would affect how the wagon rode over vertical track geometry faults. In order to gain a better understanding of what effect a loss of damping would have on the wagon's ride performance, dynamic modelling was undertaken using the *VAMPIRE*® computer software simulation package. Further information about the vehicle and track models used for the dynamic modelling is provided in appendix D.

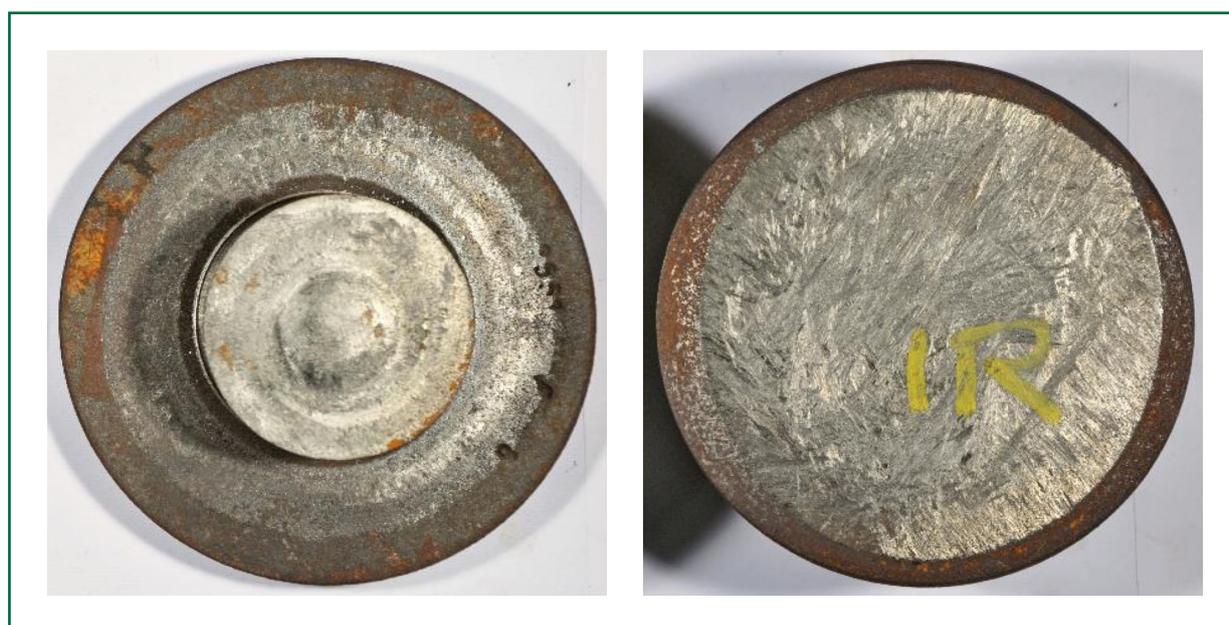
Figure 13: The wear faces on the damper pad from the leading right-hand corner

60 When the damper pad from the leading right-hand corner was tested, no traces of hardening were found. Almost 12 mm of material had been worn away, exceeding the depth of any hardening. A residual centrally raised portion could be seen on the surface of this wear face (figure 13), which indicated that it had been hardened at manufacture. If this was not the case, then it is likely that the worn end would have been flat. However, the effectiveness of any hardening at manufacture could not be confirmed, as this material had worn away. The opposite wear face on the damper pot also indicated that the damper pad had been hardened.

- 61 The scuff marks on the larger diameter end of the damper pad are shown in figure 13. These marks are aligned in different directions and indicate that the damper pad had been rotating while in service. Evidence of rotation could also be seen on the spigot end of the damper pad and on the damper pot it wore against. This rotating movement would have worn away the material at the spigot end of the damper pad.

- 62 While the possibility that the damper pad was defective cannot be discounted, the available evidence indicates that this was unlikely. Instead, it is likely that all of the hardened material at the damper pad's spigot end had worn away due to it rotating in service. Once the hardened material was worn away, the rate of wear significantly increased, resulting in 12 mm of wear in a 9 month period. This occurred because:

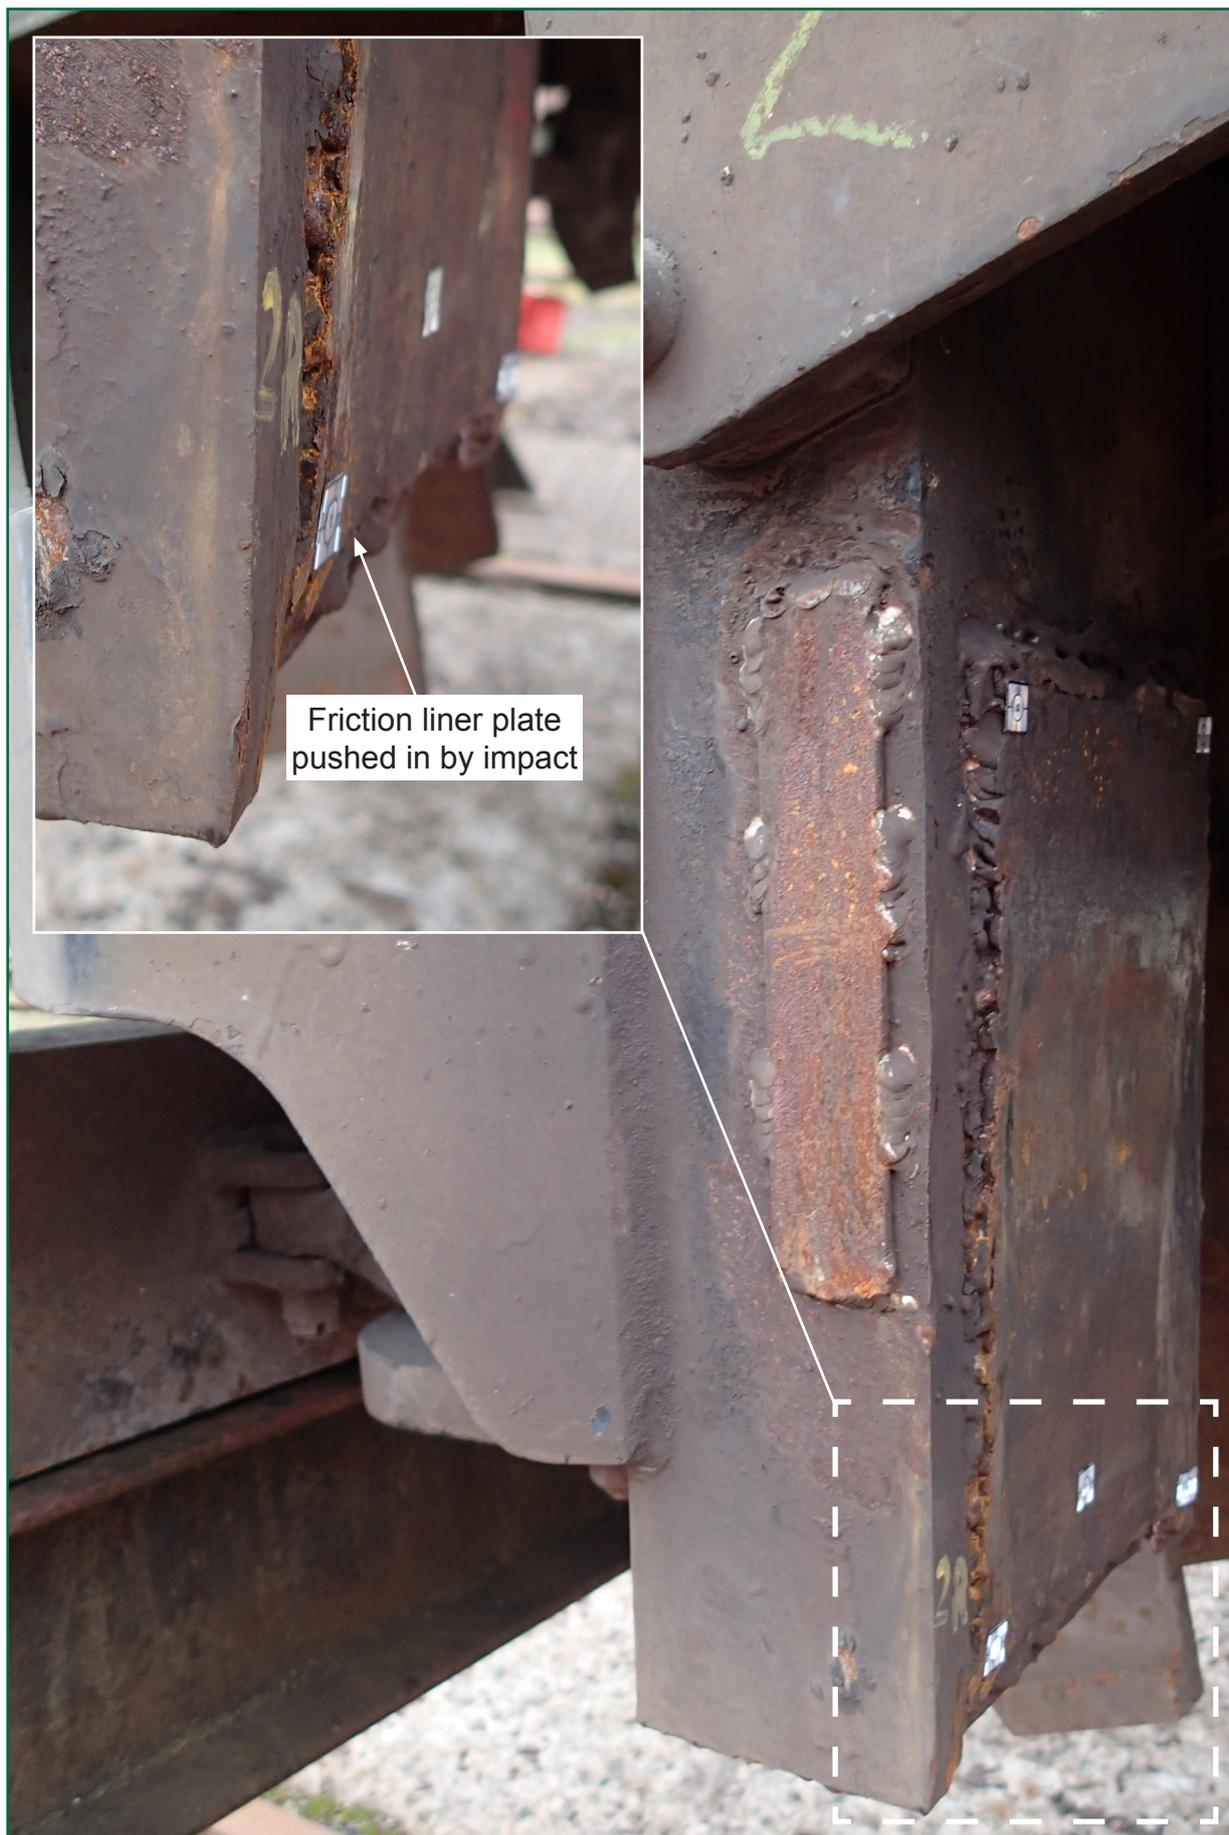
Figure 16: The damage to the trailing right-hand pedestal

- 70 The RAIB surveyed wagon 10769 after the accident to measure these dimensions and found the results did not fall within the defined tolerances². This was probably due to the amount of damage that the pedestals had sustained while the wagon ran derailed. The trailing right-hand pedestal was the most damaged (figure 16). Further measurements taken at the top of the pedestal friction liner plates, where there was less damage to the pedestals, showed dimensions A and B and dimensions C and D (figure 15) were within about 1 mm of each other, which is within the specified tolerance. The measurement for dimension E (leading end) was in tolerance at 1.9 mm but dimension F (trailing end) was outside the tolerance at 3.8 mm.

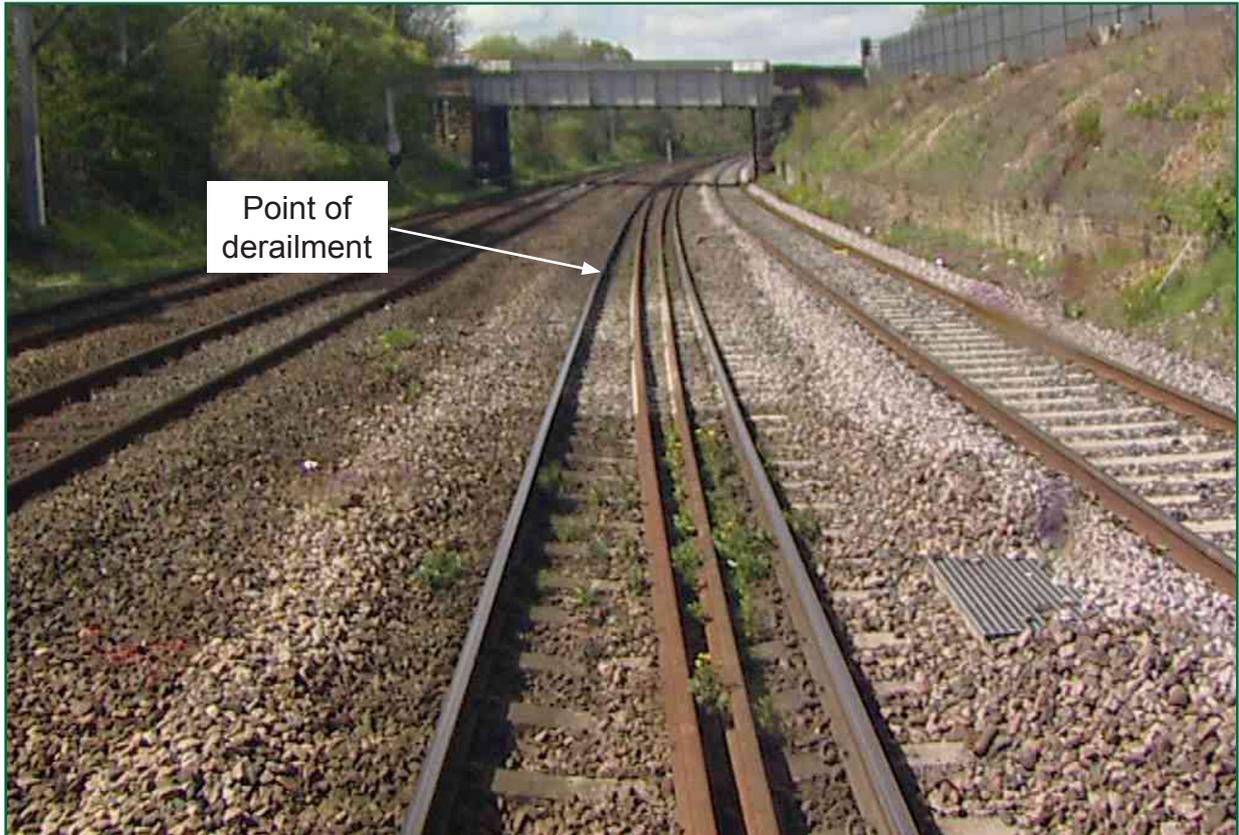
Figure 23: Footage recorded in May 2014 showing vegetation growing in the four foot of the Down Sunderland line (image courtesy of Network Rail)

- 94 In 2006, the then Track Maintenance Engineer proposed that the track in the Pelaw to Heworth area should be renewed, citing ballast contamination as the key reason. Documentation for the proposed renewal noted that the installed ballast dated back to 1972 and over many years the ballast on the Down Sunderland had become contaminated by coal dust. In 2011 when this renewal work was scoped, it included Network Rail digging trial pits at various locations along the Down Sunderland line. A trial pit was dug at 99 miles 220 yards, which is close to the point of derailment, and found that from the surface of the ballast to a depth of 400 mm, the ballast was heavily contaminated with coal dust and silt. From 400 mm to 650 mm down, the ballast was noted as heavily contaminated with clay and silt. Standing water was found at 650 mm below the surface. Track renewals subsequently took place in the Pelaw to Heworth area in 2012 and 2013 but this work did not include the point of derailment (see paragraphs 120 to 125).

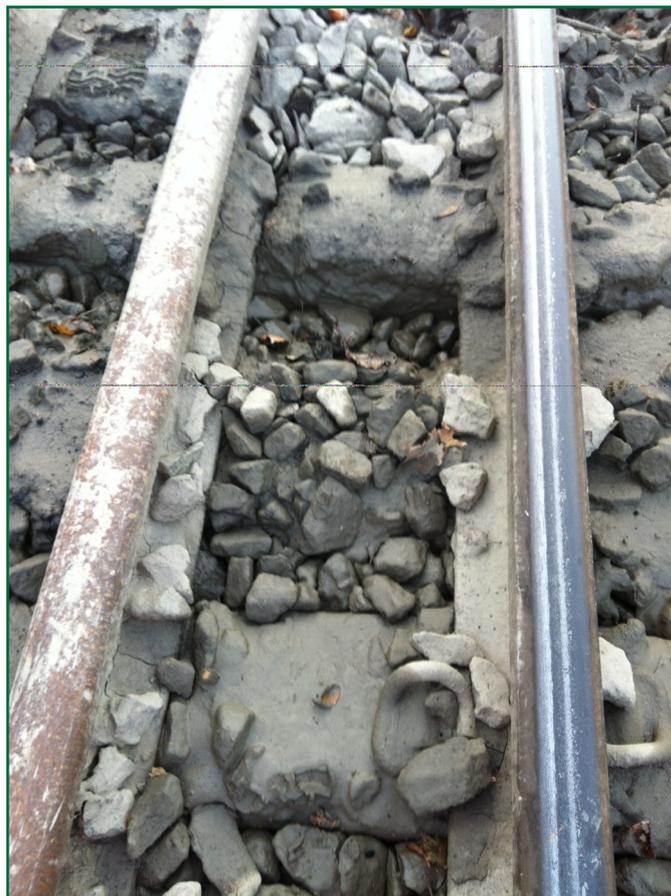
Figure 24: Close up view of a wet bed at the point of derailment on the Down Sunderland line (image courtesy of Network Rail)

- 95 Ballast can also become worn and rounded over time due to the pieces rubbing against each other when a train passes. Ballast will rub and wear against the bottom of the concrete sleepers sitting on top of it. This rubbing action creates small pieces of ballast, like sand, and concrete dust, which collectively are referred to as 'fines'. When these fines and the coal dust combine with water that has not drained out of the track bed, they stick together and solidify to create a slurry and a wet bed forms. The action of passing trains pumps the slurry up to the surface where it covers the sleepers, track fastenings and foot of the rail (figure 24).

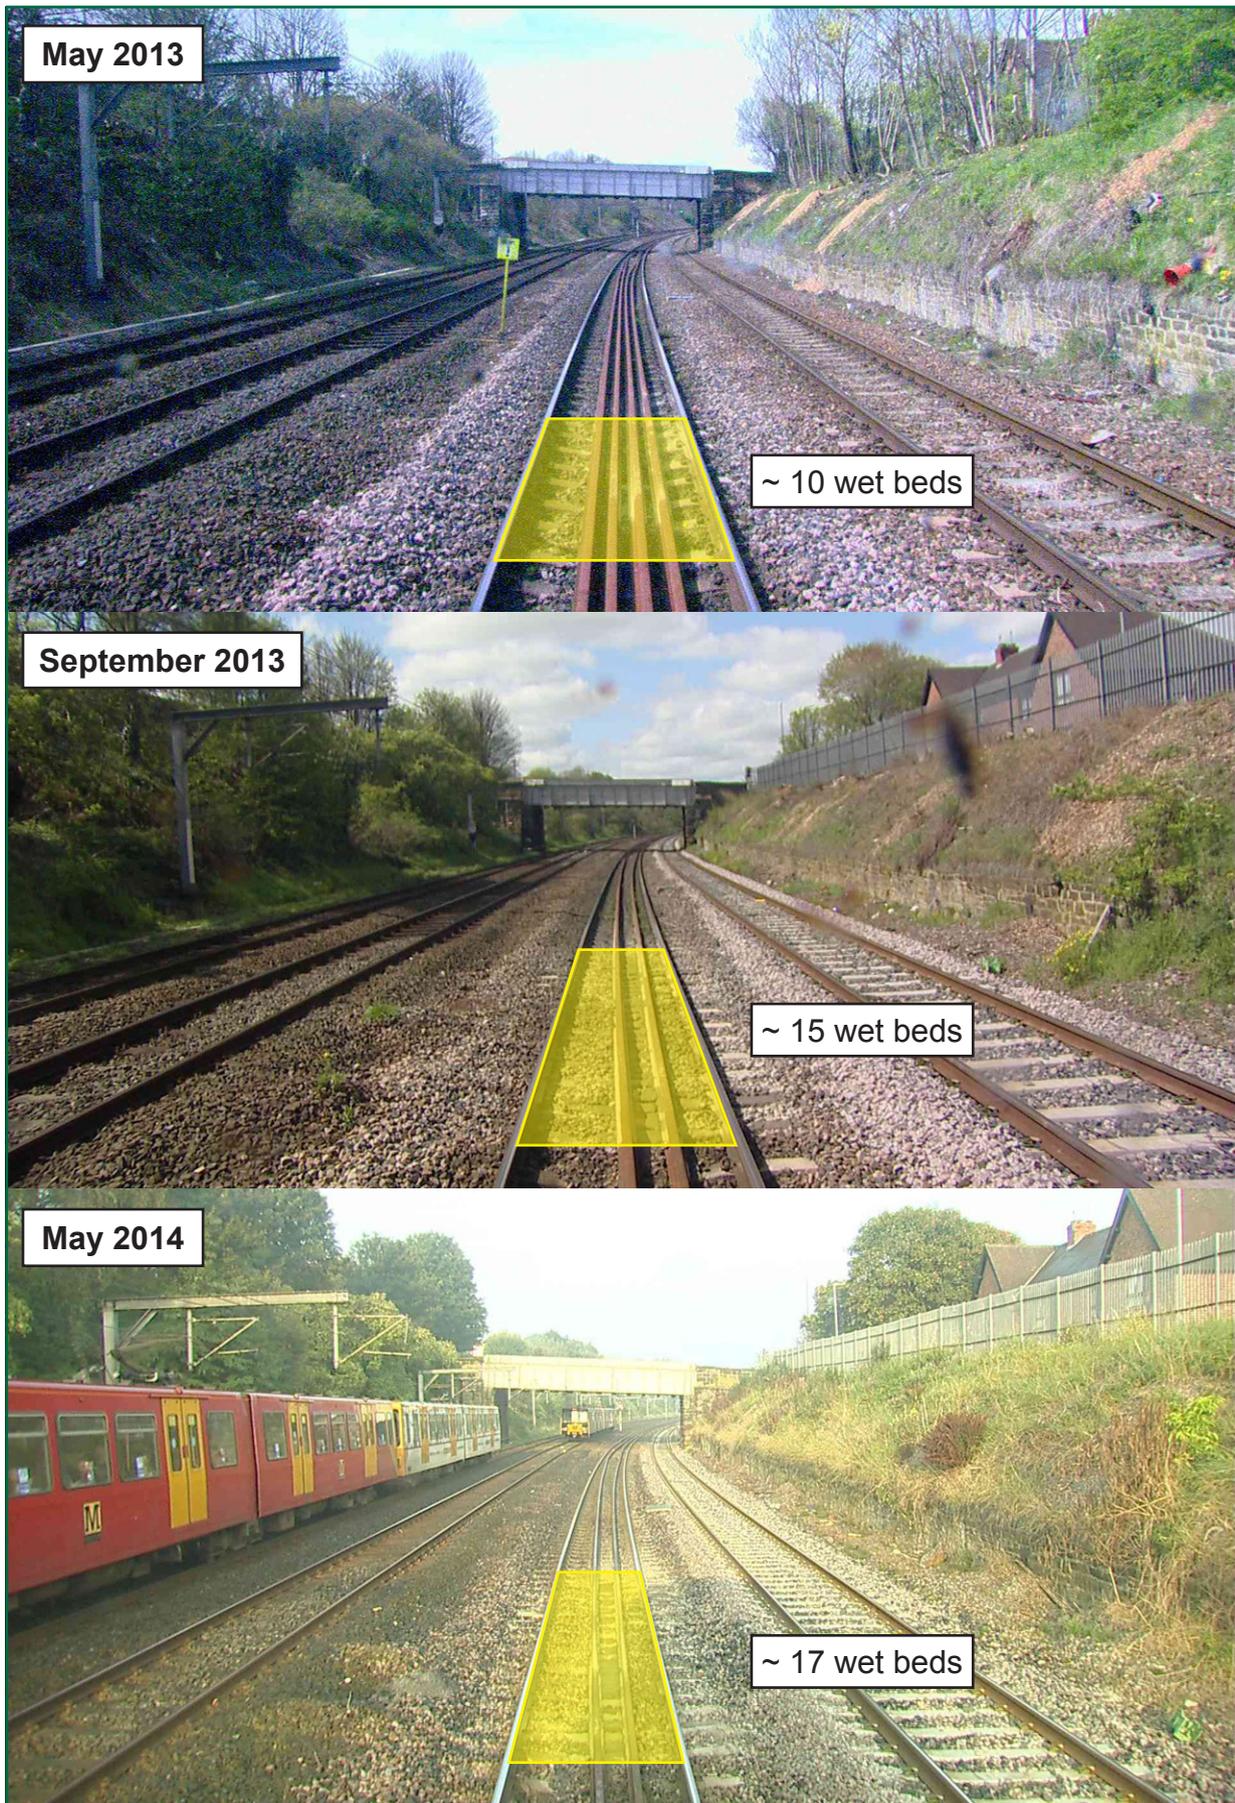
Figure 25: Footage showing increasing numbers of wet beds over time (images courtesy of Network Rail)

- 100 Network Rail's track geometry recording trains are also fitted with forward facing cameras. Footage from runs dating back to 2012 shows how the ballast contamination and number of wet beds grew over time (figure 25). The data and footage from track geometry recording trains was showing that the track at the point of derailment was deteriorating, and the amount of contaminated ballast was increasing.
