Rail Accident Investigation Branch

RAIB Bulletin 03/2015

Collision between a train and a wooden sleeper, near Somerleyton, Suffolk, 18 June 2015

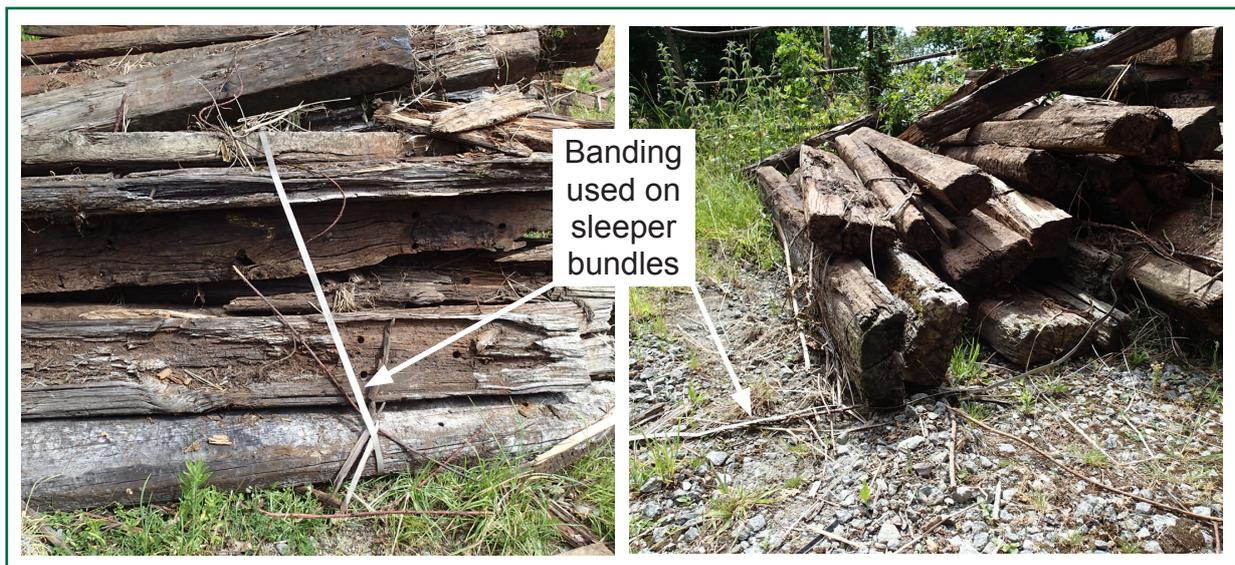
- 14 While travelling along the up line, the MC looked out for bundles of wooden sleepers alongside the railway. Most bundles comprised about 20 sleepers. The sleeper bundle locations were not recorded anywhere so the MC needed to spot them as they went. This was difficult for the MC as it was dark and some bundles were overgrown with vegetation. Once a bundle was located, the MC stopped the RRV and instructed the MO to pick up the bundle. The MO used the log grab to pick it up and drop it onto one of the trailers as directed by the MC. Banding had been placed around the bundles but this often broke when the bundle was picked up (figure 6). The MO loaded the sleepers across the trailers, in a pyramid shape, with its peak towards the trailer's centre. It is common practice for sleepers to be loaded in this way.

Figure 6: Broken banding around the sleeper bundles

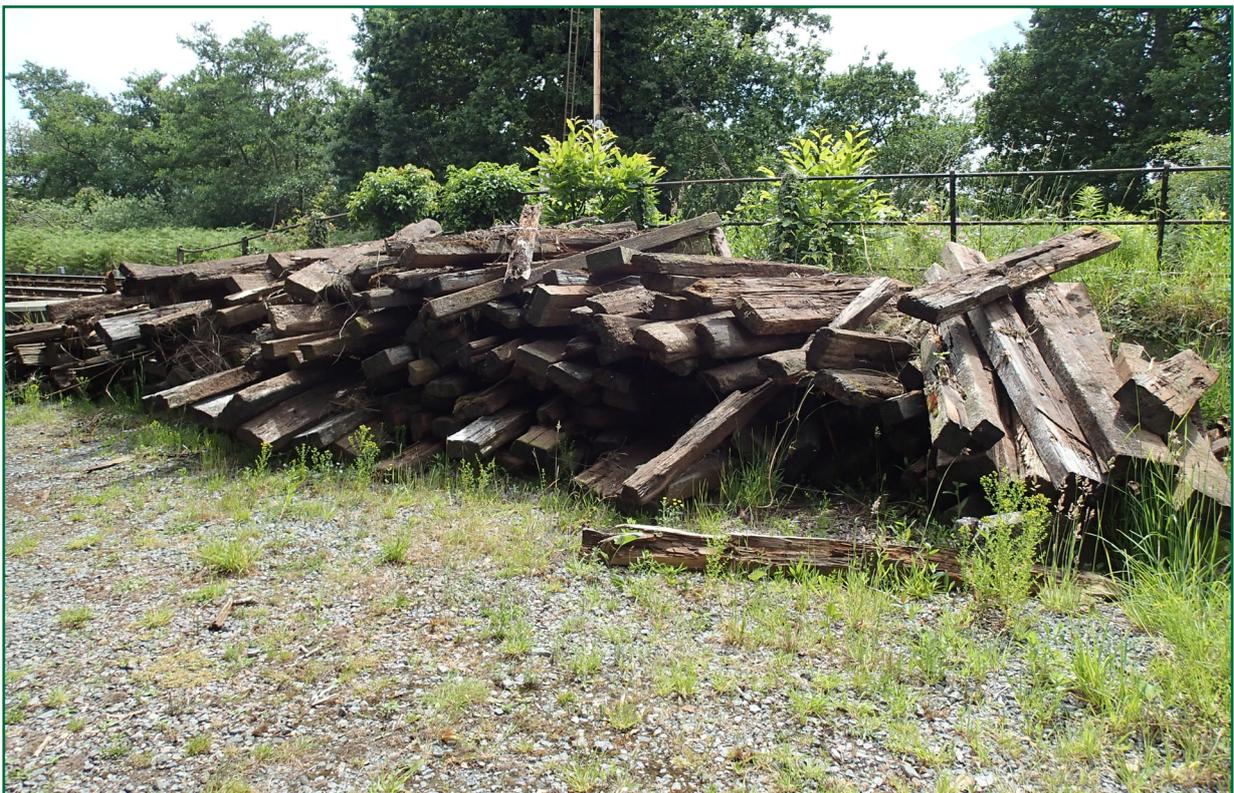
Figure 7: The scrap wooden sleepers piled up in the yard

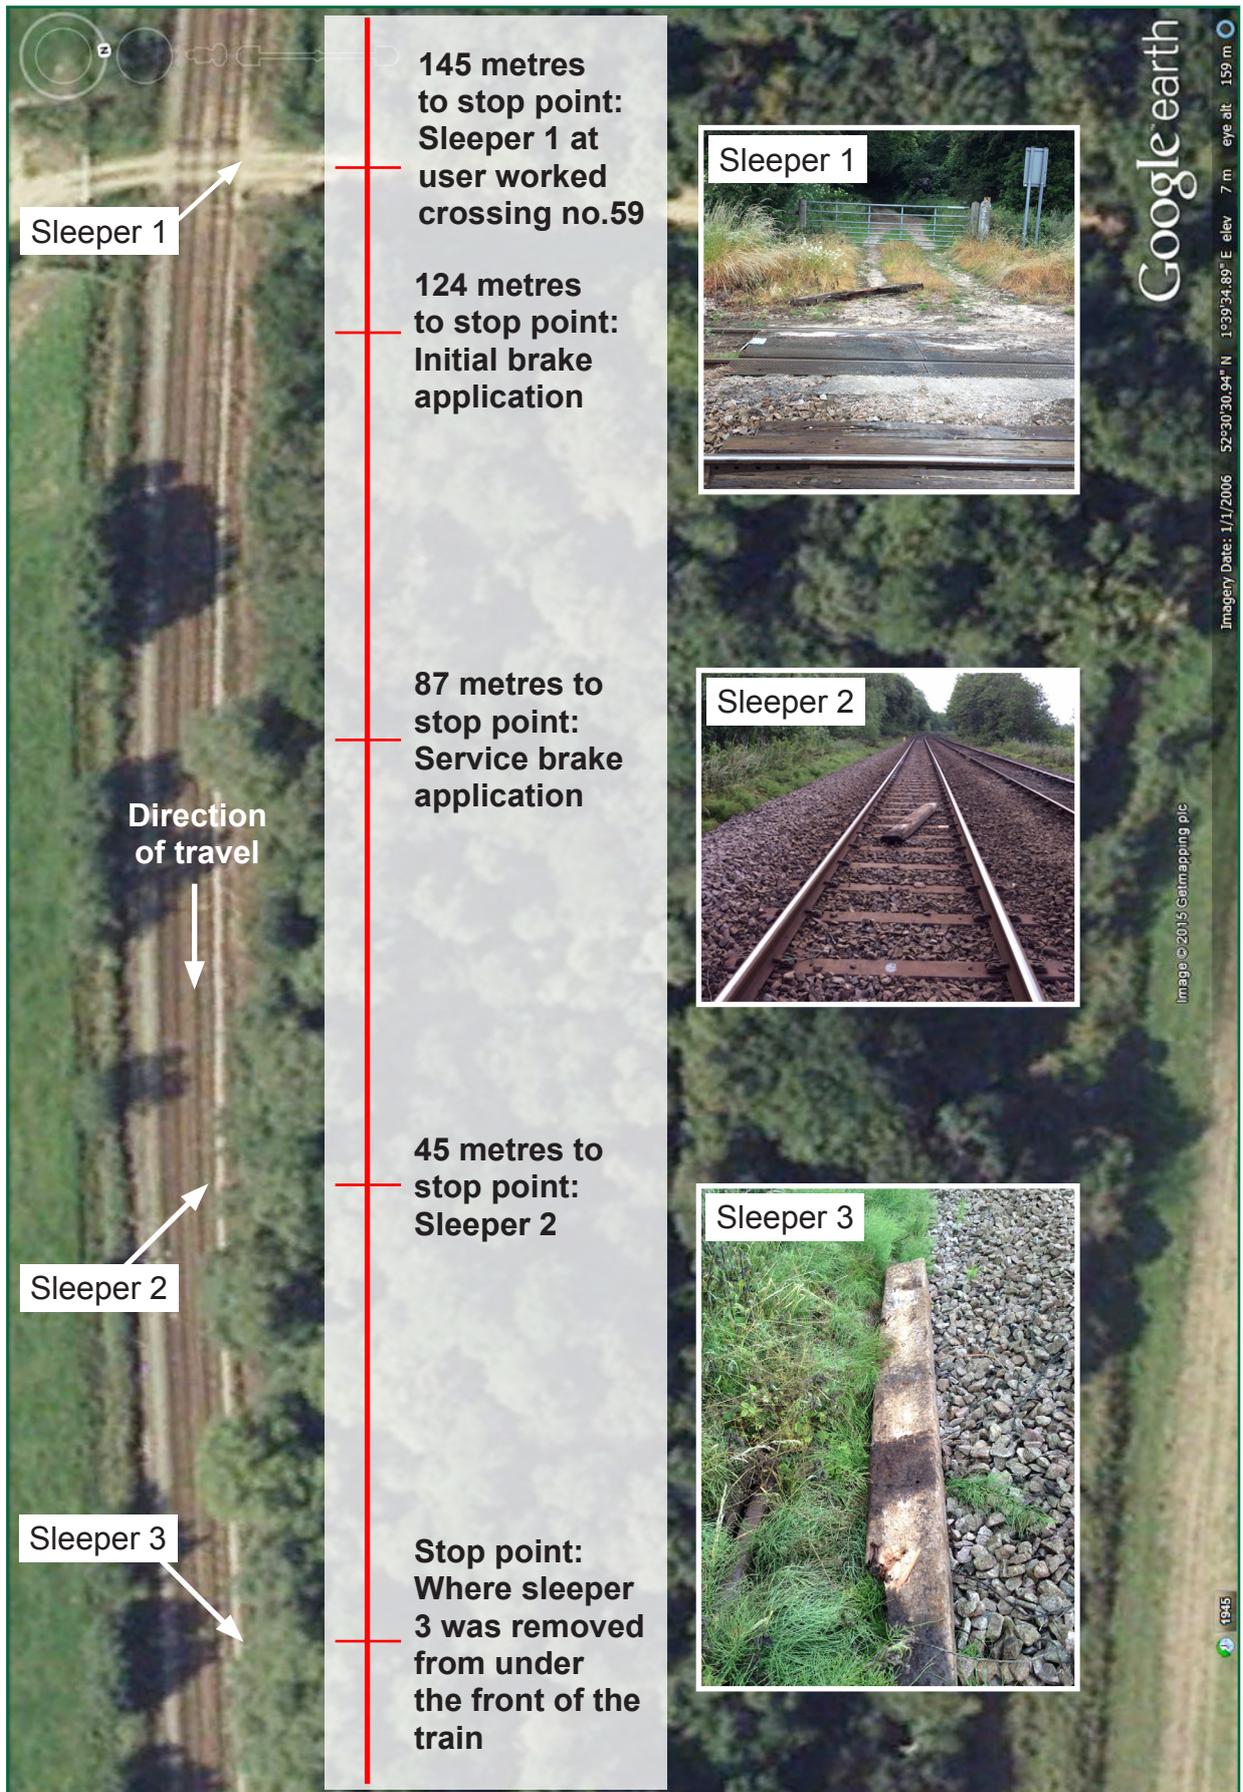
- 10 The following key people were involved in this work:
- The Person in Charge of the Possession (PICOP) who was the Network Rail employee responsible for taking the possession, arranging the protection for the possession, giving permission for work sites to be set up, allowing work to start within them, and giving up the possession.

- 21 The driver reported this to the signaller, and once the signaller had taken steps to stop any trains from passing on the adjacent line, the driver got out and examined the train. The driver, who was accompanied by a second driver, found a wooden sleeper wedged under the front. They removed it and after looking around the rest of the train they found another two sleepers nearby. One was lying in the track under the train and another was lying on user worked crossing number 59 behind the train (figure 8). There were no marks on these sleepers to indicate that either had been struck by the train.

Figure 8: The wooden sleepers found on the track afterwards (inset images courtesy of Network Rail)

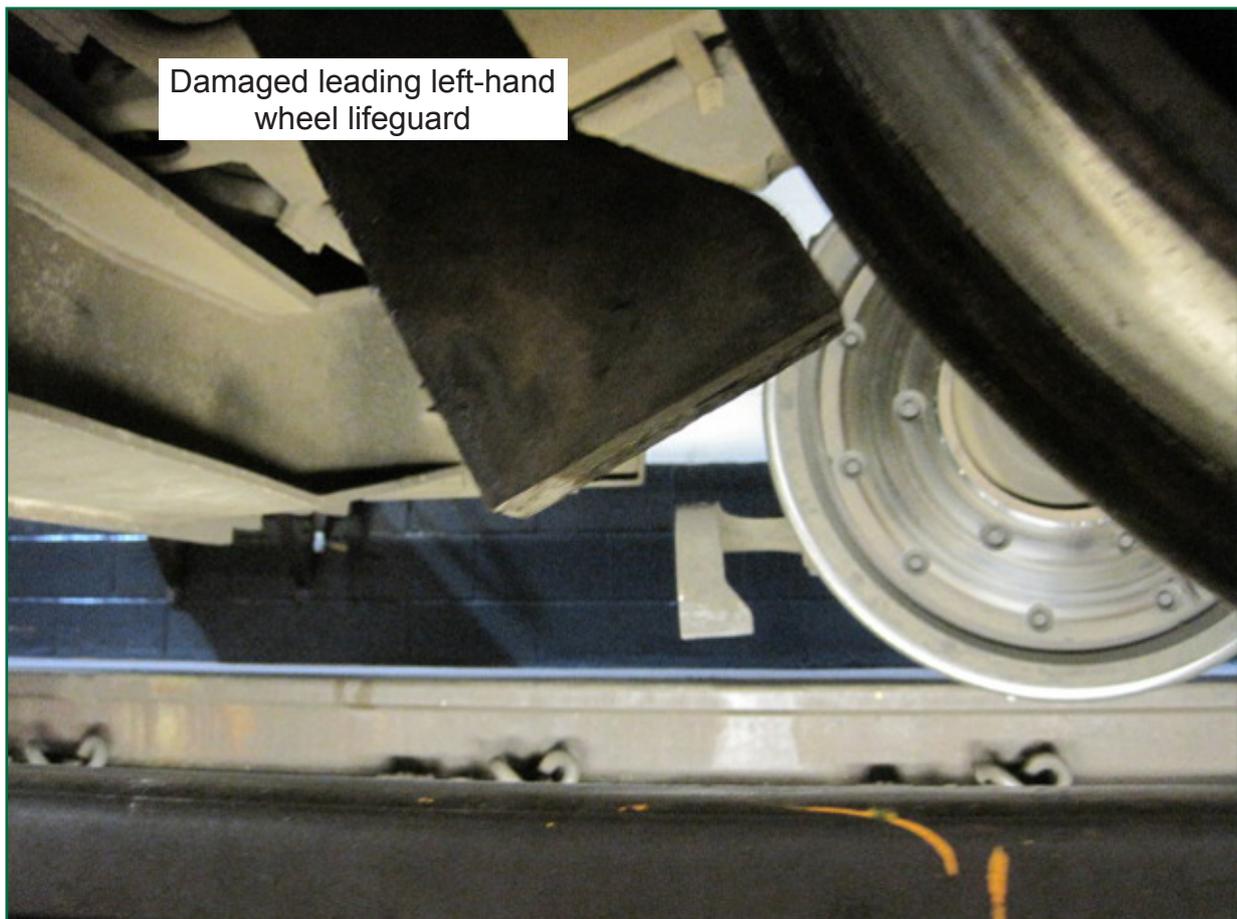
- 22 The driver decided that the train was fit to move and continued to Lowestoft at a reduced speed. Here it formed a passenger train back to Norwich with the damaged vehicle now at the trailing end of the train. Upon arrival back at Norwich, engineering staff inspected the train and saw the damaged *lifeguards* (figure 9). Due to this damage, the train was taken out of service and moved to Norwich Crown Point depot.

Figure 9: Minor damage to the train (image courtesy of Abellio Greater Anglia)

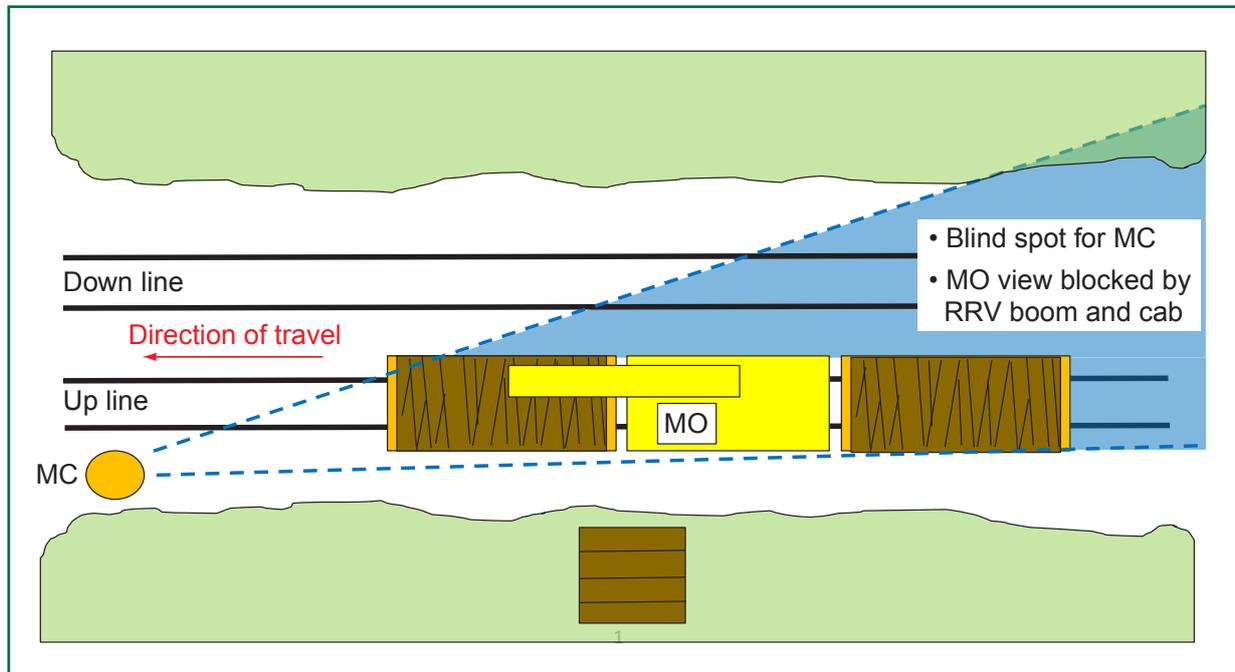
28 The method of working followed that night also meant it was difficult for the MC to check that no sleepers had fallen off the trailers as they moved along. The MC could not see the far side of the rear trailer as it was in a blind spot (figure 10). Additionally, the position of the RRV's boom next to the cab meant the MO could not see that side either.

Figure 10: The MC's view of the trailers while travelling

- 1 Network Rail needs to remind its staff who plan work involving the lifting and transporting of loads on trailers, that control measures should be specified in the authorised work plan. This is particularly important where flatbed trailers are to be loaded with sleepers stacked in a pyramid shape. Network Rail also needs to remind its staff who are responsible for carrying out the planned work that these control measures should be implemented in full. If loads are to be carried on trailers, and the authorised work plan calls for a person to be appointed to monitor the load on each trailer, Network Rail should resource this control measure or provide the MC with a modified authorised work plan with control measures that can be put in place by the MC. This would prevent MCs being faced with situations where they either have to continue work without the control measure being in place, deviate from the authorised work plan so that they try to manage the risk themselves, or invoke Network Rail's work safe procedure and not carry out the work at all.
