FLYER TO FISHING VESSELS

Capsize and sinking of the fishing vessel *Ocean Way* with the loss of three lives, 2 November 2014

Marine Accident Investigation Branch
November 2015

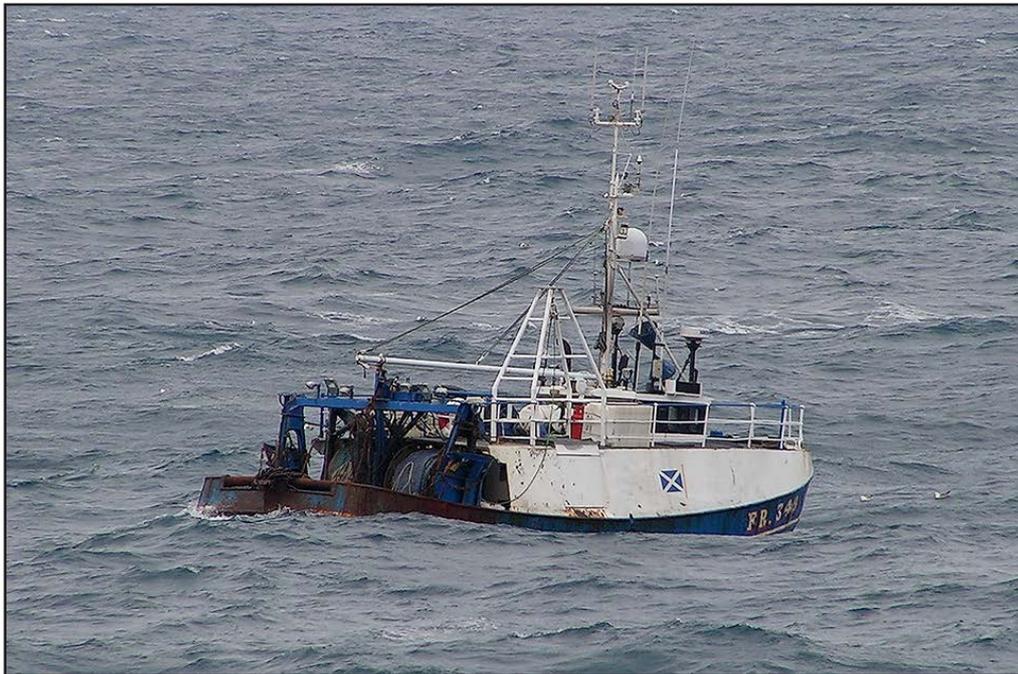
Figure 1: Fishing vessel *Ocean Way*

At 1058 on 2 November 2014, the 17m, twin rig fishing vessel *Ocean Way* (**Figure 1**) capsized and subsequently sank about 100 miles off the north-east coast of England while on passage to its fishing grounds. Two of the crew were rescued about 3 hours later when the body of the skipper was also recovered; the other two crew have not been found.

It is probable that *Ocean Way* broached and capsized in high following seas. The vessel's stability, which would have been reduced while surf riding, was probably further reduced due to entrapped water on deck as, unlike its sister vessels, its shelter deck area was not weathertight. It was calculated that with around 6 tonnes of water on deck (about a foot of water), the vessel would have become unstable.

- If *Ocean Way*'s EPIRB had been fitted with an integral GNSS receiver the rescue services would have arrived sooner.
- The water trapped on deck had an adverse effect on stability. Had the freeing ports been of the correct size and functioning this water would have been able to drain more quickly. Further, the amount of trapped water could have been significantly reduced had the shelter deck been made weathertight.
- Quartering seas create a broaching risk for well-found vessels, and can be exceptionally hazardous to vessels with marginal stability.
