Report on the investigation of
a chief officer's fall from
a hatch cover on board the general cargo ship

Norjan

at Southampton, United Kingdom

18 June 2014

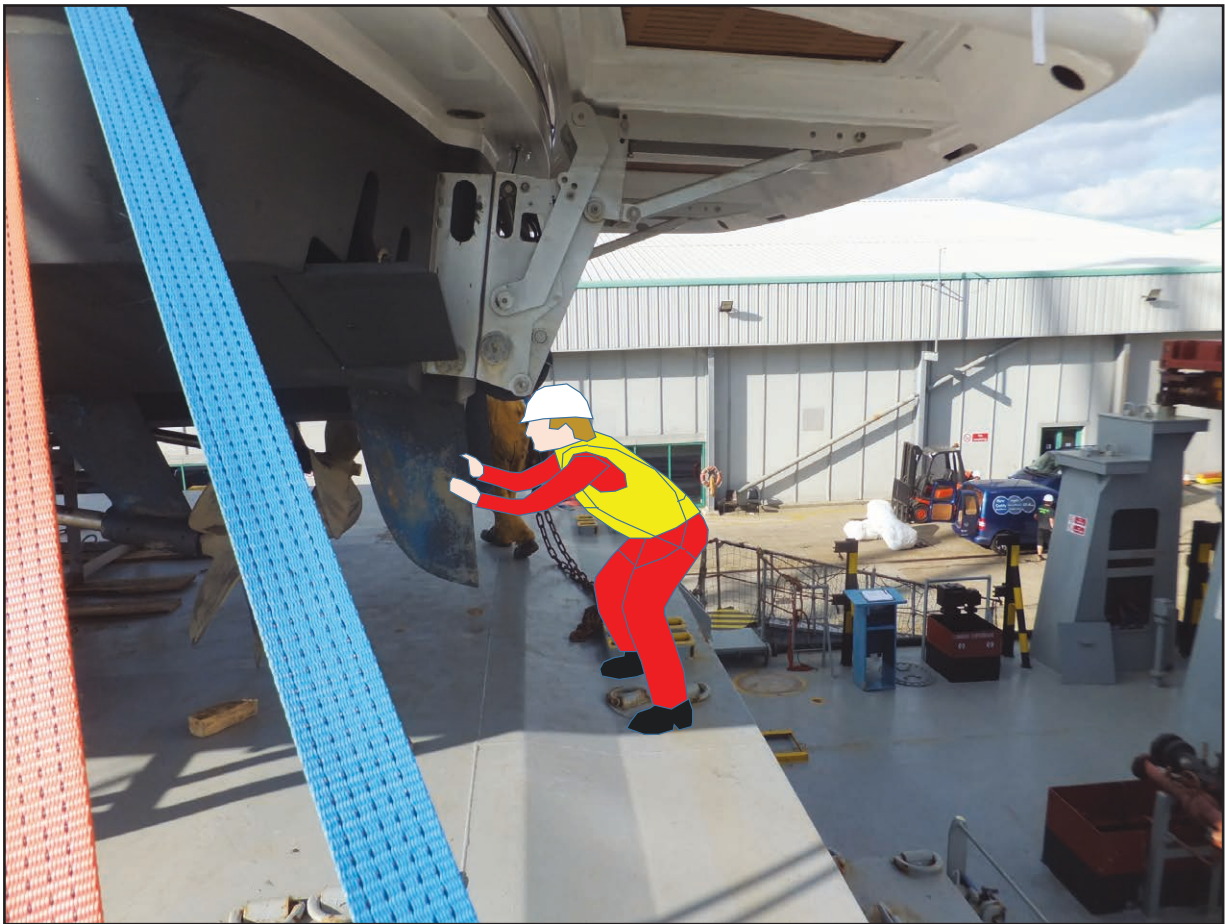
Figure 3: Position of the chief officer as he checked and adjusted the alignment of the yacht's keel

Norjan's chief officer fell off the edge of the hatch cover while supervising the cargo loading operation, and suffered multiple fractures to his ankles that prevented him working for almost a year. Following the instructions of the Peters & May loadmaster, he had positioned himself under the stern of a suspended motor yacht close to the unfenced edge of the aftermost hatch cover (**Figure 3**). Having helped guide the suspended yacht into its cradle, the chief officer turned to walk back towards his original control position. As he turned, he tripped, lost his balance and fell to the deck below.

There were several trip hazards close to where the chief officer had been standing and the surface of the hatch cover was slightly uneven, but no one saw him fall and it is uncertain what caused him to stumble. The chief officer might have tripped on a raised container deck socket or a D-ring, or he might simply have dragged his feet and stumbled as he tried to walk up the inclined section of the hatch cover.

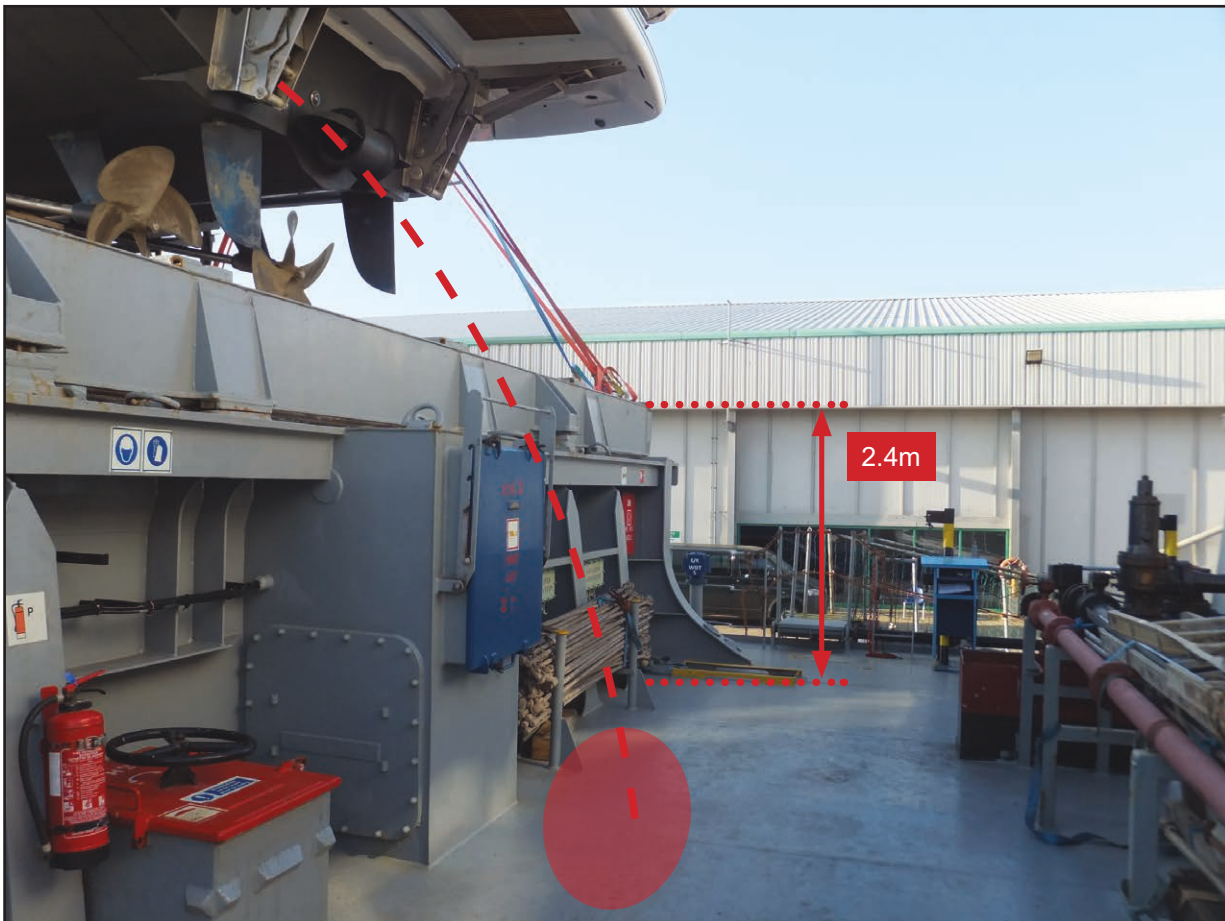
Figure 4: Area of main deck where the chief officer landed after his fall

The chief officer, screaming out as he fell, landed feet-first and collapsed onto his knees. Having heard the chief officer's scream, the master and nearby crew attended to him and administered first-aid. The chief officer had broken both his ankles and was in severe pain. The loadmaster telephoned for an ambulance using his mobile phone.

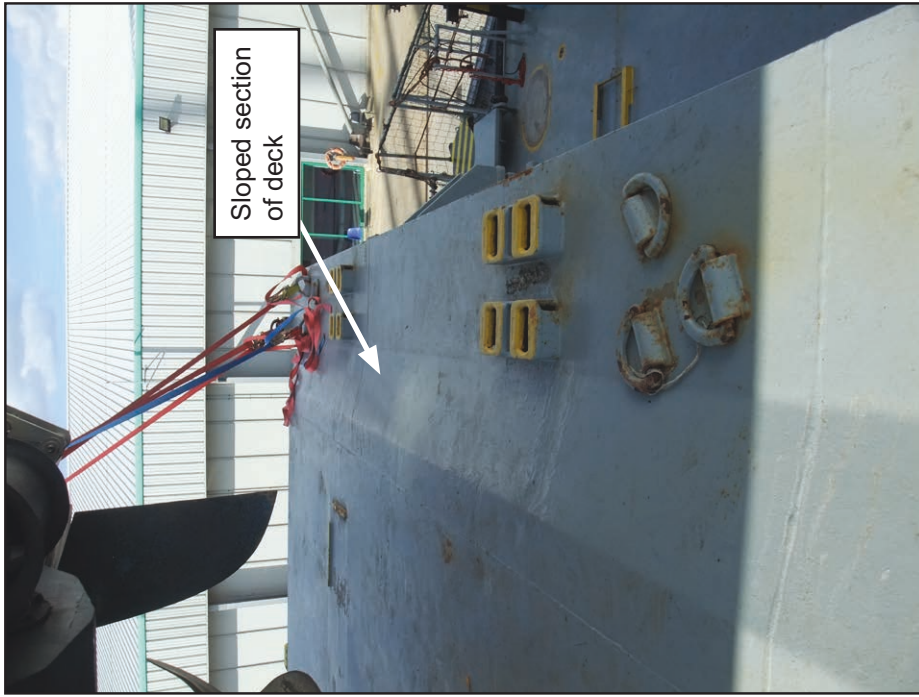
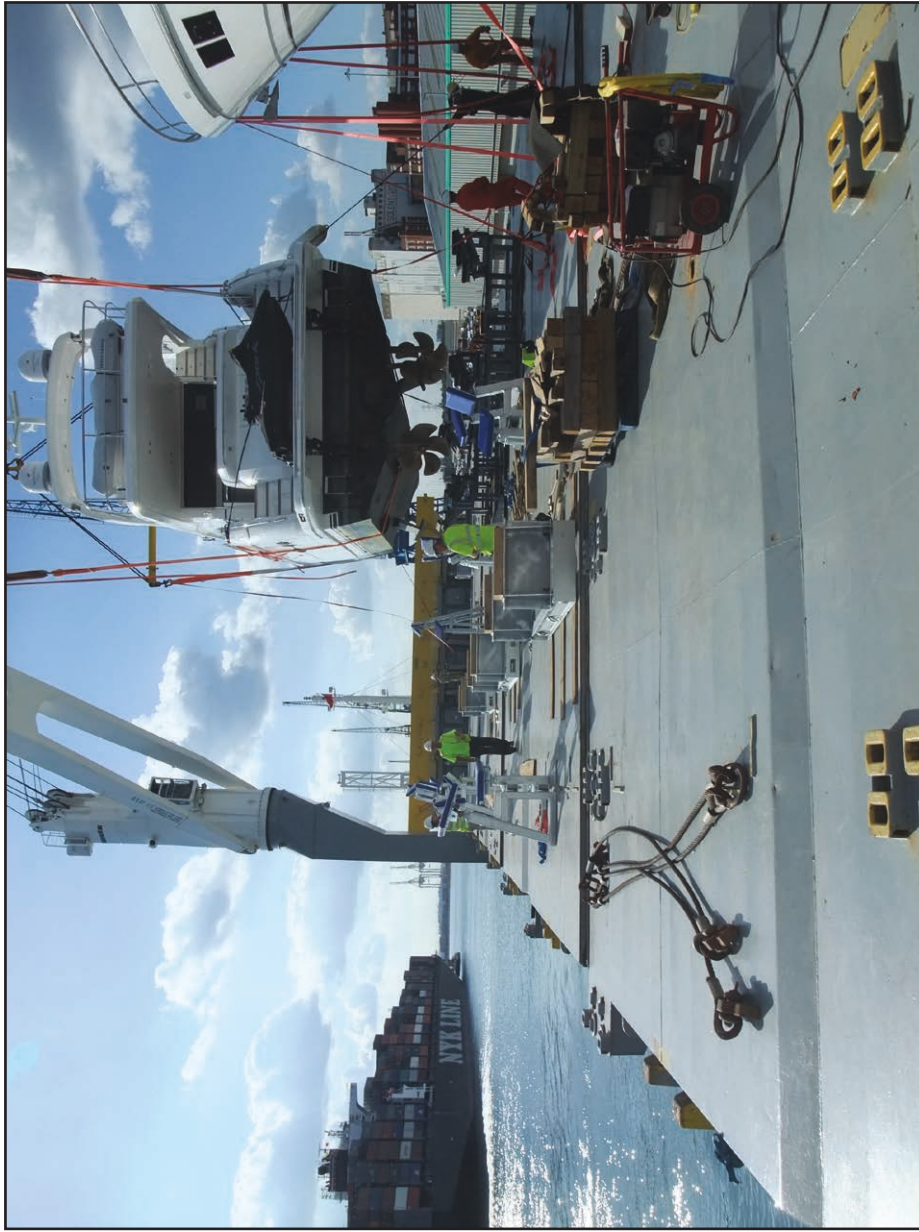
Figure 8: Trip hazards on the hatch covers

Several additional trip hazards (**Figure 8**) had been created on the surface of the hatch covers during the cargo loading operation; these included: lifting strops, rope, wooden planks and chocks, and portable ladders. Access routes and safe areas had not been designated and no provision had been made for the rigging of temporary fencing⁶ around the exposed edges of the hatch covers.

Area where chief officer tripped

Hatch covers looking forward - lashing gear, electric cables, wooden planks etc on deck

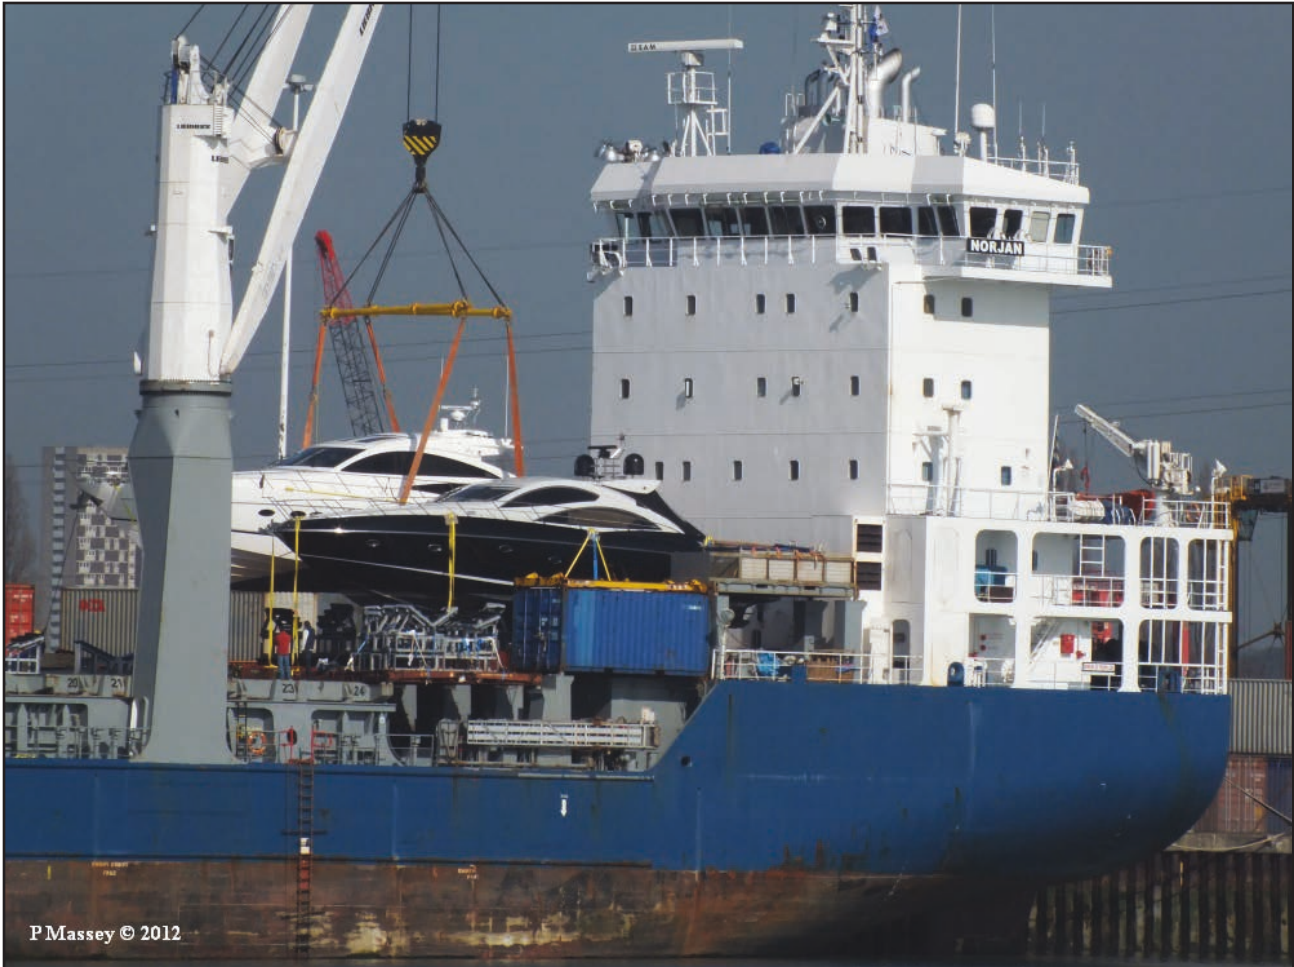
Figure 9: Motor yachts loaded onto *Norjan's* aft container landing platforms

existed on the container flat rack platforms aft of the hatch covers, which were also used to stow motor yachts (**Figure 9**), but the height above deck level was even greater.

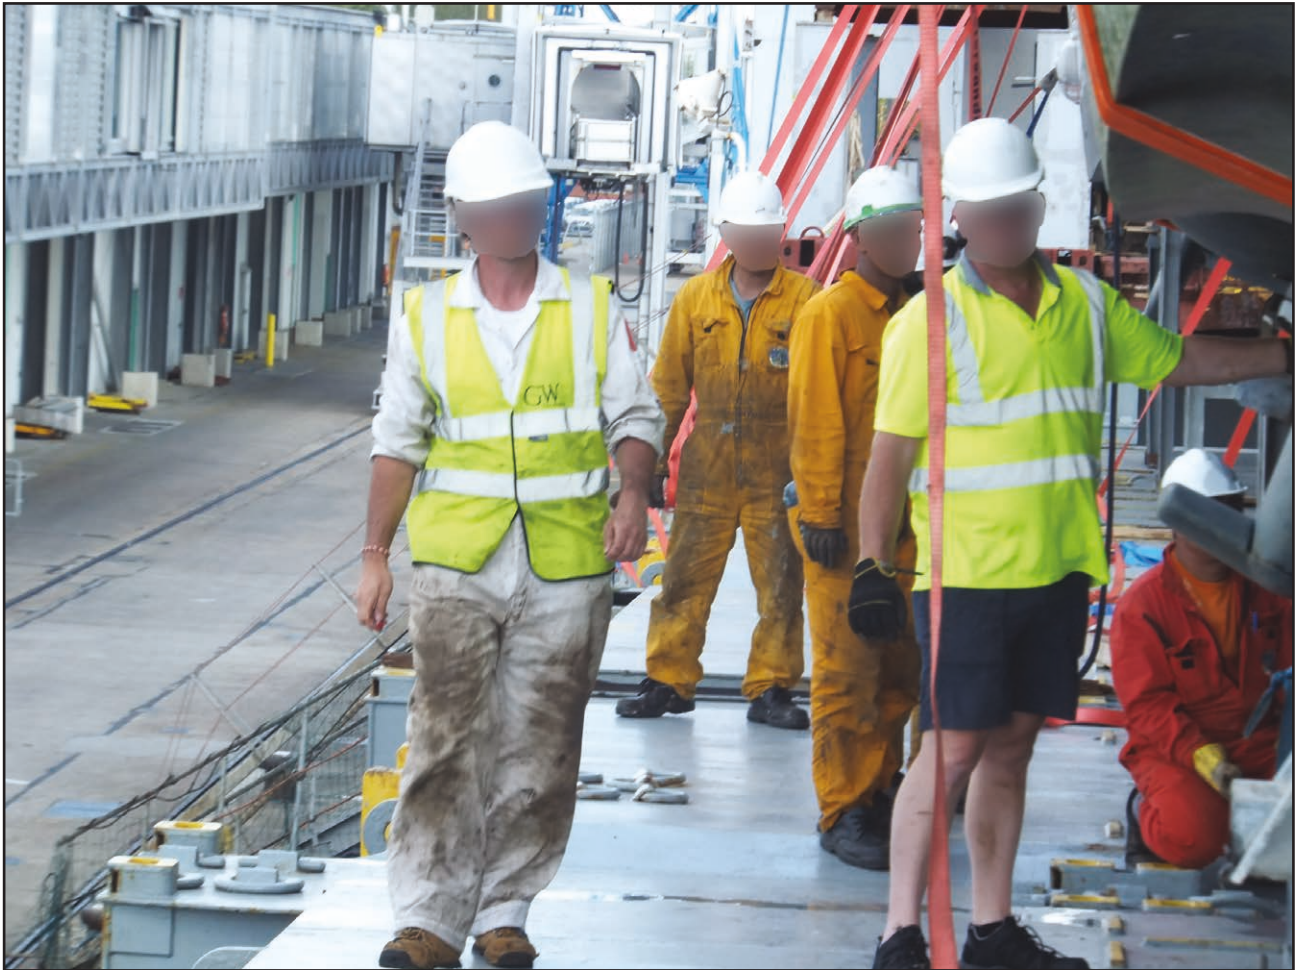
Figure 10: People walking and working close to the exposed edges of the hatch covers

It was apparent that the free movement of personnel on *Norjan's* hatch covers was not considered to be particularly hazardous. This was evident during the loading operation when the crew continually walked and worked close to their unfenced edges; as did the loadmaster and other shore-based workers (**Figure 10**). It was also apparent that the perception of the crew was that personal care and vigilance was sufficient to avoid tripping on, or falling off the hatch covers.

Personal care and vigilance must always be exercised when working cargo; this is particularly so during lifting operations and when personnel are exposed to fall hazards. However, when a person is required to undertake work in a hazardous environment, it is difficult for them to give full attention to the task while at the same time guard themselves against danger. This was the case when the chief officer was tasked to align the motor yacht in its cradle, and therefore additional precautions should have been taken.
