AAIB
Air Accidents Investigation Branch

AAIB Bulletin

12/2015

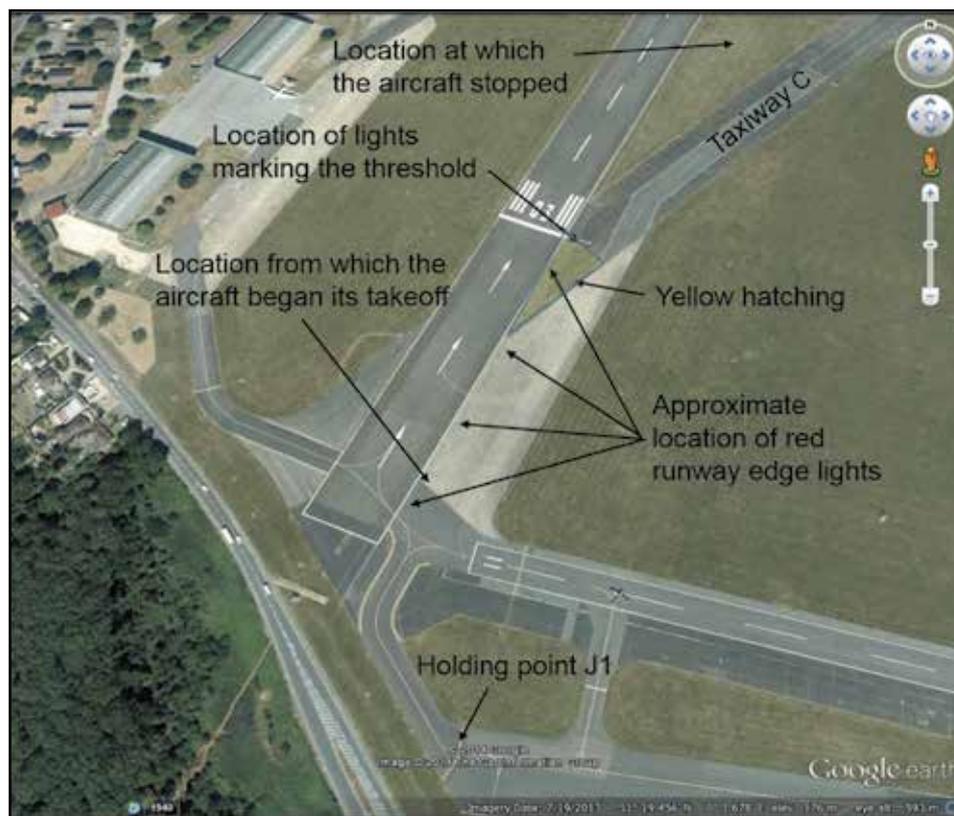
Figure 1

The area near the threshold of Runway 03

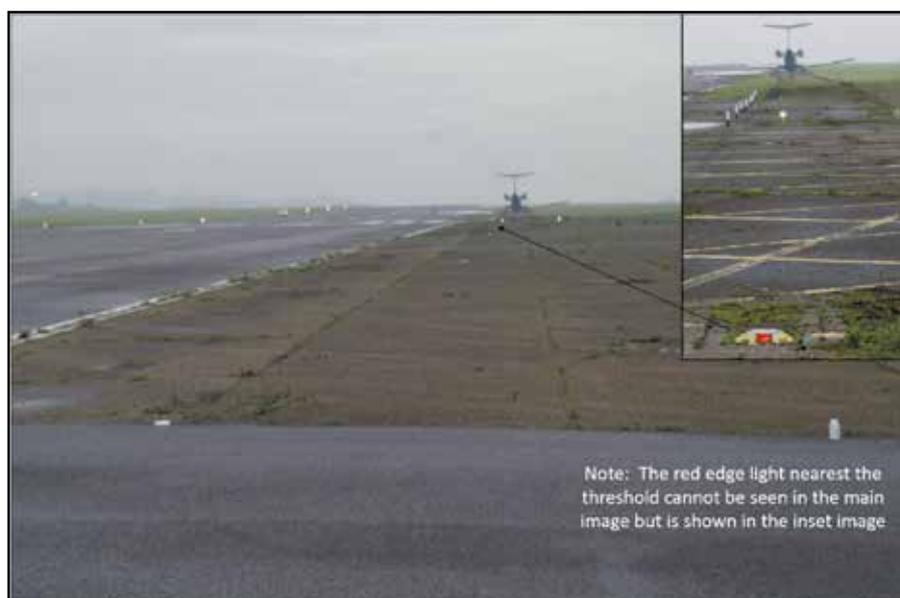
Figure 2

line that marked the edge of the runway. The most northerly light was located 30 m from the threshold of Runway 03 (Figure 2). Beyond the lights marking the runway threshold, white runway edge lights were mounted on poles located in the grass.

Marks made by the aircraft tyres showed that on exiting Taxiway J the aircraft entered the ORP with the left main wheels in line with the red runway edge lights. When the aircraft began its takeoff run, it had passed the first red runway edge light and the next edge light ahead of the aircraft was approximately 46 m away. The aircraft track continued parallel to the runway and 248 m from the start of the ORP the aircraft left the paved area and ran onto the grass. All the wheels sank approximately 0.25 m into the soft ground; however, the depth of the furrow made by the nosewheel varied, indicating that the aircraft was oscillating about the main landing gear. After travelling 120 m across the grass the nose landing gear and radome detached. The aircraft eventually came to a halt 424 m from the start of the ORP, in line with the PAPI. After passing the threshold lights, the left main wheel damaged two of the three white edge lights.

Red lighting on the ORP and the ORP's boundary with the taxiway

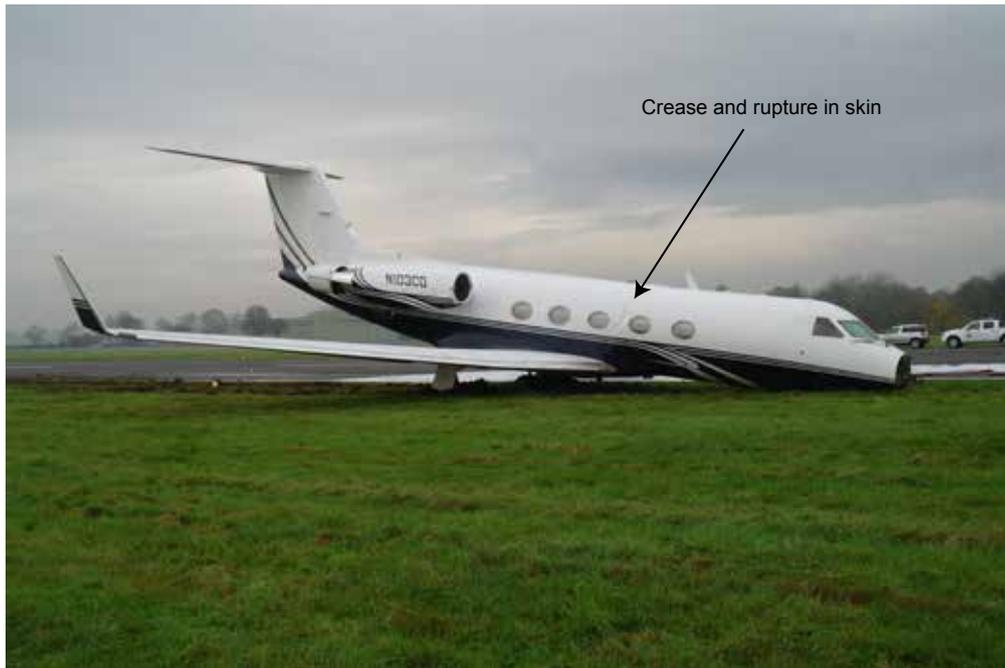
Figure 3

After the nose landing gear separated from the aircraft, it struck the lower fuselage approximately 0.3 m aft of the nose landing gear bay, tearing a hole in the skin 6.5 m long. A number of frames in this area were damaged and all the aerals mounted on the forward lower section of the fuselage were found detached. There was also a crease and rupture in the skin over the top of the fuselage, just aft of the second window in the cabin (Figure 3). The aircraft was assessed as being beyond economic repair.

The aircraft as it came to rest, showing area of skin crease and rupture

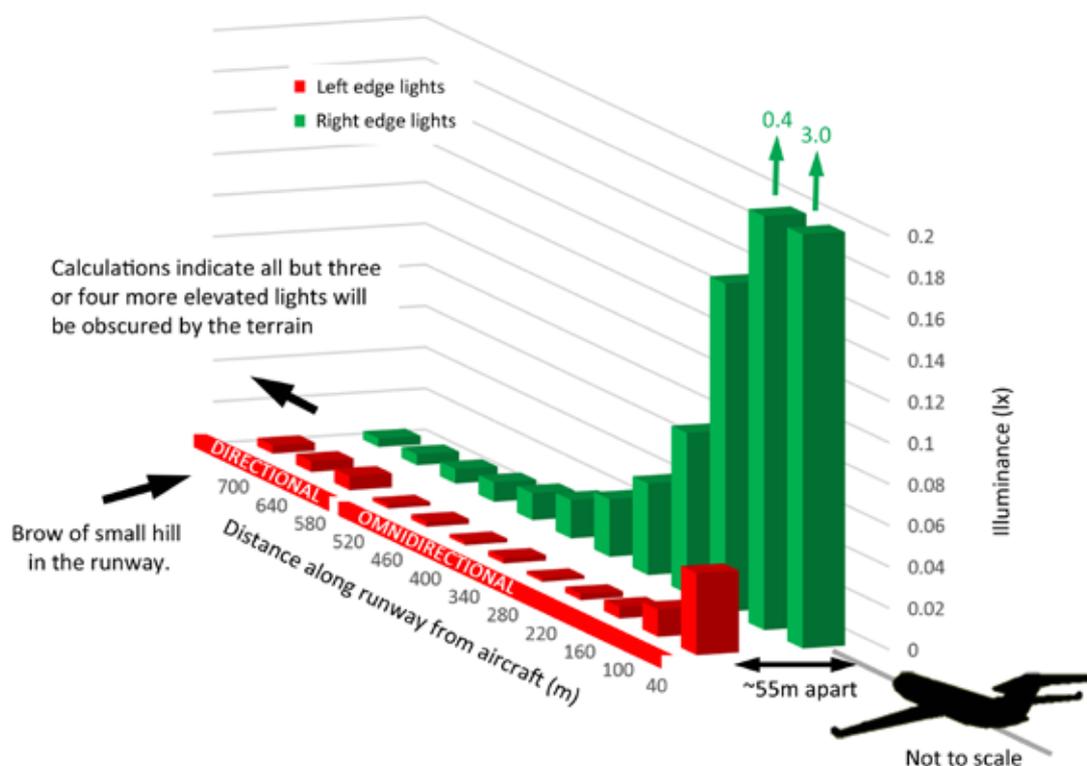
To show this point, Figure 8 illustrates the modelled illuminance of the edge lights from the approximate start position of the accident flight, using the minimum light intensity values given in the standards. This assumes the lights were set at 100% power and, as an indicative value, uses 1 km visibility.

Illustration of light intensity of a combined omnidirectional and bi-directional runway edge light, assuming optimal vertical viewing angle and 1 km visibility

It is recommended that the International Civil Aviation Organisation initiate the process to develop within Annex 14 Volume 1, '*Aerodrome Design and Operations*', a standard for runway edge lights that would allow pilots to identify them specifically, without reference to other lights or other airfield features.

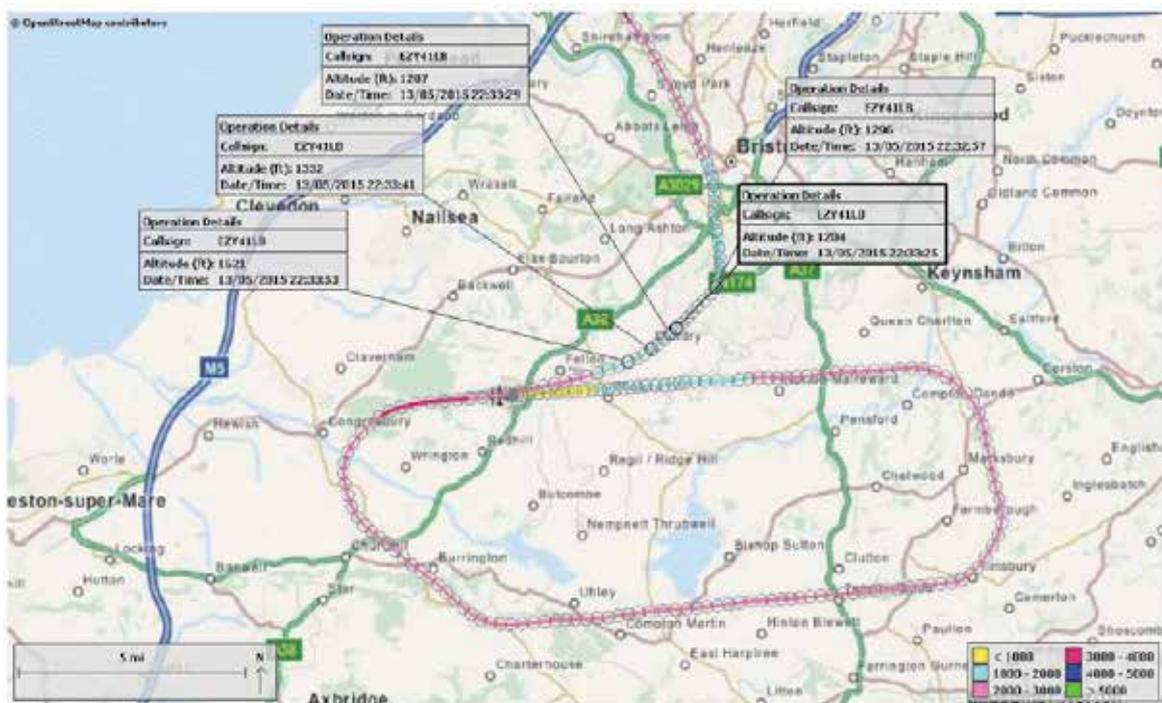
The aircraft made its turn towards Runway 27, approximately 2 nm to the north of the runway centreline at a slant range from the threshold of 4.3 nm. The aircraft was turned through 50° and its rate of descent was reduced. The aircraft then flew level at 1,200 ft for 25 seconds, during the last 10 seconds of this, the indicated radar altimeter height reduced from 950 ft to 488 ft. The go-around was executed at 2.75 nm slant range from the threshold, still approximately 1 nm north of the centreline. The go-around altitude was set in the altitude window of the FCU during the manoeuvre.

Figure 1
Bristol Airport noise trace

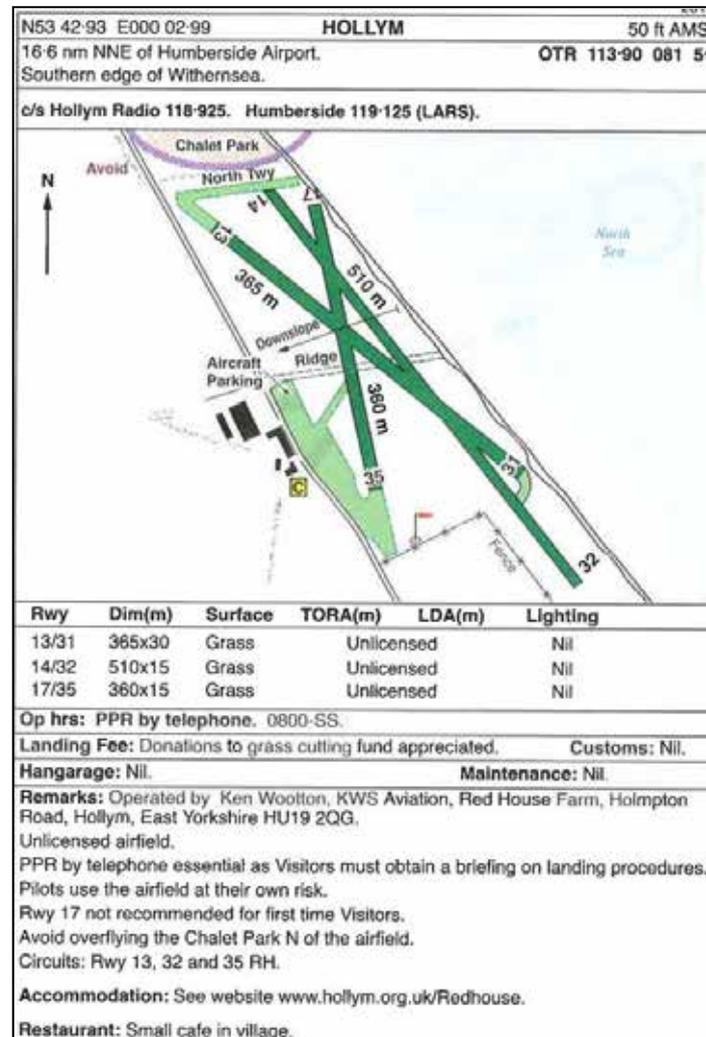
Figure 1

Hollym is an unlicensed strip located on the edge of a cliff with three runways, two of which (Runways 31 and 17) are subject to coastal erosion (Figure 1). The pilot performed a fly-by to assess the options and reports that she felt that, although it was the most into-wind, the usable part of Runway 31 looked rather short. Runway 32 was longer and, although narrow and partially bordered by a fence to the west (that is, the landward side of the runway), she felt it was preferable to use this and accept the increased crosswind component, which she estimated to be about 7 kt and relatively steady. The pilot lined up on finals and, after an approach and touchdown which she thought was "OK", she concentrated on looking straight ahead and admits that she was not initially aware that the aircraft was drifting to the

left, towards the fence. Her companion, however, had seen the proximity of the fence and tried to alert her but it was too late; the left wingtip struck about four of the fence posts and ground looped around the last one before coming to a halt in the long grass at the side of the runway.

Chart of Hollym Airfield. Note proximity of fence to the first part of Runway 32
