Rail Accident Investigation Branch

# Rail Accident Report

**Container detachments at Scout Green,  
Cumbria, 7 March 2015 and near Deeping St  
Nicholas, Lincolnshire, 31 March 2015**

Report 19/2015  
December 2015

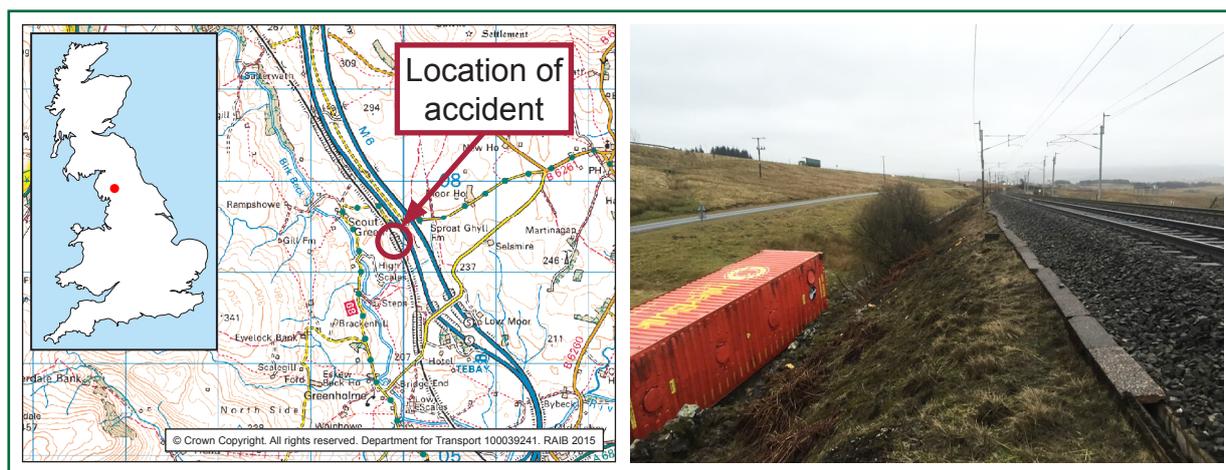
- 4 At around 02:20 hrs on 7 March 2015, an empty 30 ft container was blown from freight train 4S83<sup>1</sup>, the 23:54 hrs Freightliner service from Basford Hall to Coatbridge, while it was travelling on the down<sup>2</sup> main line of the West Coast Main line at Scout Green, Cumbria (figure 1). The container toppled over the adjacent up<sup>3</sup> main line and came to rest at the bottom of the embankment on the east side of the railway (figure 1). There was no damage to the train or to the infrastructure but some trees on the embankment and a boundary wall at the foot of the embankment were knocked over. There were no passing trains at the time of the detachment although the Glasgow Central to London Euston sleeper service had passed the site of the incident on the adjacent line about four minutes earlier.

- 5 Train 4S83 comprised 26 container carrying vehicles hauled by a pair of class 86 locomotives and was travelling at around 75 mph (121 km/h). The detached container was being carried on an FEA-B type wagon, number 640017, which was the 20th vehicle in the train. The container was one of two empty 30 ft containers carried on the wagon and was located at the leading end (in the direction of travel).

Figure 1: Extract from Ordnance Survey map showing location of incident and photograph of the detached container at Scout Green (Image courtesy of Network Rail)

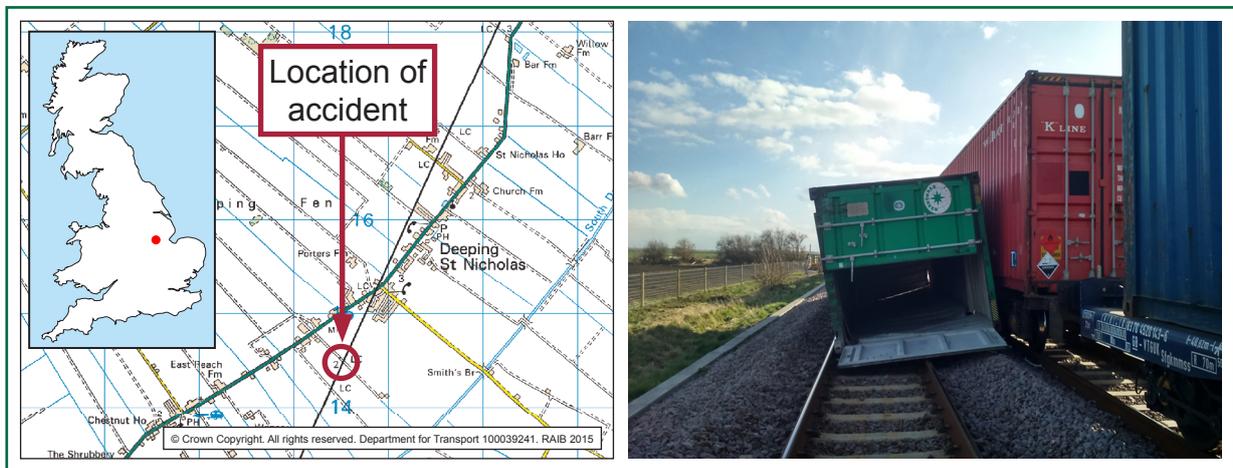
- 9 The container fell against the side of the wagon and was dragged a short distance before coming to rest on the adjacent track (figure 2). The train continued for approximately 250 metres until it was brought to a stand by the train's brakes. The brakes were applied automatically when the container struck the handbrake handwheels of several wagons and damaged a brake safety mechanism.

Figure 2: Extract from Ordnance Survey map showing location of incident and photograph of the detached container near Deeping St Nicholas (Image courtesy of Network Rail)

- 11 The detached container caused significant damage to the infrastructure, including a trackside telecommunications cabinet, a level crossing surface, sleepers, rail fixings, and signalling equipment. Thirteen vehicles also suffered damage, mainly to handbrake handwheels. There were no trains passing at the time of the incident although another freight train operated by GB Railfreight carrying containers had passed on the adjacent line about five minutes earlier.

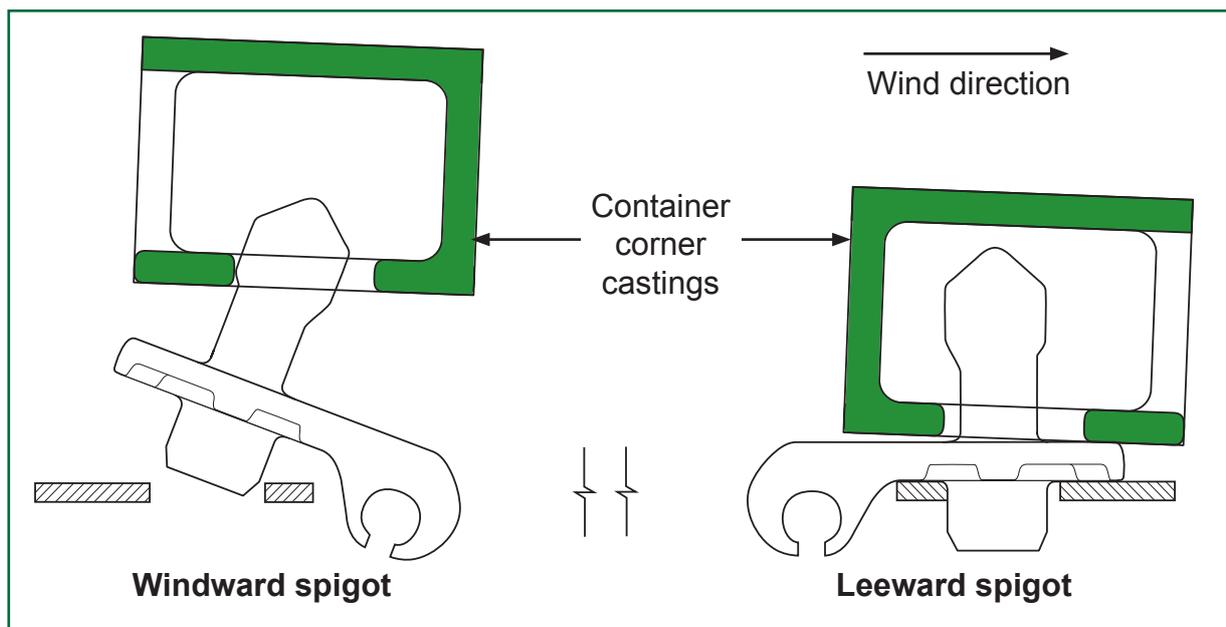
- 27 In May 2009 the RAIB published its investigation report into the container detachments at Hardendale and Cheddington ([RAIB report 12/2009](#)). The investigation found that spigots with inboard hinges do not comply with UIC 571-4 because the spigot is free to tilt inwards towards the centre of the vehicle by more than the permitted two degrees of rotation (paragraph 19). Once a container starts to lift on the windward side and engages with the neck of the spigot, the spigot rotates on its inboard hinge with the container and cannot prevent the container from overturning (figure 8).

Figure 8: Mechanism of container detachment on spigots mounted on inboard hinges (not to scale)

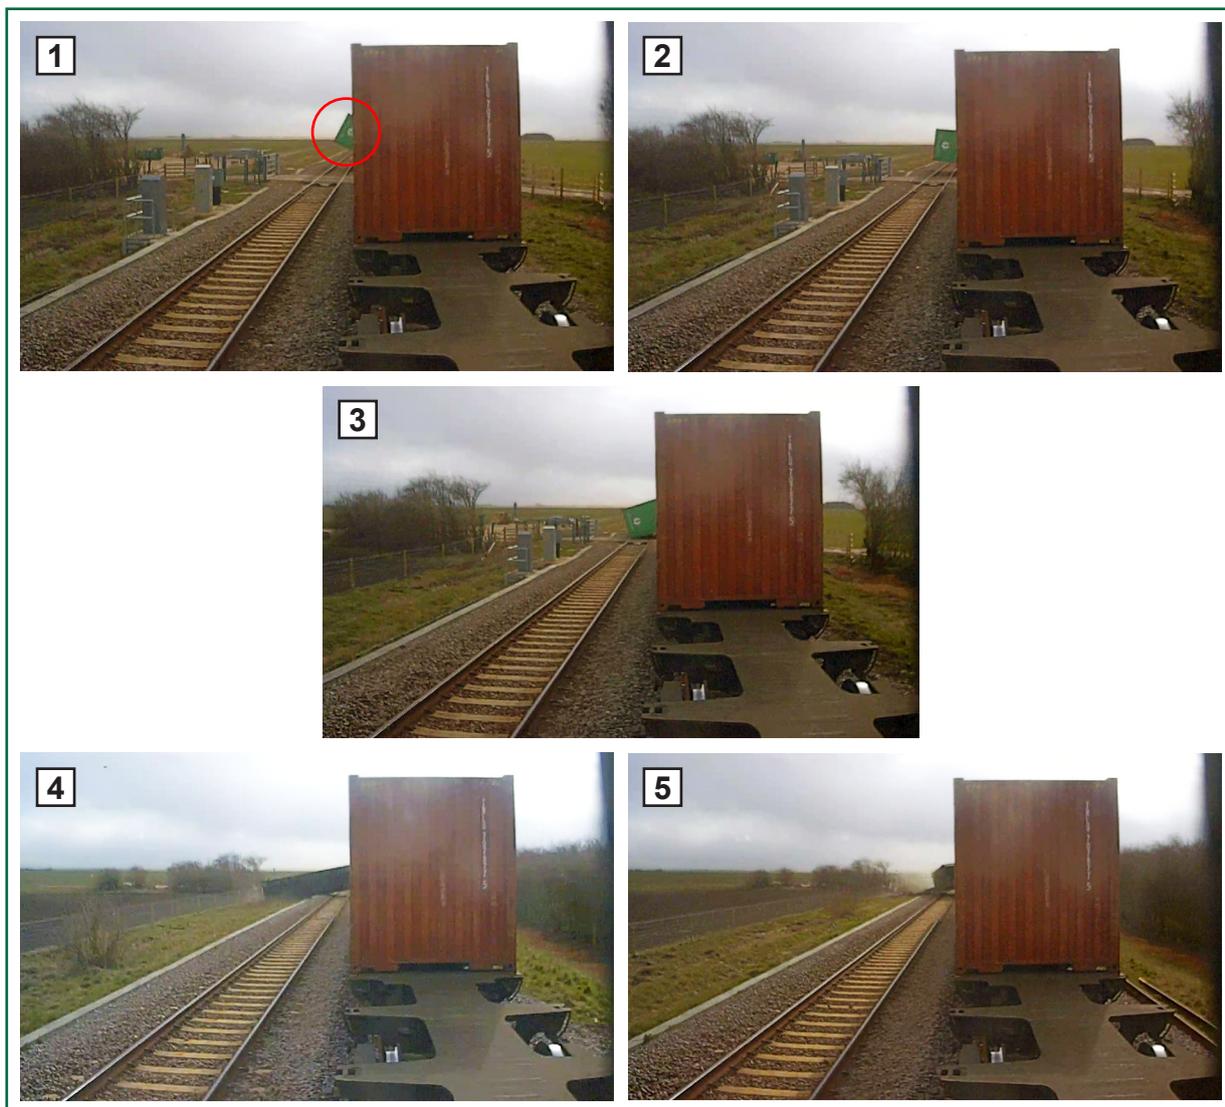
- 57 The locomotive hauling train 4Z33 was fitted with forward and rear facing closed circuit television (CCTV) cameras. These recorded an apparent deterioration in weather conditions around the time of the detachment; the sky darkened and strong gusts of wind blew debris across the track from adjacent fields. Images from the rear facing camera captured the third container in the train overturning about its leeward spigots and falling from the wagon (figure 9). It was struck by a wagon outrigger and swung across the adjacent track before being pulled into line and dragged by the train for about 60 metres.

- 58 Taking the worst case wind gust speed of 67.8 mph (109 km/h) measured near the site of the container detachment, and a train speed of 38 mph (61 km/h) the RAIB has calculated the resultant wind speed to be 78 mph (125 km/h) at a wind angle of around 61 degrees (paragraph 22). These figures indicate that a container overturning could theoretically occur, but there is no record of any containers previously detaching in these conditions. It is possible that the wind gust speed was higher at the railway than that measured at the wind farm. It is also possible that the gap in the line of containers immediately in front of the container that detached may have had some bearing on the aerodynamics around the container (there were similar gaps preceding the first containers to detach at Hardendale, Cheddington, and at Scout Green).

Figure 9: Series of images recorded by the rear facing camera on the locomotive of train 4Z33 to show the container detachment (images courtesy of GB Railfreight)

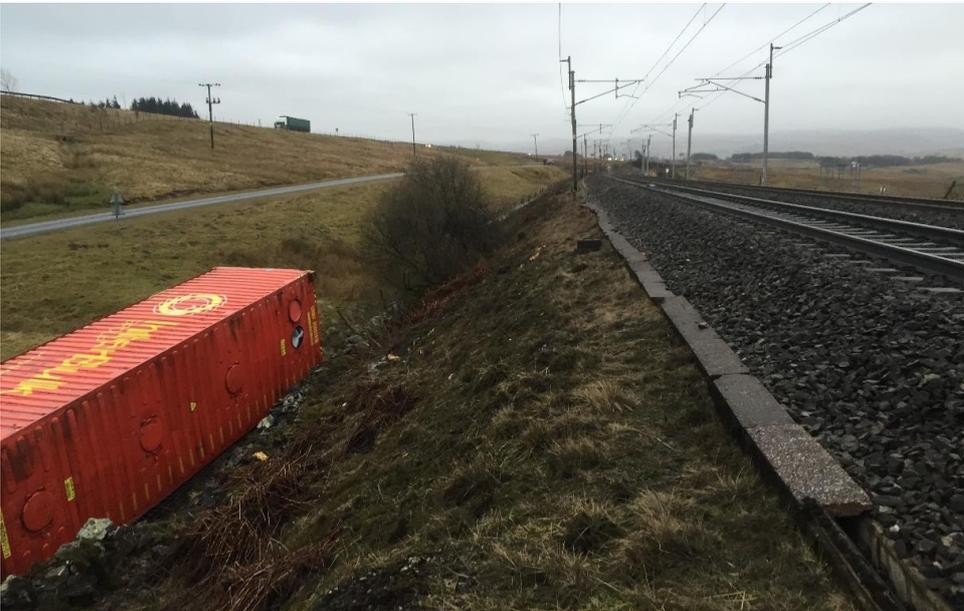
1. INCIDENT DESCRIPTION			
<b>LEAD / INSPECTOR</b>		<b>CONTACT TEL. NO.</b>	
<b>INCIDENT REPORT NO</b>	0744	<b>DATE OF INCIDENT</b>	7 March 2015
<b>INCIDENT NAME</b>	Scout Green		
<b>TYPE OF INCIDENT</b>	Container blown off freight train		
<b>INCIDENT DESCRIPTION</b>	<p>At around 02:20 hrs on 7 March 2015, an empty 30 ft container was blown off an FEA(B) wagon, that formed part of train 4S83 operated by Freightliner. The train was travelling at around 75 mph (120 km/h) on the Down Main line in the vicinity of Scout Green, Cumbria, around 2.5 miles south of Shap Summit. The container passed over the adjacent Up Main line and came to rest at the bottom of the Up side embankment. There was no damage to train 4S83, any other train, the overhead line equipment or the track. Trees on the embankment and a boundary wall at its foot were knocked over.</p> <p>The incident took place at a time of high cross-winds. Although it did not result in injuries, the potential for more serious consequences is evident.</p>

<p>[Image courtesy of Network Rail (looking south)]</p>
