Rail Accident Investigation Branch

# Rail Accident Report

## **Derailment at Washwood Heath West Junction, Birmingham 23 March 2015**

Report 01/2016  
January 2016

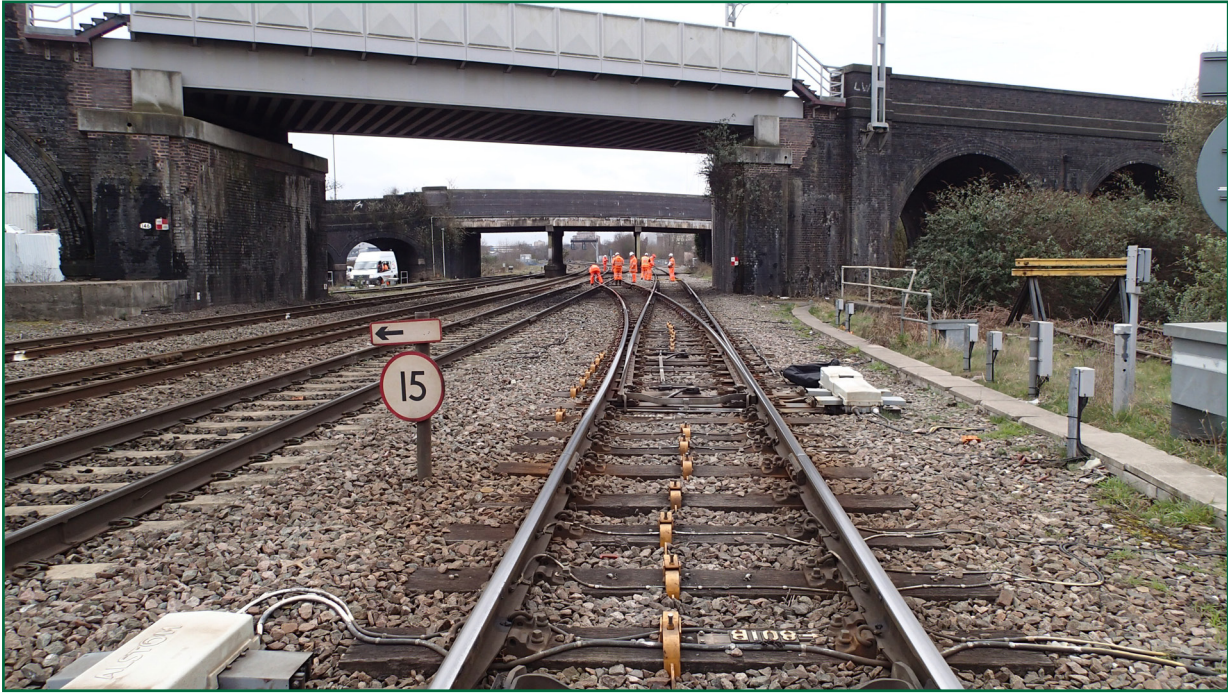
Figure 2: Site of the derailment, looking in the direction that the train was travelling

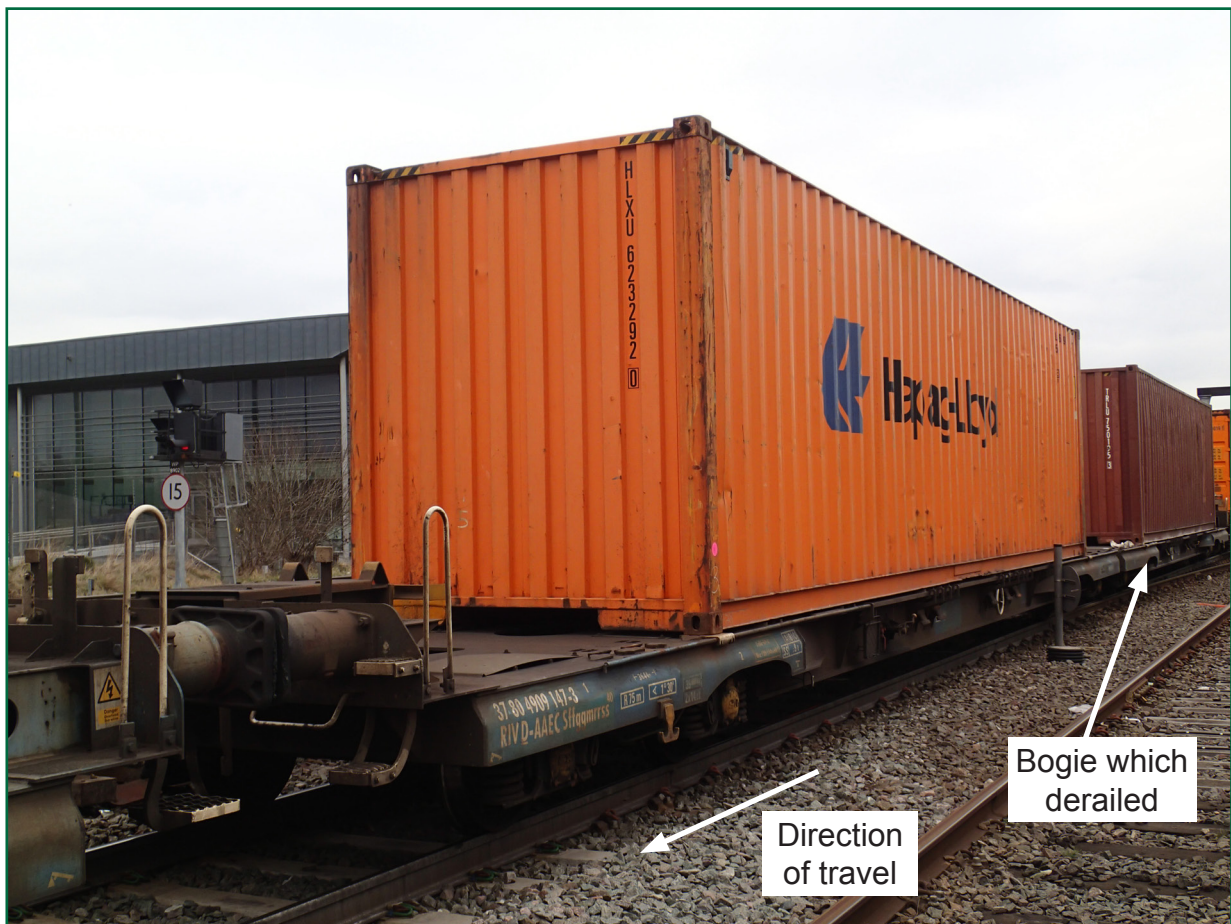
- 20 The wagon which derailed was number 37 80 4909 147-3, a 'Megafret' type (TOPS code IKA, UIC code Sffggmrrss). This was the tenth wagon in the train. The ninth wagon was also a Megafret, and these were the only Megafret wagons on the train.
- 21 A Megafret wagon consists of two semi-permanently coupled *platforms*, each of which has two bogies. The combination of the two platforms is regarded as a single wagon for operational purposes and is given one wagon number. Each platform of a Megafret can carry a container up to 45 ft<sup>1</sup> long. At the time of the derailment, wagon 37 80 4909 147-3 conveyed an empty 40 ft container on the leading platform and a 40 ft container loaded with scrap plastic chips on the trailing platform. The bogie which derailed was the leading bogie of the trailing platform (figure 4).

Figure 4: Wagon 37 80 4909 147-3 after the incident

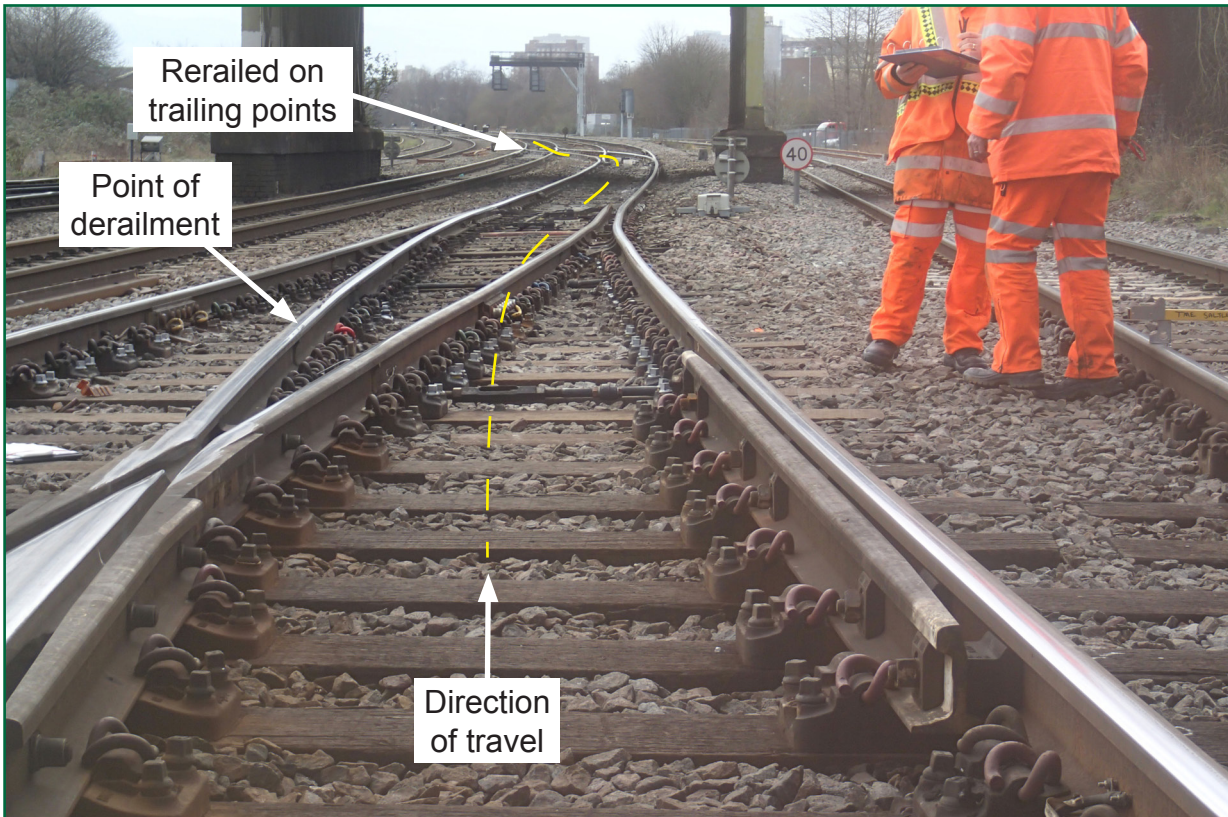
- 27 The bogie ran derailed through the *switches* of 802B points, the plain line between them and 805A points and through those points (figure 5). Significant damage was caused to 802B and 805A points and the track between them (figure 6).

Figure 5: Path of the derailed bogie

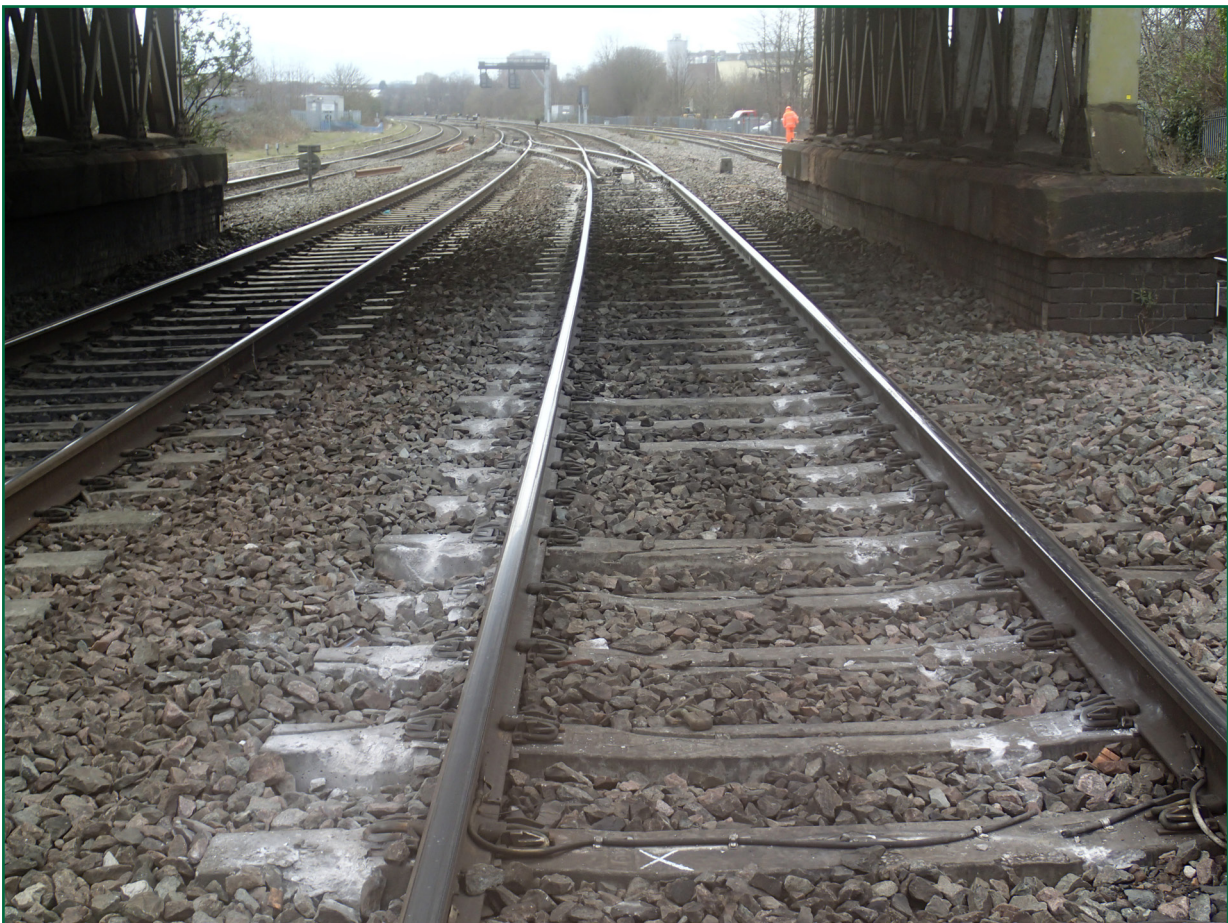
Figure 6: Damage caused to track by the derailed bogie

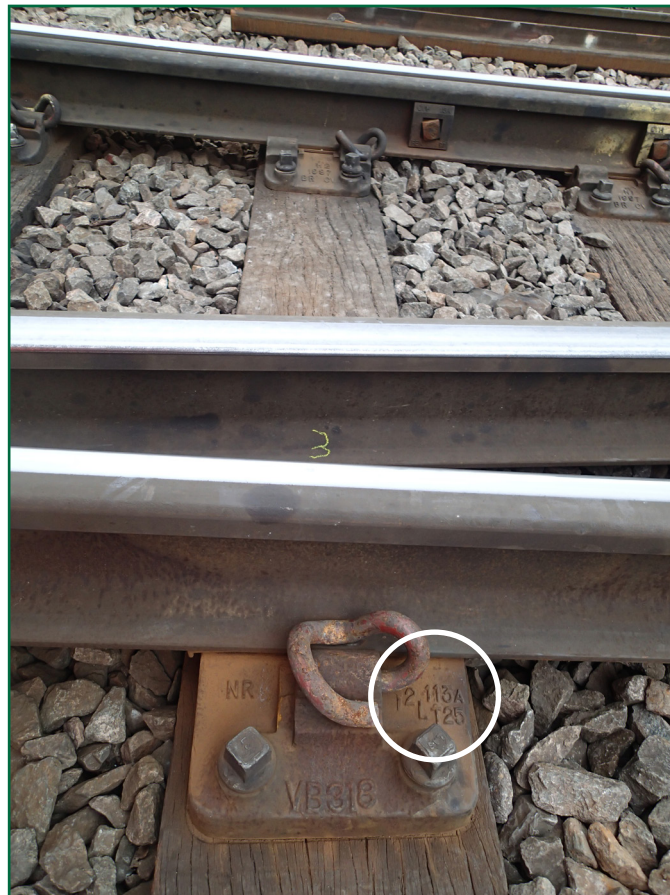
- 56 A simple *turnout* (point) consists of two diverging routes which only become completely separate after the *crossing*. As the two tracks diverge, the sleepers which support the two tracks become longer, but do not become separate sleepers until the distance between the diverging tracks is great enough to allow space for two sleeper ends. These long sleepers are known as *bearers* and both of the tracks supported by them normally have the same cant.
- 57 Where the two routes through a turnout need to have different amounts of cant, as was the case with crossover 802, some of the rails within the turnout are raised by using thicker baseplates beneath them. This practice is known as *two-levelling* and the thicker baseplates are identified by having markings cast on them to show how much thicker they are than standard baseplates (figure 7).

Figure 7: Two-levelled baseplate with marking (circled) to show it is 25 mm thicker than the standard baseplate

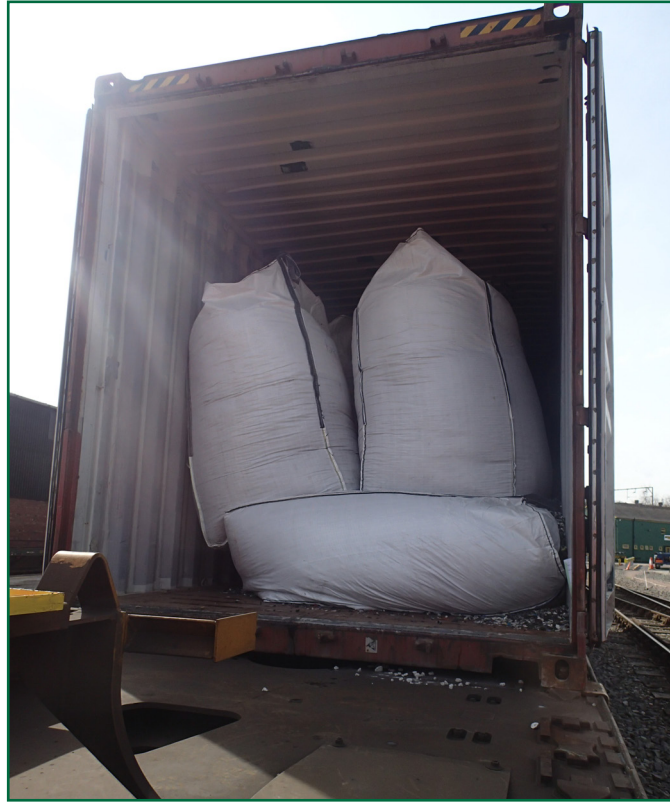
- 62 The container on the wagon was opened under RAIB supervision and its contents appeared to be reasonably evenly loaded (figure 8).
- 63 The RAIB arranged for the wagon to be tested on site, to measure the amount of wheel unloading on twisted track. The test method followed that specified in Railway Group Standard GM/RT2141 'Resistance of vehicles to derailment and rollover'. The two platforms of the wagon were separated and the trailing platform was tested with the loaded container in place. The loads on the leading wheels of the bogie which derailed were found to be reduced by 79% of their original value when the other wheels on the platform were jacked up by the amount specified in the standard. Standard GM/RT2141 specifies a maximum of 60% wheel unloading to minimise the risk of flange climb derailment on twisted track.

Figure 8: Contents of the container that was loaded on the trailing platform of wagon 37 80 4909 147-3

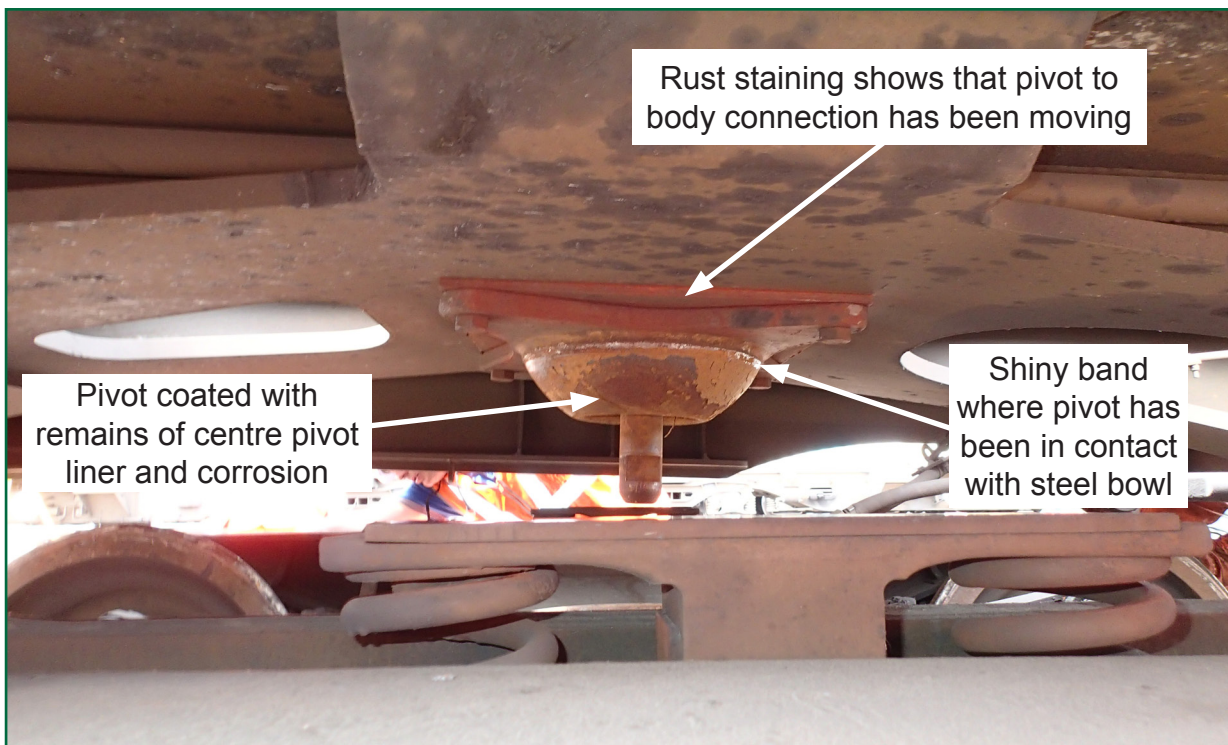
- 68 The wagon body was lifted from its bogies under RAIB supervision at Lawley Street Freightliner terminal. The centre pivot liners of all four bogies of the wagon were found to be worn to the extent that the steel centre pivot on the wagon body was in contact with the steel casting on the bogie. These plastic centre pivot liners are intended to prevent direct contact between the centre pivot on the body and the casting on the bogie. This is because the friction involved in direct steel to steel contact is much higher than the intended level of friction between the polished steel surface and the plastic liner. This increased frictional resistance would have prevented the bogies from rotating freely in curves. Figure 10 shows the centre pivot of another Megafret wagon whose liners had not worn so as to cause steel to steel contact. Figure 11 shows the centre pivot of the bogie which derailed.

Figure 11: Centre pivot of the bogie which derailed

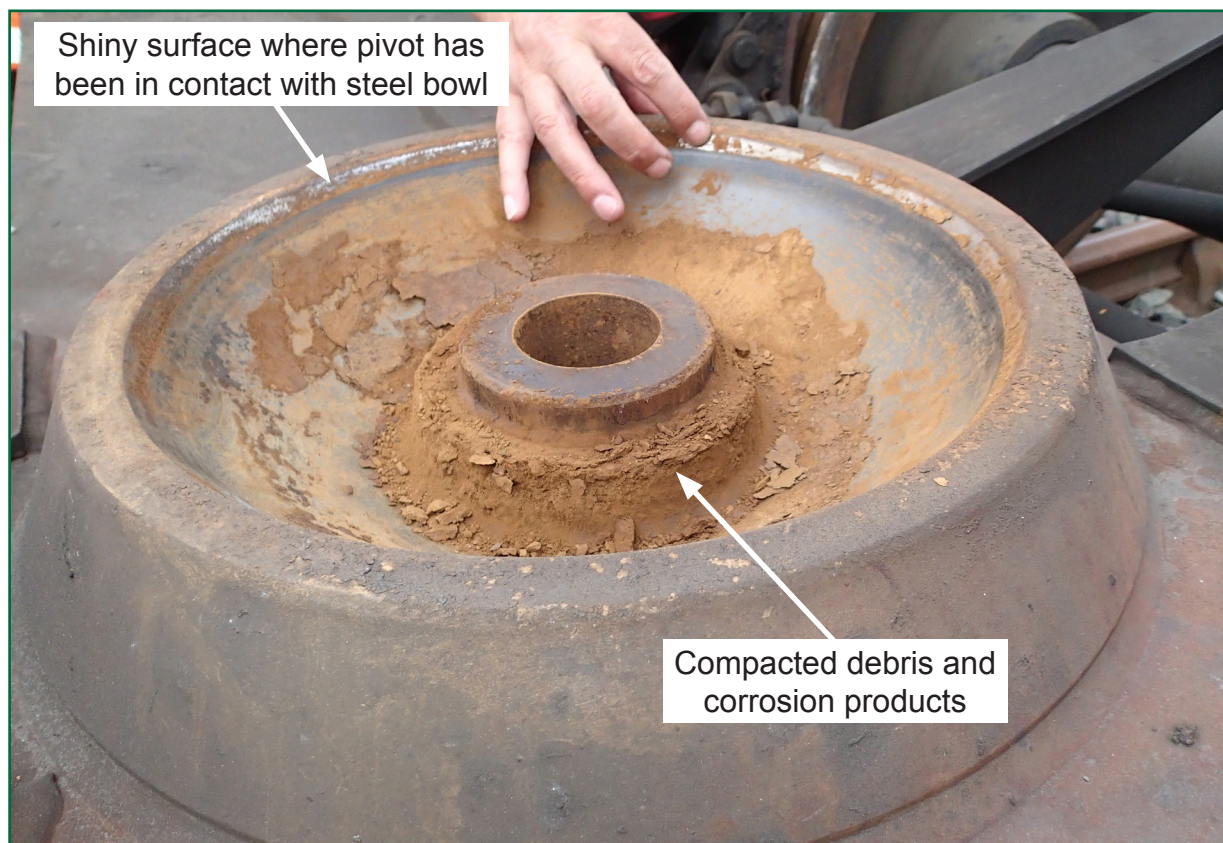
70 DWS used a small step gauge, shaped to the curvature of the liner, to assess the wear at the top and bottom of the liner. This gauge was specified in the maintenance instructions for other Y-series bogies with the same centre pivot arrangement. It measures whether the projection of the liner above the bowl is 1.5 mm. The RAIB does not consider that the use of different measurement gauges would have affected the assessment of the wear on the liners of this wagon as the liners had worn to the extent that their surfaces were below the steel rim of the bowl (figure 12).

Figure 12: Worn centre pivot liner on the bogie which derailed

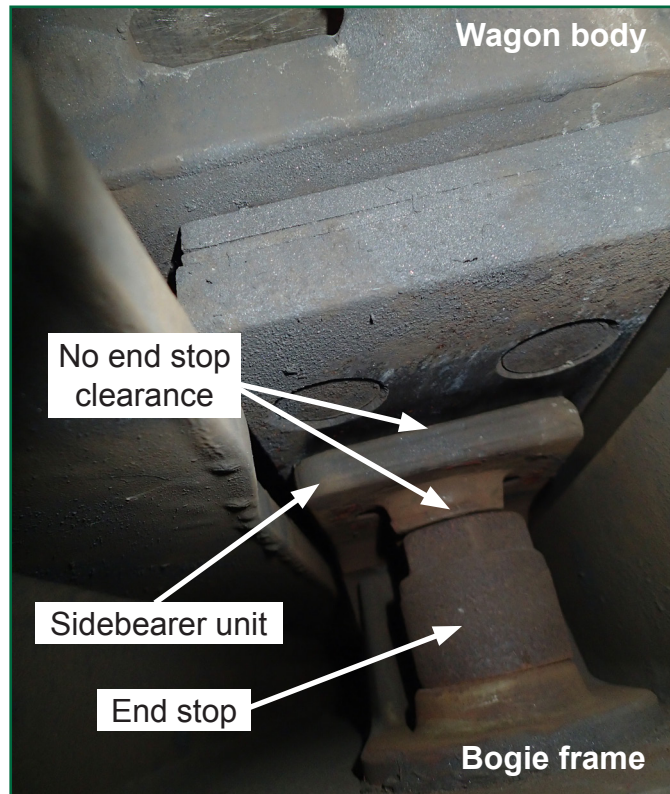
- 73 The worn centre pivot liner reduced the clearance between the steel sidebearer castings and their steel end stops (figure 9). The AAE TSO specified that this clearance should be 12 mm, with a tolerance of  $-1/+2$  mm (ie an acceptable gap between 11 and 14 mm). Other maintainers' maintenance instructions for the Y33 bogie specified the same clearance but with a tolerance of  $-0/+2$  mm. When measured during the wagon examination, this gap was found to be zero on one side of the bogie which derailed and 4 mm on the other side (figure 13).

Figure 13: Sidebearer on the left side of the bogie which derailed, showing no clearance between sidebearer casting and end stop (arrowed)

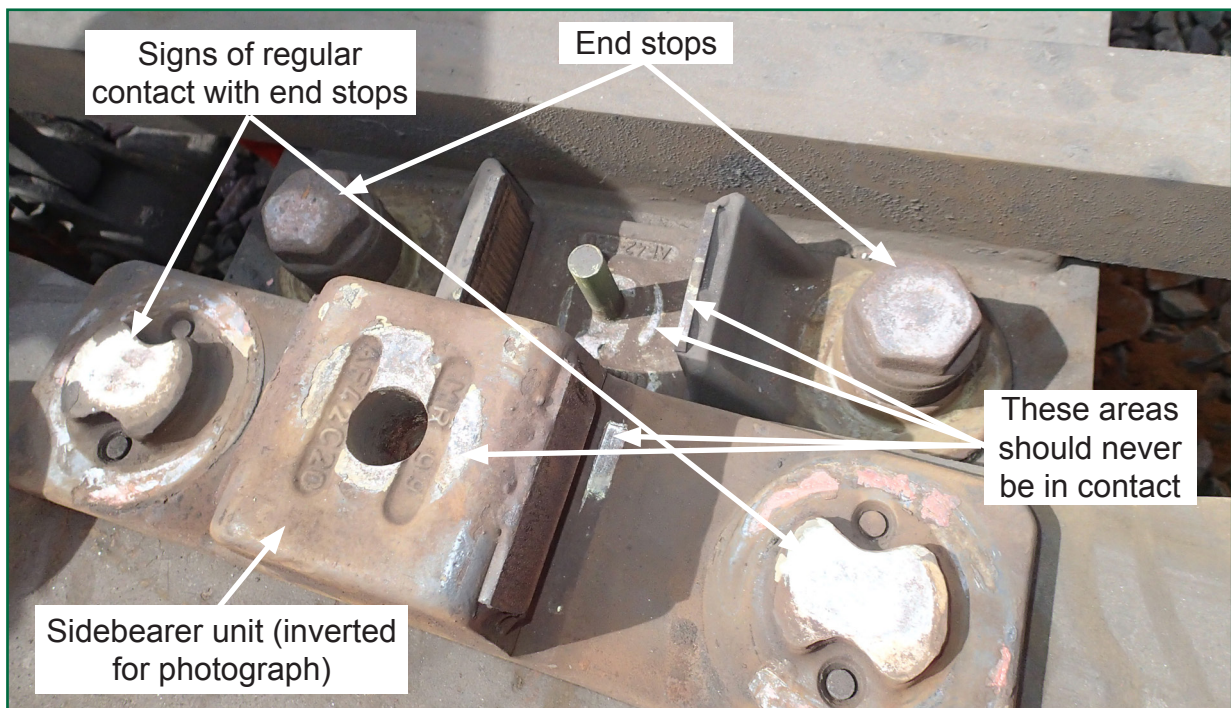
74 The reduction in end stop clearance had caused the sidebearer castings to come into contact with the end stops much more frequently than they were designed for. This caused wear of the castings and damage to the castings and the saddles in which they slide (figure 14).

Figure 14: Sidebearer on the left side of the bogie which derailed, showing where contact has occurred with the saddle (arrowed)

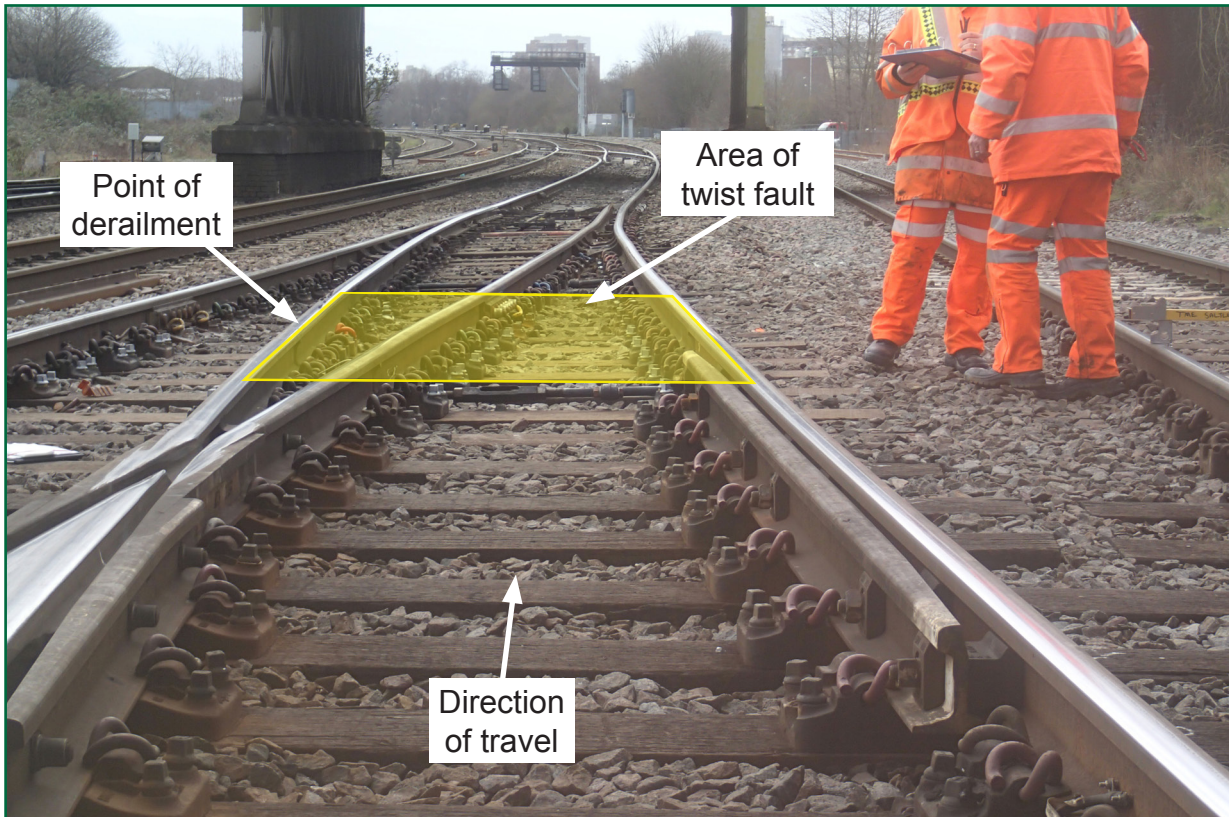
- 103 The RAIB surveyed the track after the derailment using an Amber trolley (paragraph 55). The data from this survey was supplemented by void measurements made using a class 66 locomotive. It was not possible to obtain a full set of void measurements as damage to the track caused by the derailment prevented the locomotive from travelling completely through the crossover. The survey showed that the track contained a static twist of 1 in 121 over 3 metres. The location of the twist was at the point of derailment (figure 16). The sense of the twist was such that the leading left-side wheel of a vehicle would see a reduction in load. Network Rail’s standard NR/L2/TRK/001mod ‘Track geometry - Inspections and minimum actions’ states that a twist between 1 in 91 and 1 in 125 requires remedial action within 36 hours of its discovery.

Figure 16: Location of track twist at the point of derailment

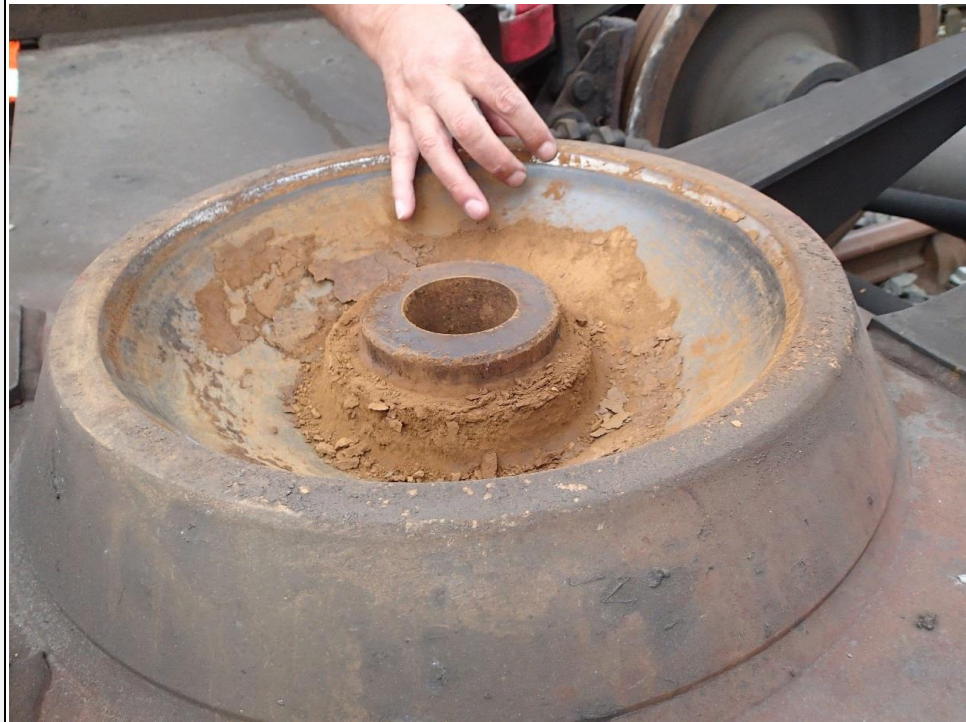
Figure 2: Centre pivot liner worn below level of steel rim, leading to contact between steel surfaces

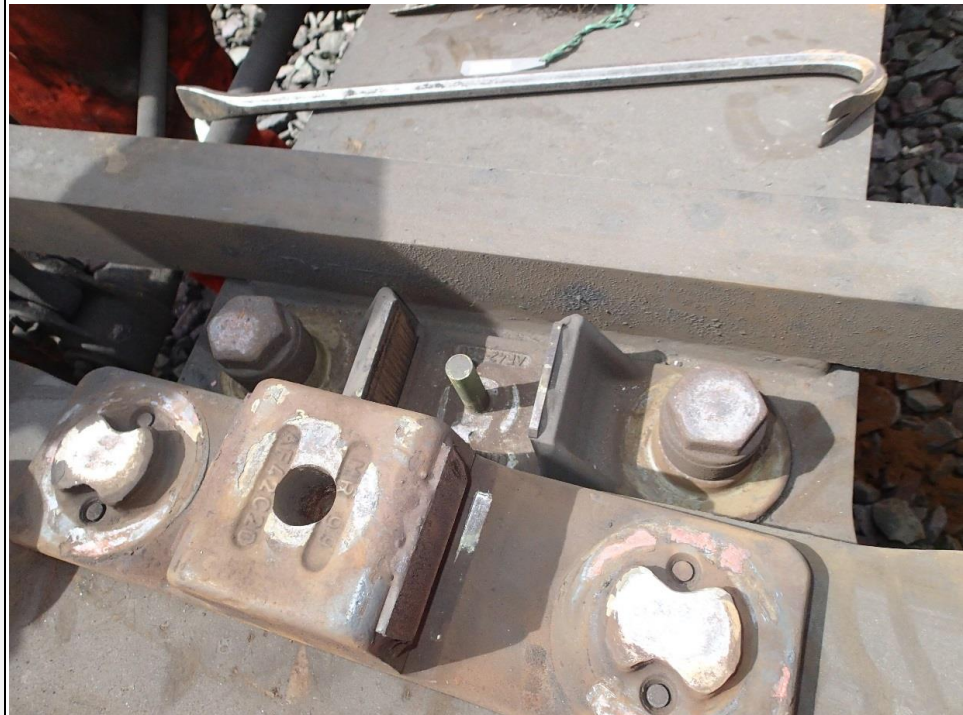
Figure 3: Sidebearer showing signs of frequent contact with end stops
