# Rail Accident Report

**Collision between a train and a fallen bridge  
parapet at Froxfield, Wiltshire  
22 February 2015**

Report 02/2016  
January 2016

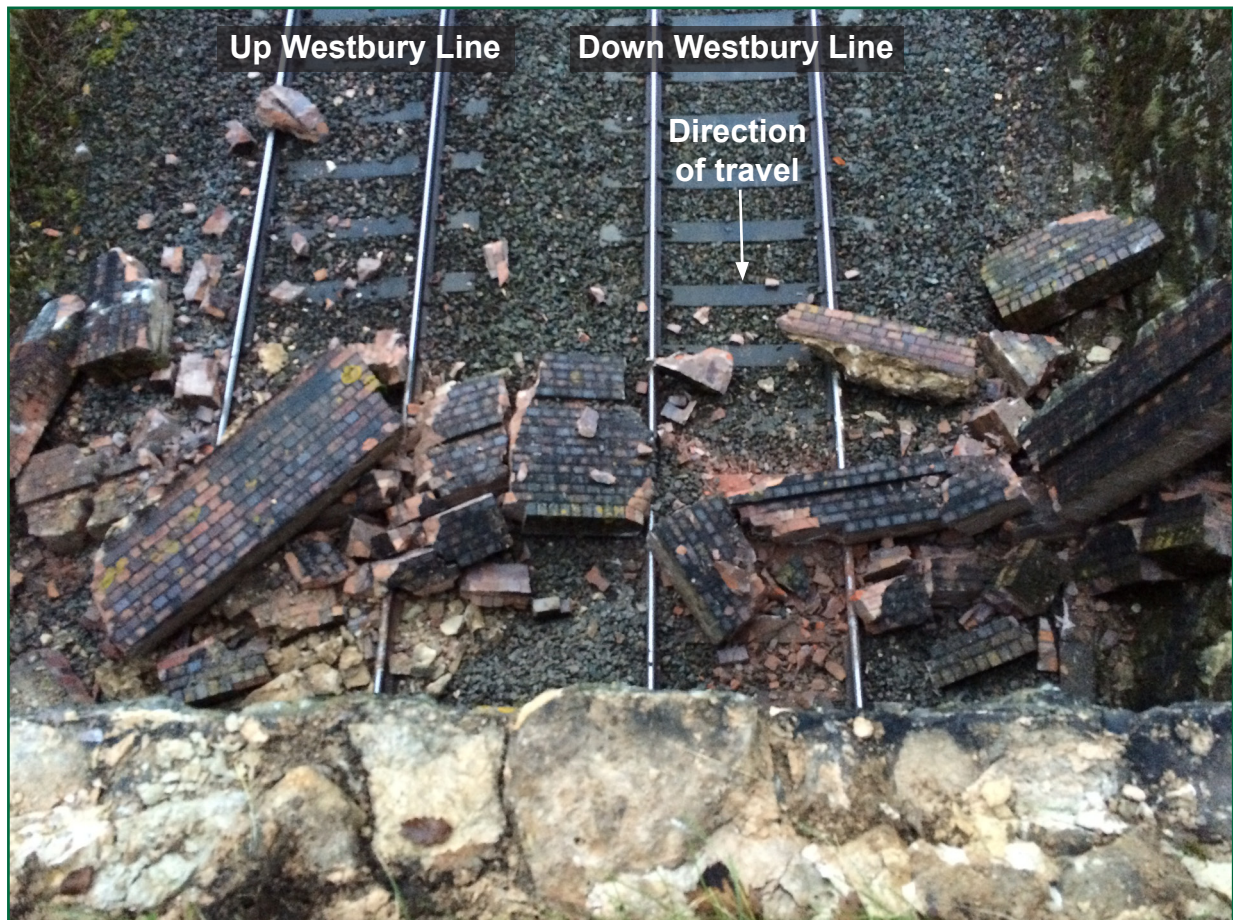
- 5 Eleven minutes before the train arrived at the bridge, a reversing articulated heavy goods vehicle (HGV) struck the eastern parapet of the bridge. The lorry driver had turned off the nearby A4 at the junction just north of the railway bridge, and crossed over the railway before encountering a canal bridge which he considered too narrow to pass. The lorry driver was attempting to reverse back over the railway bridge when the rear of his trailer struck the eastern parapet and pushed it off the bridge. The entire brick parapet, weighing around 13 tonnes, fell onto the railway, obstructing both tracks.

Figure 3: The fallen parapet on the tracks just before the collision (image supplied by Mr John Brown)

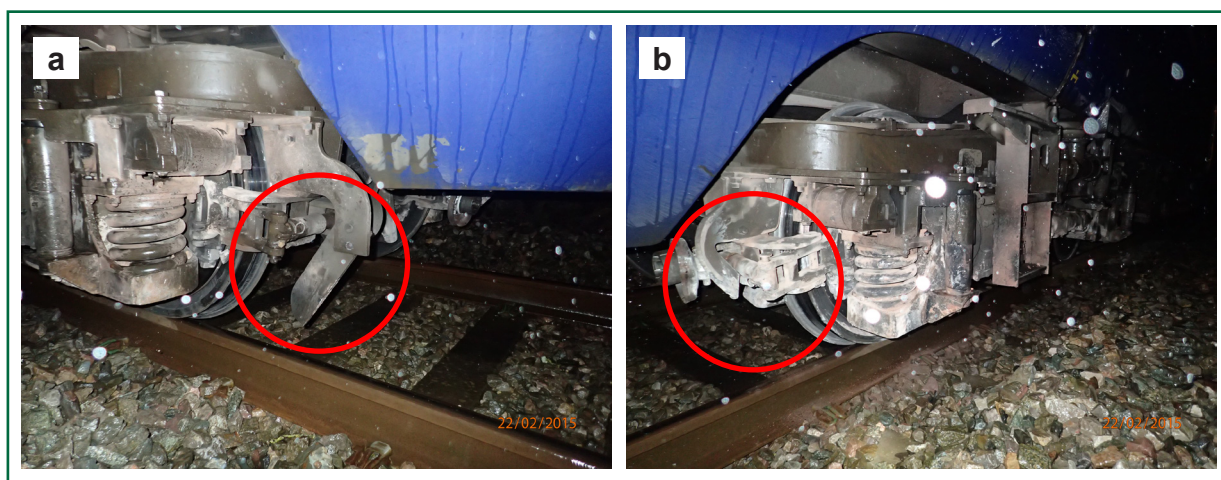
- 19 In the collision with the parapet debris, the leading power car suffered significant damage, as follows:
- both *lifeguards* were bent back and the left-hand lifeguard became detached (figure 6);
  - braking system components on the leading bogie were severely damaged resulting in a complete loss of air in the braking system which rendered the train immovable;
  - the aerial for the *train protection and warning system* (TPWS), which was mounted on the leading bogie, was knocked off; and
  - there was impact damage to the axles, wheels, and various other running gear and underframe equipment.

Figure 6: The damaged right-hand (a) and missing left-hand (b) lifeguards of the leading power car

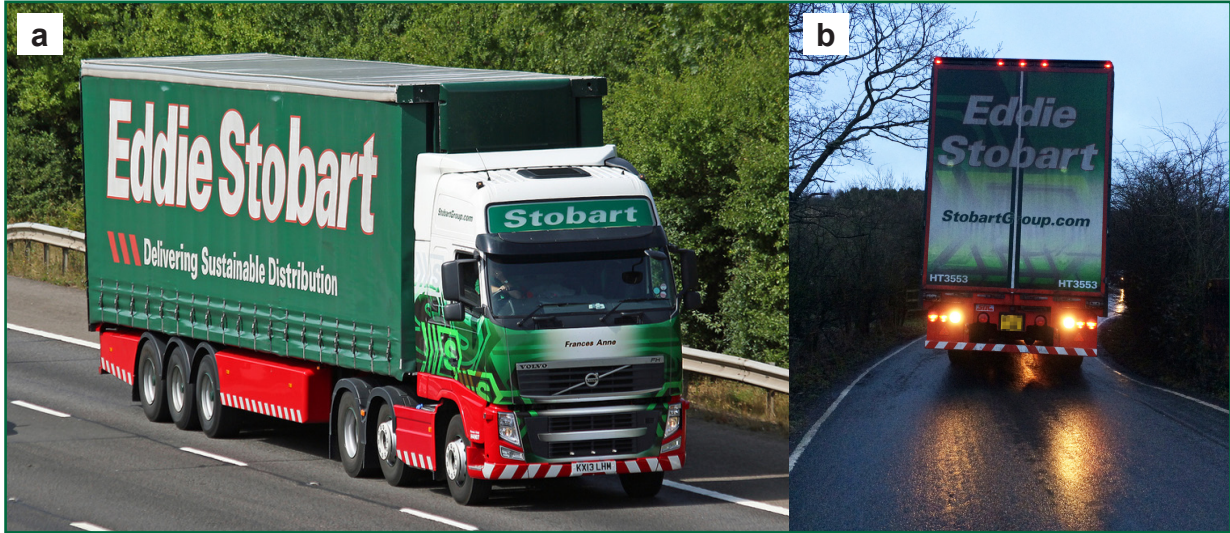
Figure 7: An HGV of the type involved in the accident (a) and the HGV on Oak Hill Road after the accident (b). (Left-hand image courtesy of Mr Paul Evans, right-hand image supplied by Mr John Brown.)

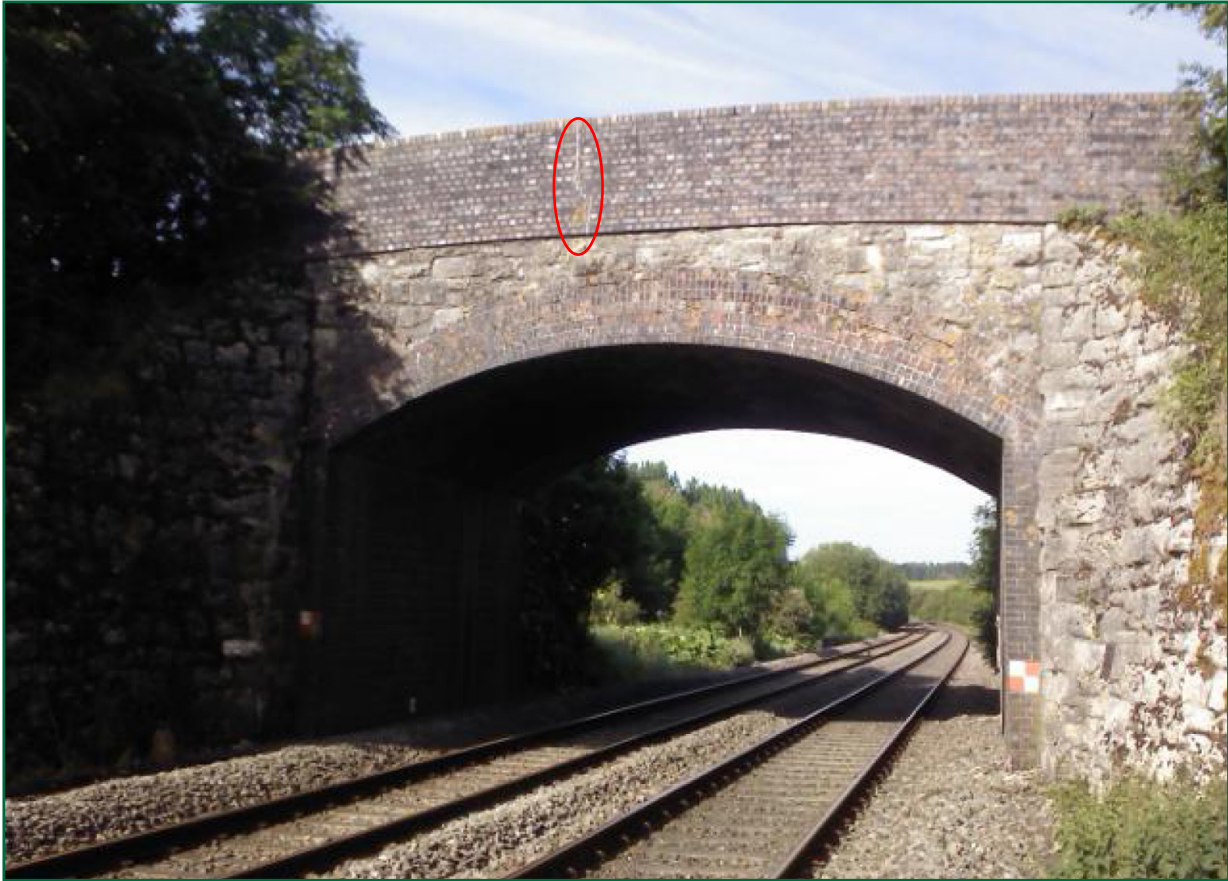
- 53 The first detailed examination for which records are available took place in April 2001. It noted that there were full height vertical cracks in the eastern parapet on each of the road and track faces around 1 - 2 mm in width and located about 5 metres from the down side end (figure 8). Similar cracks were also noted on the western parapet. The examination also found that both parapets were leaning outwards (by between 10 - 15 mm over a measured height of 900 mm) along their length. The last detailed examination in August 2006 also examined the cracks in the parapets. No deterioration in the condition of these cracks was noted and no repairs to these cracks were recommended. Between the last detailed examination and the accident there had been eight visual examinations, none of which reported any deterioration of the cracks.

Figure 8: Crack in the eastern parapet (circled) as recorded in Network Rail's visual examination report of 12 June 2014

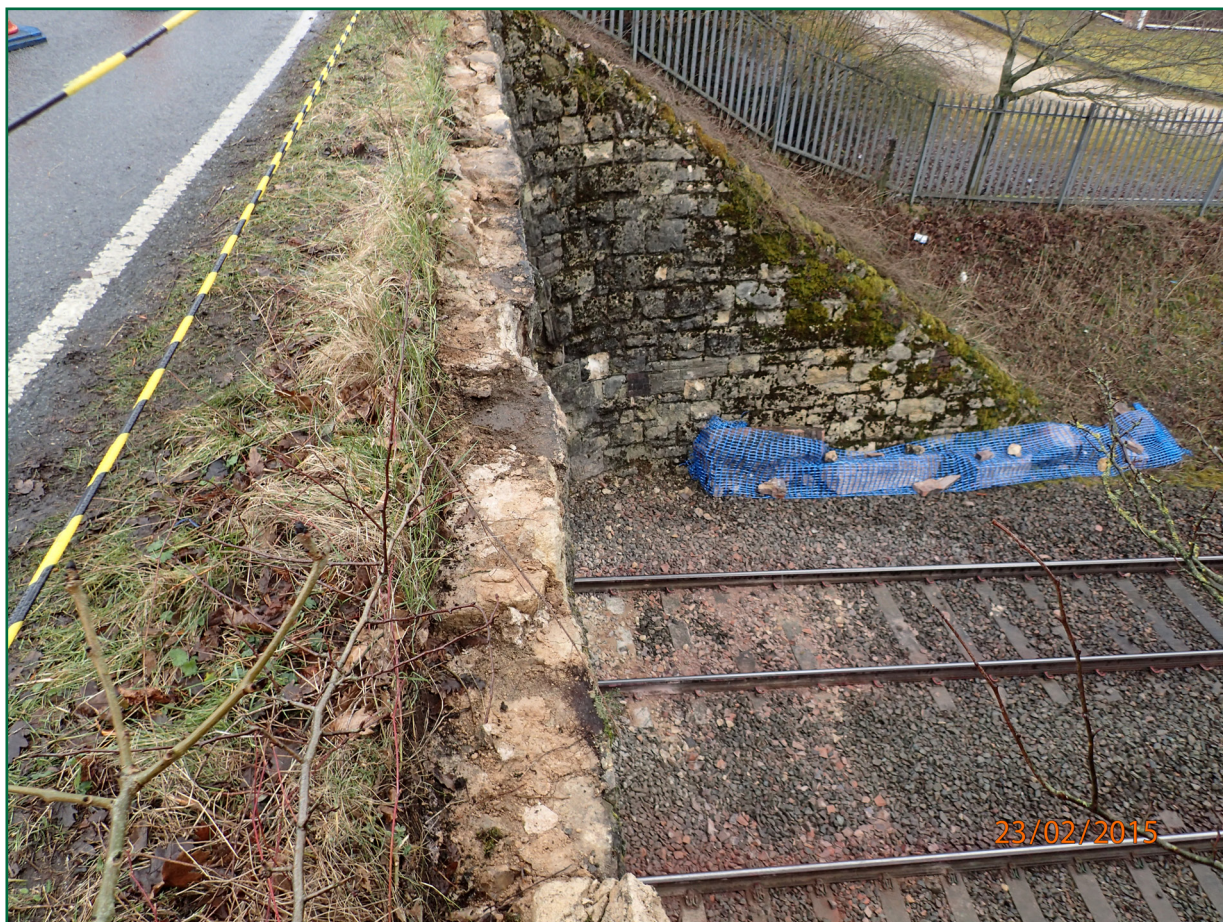
- 54 The parapets on Oak Hill Road overline bridge were constructed from bricks, bedded down with mortar onto the stone blocks of the bridge *spandrel*. There was no steel reinforcement to the wall nor any steel anchors to tie the base of the parapet down to the spandrel. The parapet, which was constructed as part of the original bridge in 1847, was intended to prevent pedestrians, livestock and horse drawn carts from falling onto the railway. Its ability to contain impacts with road vehicles would be modest compared to a more modern reinforced parapet. To resist the force applied by an impacting road vehicle, the parapet would be reliant on a combination of the mechanical strength of the brickwork and its large mass.

- 55 Examination of the parapet debris and the top of the spandrel indicated that the mode of failure under the loading from the HGV was by toppling of the whole parapet about its base joint to the spandrel (figure 9). The HGV would have applied a concentrated load to the parapet at a height of around 1 metre above the road surface. The way in which the whole parapet, on both sides of the pre-existing crack (paragraph 53) toppled over, indicates that there was sufficient remaining structural connection between the parapet sections either side of the crack, to allow the force applied by the HGV to be transferred across the cracked section. Had the crack separated the parapet into two disconnected sections, only that section of the parapet that had been struck would have toppled over. Therefore, the mode of failure indicates that, for the loading applied by the HGV in this case, the pre-existing crack did not cause a premature failure of the parapet because the whole of the parapet mass and its connection to the spandrel was involved.

Figure 9: Location of failure of the parapet

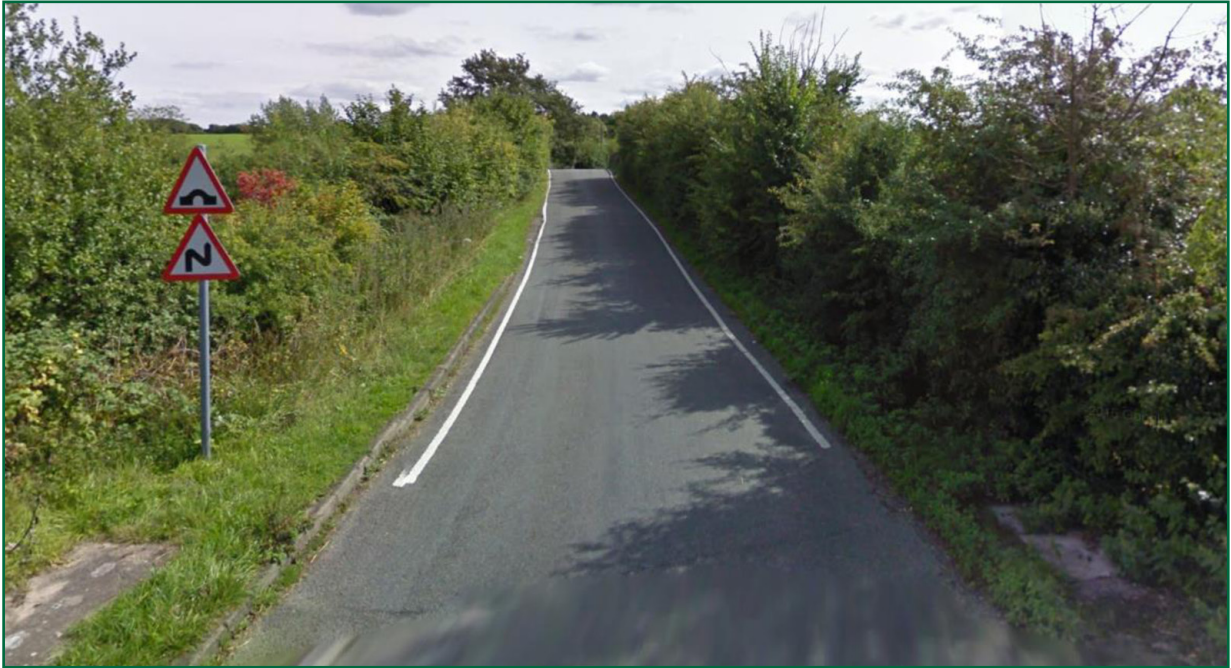
- 57 The entrance to Oak Hill Road from the A4 Bath Road is relatively wide compared to the width of the rail bridge (figure 2). There was no signage such as 'Unsuitable for HGVs' on the approach to Oak Hill Road from the A4 Bath Road and none just before the rail bridge. Furthermore, there was no signage on the approach to the rail bridge to warn drivers that the road narrowed further on. Had signage been in place, it is unlikely the driver of the HGV would have turned into Oak Hill Road and proceeded on to the rail bridge. The only signs that were in place on the approach to the rail bridge were a 'double bend' bend sign and a hump-back bridge warning (figure 10).

Figure 10: Extract from 'Google Street View', showing signage on the approach to Oak Hill Road overline bridge from the A4 Bath Road

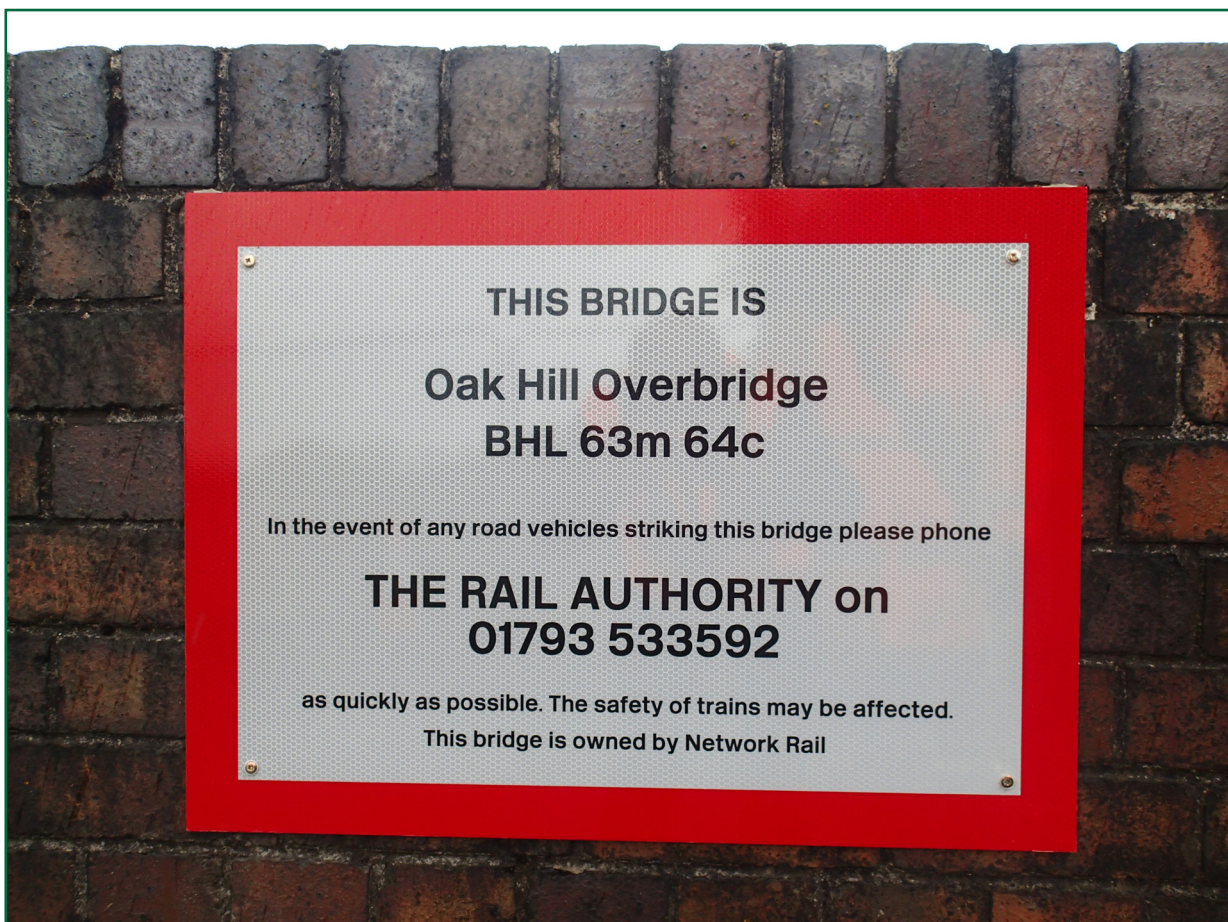
- 69 Identification plates like those now fitted to Oak Hill overline bridge following the accident (figure 11), provide details of the name of the bridge, its location (expressed as an *engineer's line reference* and mileage) and a telephone number to contact the relevant route control centre directly in the event of an emergency that endangers the safety of the railway. Had such plates been fitted to Oak Hill Road overline bridge at the time of the accident, the witness would have been able to contact Network Rail's Western Route Control directly, and the accident could have been averted. Given the witness's presence of mind throughout the incident, it is highly likely that he would have done so.

Figure 11: Bridge identification plate fitted to Oak Hill Road overline bridge after the accident
