## FLYER TO THE FISHING INDUSTRY

### *Good Intent* (SY79) and *Silver Dee* (B310): Collision & Sinking

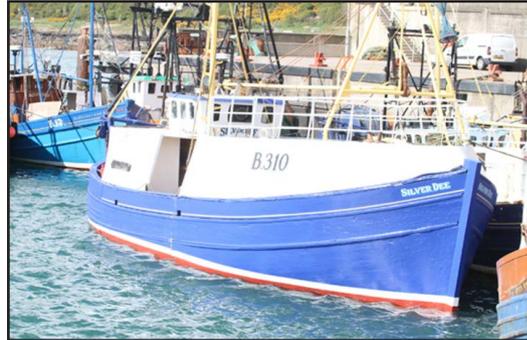
FV *Silver Dee*

*Silver Dee* struck *Good Intent's* port shoulder. *Silver Dee's* planking split either side of the stem and water flooded into the cabin space and quickly spread to the fish hold. *Good Intent* suffered only minor damage. The two vessels were manoeuvred alongside each other and *Silver Dee's* crew stepped across to *Good Intent*. *Good Intent's* skipper broadcast a DSC alert and informed Belfast Coastguard of the situation by VHF radio. *Silver Dee's* EPIRB and liferaft surfaced immediately after the vessel sank. There were no injuries.

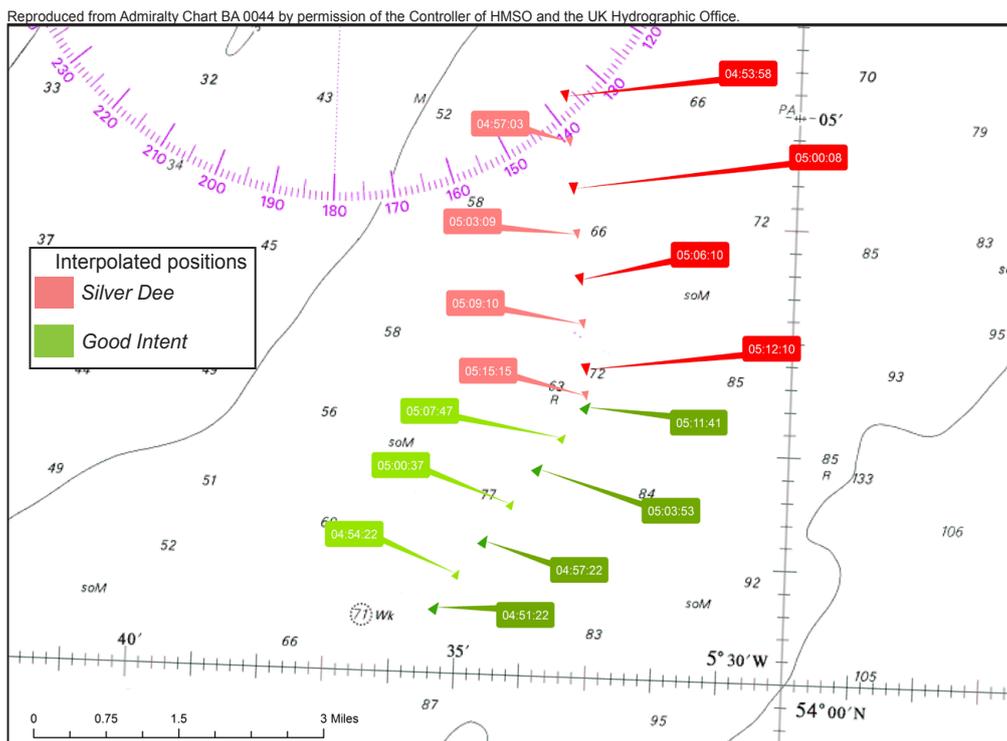
*Silver Dee* was heading towards fishing grounds to the south at 8kts. The skipper was alone, seated in the wheelhouse chair, and spent some time planning the day's fishing. He was not monitoring other vessels, and he did not see *Good Intent* until seconds before the collision.

*Good Intent* had been drifting overnight, and at 0430 got underway to re-position ready for the day's fishing. The vessel's watchkeeper had not been in the wheelhouse for much of the 45 minutes before the accident. He had not seen *Silver Dee* and, at 0510, having reached the

Figure 1: AIS tracks of *Silver Dee* and *Good Intent*

position marked by the skipper, he stopped *Good Intent* directly in its path when the vessels were only 0.6nm apart. *Good Intent's* watchkeeper then went to wake the skipper and crew. When he returned to the wheelhouse, he saw *Silver Dee* extremely close off the vessel's port side. Although he put the engine to full astern, it was already too late to prevent the collision.

- MGN 313 (F) Keeping A Safe Navigational Watch on Fishing Vessels contains excellent advice based on lessons learned from previous accidents. All skippers should be aware of its content.

- A vessel that is seen can be avoided. A vessel that isn't seen is an accident waiting to happen. Wheelhouse watchkeepers need to be well rested, alert and use all means available to keep a proper lookout.

- The wheelhouse is the best place to keep a navigational watch. Situations quickly change, and leaving the wheelhouse unattended is fraught with danger. Other jobs can wait or can be done by somebody else.

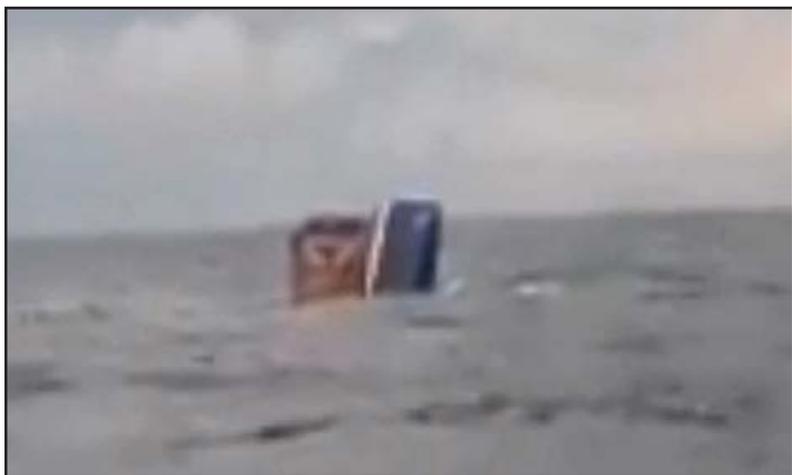
**Figure 2:** *Silver Dee* stern seconds before sinking

- Many older wooden fishing vessels do not have collision or other watertight bulkheads and are susceptible to rapid flooding and foundering if damaged.
