Collision between the fishing vessels *Silver Dee (B310)* and *Good Intent (SY79)* resulting in the foundering of *Silver Dee* Irish Sea 29 July 2015

SUMMARY

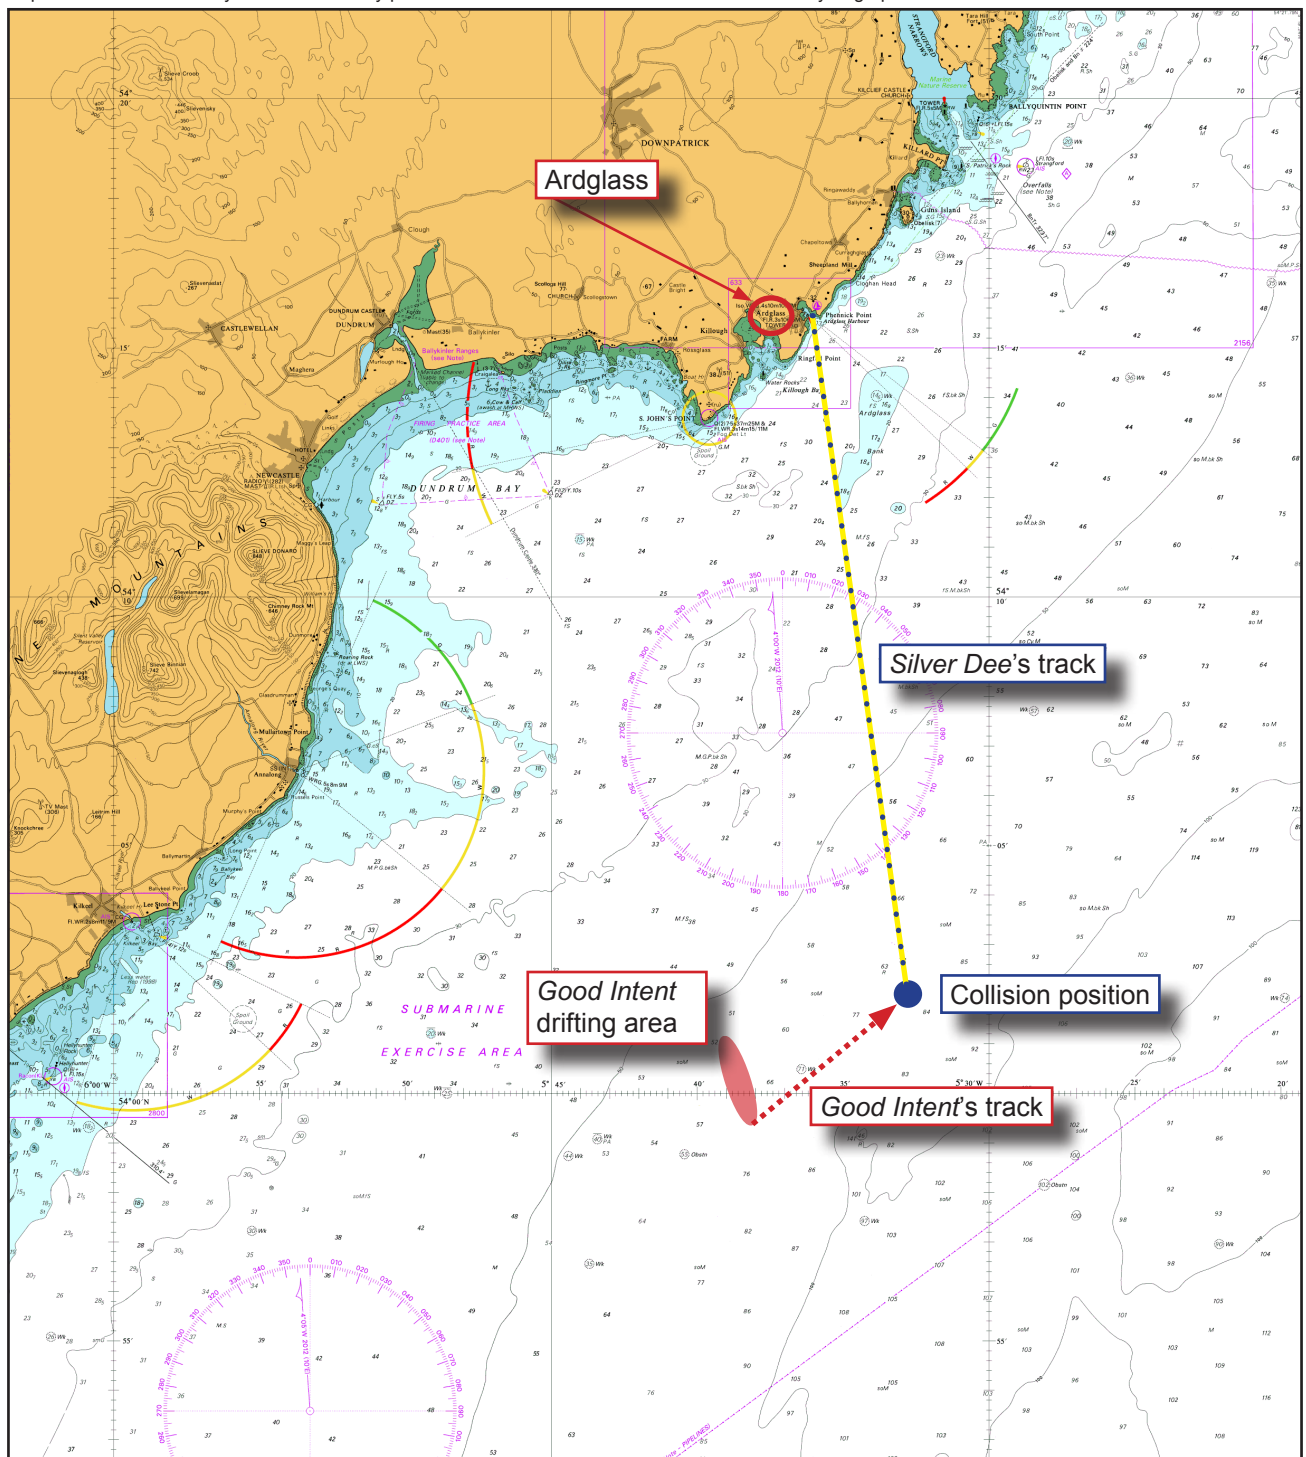
Figure 1: Extract from Chart 0044 showing tracks of *Silver Dee* and *Good Intent*

At 0330 (UTC+1)¹ on 29 July 2015, the stern trawler *Silver Dee* sailed from Ardglass, Northern Ireland, bound for prawn fishing grounds to the south (**Figure 1**). On board were the vessel's skipper and four deckhands. The wind was north-north-westerly between 7 and 10 knots, the sea was slight and the visibility was good. It was dark, and *Silver Dee*'s deck and navigation lights were on.

Meanwhile, the stern trawler *Good Intent* was drifting 17nm south of Ardglass (**Figure 1**). The vessel's navigation and deck lights were on and its engine was running in 'idle' but it was not in gear. The bosun (senior deckhand) was on watch. He spent much of his time on the deck or inside the accommodation but periodically visited the wheelhouse to check for other vessels in the vicinity. The skipper and the vessel's other four deckhands were asleep in their bunks.

At 0430, *Good Intent*'s bosun went to the wheelhouse and checked visually and by radar that no other vessels were close by. He then put the engine to 'full ahead' and selected autopilot controlled steering. *Good Intent* was soon making good a course of approximately 040° at 7.3kts (**Figures 1 and 2**). The vessel was heading towards a position about 5.6nm to the north-east that was marked by a cursor on a chart plotter. The bosun had been instructed by the vessel's skipper to be in that position at 0515 to start the day's fishing. The bosun then left the wheelhouse to prepare the fishing gear. He kept a lookout from the deck but occasionally visited the wheelhouse to check the vessel's progress.

At 0430, the distance between *Silver Dee* and *Good Intent* was 9.25nm and closing (Figure 1). The visibility was good and the vessels were displaying navigation and deck lights. Therefore, by the time the vessels had closed to 3nm at about 0500, they would have been in sight of each other and showing on the radar displays. At that point, if both vessels had maintained their courses and speeds *Good Intent* would have passed between 0.6nm and 0.8nm ahead of *Silver Dee*.

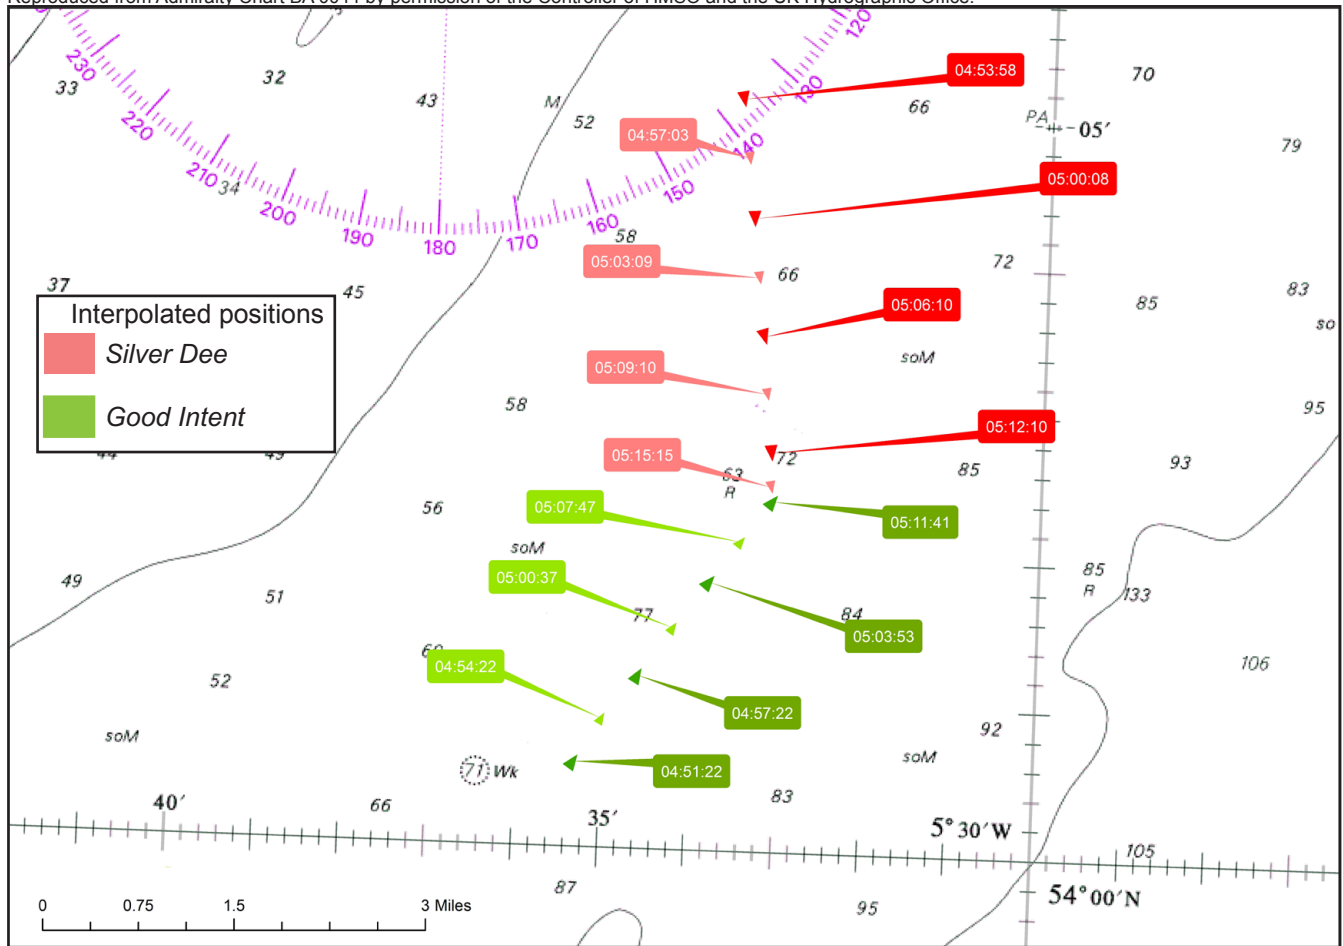
Figure 2: AIS tracks of Silver Dee and Good Intent

At about the same time, *Silver Dee's* skipper saw *Good Intent* immediately ahead. The vessels collided before he had time to react; *Silver Dee's* bow struck *Good Intent's* port shoulder.

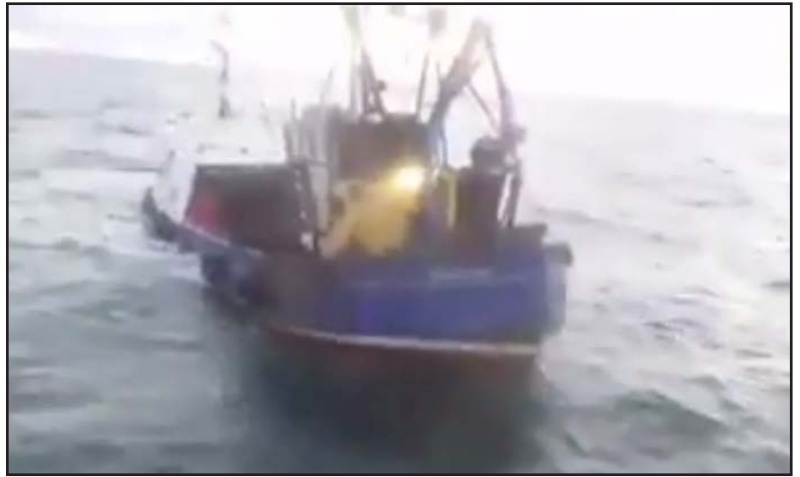
Figure 3: *Silver Dee* after abandonment

informed Belfast Coastguard on VHF radio that both vessels' crews were safe and uninjured. He also advised the coastguard that *Good Intent* did not appear to be in immediate danger. Over the next few minutes, *Silver Dee* slowly submerged (**Figure 3**) and eventually sank at about 0545 (**Figure 4**). Shortly afterwards, the vessel's Emergency Position Indicating Radio Beacon floated to the sea surface and started transmitting. Its liferaft also released and inflated.

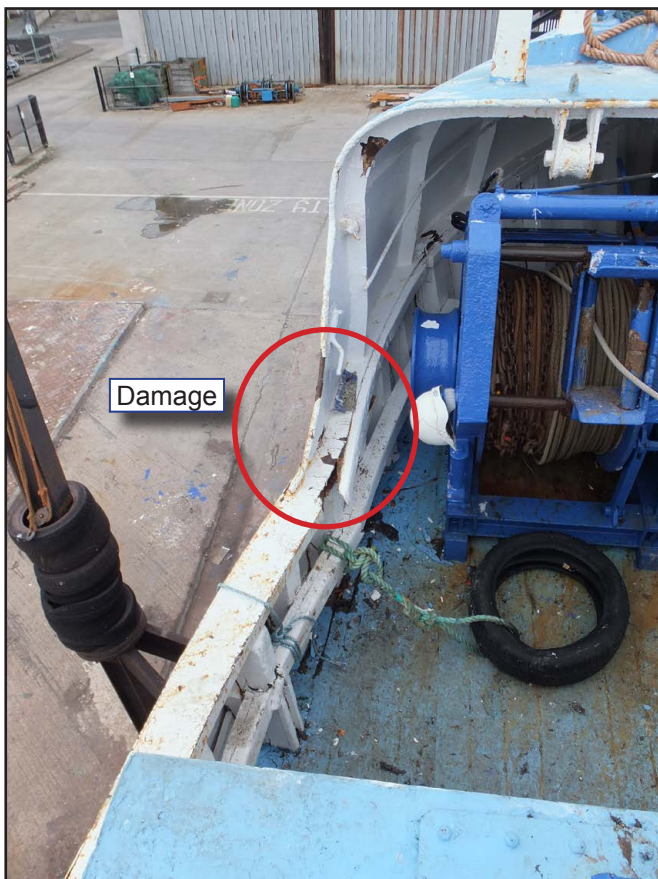
Figure 5: Damage to port shoulder of *Good Intent*

Good Intent proceeded to Ardglass where *Silver Dee*'s crew disembarked. Inspection in port established that *Good Intent* had suffered damage to steelwork and planking on its port side (**Figure 5**).

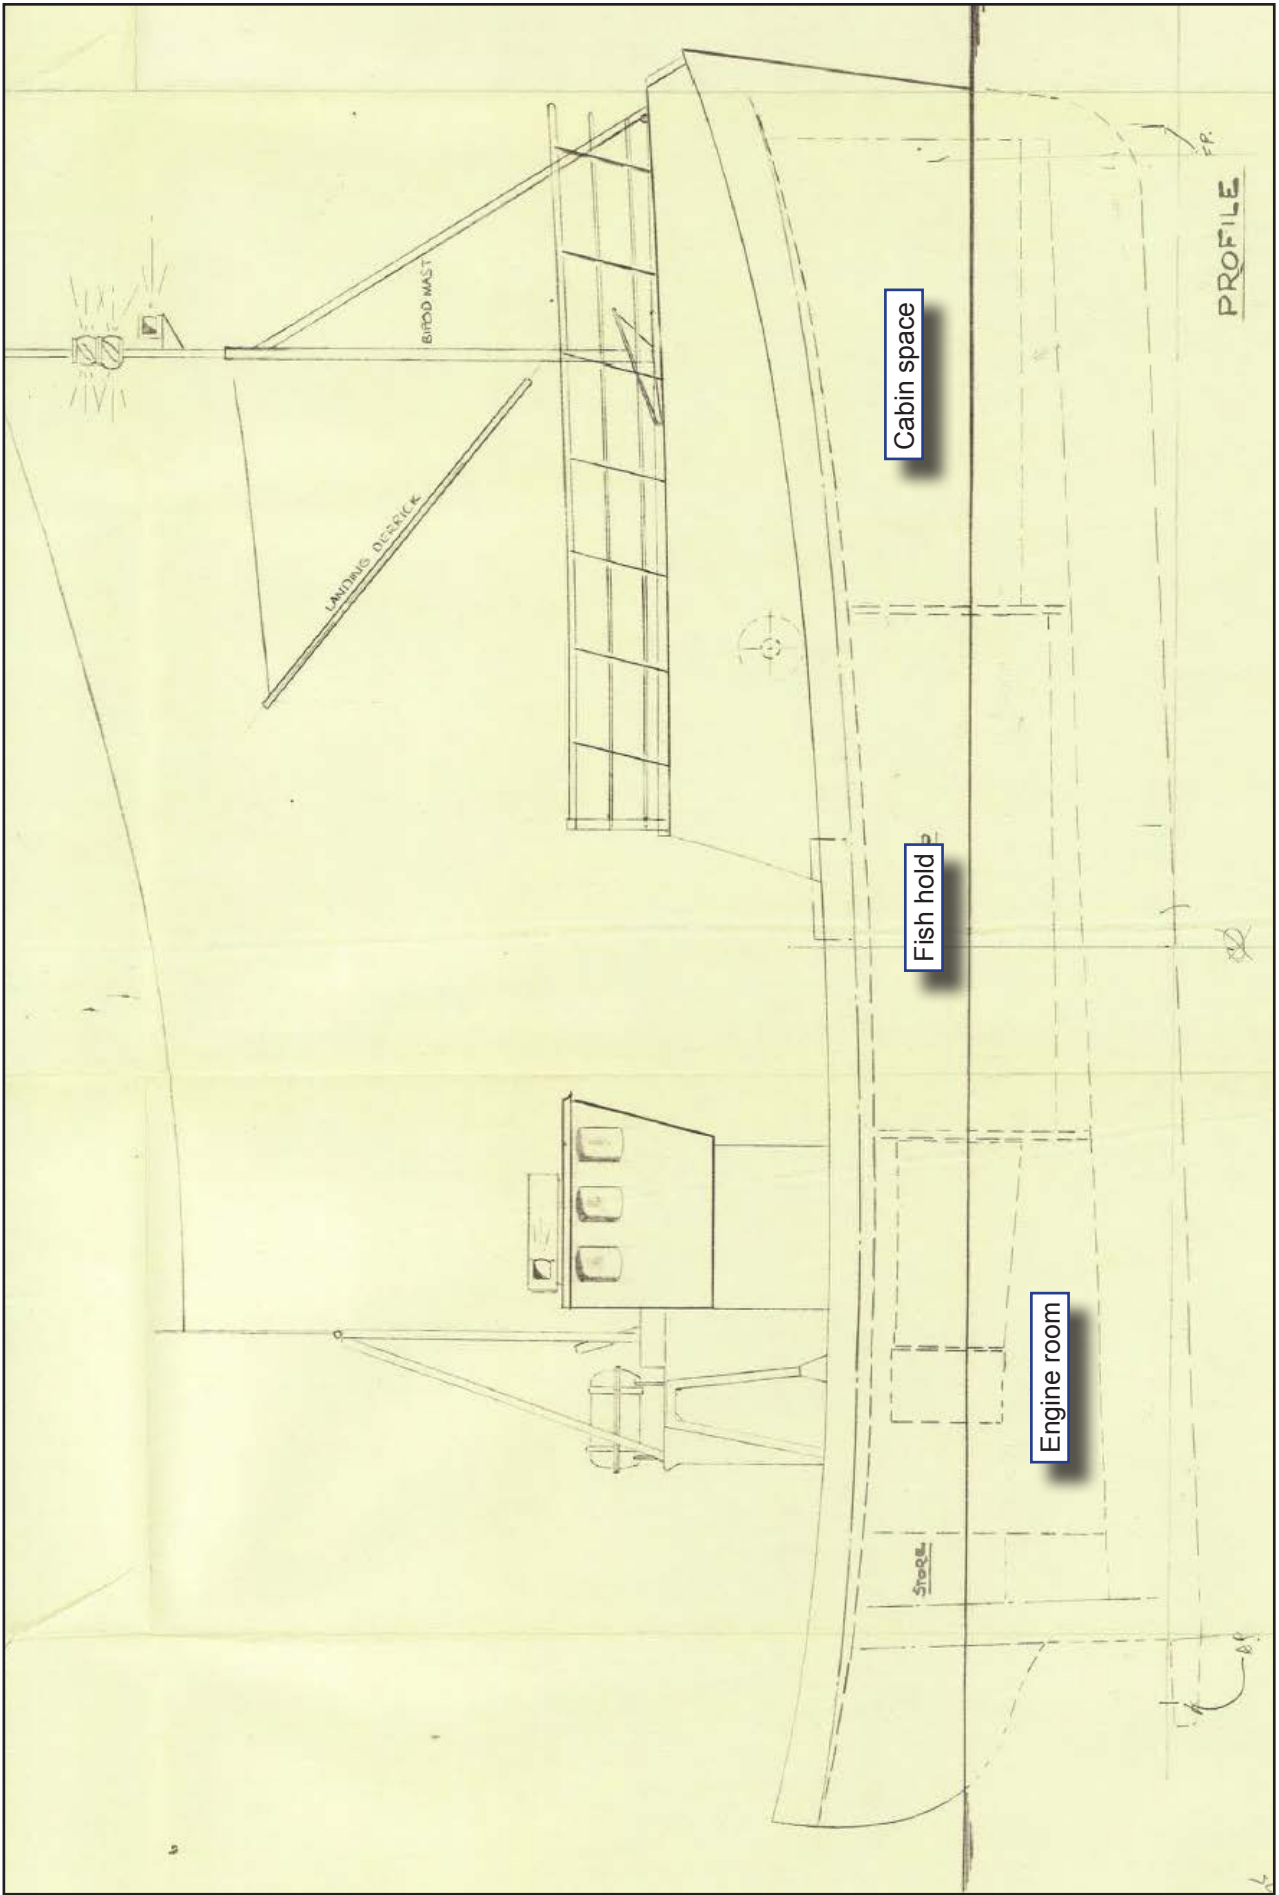
Figure 6: Silver Dee side profile

Silver Dee and *Good Intent* were wooden, twin-rigged stern trawlers. *Silver Dee* was 18.54m in length and was built in 1971. *Good Intent* was 18.21m in length and was built in 1981. Both vessels complied with the requirements of The Fishing Vessels (Safety Provisions) Rules 1975. *Silver Dee* had three main compartments below the waterline; the cabin space, the fish hold and the engine room (**Figure 6**). The vessel was not fitted with a collision bulkhead or any other watertight bulkheads.

Silver Dee's rapid flooding was due to its lack of a collision bulkhead and other watertight subdivisions. Floodwater was able to rush through the damaged planking at the stem and then spread quickly through the vessel.

Since the Fishing Vessels (Safety Provisions) Rules 1975 were introduced, there have been numerous changes to the construction requirements applicable to new vessels; *Silver Dee* did not have to meet these revised requirements due to "grandfather rights"⁹. Had *Silver Dee* been constructed today, it would be required to be fitted with a collision bulkhead and watertight bulkheads either side of the engine room. Specifically MSN 1770 (F)¹⁰ states:

In vessels constructed of wood, a collision bulkhead and bulkheads at the fore and aft ends of the machinery space, should be provided. The after bulkhead of the machinery space may terminate on a horizontal, flat that extends aft to the stern, above the line of shafting. The bulkheads and flat referred to in this section should be of adequate strength and gasketed and/or caulked to prevent significant leaks or flooding.

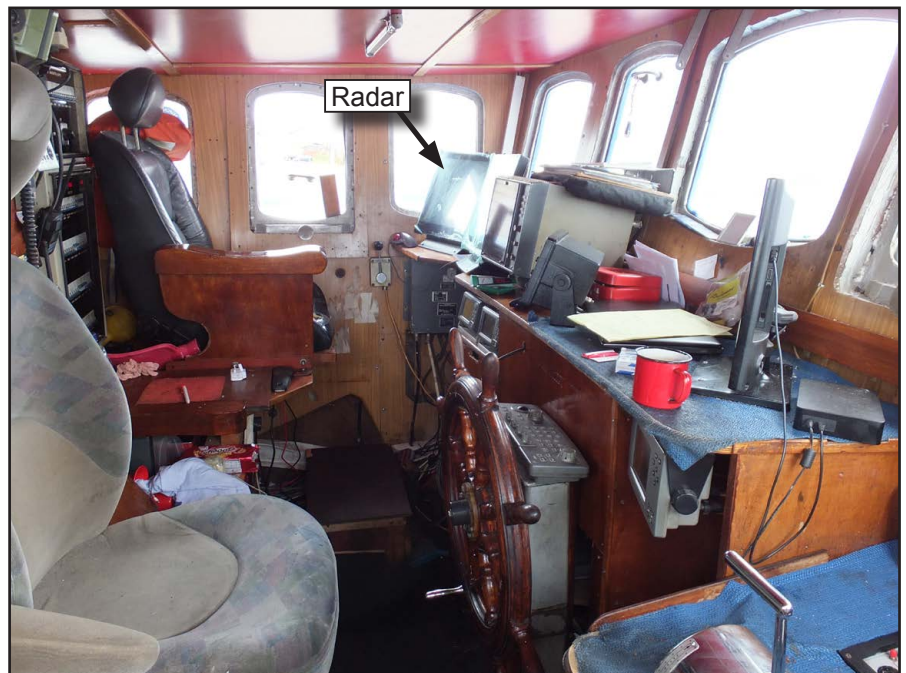
Figure 7: *Good Intent's* wheelhouse

The wheelhouses of *Silver Dee* and *Good Intent* were similarly equipped with two plotters, a radar display, an echo sounder, two VHF radios, two GPS⁷ receivers, an AIS⁸ and an autopilot. The vessels' AISs were not integrated with the radar displays or the plotters. Before the collision, *Silver Dee's* skipper had switched the radar display between the 3nm and 6nm range scales; *Good Intent's* radar display was set on the 3nm range scale. No watch alarm was fitted on board either vessel. *Silver Dee's* wheelhouse had a chair located on the centreline. Two chairs were fitted in *Good Intent's* wheelhouse, one either side of the centreline (Figure 7).

However, it would have been almost impossible for the bosun to enter the wheelhouse, look at the plotter and adjust the engine control lever without looking out of the windows with peripheral vision. Therefore, it is likely that the bosun did not notice *Good Intent* because the vessel was obscured from his view by either the port side wheelhouse chair, the radar display or a window frame (**Figure 7**).

- 106/2016** Take steps to improve the standard of watchkeeping on board vessels they are in charge of in the future, taking particular account of the guidance contained in MGN 313 (F) - Keeping a Safe Navigational Watch on Fishing Vessels.

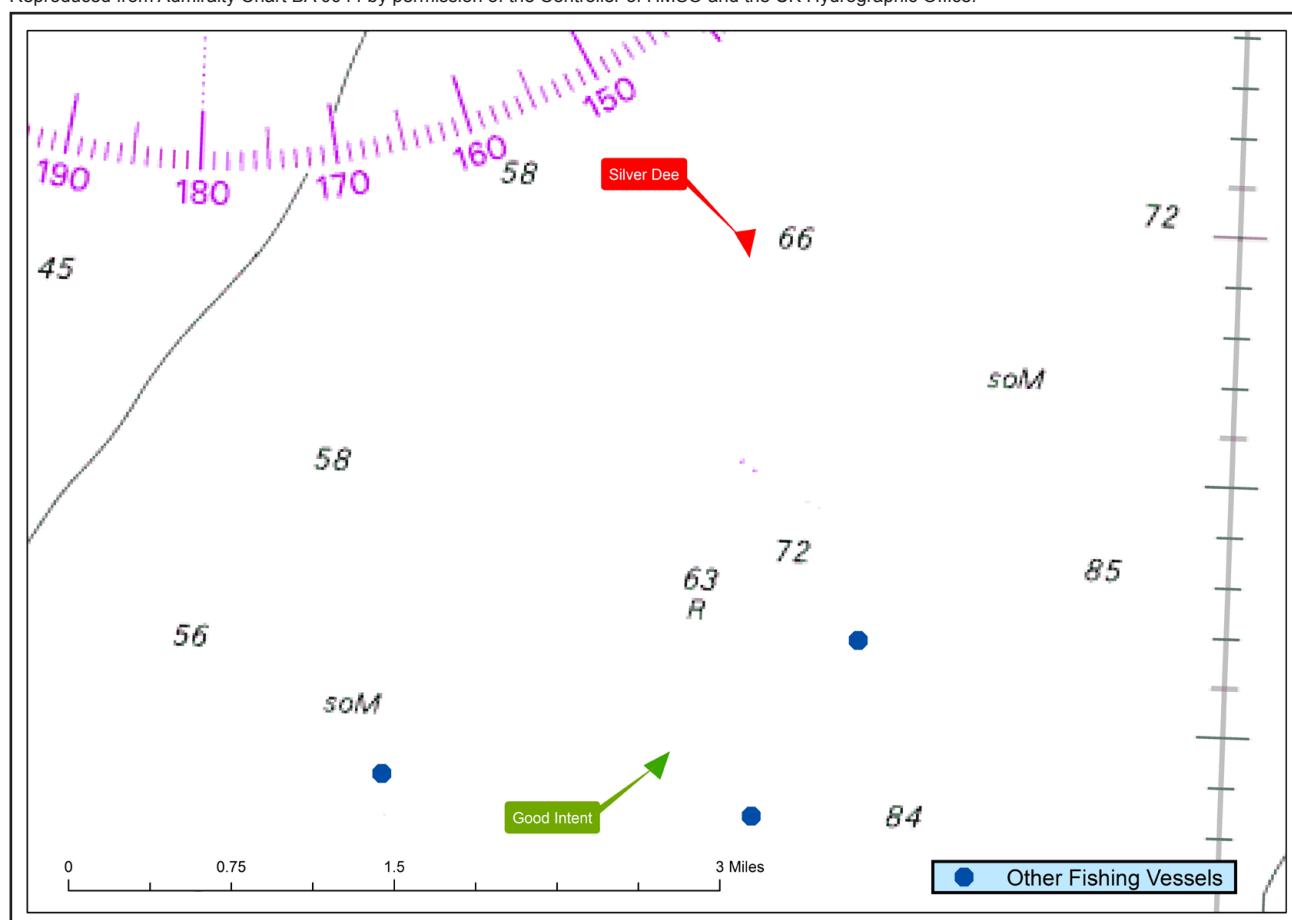
Figure 8: Disposition of vessels at 0500

Throughout the passage, the skipper was seated in the wheelhouse chair and appears to have been relatively inactive. He was 'relaxed' about other nearby fishing vessels heading in a similar direction, which was a routine occurrence, and he did not monitor their movement. At 0500, *Good Intent* was one of four fishing vessels within 3nm that were ahead of *Silver Dee* (**Figure 8**) but the skipper did not notice that *Good Intent* was moving to the north-east. Such movement would have been readily apparent by radar and by sight, as *Silver Dee*'s port navigation light would have been visible.
