FLYER TO THE FISHING INDUSTRY

***Kairos* (BF190): Capsize and sinking on 18 May 2015**

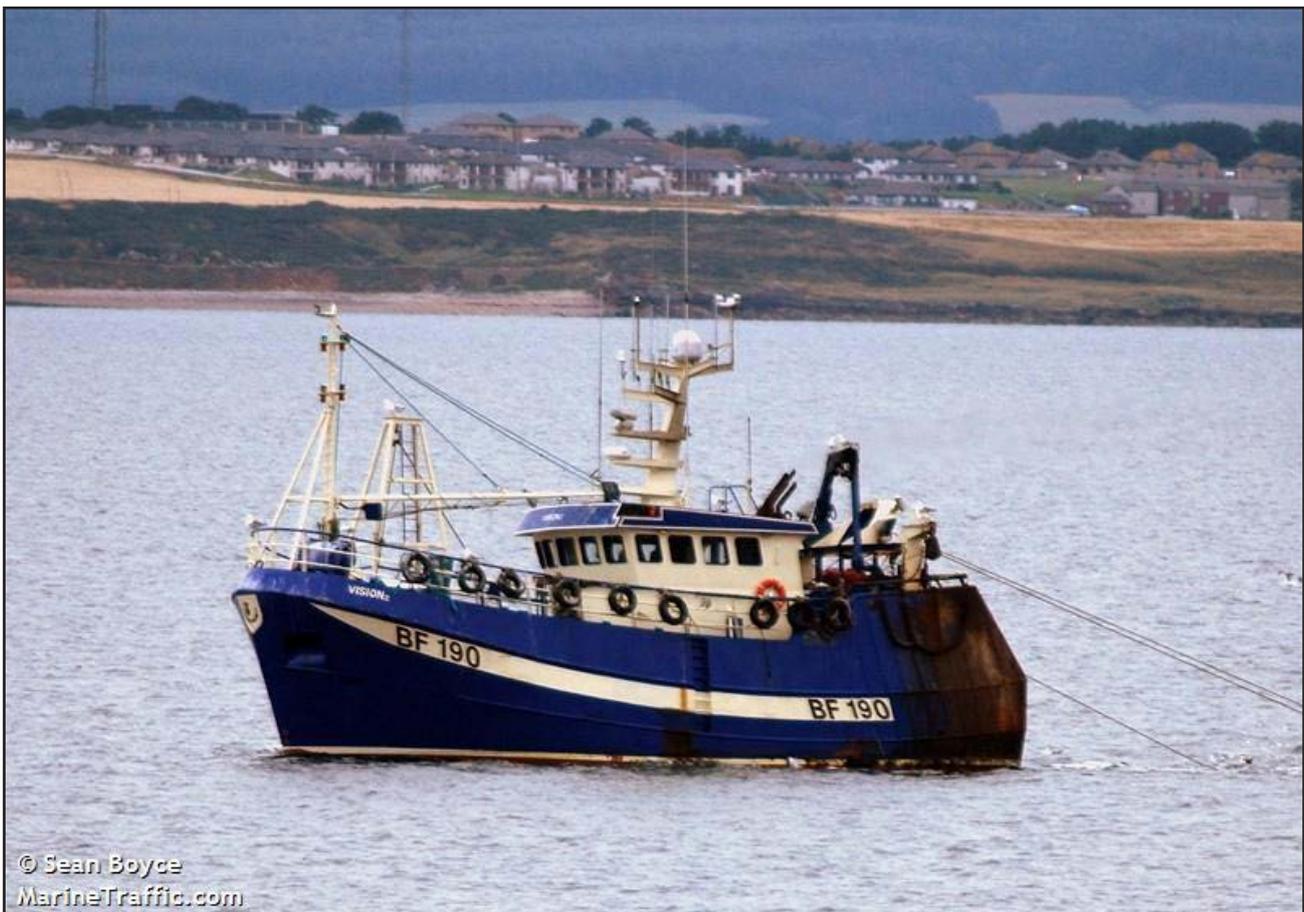
Photograph of *Kairos*
