CONTENTS**SPECIAL BULLETINS / INTERIM REPORTS**

AAIB FIELD INVESTIGATIONS**COMMERCIAL AIR TRANSPORT****FIXED WING**

BAe 146-200	G-RAJJ	23-Feb-15	3
-------------	--------	-----------	---

Aircraft Type and Registration:	BAe 146-200, G-RAJJ
No & Type of Engines:	4 ALF502R-5 turbojet engines
Year of Manufacture:	1988 (serial number E2108)
Date & Time (UTC):	23 February 2015 at 1854 hrs
Location:	Guernsey Airport, Channel Islands
Type of Flight:	Commercial Air Transport (Passenger)
Persons on Board:	Crew - 4 Passengers - 47
Injuries:	Crew - None Passengers - None
Nature of Damage:	Shock absorber damaged beyond economic repair, damage to left main landing gear and No 1 tyre burst
Commander's Licence:	Airline Transport Pilot's Licence
Commander's Age:	58
Commander's Flying Experience:	8,428 Hours (of which 5,300 were on type) Last 90 days - 32 hours Last 28 days - 23 hours
Information Source:	AAIB Field Investigation

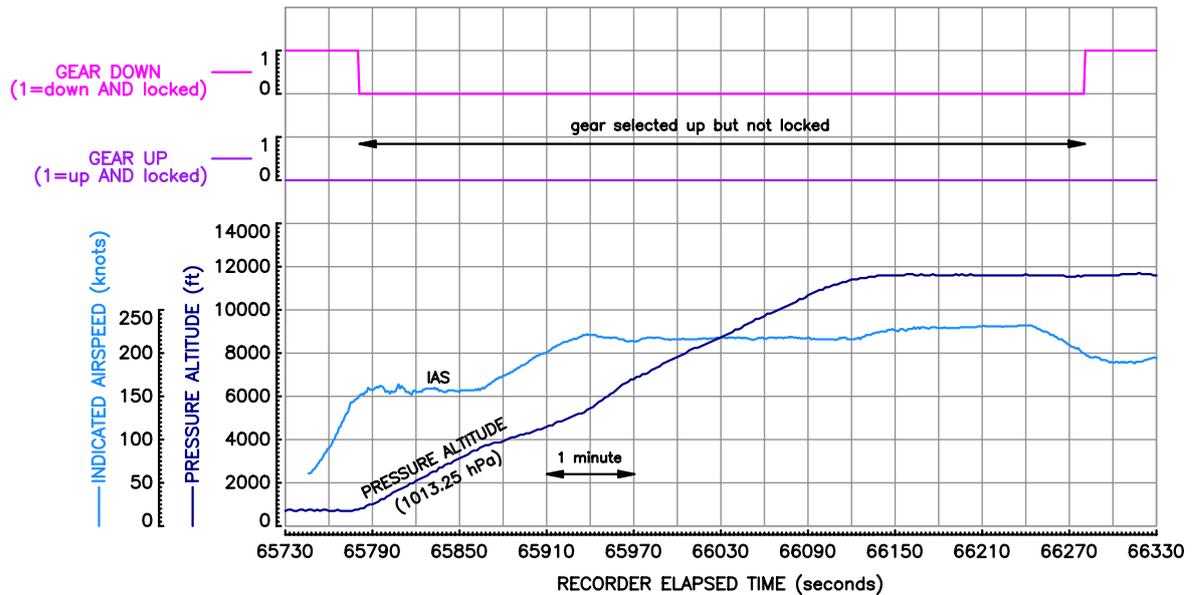
Figure 1

A time history of the salient parameters from the QAR for the takeoff from Gatwick Airport is shown at Figure 1. The data shows that during the climb, at between 75 ft and 99 ft agl, the landing gear was no longer down-and-locked, which was consistent with the gear selector

being moved to the UP position. However, the landing gear did not go into the up-and-locked position, which was consistent with the position indicators showing red. The gear returned to the down-and-locked position just over eight minutes later, when the aircraft was at about FL120, which was consistent with the gear selector being moved to the DN position and the position indicators showing green. The landing gear remained in this state for the rest of the flight.

G-RAJJ salient flight data from QAR

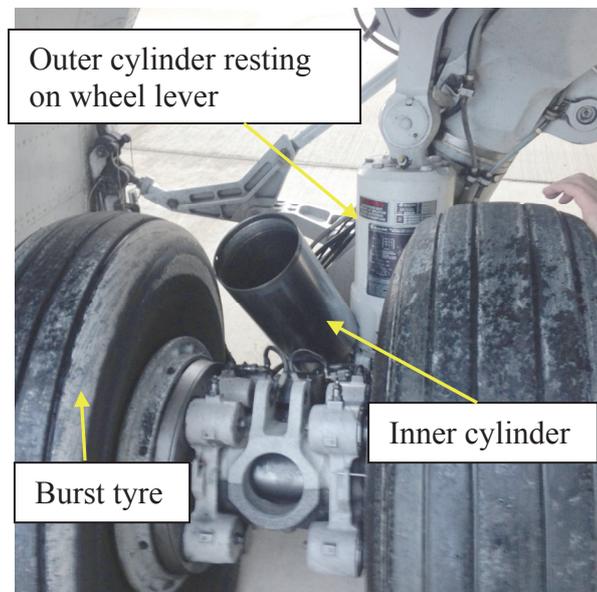
Figure 6
Left main landing gear

Following the accident the shock absorber inner cylinder was found to have separated from the outer cylinder, Figure 6. The top surface of the wheel lever had sustained damage as a result of contact with the outer cylinder. The inner cylinder had made contact with the No 1 brake pack Green hydraulic system quick release pipe, causing it to detach from its connecting union. The operator's engineers later established that the Green hydraulic system had only lost one litre of fluid.

The inner cylinder also rubbed against the inner sidewall of the outer tyre (No 1 mainwheel), which had punctured and deflated. The frame, which runs down the centre of the lower fuselage between the main landing gear bays, had been damaged. Tyre marks indicate that the No 2 mainwheel caused this damage during the retraction sequence. The sheared bolt head attached to a long section of locking wire recovered from the runway was identified as being from one of the shock absorber diaphragm locking bolts. There was no damage to the bottom of the wheel lever.

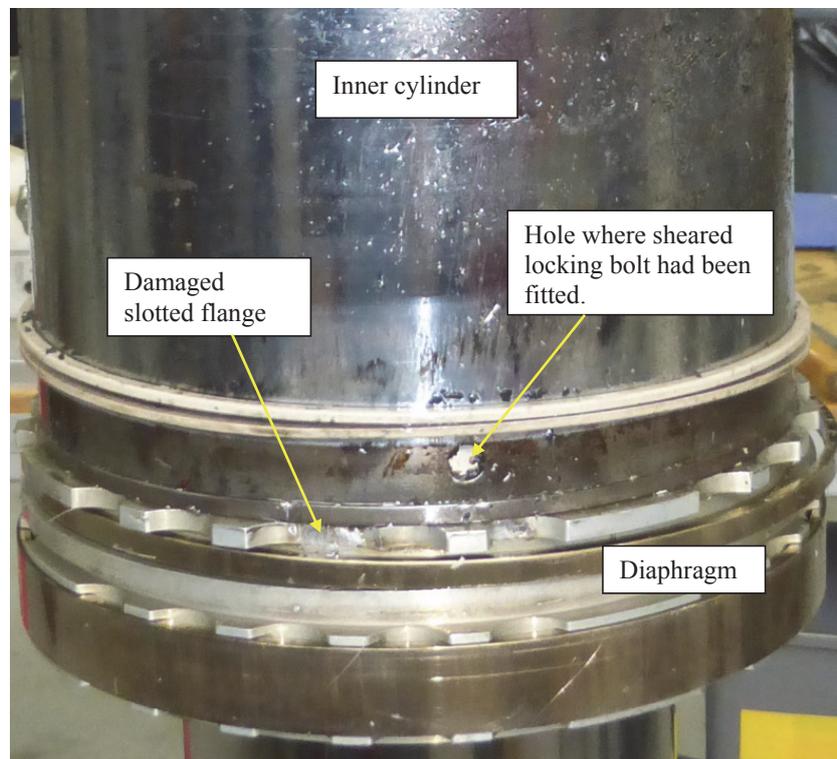
Figure 7
Inner cylinder and diaphragm

- The threads on the inner cylinder (steel) were found to be intact, whereas the threads on the diaphragm (aluminium alloy) had sheared in a direction consistent with a compressive load forcing the diaphragm and inner cylinder together.

- One of the slotted flanges had broken away from the diaphragm. It was concluded from the damage to the flange that the sheared diaphragm locking bolt head had become trapped between the flange and the outer cylinder bore causing the flange to break, Figure 7.

- Mechanical damage on the diaphragm, shim, recoil ring and outer cylinder, was assessed as having been caused by the bolt head, which suggests that the locking bolts had sheared some cycles before separation of the shock absorber.

- One small area of fatigue cracking was seen in the threads on the diaphragm, in the first full thread immediately below one of the locking bolt holes. The cracking consisted of two fatigue cracks, one on each side of the thread. This damage was consistent with the threads on the diaphragm and inner cylinder having been cyclically loaded in both tension and compression.
- The hardness of the diaphragm and inner cylinder materials were within specification. The locking bolt hardness was slightly above specification, but this is not thought to have contributed to its fracture, or separation of the shock absorber.
- The material microstructures of the diaphragm and inner cylinder were normal.

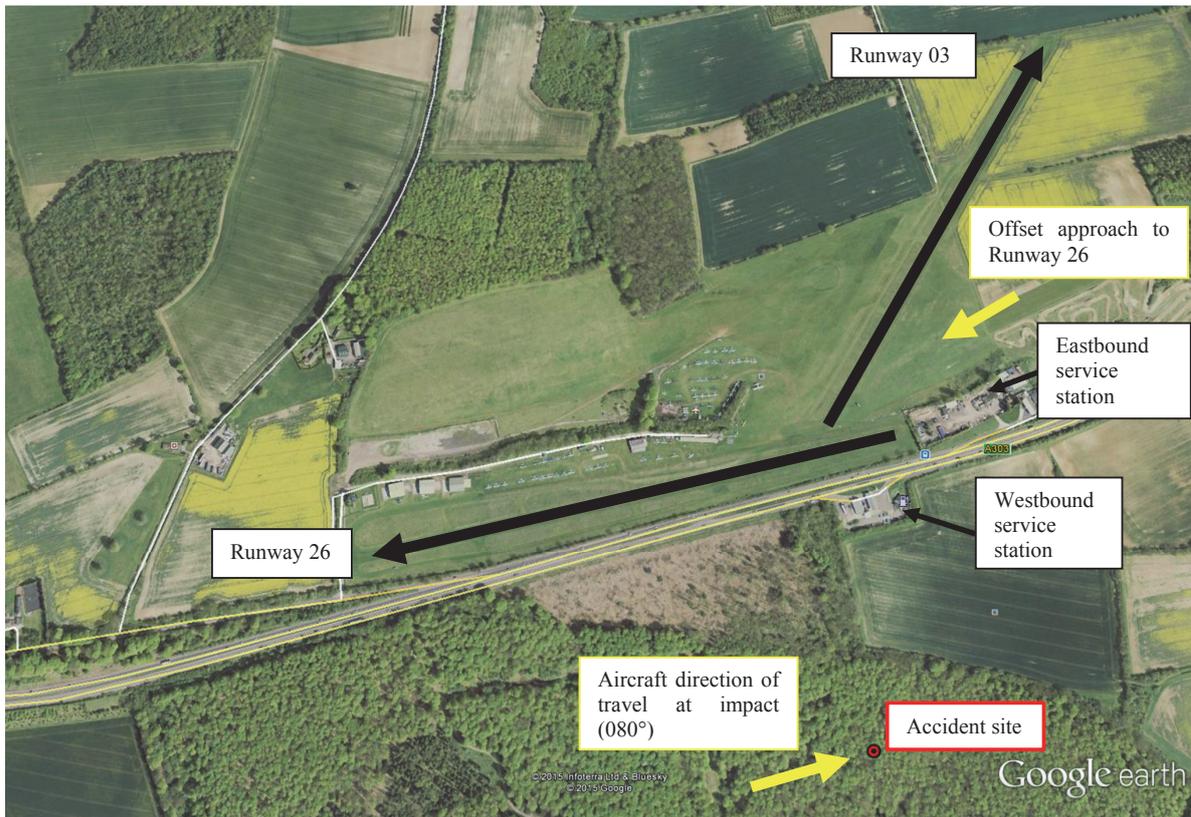
Figure 1

At approximately 1525 hrs a motorist who was driving west on the A303 road (Figure 1), briefly observed the aircraft heading towards the airfield at low level. He believed it to be north of the road and presumed it was approaching to land on the westerly runway (Runway 26).

The aircraft came to rest in woodland approximately 350 m south of the service station on the westbound carriageway of the A303. The initial contact point of the aircraft was identified by damage marks on a large tree approximately 60 ft above the ground, with material from the aircraft wing retained in the branches. Roughly half the right wing had detached from the aircraft and was scattered between the base of this tree and the location of the main fuselage 40 m away on a bearing of 080°. A second tree adjacent to the main wreckage also exhibited a number of damage marks approximately 10 ft above the ground, with sections of the left wingtip scattered a few metres away from its base.

Popham Airfield and accident site

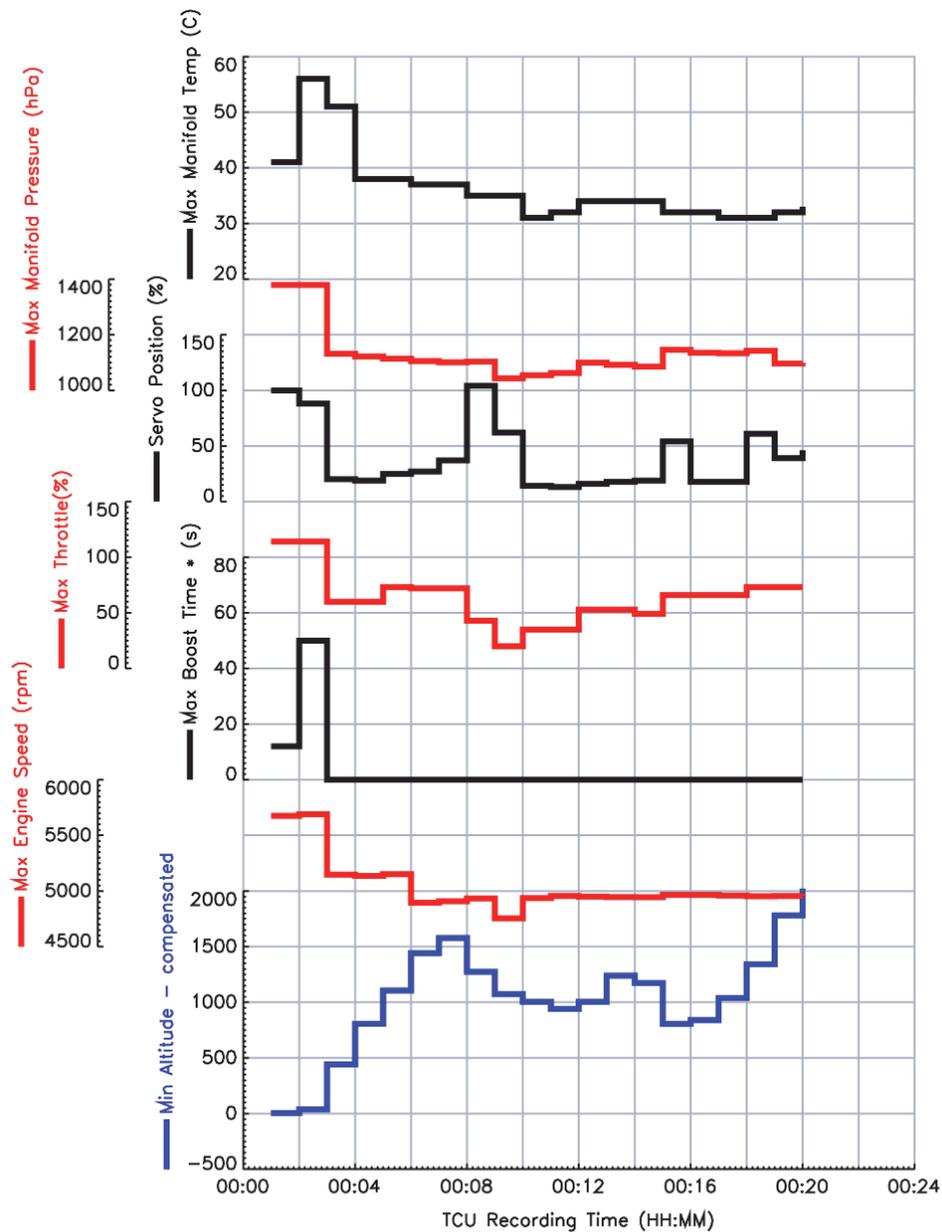
Figure 4

TCU download of the last 20 minutes of recorded operation

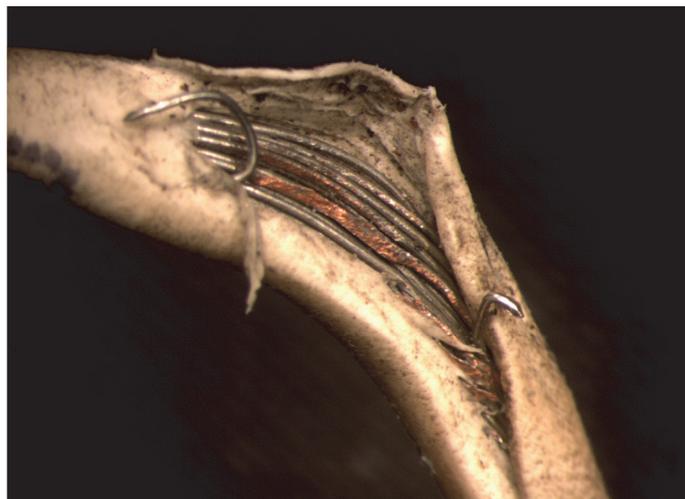
Figure 6

A detailed inspection of the aircraft instrument panel and aircraft wiring was also carried out to identify any defects which may have resulted in the loss of power supply or tacho signal to the TCU. The power supply circuit breaker for the TCU was found in the open position, although several other circuit breakers close to it on the panel were still in the normal closed position. The wiring looms on the engine and behind the instrument panel had suffered damage during the accident sequence, but there was full continuity for the TCU rpm and power supply wiring. However, one of the wires from the throttle position sensor to the TCU was damaged approximately three centimetres from the sensor connector, in a manner that was not consistent with the other examples of impact damage. On closer inspection the inside of the wire's insulation was found to be coated with residue. Inspection of the wire under a microscope showed that the copper conducting wires had been worn flat, with the surface covered in microscopic striations oriented in slightly different directions. (Figure 6)

Magnified image of damaged throttle position sensor wire

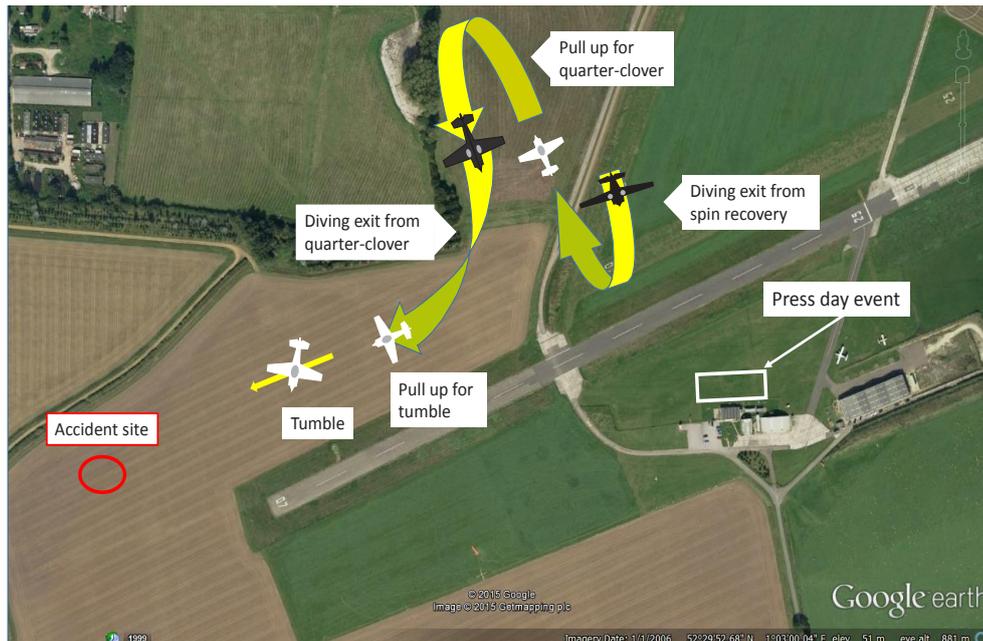
Figure 2

Representation of the aircraft's final manoeuvres

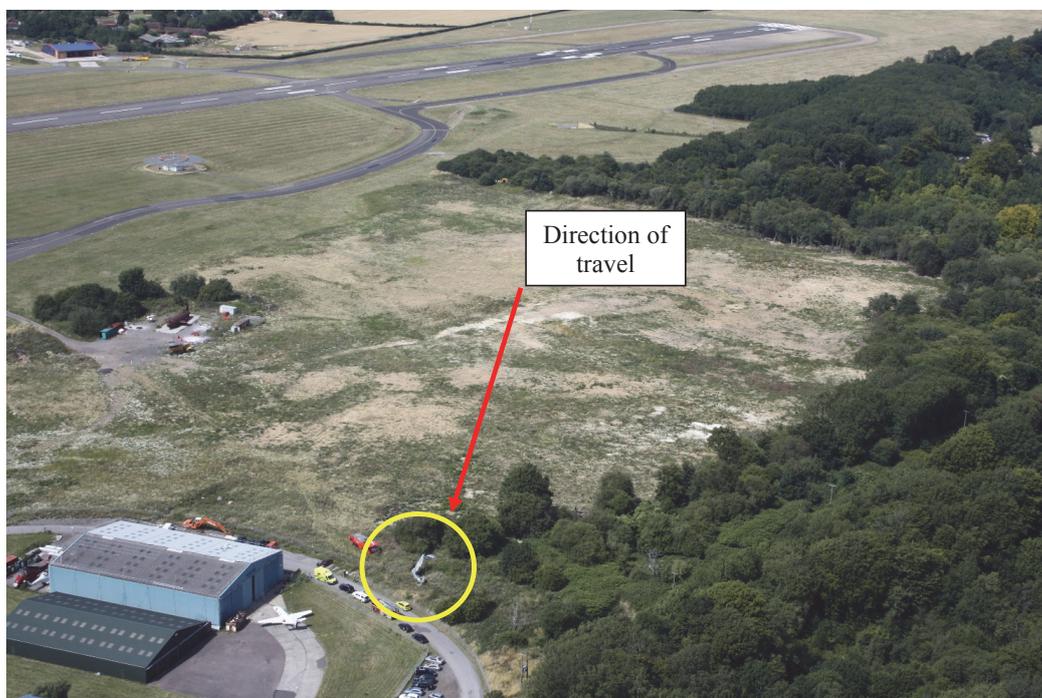
Figure 1

He closed the throttle but realised that he did not have enough total energy to return to the airfield. He therefore increased throttle, finding that only some 10-20% power was achievable, but this, combined with a reduction in airspeed, was just sufficient to reach the airfield. However, it was not enough to reach a runway so, by the time the airfield boundary was crossed, the pilot levelled the wings and landed straight ahead since he feared that the aircraft might stall. The aircraft touched down on its main landing gear on waste ground

to the eastern side of the airfield (Figure 1). It was heading towards a line of trees and the pilot attempted to steer towards a small gap between them but the right wing was detached at the root when it struck a tree. The aircraft spun round and ran backwards up a bank before coming to rest on its right side. The pilot was taken to hospital as a precaution but had suffered only minor injuries.

Aerial view of the accident site with G-BRRA circled.

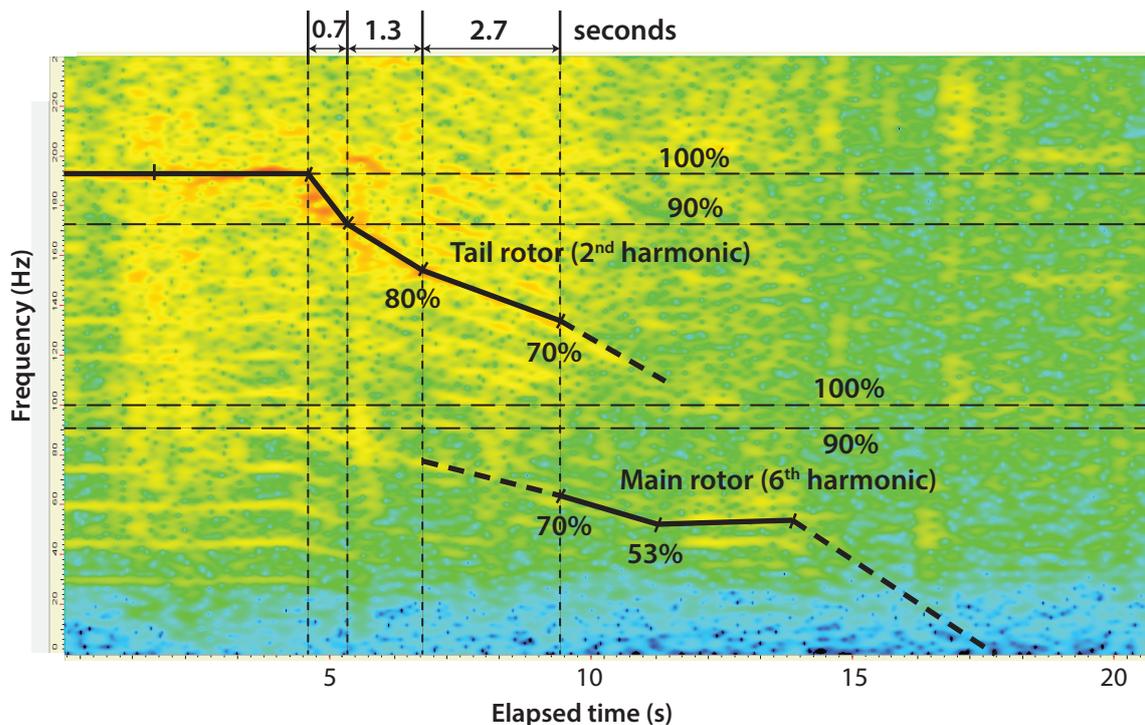
**Figure 5**

The report published in AAIB Bulletin 1/2016 included a graphical display of the main and tail rotor rpm decay, based on the frequency analysis of the witness audio recording (see Figure 5 on page 55). Figure 5 was incorrectly labelled. Reference to the tail rotor should have been to the main rotor, and vice versa. The time axis labels and harmonic references were also incorrect. However, the supporting text, analysis and conclusions were unaffected by these labelling errors. Figure 5 should have appeared, as follows:

Frequency analysis of witness audio recording showing main and tail rotor rpm decay
