Rail Accident Investigation Branch

Rail Accident Report

Derailment at Godmersham, Kent 26 July 2015

Report 05/2016
April 2016

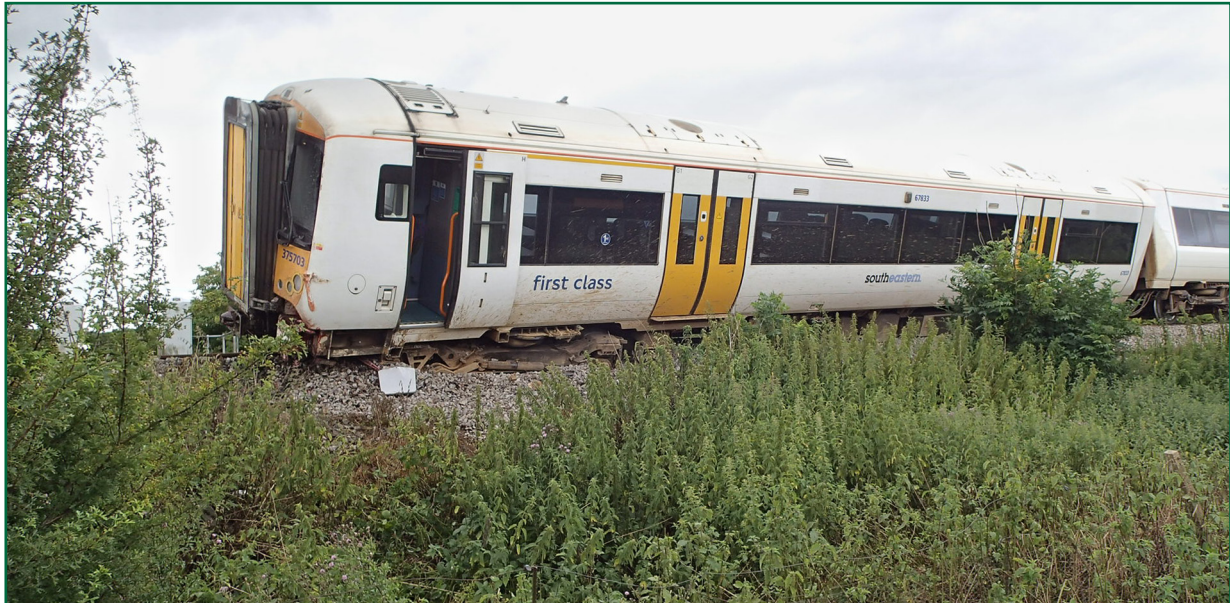
Figure 2: The derailed leading carriage of train 2R66

- 3 At around 21:40 hrs on Sunday 26 July 2015, train 2R66¹, the 20:10 hrs Southeastern service from London Charing Cross to Ramsgate, struck eight cows that had gained access to the railway at Godmersham in Kent, between Wye and Chilham stations (figure 1). The train travelled for approximately 365 metres after the first impact and stopped with the leading carriage, which had completely derailed, leaning about 20 degrees to the left above an embankment slope (figure 2).

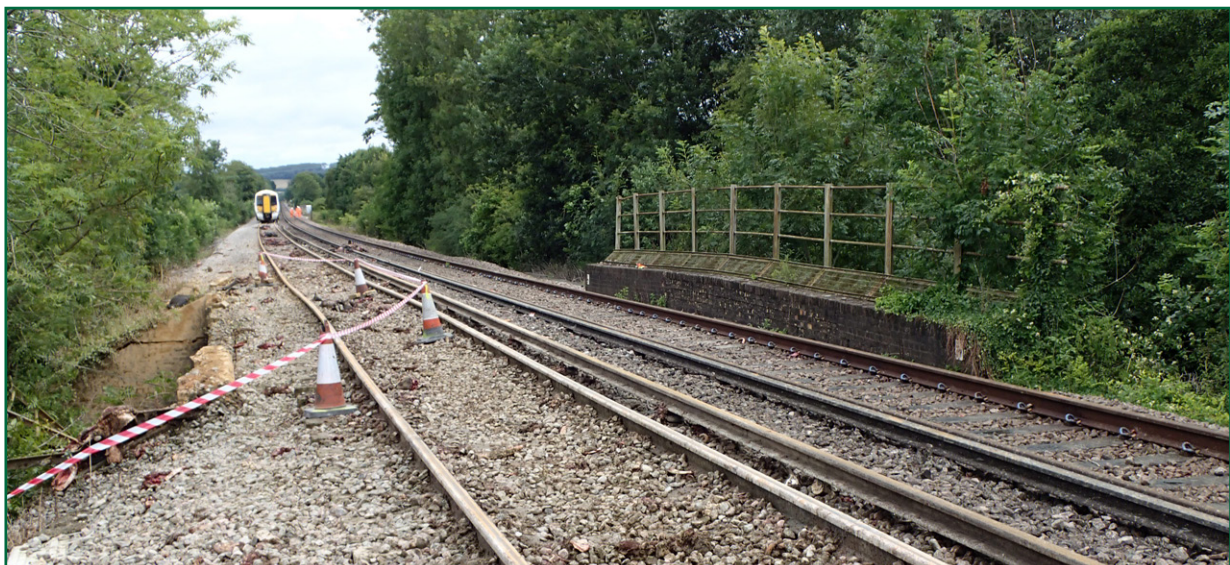
Figure 3: View of damage to the track and bridge as a result of the derailment

- 6 During the course of the derailment, the train struck a bridge parapet wall (known locally as Trimworth Bridge) on the *down* side of the railway, destroying the wall and its railings, and causing damage to the abutments. There was significant track damage, including deformation of the rails in the vicinity of the bridge (figure 3).

- 33 The derailed train was re-railed on the morning of 28 July 2015 and initially moved to Canterbury West, before being moved to LSER's depot at Ramsgate overnight on 29-30 July 2015. The damaged track was repaired and normal working was resumed on 30 July 2015 with a 50 mph (80 km/h) emergency speed restriction, which was lifted on 7 August 2015.

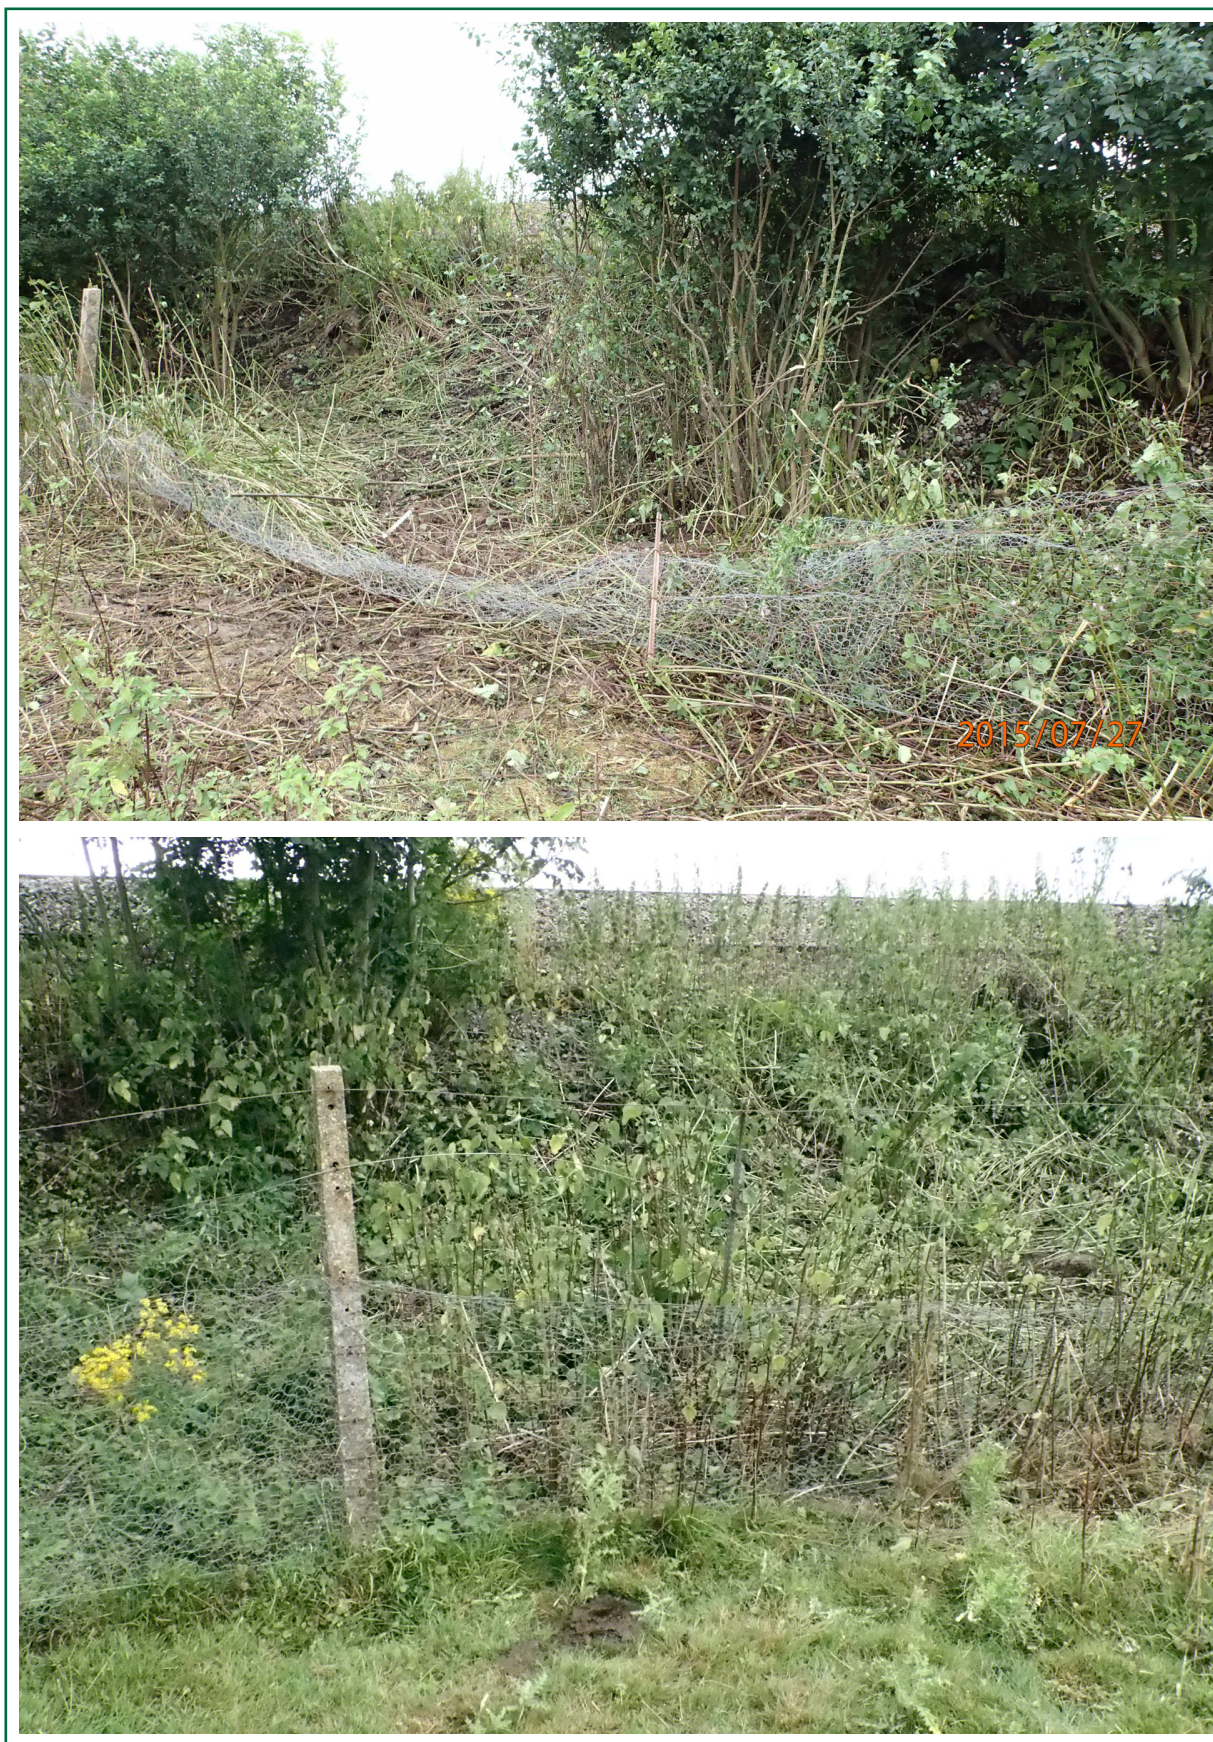
Figure 5: Sections of fence at Godmersham showing the site which was breached by the cows (top) and a representative area approximately 40 metres from the animal incursion (bottom)

- 111 Locally, the off-track section at Ashford DU has replaced around 1300 metres of boundary fence at Godmersham, which includes the site of the cow incursion, with chain link fencing. In terms of Network Rail's company standard (NR/L2/TRK/5100), this represents an upgrade to a class II barrier (see paragraph 37).

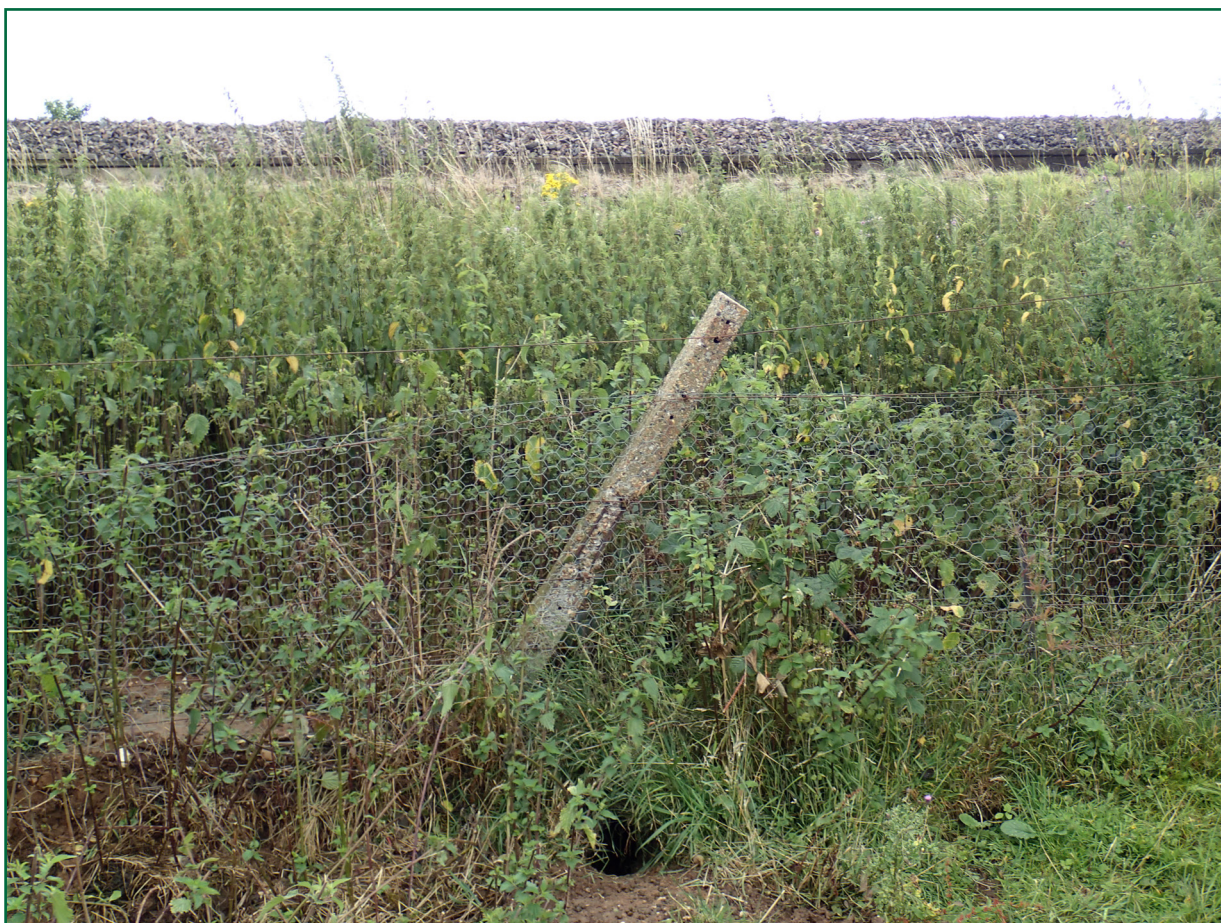
- 51 However, site observations after the accident found evidence of leaning posts, low wire tension and wire corrosion (figure 7).

Figure 7: Degraded section of fence at Godmersham (unaffected by the animal incursion)

- 52 There is no formal competence standard for fencing inspectors within Network Rail, nor is there any guidance to benchmark the condition score for a section of fence against objective criteria. In 2012, Network Rail introduced a training course on boundary inspection, which includes instruction on applying condition scores. However, to date, only a small proportion of relevant staff has completed the course; nobody in the off-track section within Network Rail's *delivery unit* (DU) at Ashford, which is responsible for this area, was aware of the course and the fencing inspector at Godmersham had not attended it. Knowledge is otherwise acquired on the job and through experience, leading to the potential for inconsistency in the ratings given by different inspectors. Similarly, there is no cross-checking or compliance reporting regarding the consistency between different fencing inspectors' assessments.

- 53 Witnesses were critical of the nominal categories available for condition ratings, with no intermediate score between 'good' and 'poor'. The system used in NR/L2/TRK/5100 is derived from earlier company standards that offered a wider scoring range, but the range was compressed when separate standards were combined into one; Network Rail has been unable to explain why the scoring system was changed in this way. The RAIB also noted the apparent ambiguity in the definition of 'poor' condition (fit for current use, but maintenance required).

- 54 The risk rating system provides little sensitivity to discriminate between maintenance priorities in an area such as Kent, where the prevalence of third rail electrification means that most of the risk scores are calculated to be of high priority (paragraphs 38 and 50). Consequently, the off-track section within Ashford DU relies heavily on subjective reports from its fencing inspectors in order to determine which fences need to be prioritised for repair or renewal. The fence at Godmersham was not identified as requiring repair or renewal.

- 112 Fencing inspectors at Ashford DU have been re-briefed to use a condition score 2 (ie poor – paragraph 38) only if the fence requires maintenance. Otherwise, the condition score 0 (ie good) should be used when no work is required.

- 113 The Ashford off-track section has also instigated a process to review its boundary risk assessments and, where necessary, accelerate the programme for repairs or renewals at high risk sites. It has also been trialling the use of additional measurement tools to quantify the condition of the fence (such as wire diameter and tension).

- 1 *The intent of this recommendation is to improve the fence inspection process such that potentially substandard fences are properly identified for repair or renewal. This might be accomplished as part of the Business Critical Rules review of standards.*

- a) the design of the fence and its appropriateness for the adjacent land use; and
- b) condition ratings based on objective and relative (benchmarked) criteria.

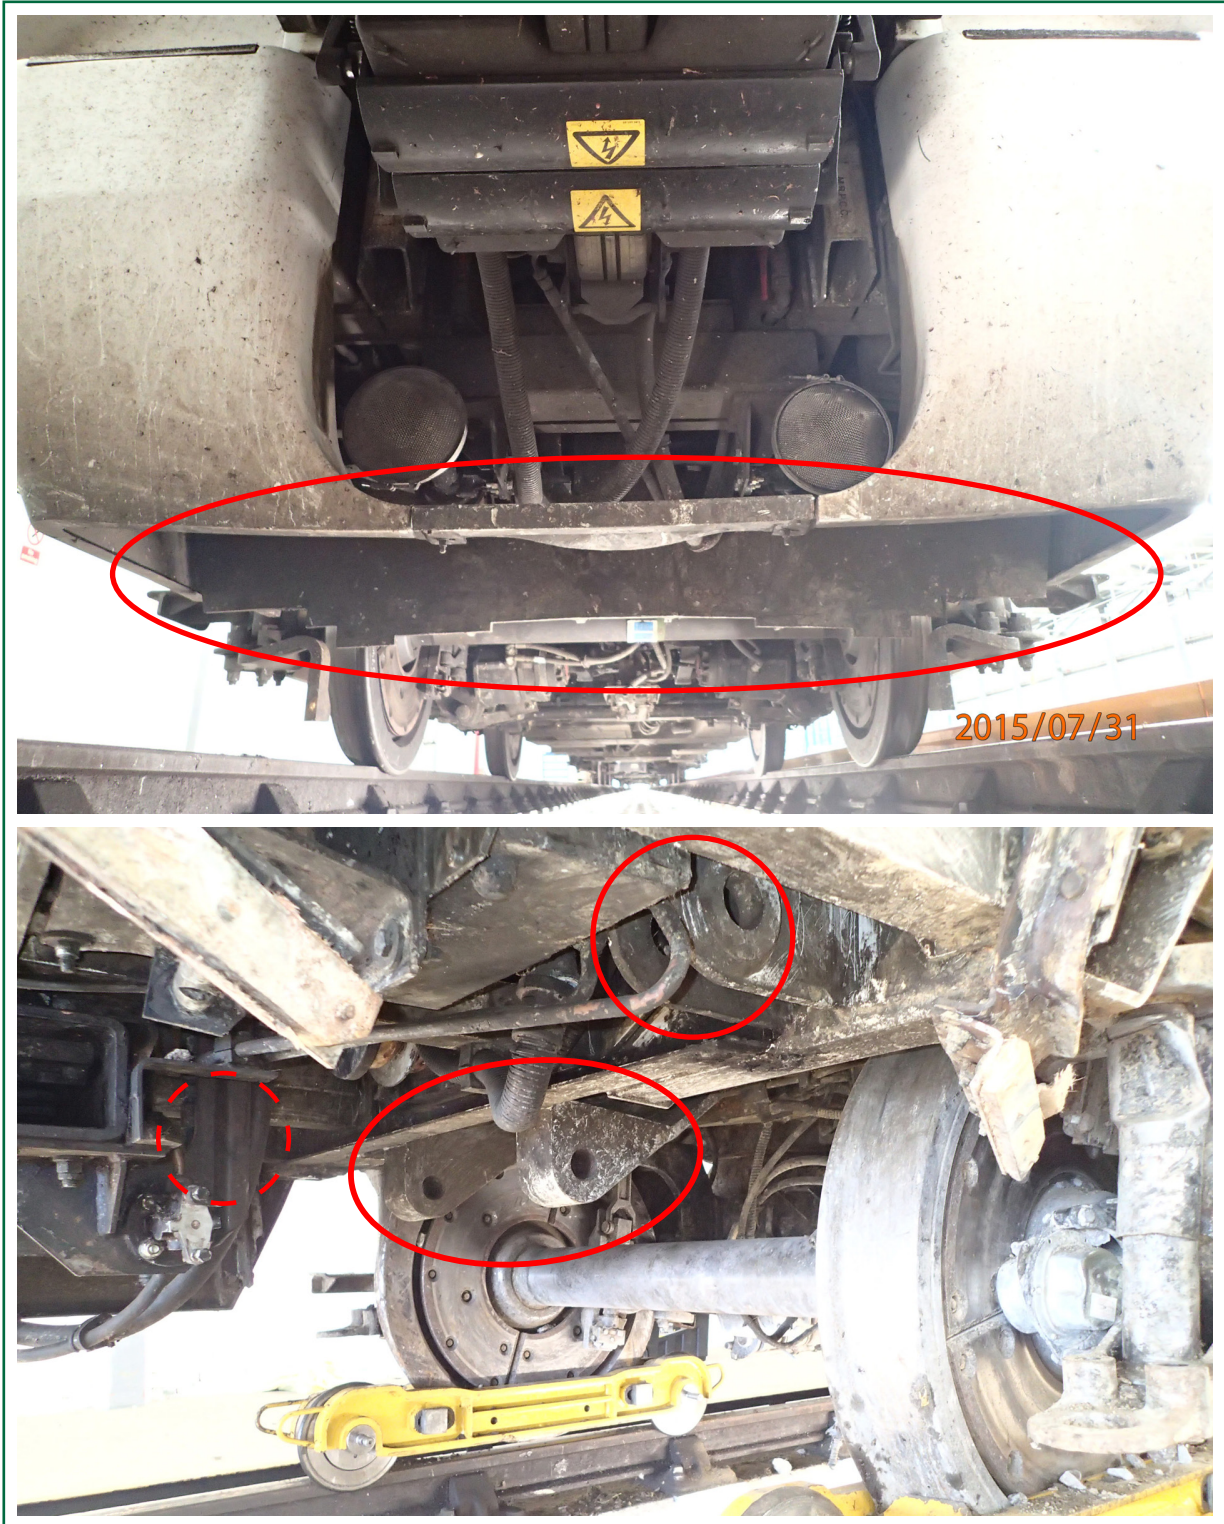
- 62 The leading unit of the train, 375703, was not fitted with obstacle deflectors, whereas the trailing unit, 375612, was equipped with them.
- 63 Obstacle deflectors are designed to shield the leading wheels and remove large obstacles (ie cars, trees and large animals) from the path of the train. Their benefit is primarily in preventing derailment as a result of such a collision. RSSB research project T189 ('Optimal design and deployment of obstacle deflectors and lifeguards') found, based on data from 1991 to 2000, that the relative derailment rate (per mile) for trains without obstacle deflectors involved in such collisions is about 75% higher than that for trains with obstacle deflectors.

Figure 8: Comparison of the leading end of unit 375612 (top) and the leading end of unit 375703 (bottom), showing the presence or absence of obstacle deflectors respectively (obstacle deflectors and mounting brackets circled in red; one mounting bracket not visible in bottom image). Note that the unit in the bottom image is mounted on wheel skates for recovery purposes.

- 3 *The intent of this recommendation is to reduce the risk of derailment arising from collisions with obstacles for electric multiple units operating exclusively on third rail lines.*

London & South Eastern Railway Limited, in conjunction with Govia Thameslink Railway, Porterbrook Leasing Company Limited¹⁷ and Eversholt Rail Group should develop, and then implement, a programme for retrofitting obstacle deflectors to Electrostar units that are not currently fitted, but are equipped with mountings for such deflectors (paragraph 91c).
