FLYER TO THE FISHING INDUSTRY

Fire leading to the foundering of the prawn trawler *Karinya* (FR 699) on 4 October 2015

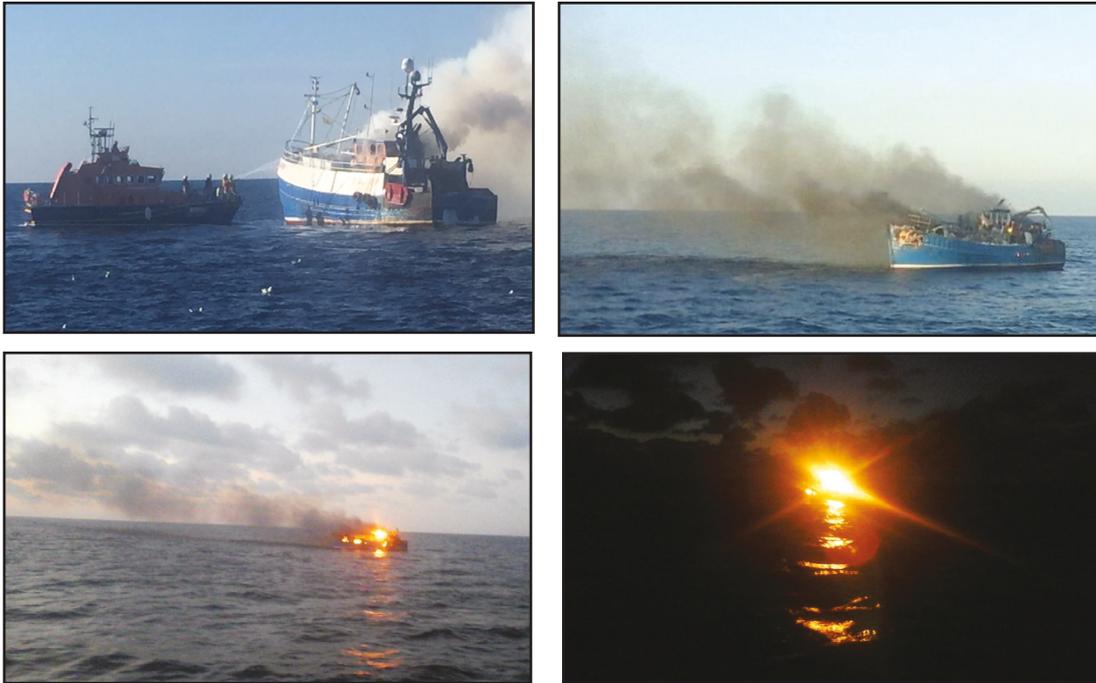
The fire almost certainly started in the cabin. Smoke then spread quickly, forcing the crew to evacuate the vessel rather than to attempt to fight the fire.

The fire's ignition source has not been determined, but it is probable that the fire was caused by a poorly discarded cigarette end that was not fully extinguished.

Sequence showing *Karinya* on fire
