Fire and foundering of fishing vessel

Karinya (FR 699)

Moray Firth

4 October 2015

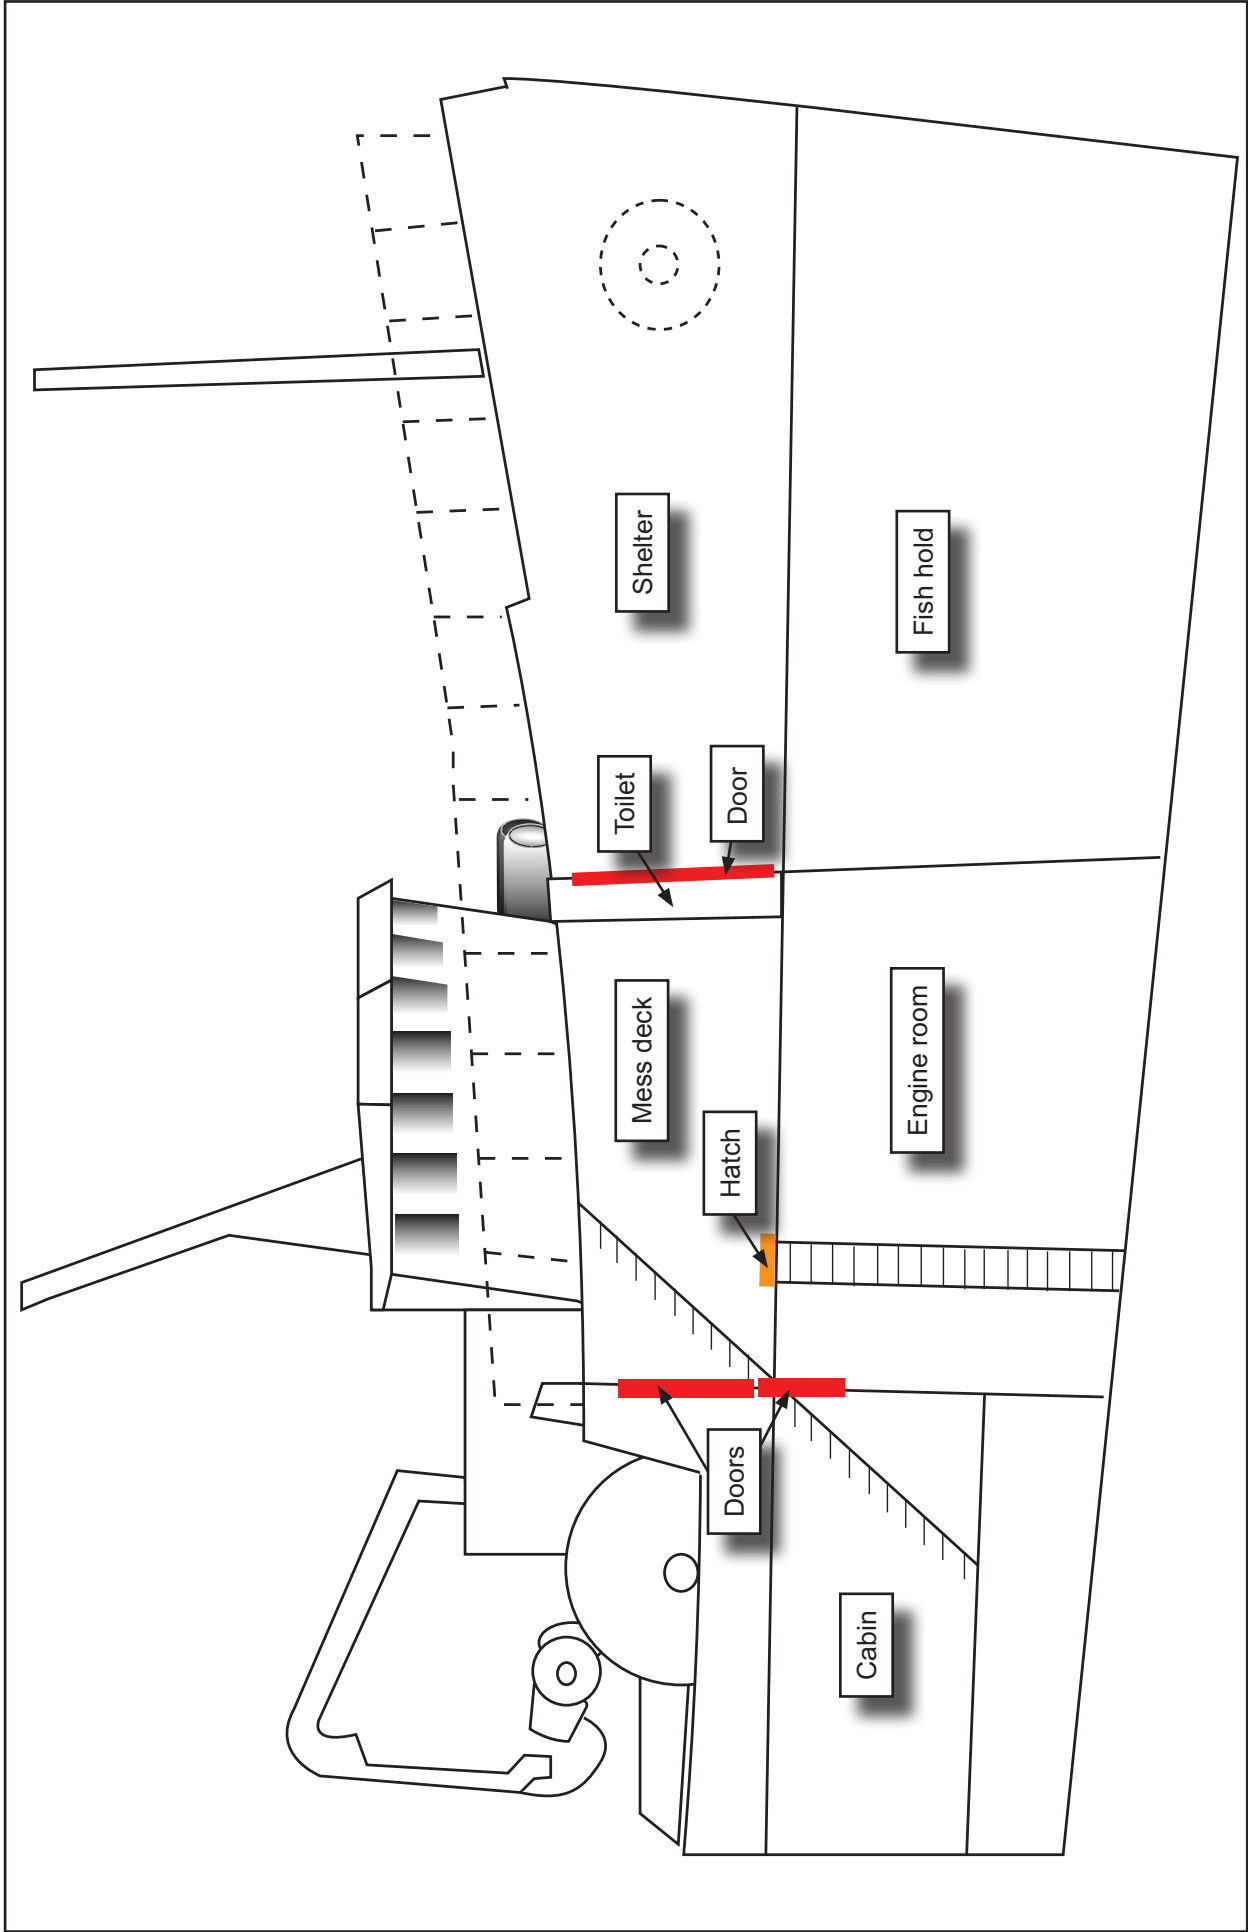
Figure 1: General arrangement

The wheelhouse was accessed from the galley area via an internal stairway. Adjacent to the galley was the mess area, which led forward to the crew toilet and shower. The single 8-berth cabin was located on the deck below, aft of the engine room and was accessed via an internal stairway from the galley area (**Figure 1**).

The cabin door, which was protected with a fire-retardant coating, was secured in the open position. The door was kept open at all times, apart from during very rough weather. There was no requirement for the door to be fitted with a self-closing device. A chimney effect existed as the smoke emitted from the cabin rose up the stairway, filling the wheelhouse and exiting the vessel through the open wheelhouse door and an open window.

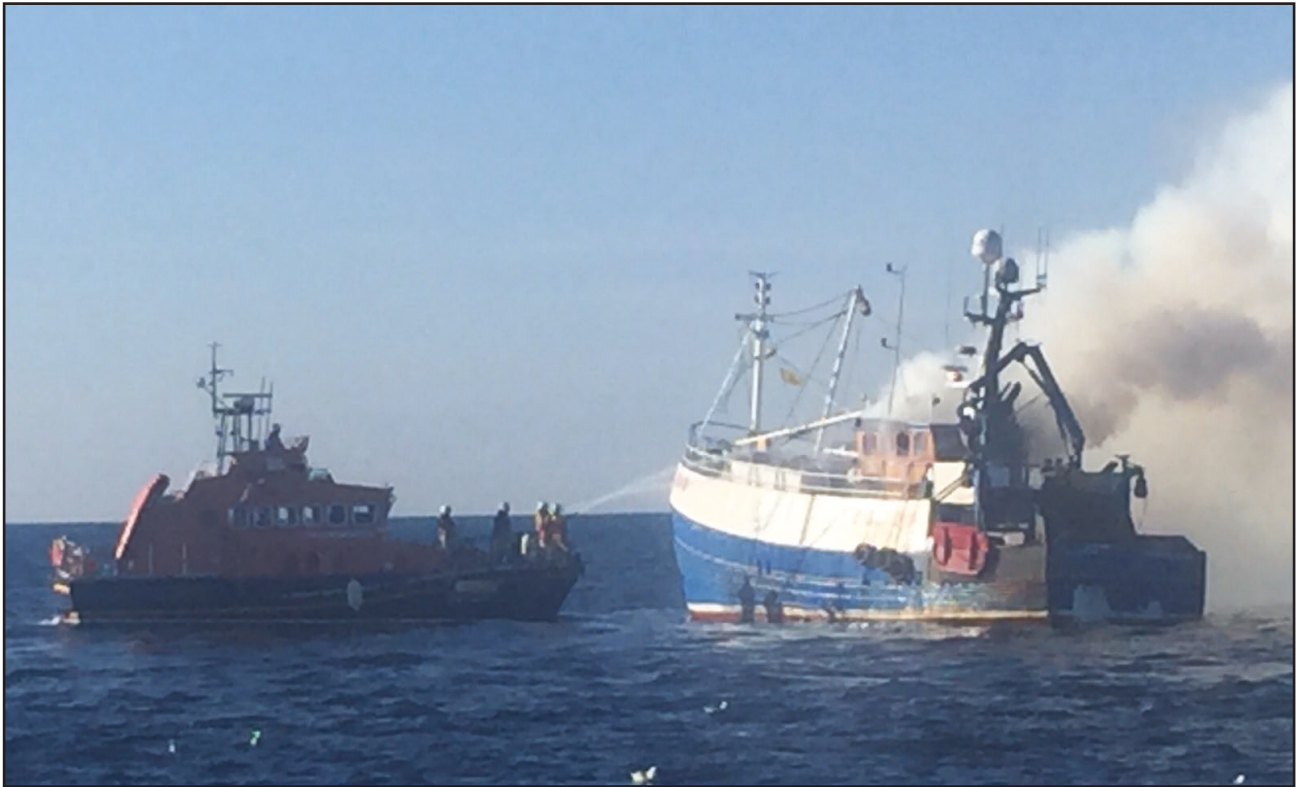
Figures 2 and 3: Accident sequence

At 1418, Fraserburgh ALB arrived on scene. Its crew then directed a jet of water through one of *Karinya*'s wheelhouse window openings (**Figure 2**).

Karinya had several gas bottles on board, stored aft of the wheelhouse, and there were an estimated 10,000 litres of bunker fuel on board. Owing to the explosion risk, and that no one was left on board *Karinya*, Fraserburgh ALB was instructed by Aberdeen Coastguard to stop fire-fighting and to maintain a safe distance from the vessel.

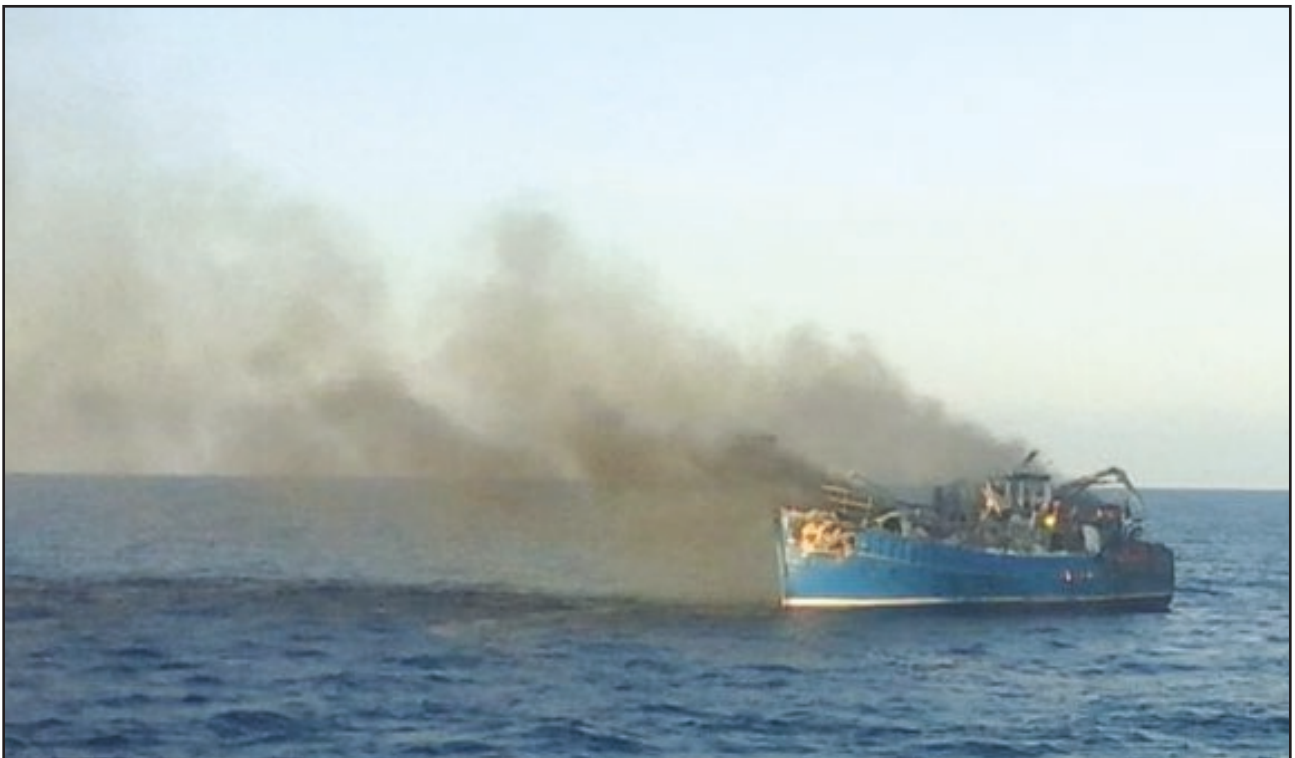
By 1603, *Karinya*'s wheelhouse had completely melted. By 1709, the entire shelter deck had burned away (**Figure 3**) and, soon afterwards, flames could be seen through the timbers on both sides of the vessel (**Figure 4**). Bunker fuel was boiling off, venting from the fuel tanks on both sides of *Karinya*, and burning violently (**Figure 5**).
