Report on the investigation into the girding and capsizing
of the mooring launch

Asterix

at Fawley Marine Terminal, Southampton, UK

30 March 2015

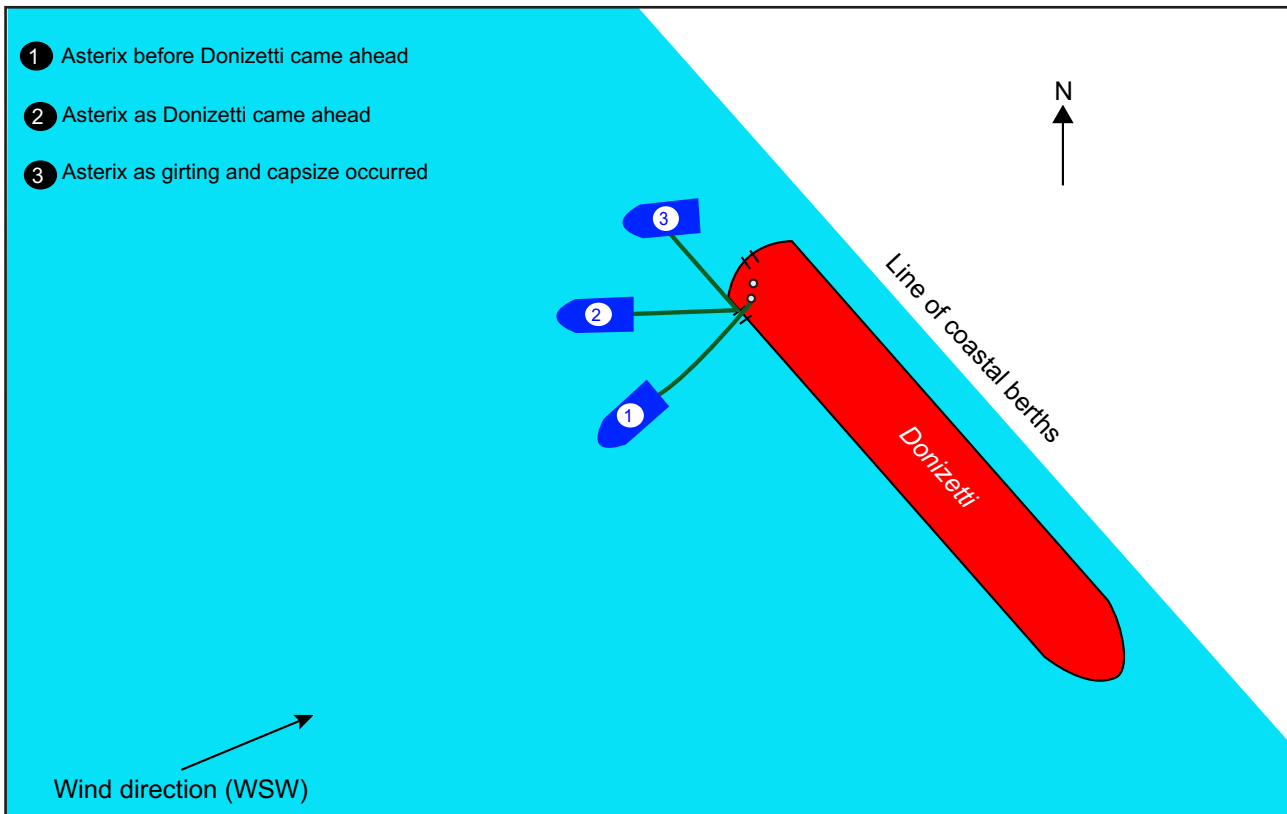
Figure 2: Indicative relative movement of *Asterix*

At around 1600, *Donizetti* completed cargo discharge and commenced preparations for departure, which was scheduled for 2000. At 1945, a pilot boarded and, shortly afterwards, there was an exchange between the pilot and the master. The pilot advised of his intention to utilise a tug to assist in manoeuvring the vessel off the berth. He considered that with a wind speed gusting to 25 knots and pushing the vessel onto the berth, an obstruction astern and another vessel berthed 30m ahead of *Donizetti*, it would be prudent to employ a mooring launch to assist, if necessary, in lifting the vessel's stern off the berth. At approximately 2000, *Asterix* came alongside and, at the request of the launch coxswain and with the agreement of the pilot, the towline was made fast through *Donizetti*'s starboard quarter fairlead (**Figure 2**).

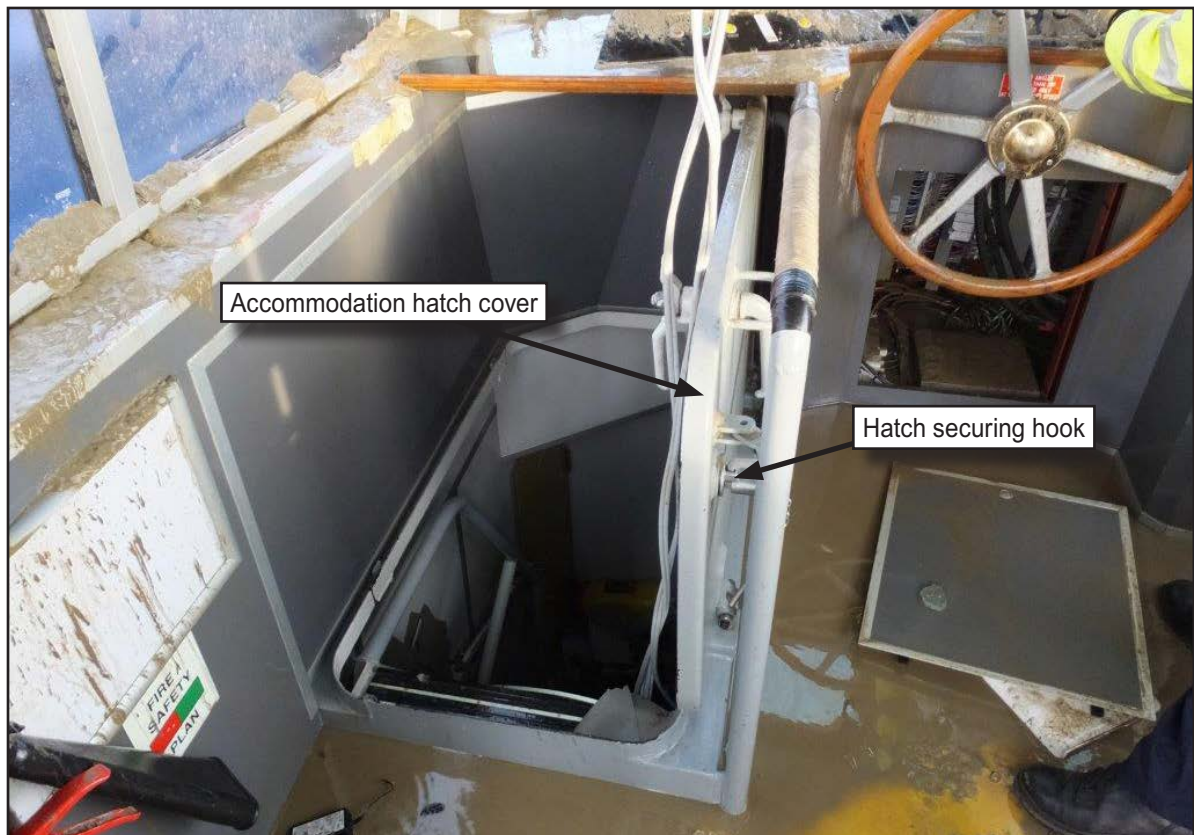
Figure 4: Accommodation hatch cover (hooked open)

At the time of the sinking, all hatch covers and doors were closed and secured with the exception of the accommodation entrance hatch cover in the wheelhouse and the wheelhouse entrance door, both of which were found hooked open when the launch was later recovered (**Figures 4 and 5**).

Asterix capsized due to girding, which caused the vessel to heel to an angle that resulted in deck edge immersion with floodwater then entering the wheelhouse through the open entrance doorway. This in turn led to the vessel's inversion. With the vessel upturned, floodwater was able to enter the machinery spaces through the now submerged compartment vents. As the vessel began to roll, water from the wheelhouse was able to enter the accommodation through the open entrance hatchway, compounding the machinery space flooding.

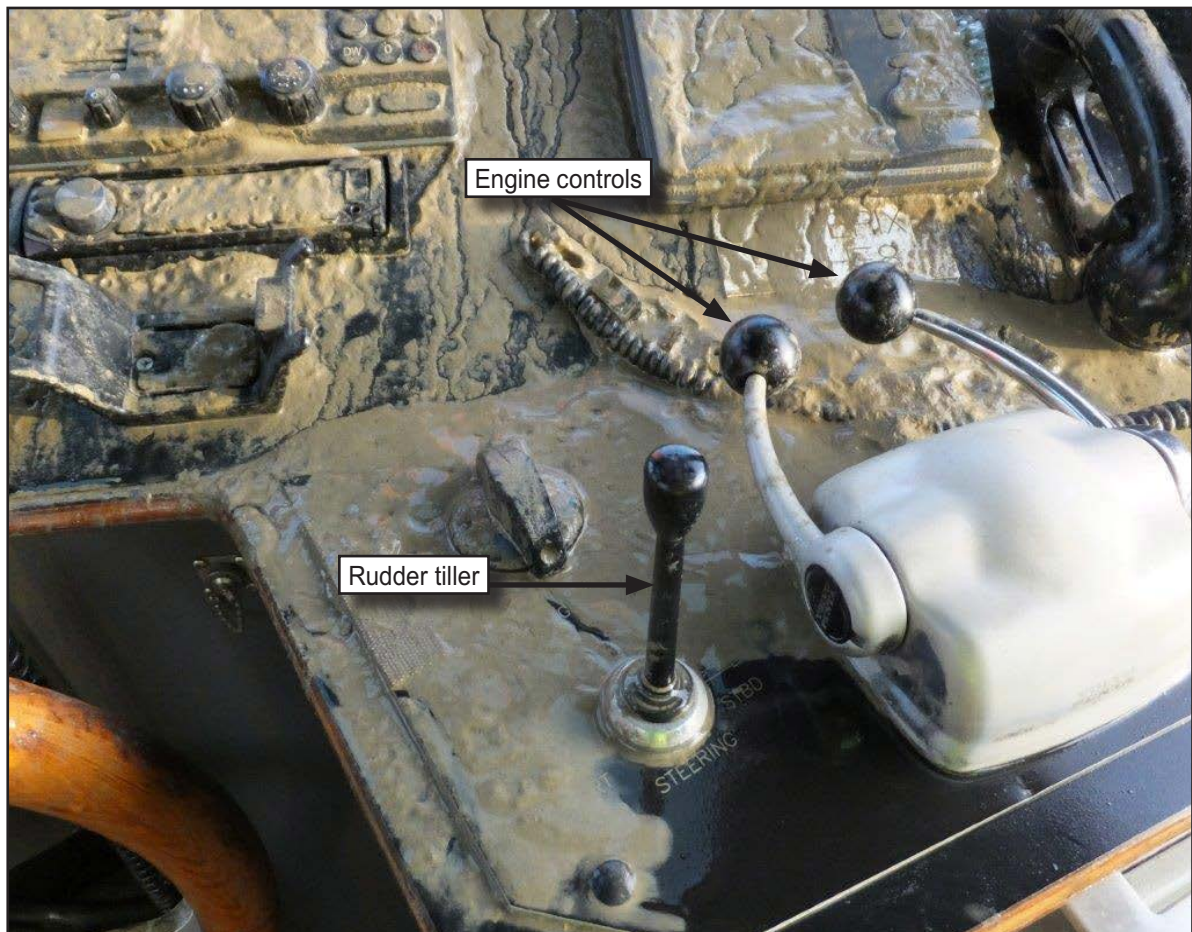
Figure 6: Asterix manoeuvring controls

Each of the main engines was a Volvo marine propulsion engine model D9 MH driving a fixed pitch propeller through a reduction gearbox. Main engine speed and ahead/astern gearbox position was achieved through electronic remote control with one handle for each engine located on the wheelhouse control console. When the vessel was salvaged, both handles were found in the 'full ahead' position (**Figure 6**).

console. At the time of the accident, the steering was being controlled using the tiller (**Figure 6**). When the vessel was recovered, the rudder indicator showed 10° to port, which corresponded to the actual rudder angle.

Asterix was designed with a forward-facing conning position. The rudder tiller and engine controls were located on a console in such a position that, when manoeuvring the launch, it was natural for the coxswain to face away from the tow. Furthermore, owing to the proximity of the oil pollution boom and adjacent shallow water, it was important that the coxswain was able to concentrate on the positioning of the mooring launch relative to these hazards. Consequently, the coxswain needed the assistance of the deckhand in order to monitor the situation effectively.

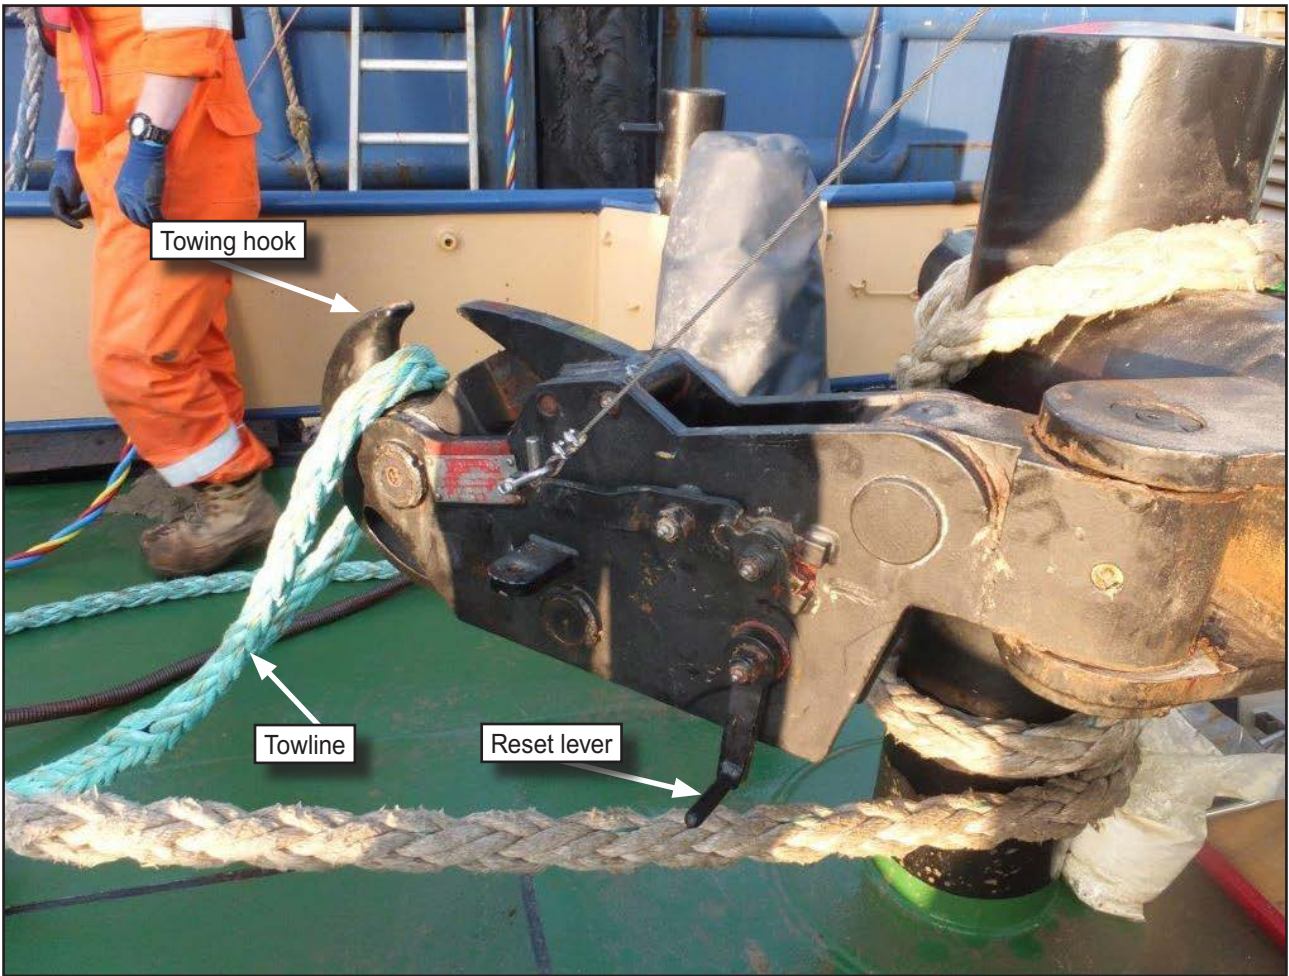
Figure 7: Towing hook (as found following salvage)

The launch was fitted with a Mampaey quick-release disc type towing hook located on the main deck just aft of the wheelhouse. The hook was designed to rotate through approximately 180° with a tow attached (**Figure 7**). The towing hook had a safe working load of 15t with a test load of 30t. It had an emergency release mechanism, which was activated by pulling on a wire. The wire was connected to an operating handle suspended from the deckhead of the wheelhouse and ran through a raised pulley forward of the towing hook before connecting to the hook release mechanism (**Figures 8, 9 and 10**). This model of towing hook could be fitted with either air or hydraulic actuators to complement the manual emergency release, but these options had not been specified for the build of *Asterix*. When the vessel was salvaged, the towing hook release mechanism was found to have only partially activated, with the towline's eye still located on the closed hook.

An initial examination of the hook found that it was in good condition with evidence of satisfactory maintenance. However, there was some evidence of light corrosion and lack of lubrication. Østensjø Rederi AS's maintenance regime was discussed and agreed to be entirely satisfactory on the premise that it was diligently adhered to. During the testing, witness marks on the hook indicated that, at some point, it had been incorrectly set. In view of this, the test procedure was expanded to include testing the emergency release with the hook set in this incorrect position.

When *Asterix* was salvaged, the towing hook release mechanism was found to have only partially activated, with the towline's eye still located on the closed hook.

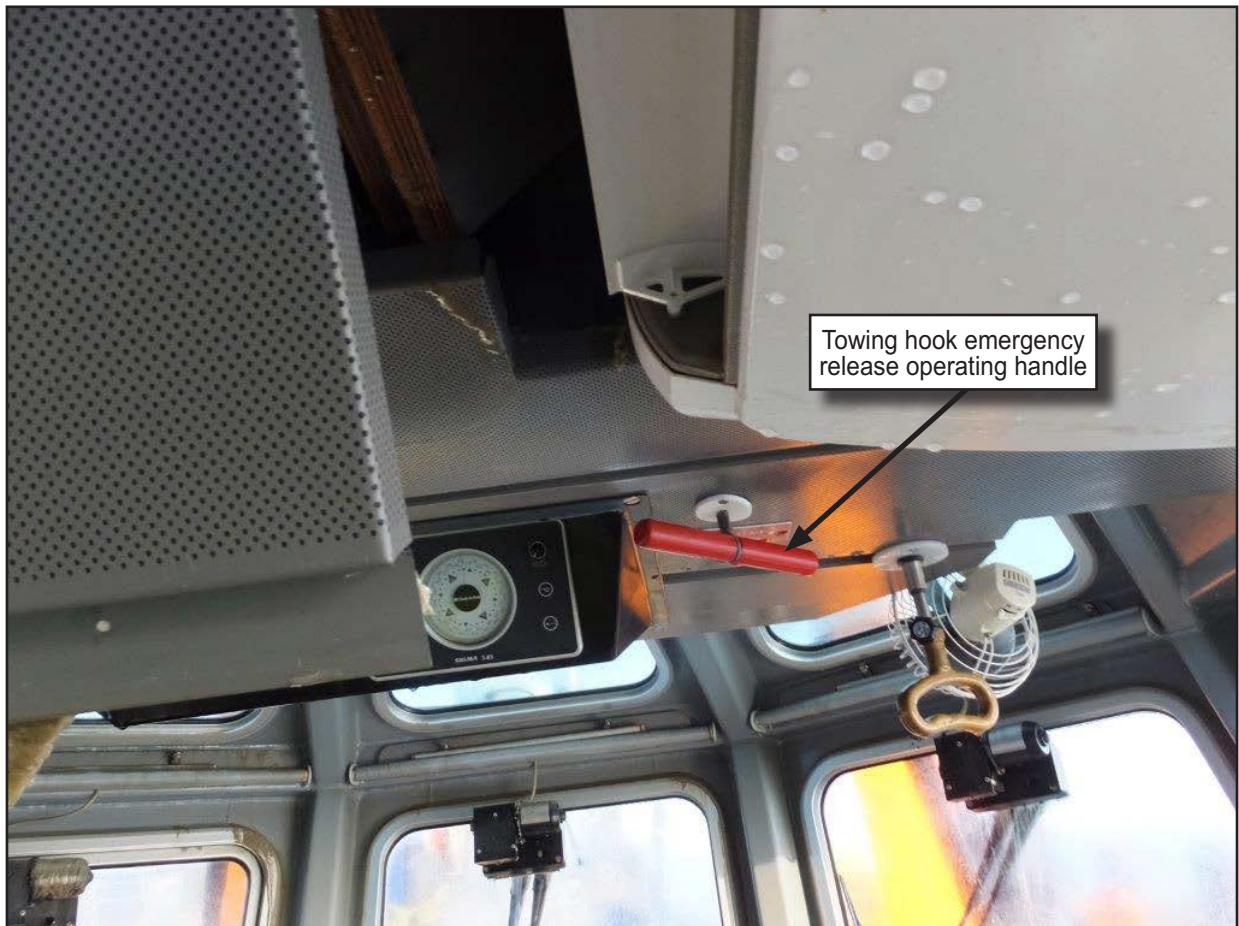
Figure 8: Towing hook emergency release handle

With no mechanical assistance, the emergency release relied on the crew to operate the manual pull in order to release the towline. Tests of the hook demonstrated that, under load conditions, a steady pull required significantly more force to operate the release mechanism than a sharp pulling action, and that the required effort increased in proportion to the loading on the hook.

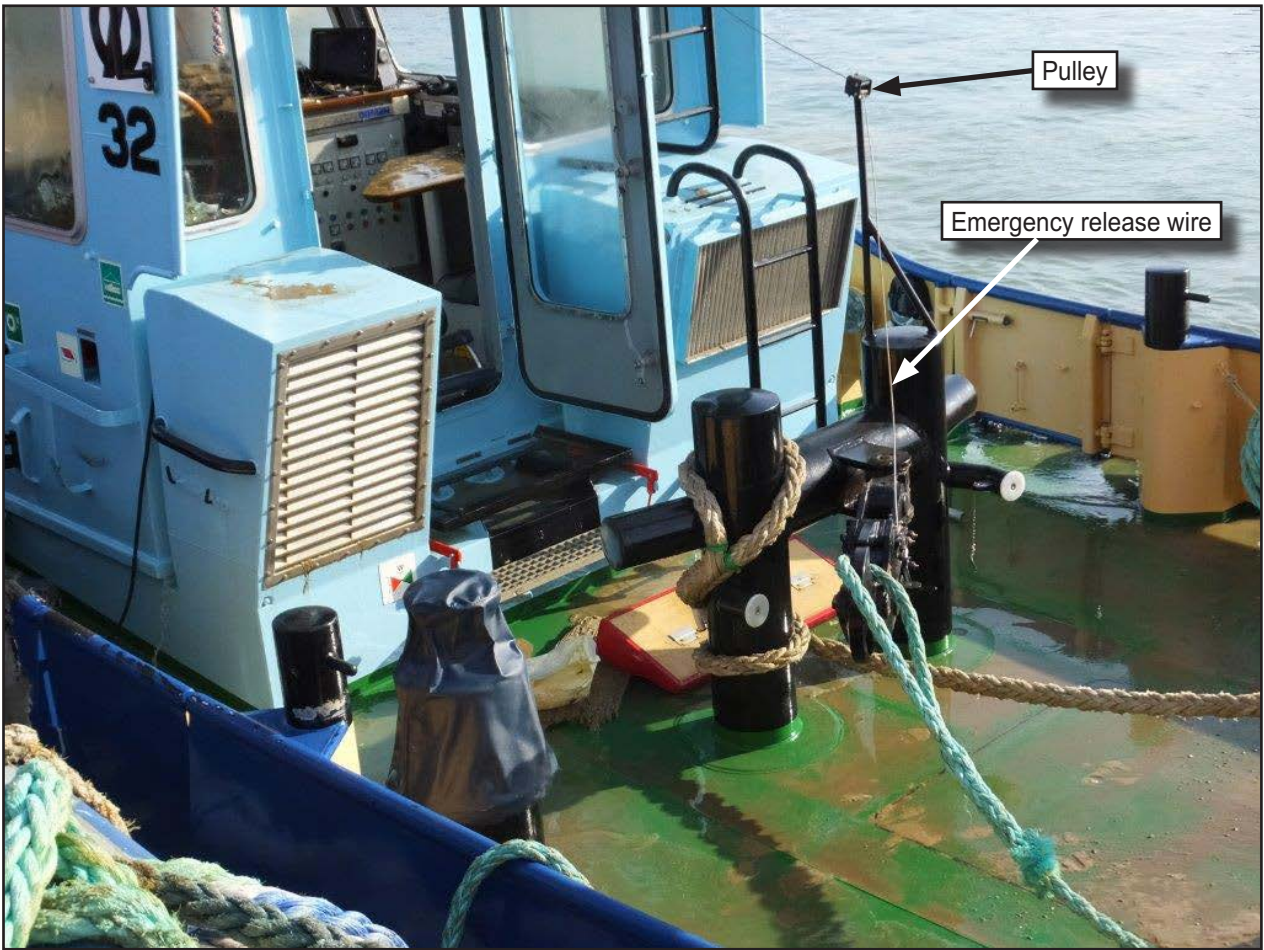
Figure 9: Towing hook emergency release wire

It was also noted that the angle of the release wire at the connection to the emergency release lever had an effect on the load required to release the hook.

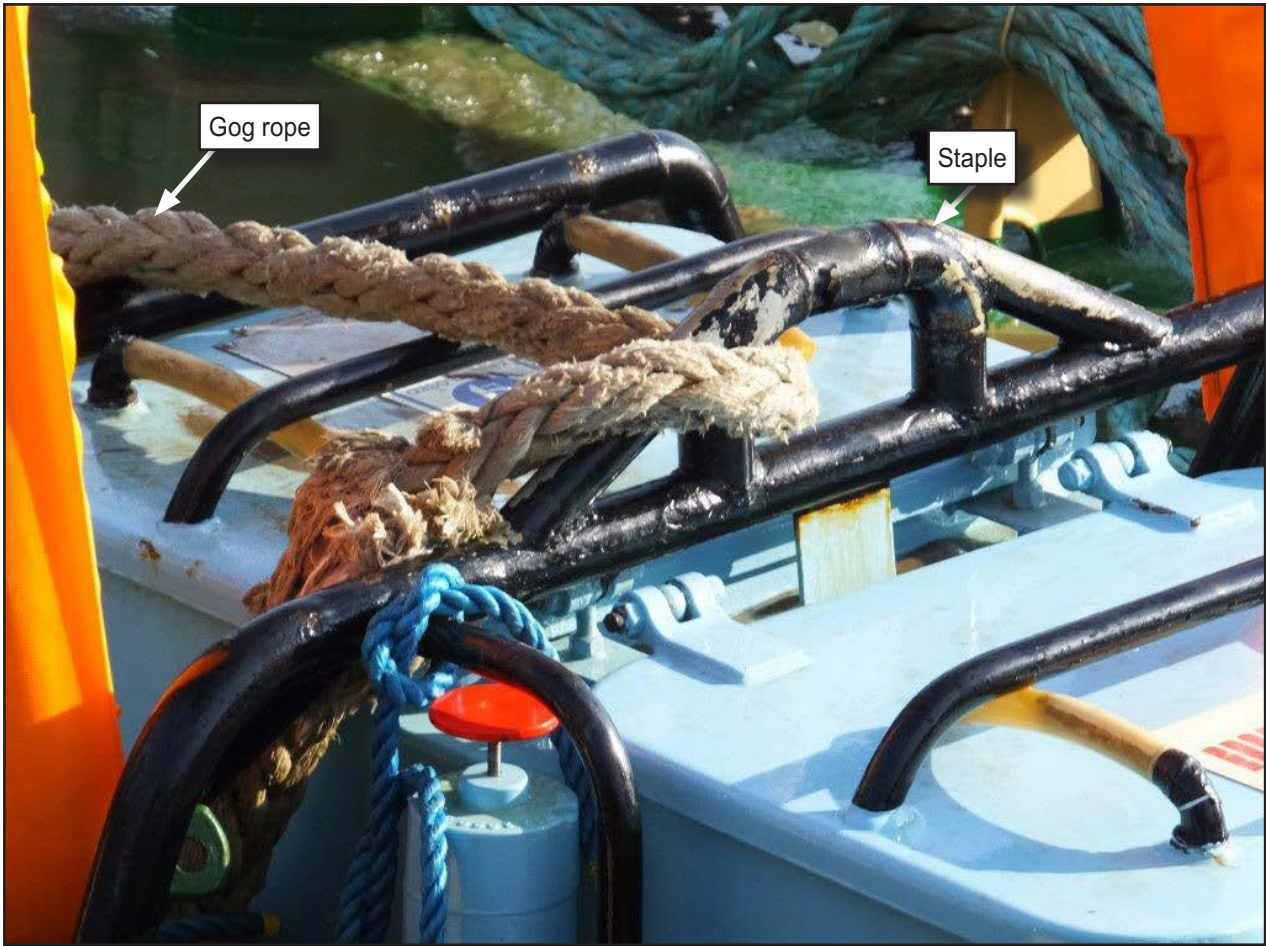
Figure 11: Gog rope staple

Shortly after *Asterix* was delivered, at the request of the owner, the manufacturer had fitted a bracket and staple between the engine room and aft peak hatches. The purpose of the staple was to allow the use of a gog rope to move the towing point further aft. An H-shaped bit, the structure of which supported the towing hook, was used to secure one end of the gog rope. When the vessel was recovered, the gog rope was found leading through the staple, with one end secured to the bit and the towline passing through a ring attached to its other end (**Figures 11 and 12**).

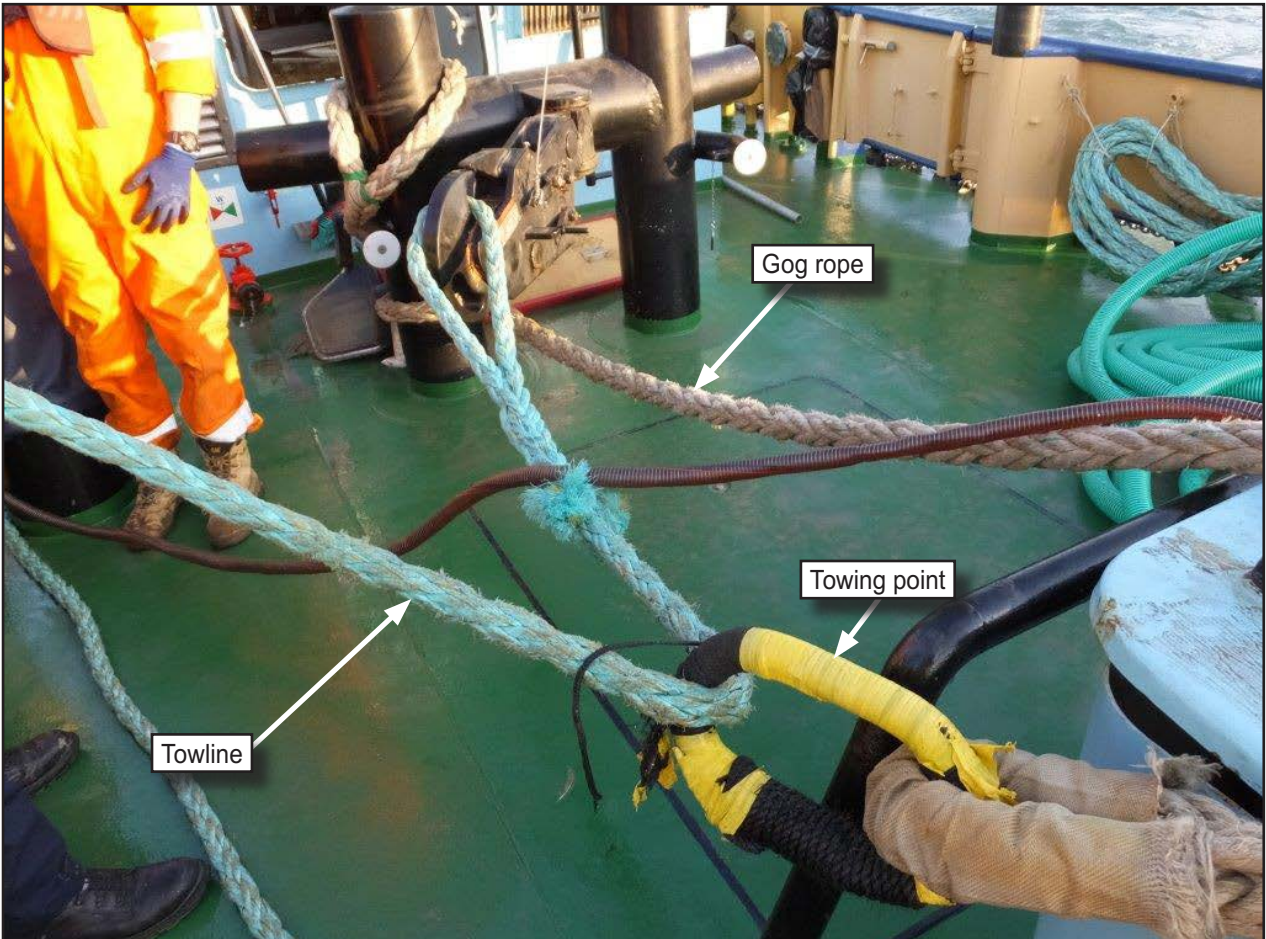
Figure 12: Gog rope arrangement (as found following salvage)

Østensjø Rederi AS's risk assessment of mooring launch operations at FMT recognised girting as a hazard. The company chose to mitigate against girting by instructing the crews to use a gog rope on every tow, and a bracket and staple had been retrofitted to *Asterix* for this purpose. The requirement to use a gog rope on every tow assumed that a risk of girting existed on every tow, and that the launch crews were proficient in adjusting the gog rope to maximise its preventive effect.

- Review and enhance its risk assessment relating to the hazard of girting.
 - Introduce comprehensive instructions and guidance relating to operations requiring the use of a gog rope.

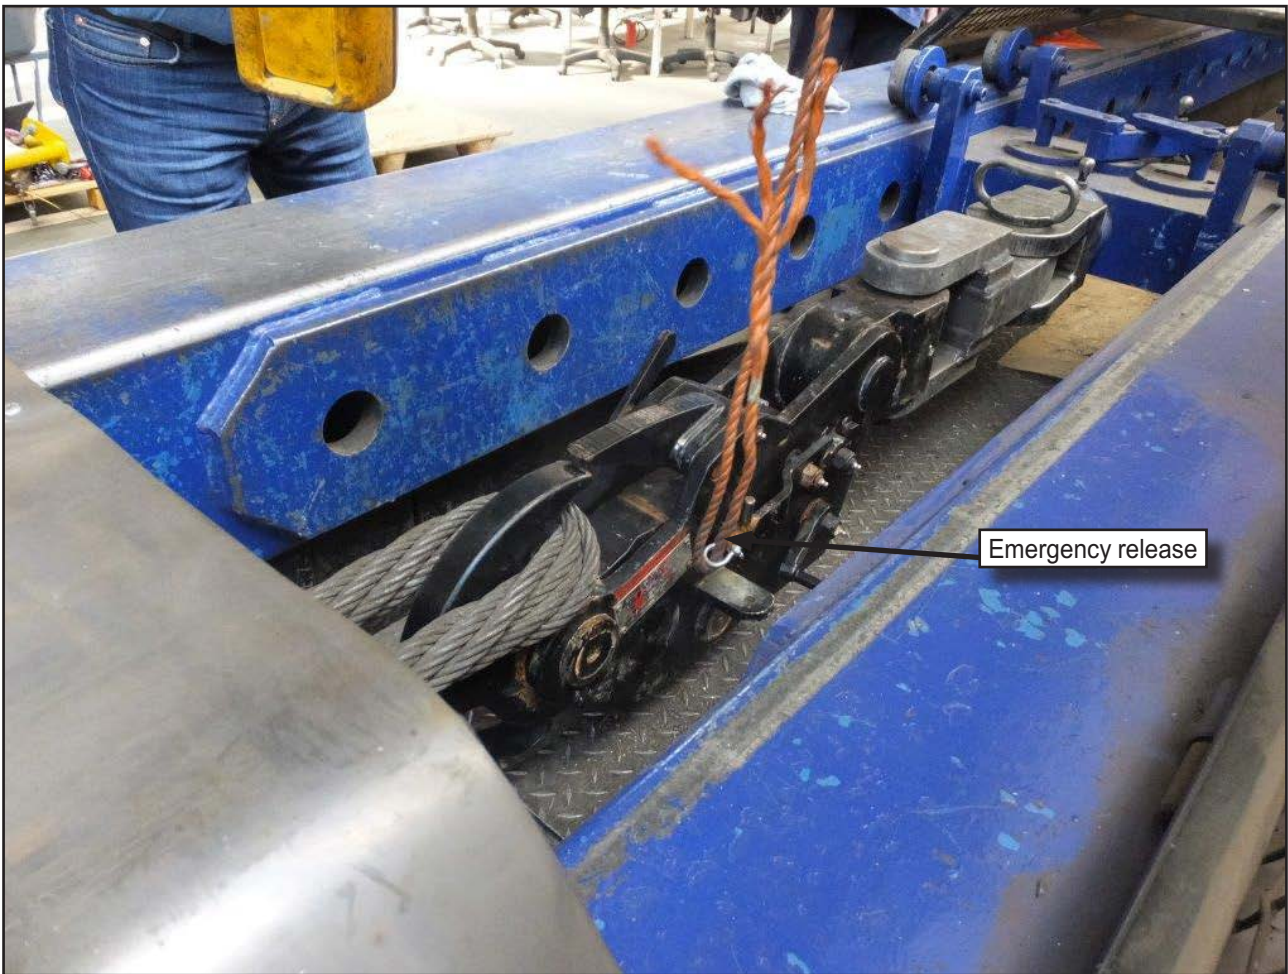
Figure 13: Towing hook emergency release testing

After the 30t release, the hook did not fully reset. Investigation revealed that a build-up of corrosion on the mating face of the hook and the roller release weight prevented the hook from fully resetting. Notwithstanding the incomplete reset, the emergency release remained functional.

It was noted that the loading needed to manually operate the emergency release increased in a linear relationship to the load applied to the hook. A load cell attached to the release mechanism lever with a manual pull to operate the release gave the following readings:

- At a hook loading of 15t the required release load was 18kg.
- At a hook loading of 20t the required release load was 24kg.

Following the 20t test, the hook was greased and the release cord attached to an electric hoist to demonstrate the effect of a steady pull on the release wire as opposed to a rapidly applied manual pull. In this case the load required during a steady pull against a 20t hook load varied between 42kg and 44kg.
