Rail Accident Report

Freight train derailment at Angerstein Junction, 3 June 2015

Report 10/2016
June 2016

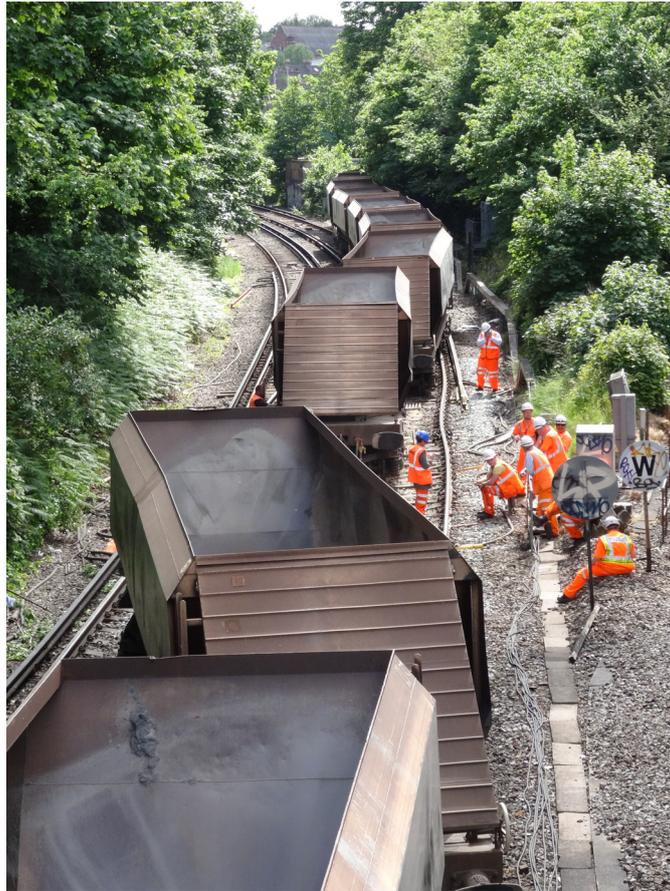
Figure 2: Derailed portion of the train (courtesy of Network Rail)

- 5 At about 12:10 hrs on Wednesday 3 June 2015, three wagons of an empty freight train derailed as the train was leaving sidings to run onto the North Kent lines at Angerstein Junction, near Charlton in south east London (figure 1). The train came to a stand with the three wagons partly obstructing the opposite line, which was open to traffic (figure 2). No-one was injured in the accident, but there was significant damage to the railway infrastructure.

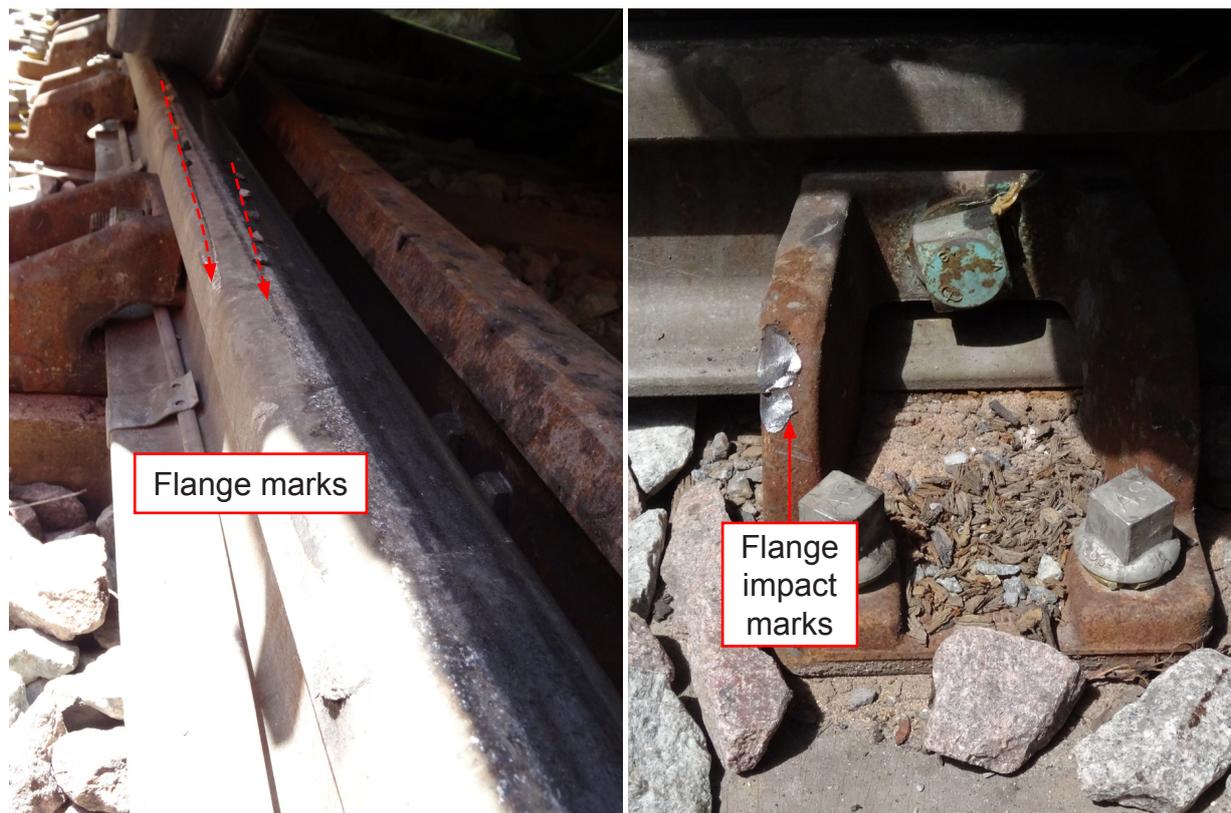
Figure 7: Derailment marks on the rail head and on the subsequent chairs

- 38 There was insufficient load on the front right-hand wheel of the leading bogie on wagon BHQ 17121 to counteract the lateral forces at the wheel-rail interface, and thus to prevent the flange climbing over the rail head in the vicinity of trap points 851A.
- 39 The marks on the rails at the point of derailment indicate that two wheel flanges climbed onto the head of the outer rail before derailing to the outside of the curve. This is supported by two sets of impact marks to the chairs supporting the outer rail (figure 7).

- 40 The RAIB considers that it was the right-hand leading wheel on the leading bogie of the eleventh wagon (BHQ 17121) that derailed first. RAIB experience of flange climb derailments and derailment theory³ indicates that the leading wheel on a bogie is much more likely to climb the outer rail on a curve than the trailing wheel, because the *angle of attack* between the wheel flange and the rail will be larger and because it is likely to run closer to the outer rail. Gotcha wheel weight data from before the derailment showed that the leading wheel on this wagon was also significantly lighter than it should have been (paragraph 46). The wheels on both the 10th and 12th wagons had close to the normal load, making them less susceptible to derailment. It is likely that the trailing wheelset on the same bogie was the second to derail, with its flange climb assisted by the increased angle of attack due to the leading wheelset being turned towards the outside of the curve after it derailed.

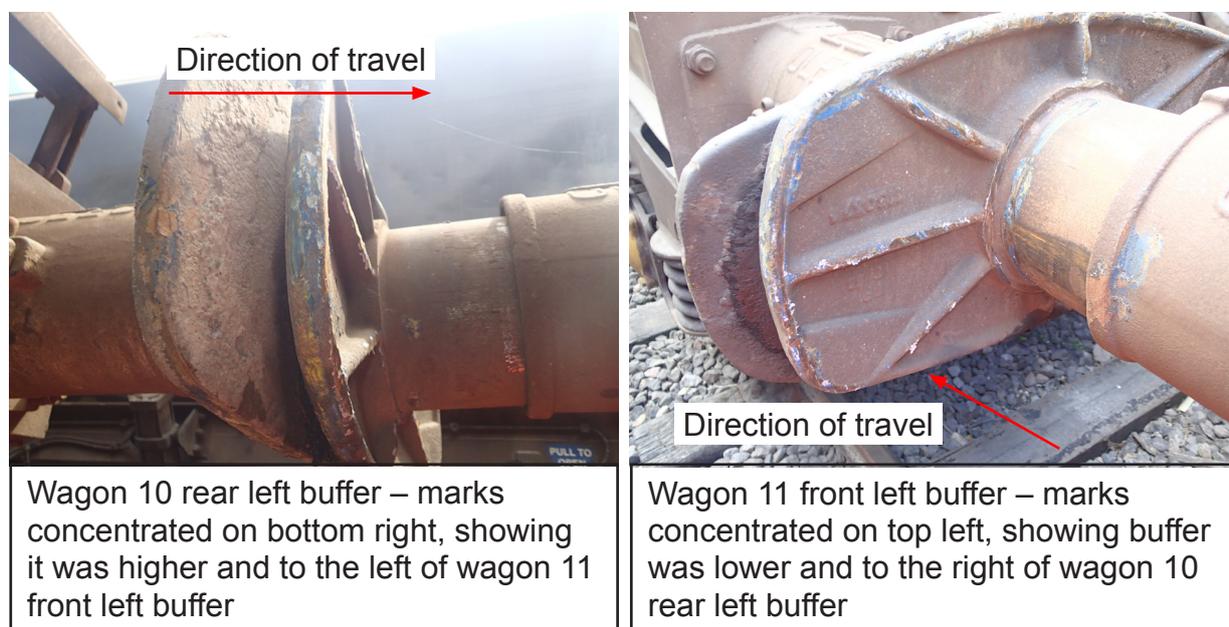
Figure 8: Buffer marks (shown after wagons had been rerailed)

- 41 The marks on the *buffers* of the 10th and 11th wagons (figure 8) are consistent with this derailment sequence, because they indicate that the front bogie of the 11th wagon derailed to the right-hand side of the train and dropped off the rails while the 10th wagon was still on the rails. This is evidenced by the buffer face marks being concentrated on the top left-hand corner of the front left buffer of the 11th wagon and on the bottom right corner of the rear left buffer on the 10th wagon.

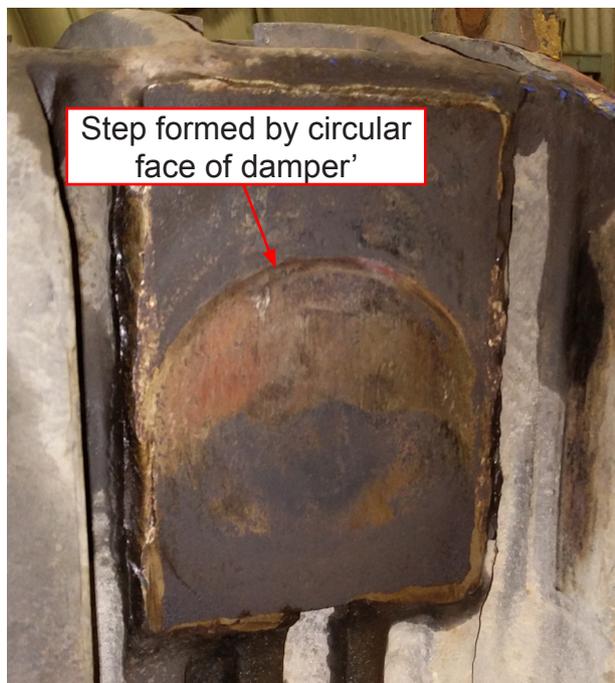
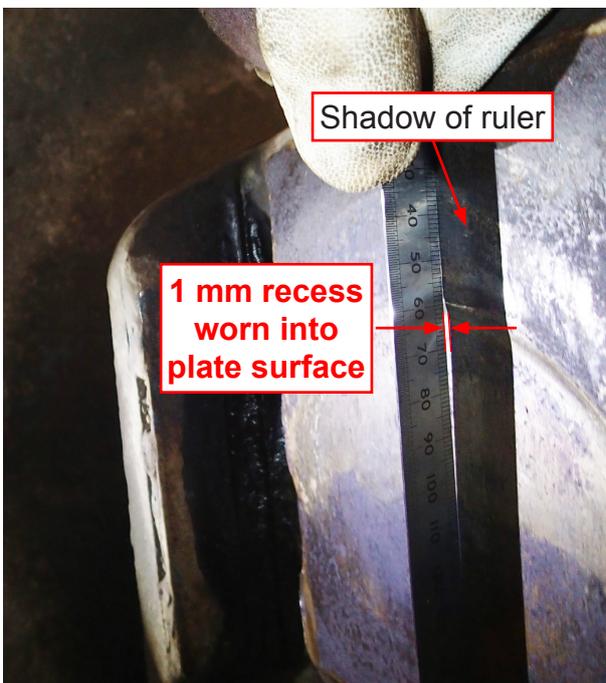
Figure 11: Worn axle box longitudinal wear plate

- 53 The RAIB observed the stripping down of the leading bogie of wagon BHQ 17121 to identify the cause of the locked suspension. The longitudinal wear plate (paragraph 36) on the front right-hand wheel's axle box had become worn such that there was a step change in profile of approximately 1 mm just above the position where the damper contacted it when the suspension was in the laden condition. The wear pattern and recess are shown in figure 11. The relatively unworn wear face of the damper is shown in figure 12.

- 54 This change in profile meant that the damper entered a recess that was approximately 1 mm deep when the wagon was laden, and was then unable to slide out of the recess onto the less worn surface that it would normally contact when the wagon was unloaded.

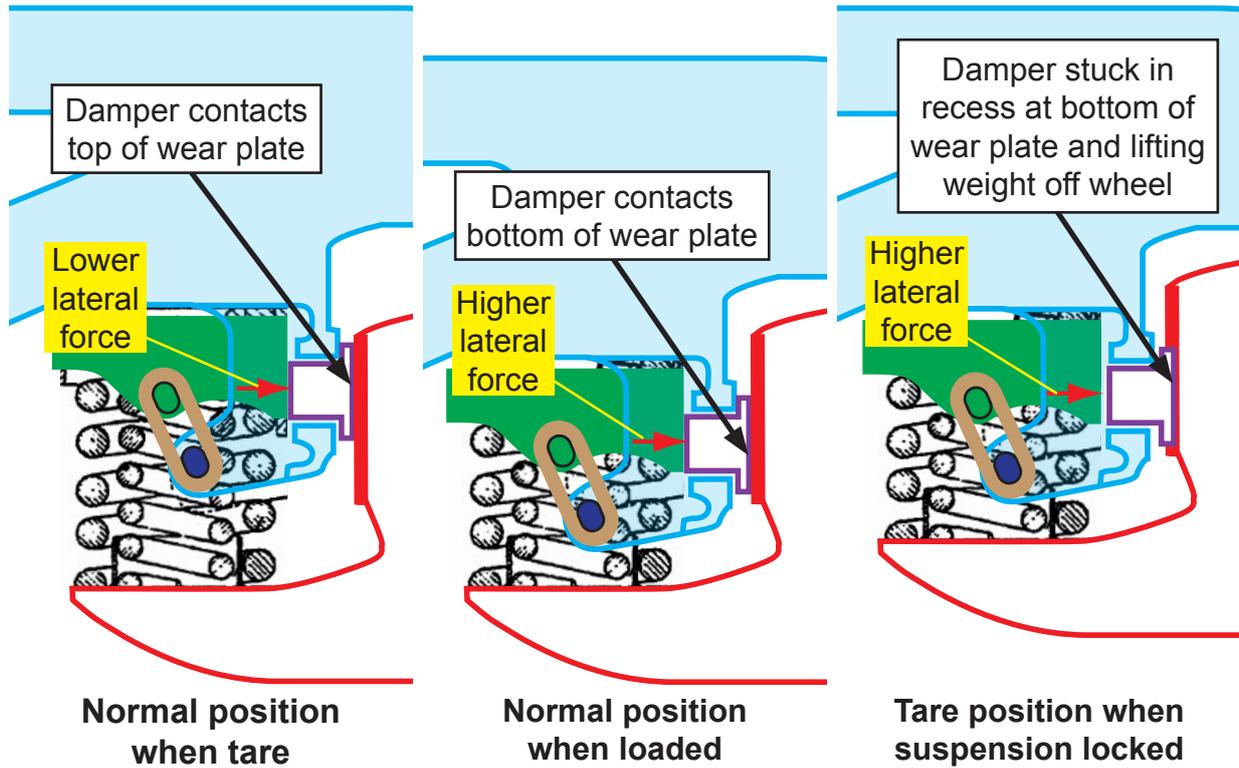
Figure 13: Suspension locking mechanism

- 55 Because the wagon normally operates either empty or heavily laden, the damper normally contacts the wear plate in one of two positions (figure 13). When the wagon is empty, the damper contacts the wear plate at the top, with a relatively low contact force. When laden, it contacts it nearer the bottom, with a larger force (paragraph 36). This means that the bottom of the wear plate is likely to be subject to more wear than the top, thus promoting the observed wear profile. Figure 13 shows the mechanism by which the change in wear plate profile, combined with the suspension and damper forces, prevented the suspension from moving to the correct unladen position.

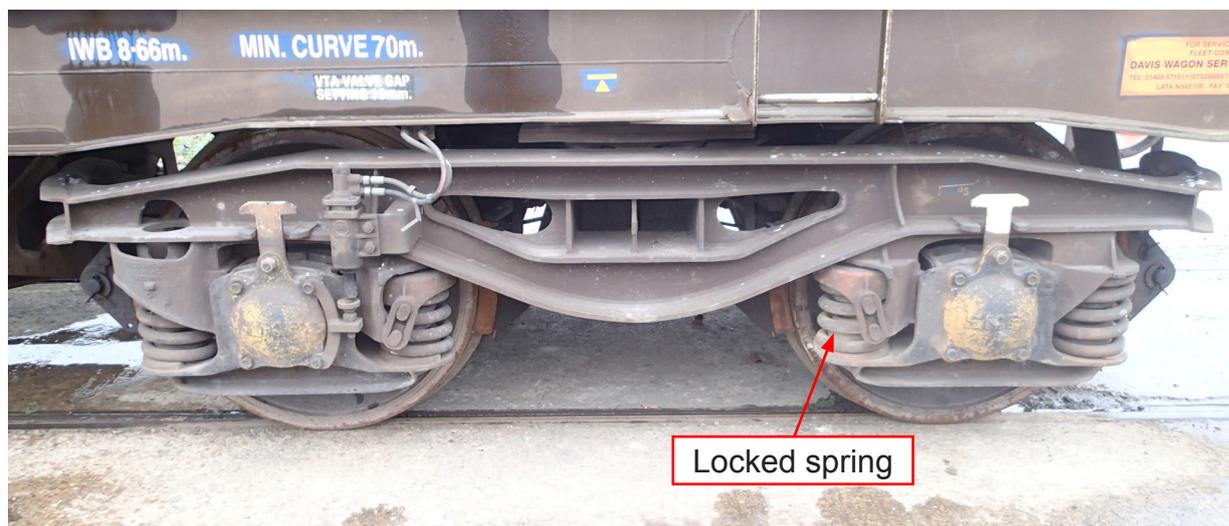
Figure 14: Wagon BHQ 17121 leading bogie – wheel with locked suspension on the right

- 74 Figure 14 shows the right-hand side of the leading bogie, with the wheel with the locked suspension on the right. Visually it is not obvious that the springs in the leading wheel are locked in the compressed position, as they do not appear to be significantly different in position from those on the trailing wheel. This demonstrates that it is probable that the locked suspension would not be identified by the visual inspections included in PPM and VIBT. The locking could be identified by measurement of, or observing the position of, appropriate components in the suspension, but this was not a specified part of PPM or VIBT.

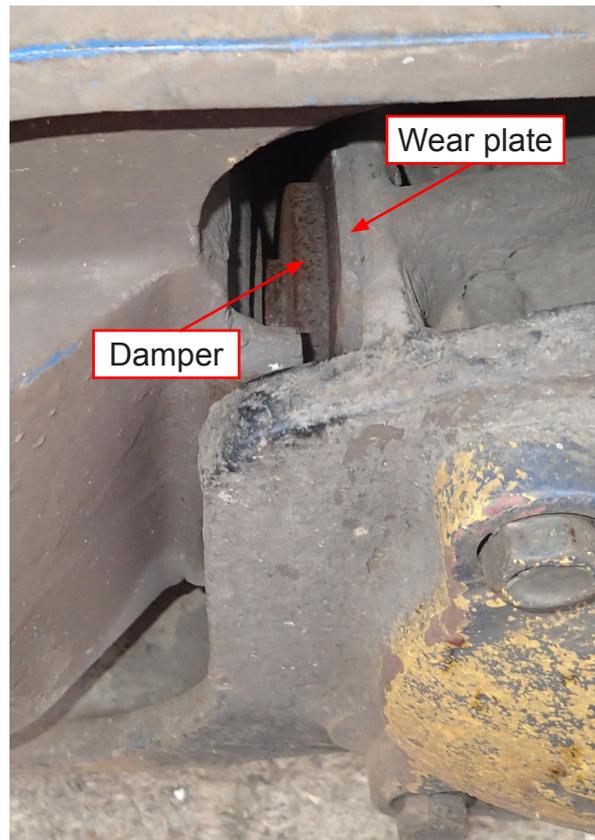
Figure 15: Visibility of the wear plate with the suspension fully assembled

- 76 During PPM and VIBT, this check is undertaken with the suspension fully assembled, and so it is not possible to see all of the surface of the wear plates, particularly the part being hidden by the damper. Figure 15 shows that only the top edge of the wear plate is visible when viewed from above, while the view from below is even more restricted. This makes it impossible to check for wear over the part of the wear plate that is being contacted by the damper, and hence the part that is being worn. Inspection of this area would require the suspension to be dismantled, which is not specified as part of the PPM/VIBT. The difficulty in seeing most parts of the wear plate surface means that the plate thickness can only be measured at the top edge, where the wear is not present, unless the suspension is dismantled.

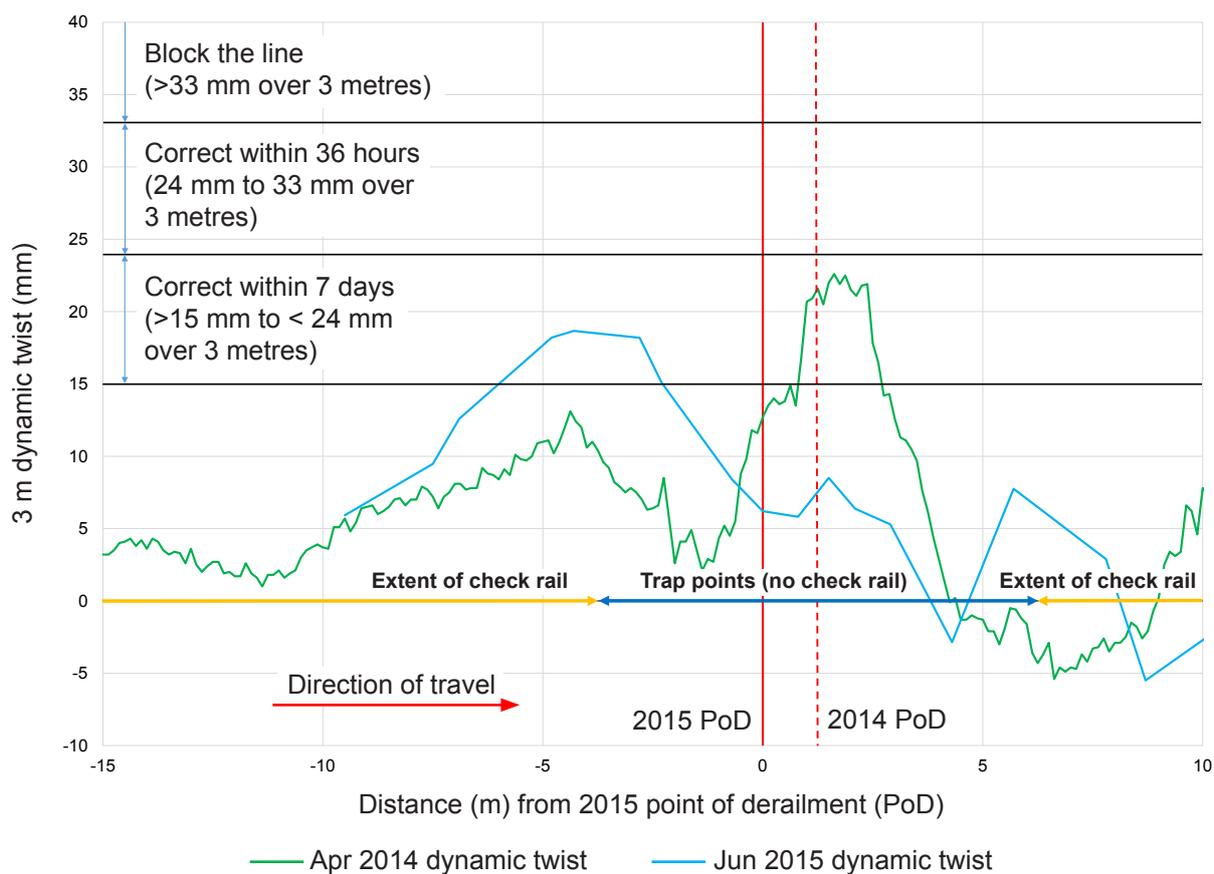
Figure 18: Track twist in the vicinity of the derailment location

- 88 Network Rail standard NR/L2/TRK/001 'Inspection and maintenance of permanent way' places limits on the amount of track twist that is allowed to be present on the network, and defines timescales within which track twists that exceed those limits should be corrected. The three metre dynamic track twist limits, and the actions required, for track with the curvature and speed limit present at the derailment location are annotated on figure 18.

- 89 The 3 metre dynamic twist at the point of derailment was well within these limits, measuring 6 mm, or an average gradient of 1 in 500. This was much less than the 22 mm that was present at the point of derailment on 2 April 2014.

- 90 However, the June 2015 survey found twist reaching a maximum of 18 mm on the approach to the point of derailment. This exceeded the first maintenance action limit of 15 mm for a distance of approximately 4 metres until 2.5 metres before the point of derailment. The first 3 metres of track that exceeded the first maintenance intervention limit was within the section of line that had a check rail, and so had additional derailment risk mitigation when compared to the last metre. There were no marks on the rail head to indicate that the derailed wheel had climbed onto the rail head in the 4 metre length that exceeded the first maintenance intervention limit.
