Rail Accident Investigation Branch

Rail Accident Report

PROGRESS REPORT: Derailment at Grayrigg, Cumbria 23 February 2007

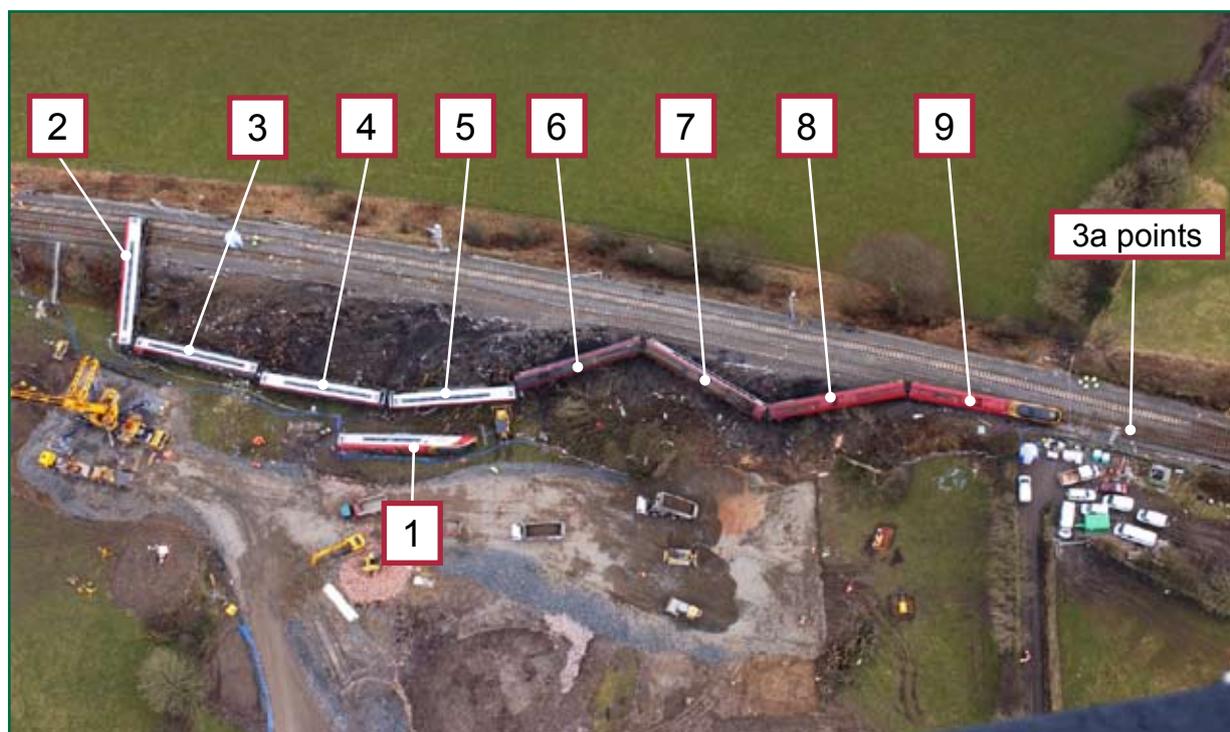
Figure 6: The train in its final position

- 39 Vehicles three to nine stayed attached to each other and followed vehicle two running derailed mainly on the down line, before sliding over the edge of the embankment and coming to rest at various positions along its northern slope. At some point late in the train's trajectory, the coupler between vehicles three and four parted.

- 40 Vehicle nine, the last vehicle in the train, ran derailed on the down line attached to vehicle eight and stopped with its front part-way down the embankment's northern slope, coming to rest with its cab just past 3A points. Figure 6 shows the train in the position where it finally stopped.

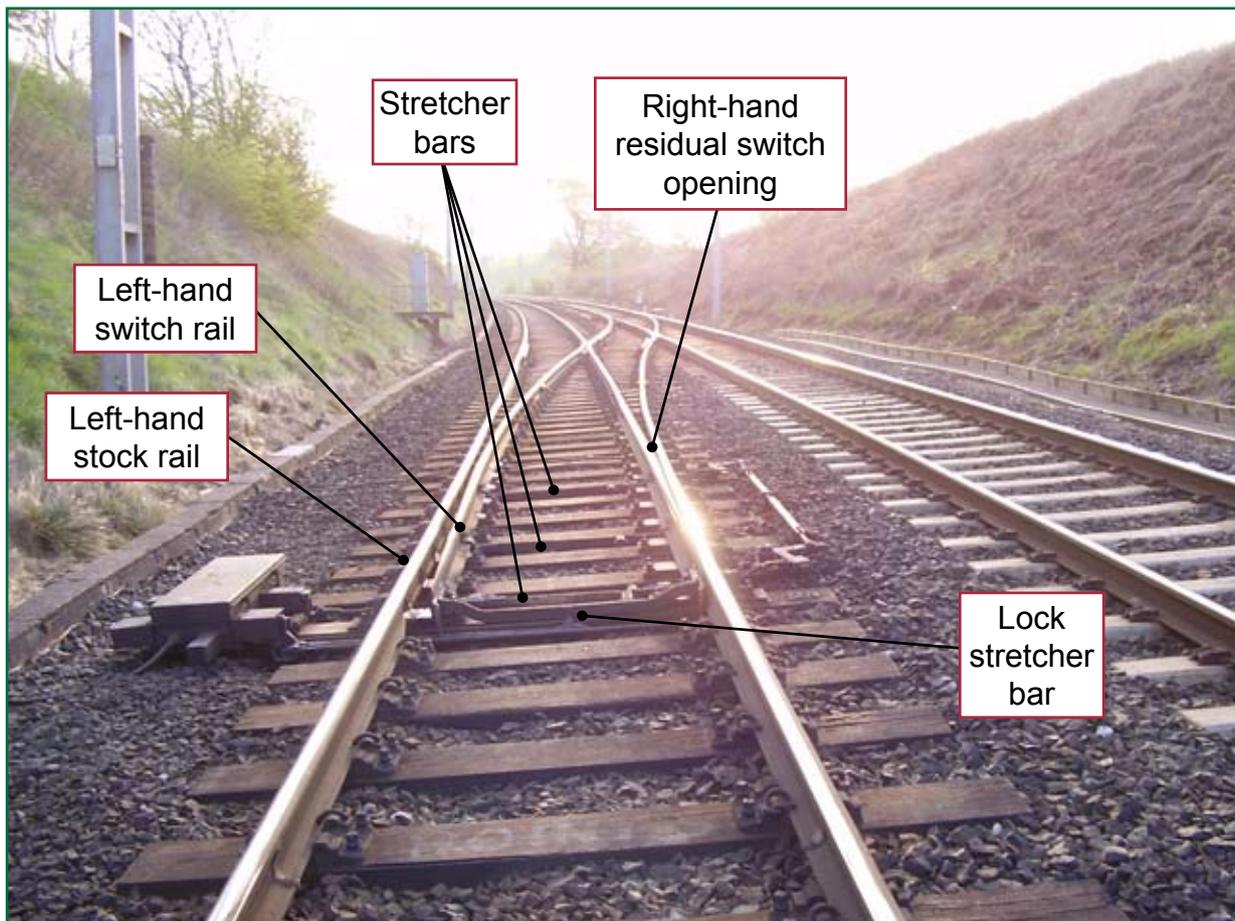
Figure 8: Lambrigg 2B points, May 2006 (Courtesy of Network Rail)

- 66 During 2004, the *Omnisurveyor3D* route photography train ran past Lambrigg on the down line. The RAIB's study of the video taken on that run showed a *residual switch opening* in the vicinity of the third stretcher bar (on the closed side) in 2B points that was between 6 and 8 mm. This exceeded the nominal 1.5 mm gap specified by Network Rail in standard RT/E/C/11772, Supplementary Point Drives and Detection, clause 4.1.2. For longer switches of type F⁴ (turnout speed 45 mph - 54 mph (72 km/h to 86 km/h), depending on the crossing angle) and above, *supplementary detection* is provided at the stretcher bar attached to the *supplementary drive*. Standard RT/SMS/Test/016 specifies that the supplementary detection must operate when the opening is 6 mm, but must fail when it is 8 mm. Whilst this implies that the residual switch opening can be of this magnitude, the RAIB has been unable to find any evidence that these dimensions were specified other than in consideration of the correct functioning of the supplementary detection system.

- 67 A still photograph taken in May 2006, during a routine inspection of the track, gives evidence that an excessive gap was still in existence (Figure 8).

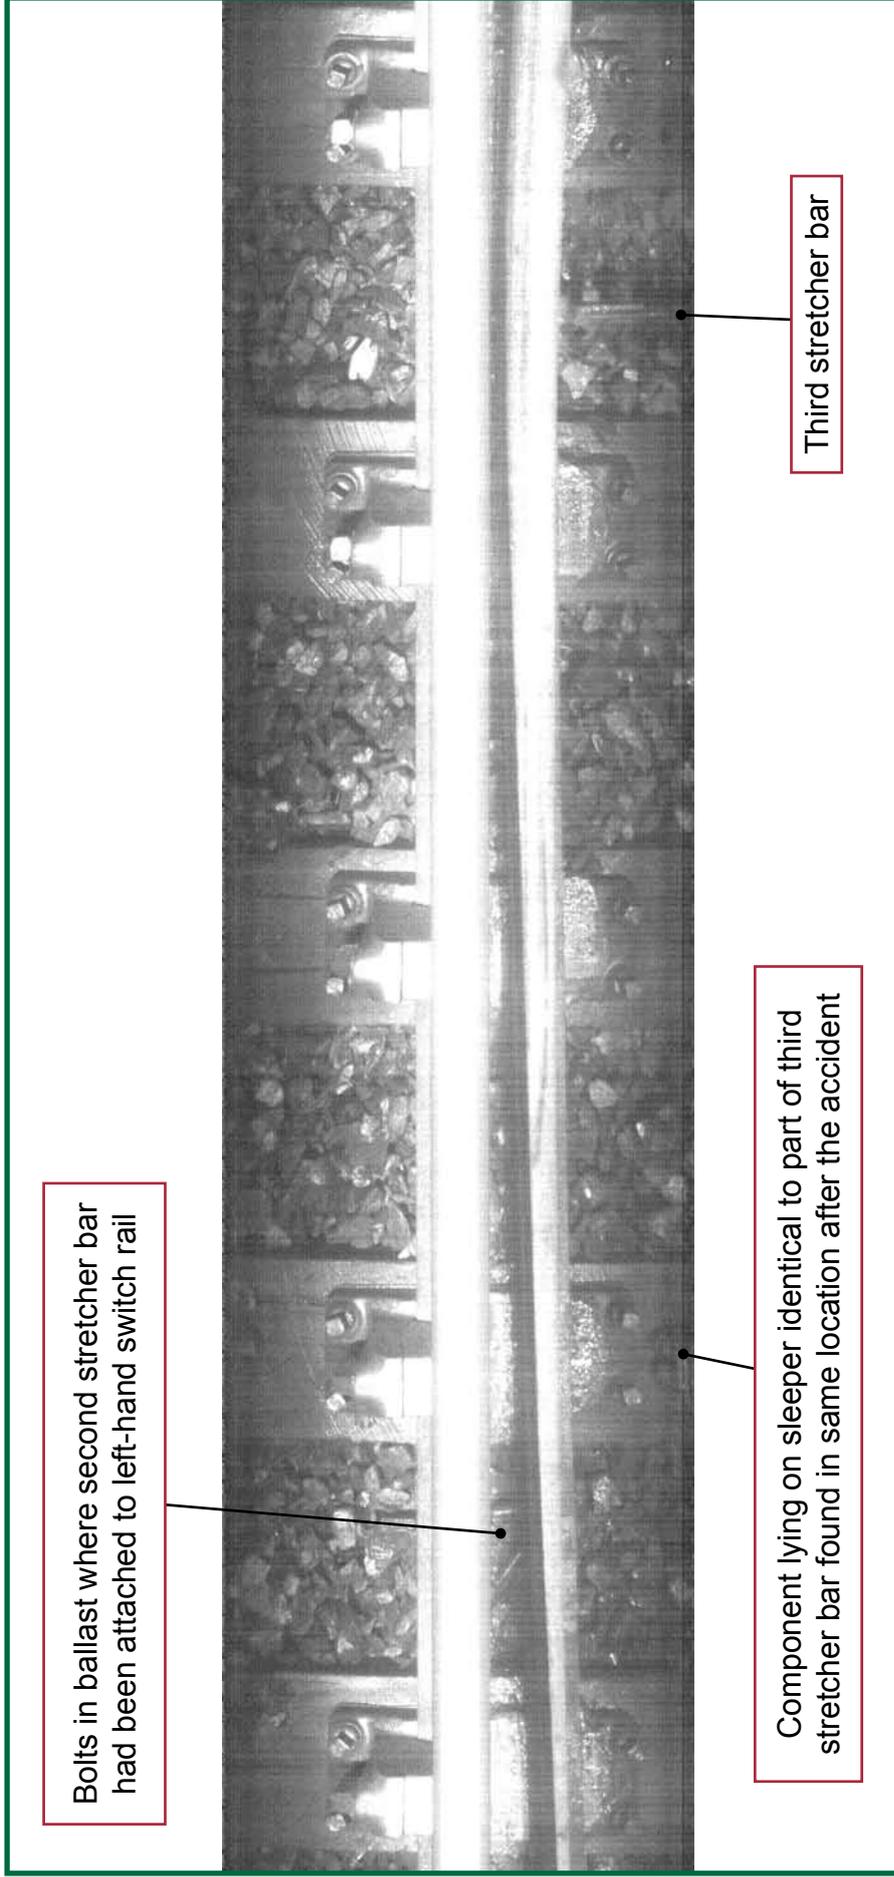
Figure 9: Cybernétix IVOIRE III image taken on 21 February 2007 showing second stretcher bar to be missing

- 69 On 21 February 2007, the NMT ran through Lambrigg on the down line. The NMT is equipped to measure various parameters, and was additionally fitted with experimental *Cybernetix IVOIRE III* equipment, which had only become operational shortly before the run on 21 February 2007 (having been on trial until then). The output from this equipment included vertical photography of the track and shows the second stretcher bar on 2B points to be missing. The photographs also show bolts in the ballast where the second stretcher bar used to be attached to the left-hand switch rail. The third stretcher bar is present but had failed. Its failure is indicated by a reduced free wheel clearance of 20 - 25 mm compared with a design minimum of 50 mm. One photograph from the NMT (Figure 9) also shows a component lying on a sleeper that is identical to the part of the third stretcher bar found in the same location after the accident, confirming that this stretcher bar had failed prior to the accident. The NMT was also equipped with a video camera that recorded the wheel – rail interface, and the recording of 21 February 2007 shows the wheel pushing the switch rail clear of its path as it runs through the switch, confirming the reduction in the free wheel clearance.

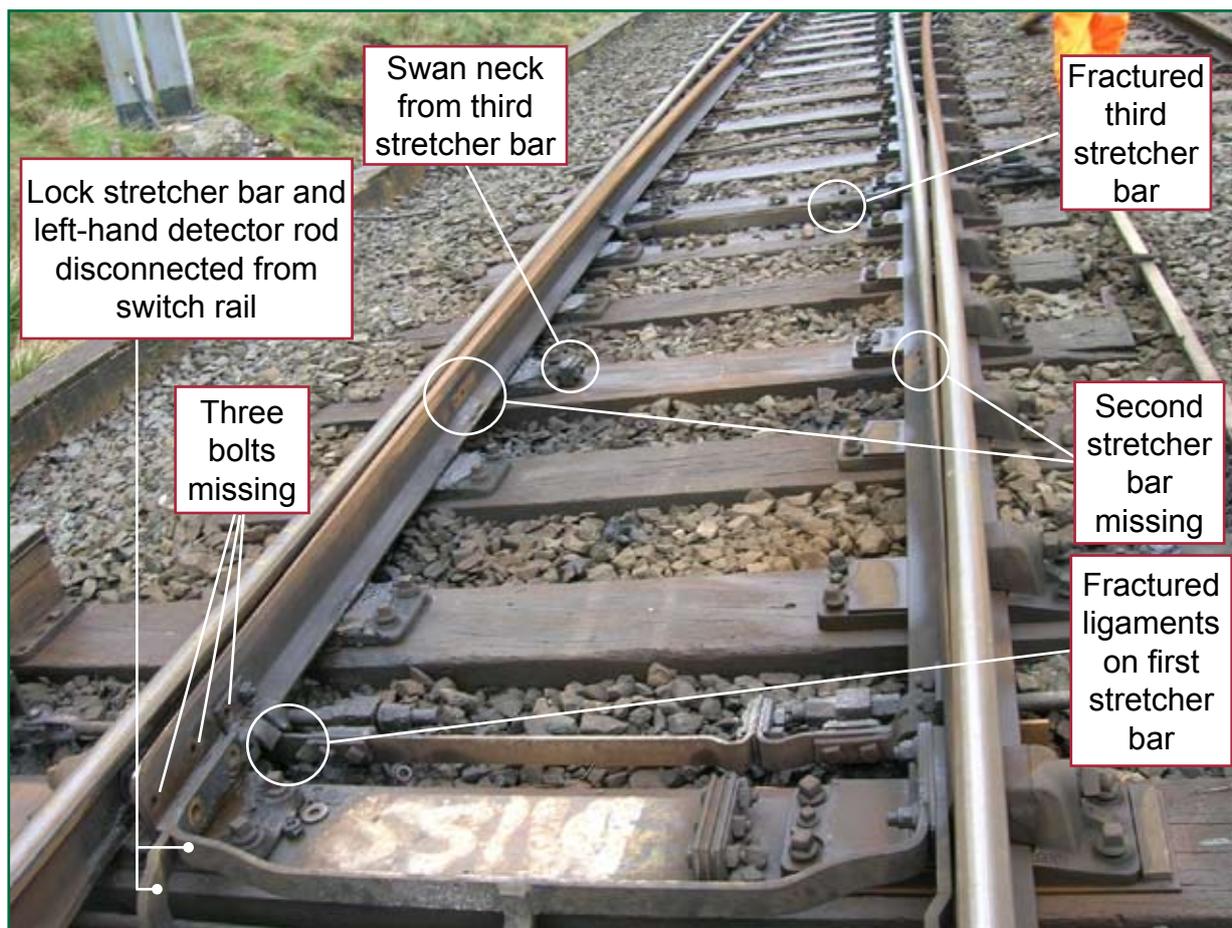
Figure 10: 2B points on 24 February 2007 (Courtesy of Network Rail)

81 The following is a summary of the condition of key components in 2B points immediately following the derailment (Figure 10):

- The lock stretcher bar and the left-hand detector rod connection were detached from the left-hand switch rail by a failure of the two threaded fasteners. These fasteners are $\frac{3}{4}$ -inch Whitworth bolts with Aerotight prevailing torque nuts and plain washers. All fastener components were present in the vicinity of the switch toes, with the exception of one of the bolts which was not found despite a full search. The photographs from the NMT taken on the 21 February 2007 (see paragraph 69) clearly showed both the bolts and their nuts to be present (Figure 12).

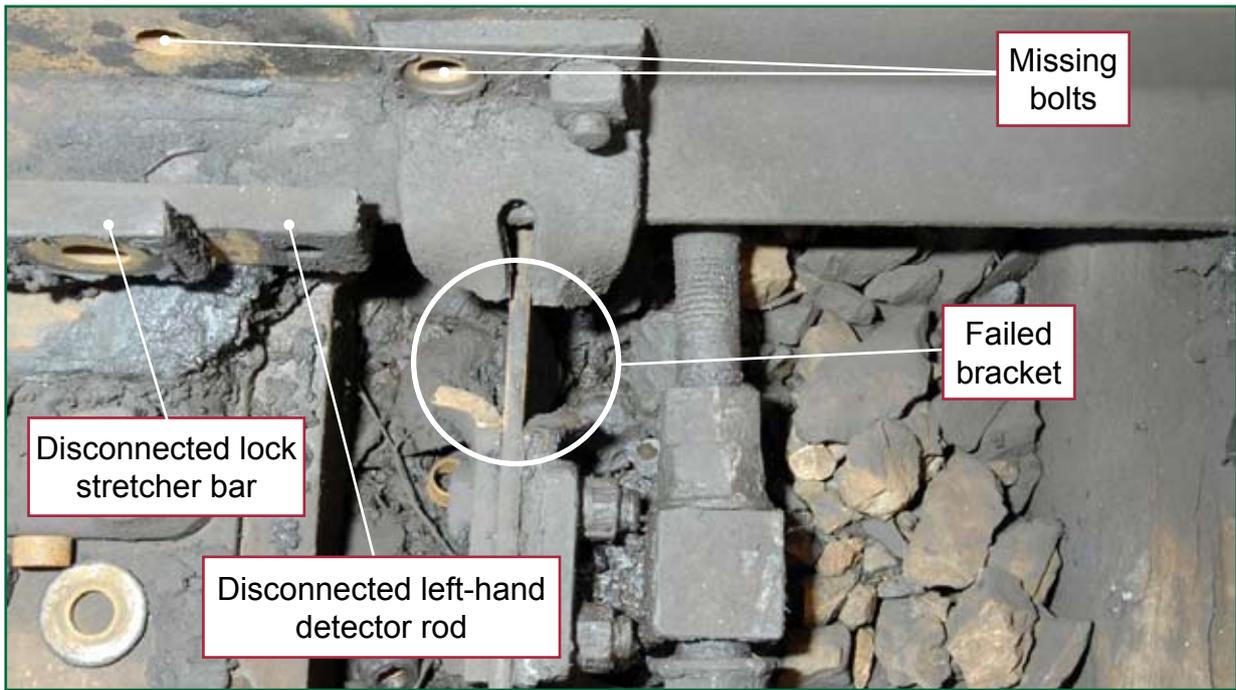
Figure 11: Failed bracket and missing bolt from first permanent way stretcher bar (24 February 2007)

- The first permanent way stretcher bar was found to be broken on both *ligaments* of its left-hand switch rail bracket close to where it is bolted to the stretcher bar itself. The fasteners are $\frac{3}{4}$ -inch Whitworth bolts and nuts made of mild steel with a single coil *spring washer* and are used for all permanent way stretcher bar fasteners on this type of points. One of the fasteners was not present between the bracket and the switch rail, while the other fastener was assembled, but only finger tight. A bolt, nut and spring washer from the bracket connection were found under the switch rail lying on the ballast (Figure 11). The photographs from the NMT taken on the 21 February 2007 (see paragraph 69) similarly showed both the bolts and their nuts to be present, although it is possible that one of the nuts may have been loose (Figure 12).

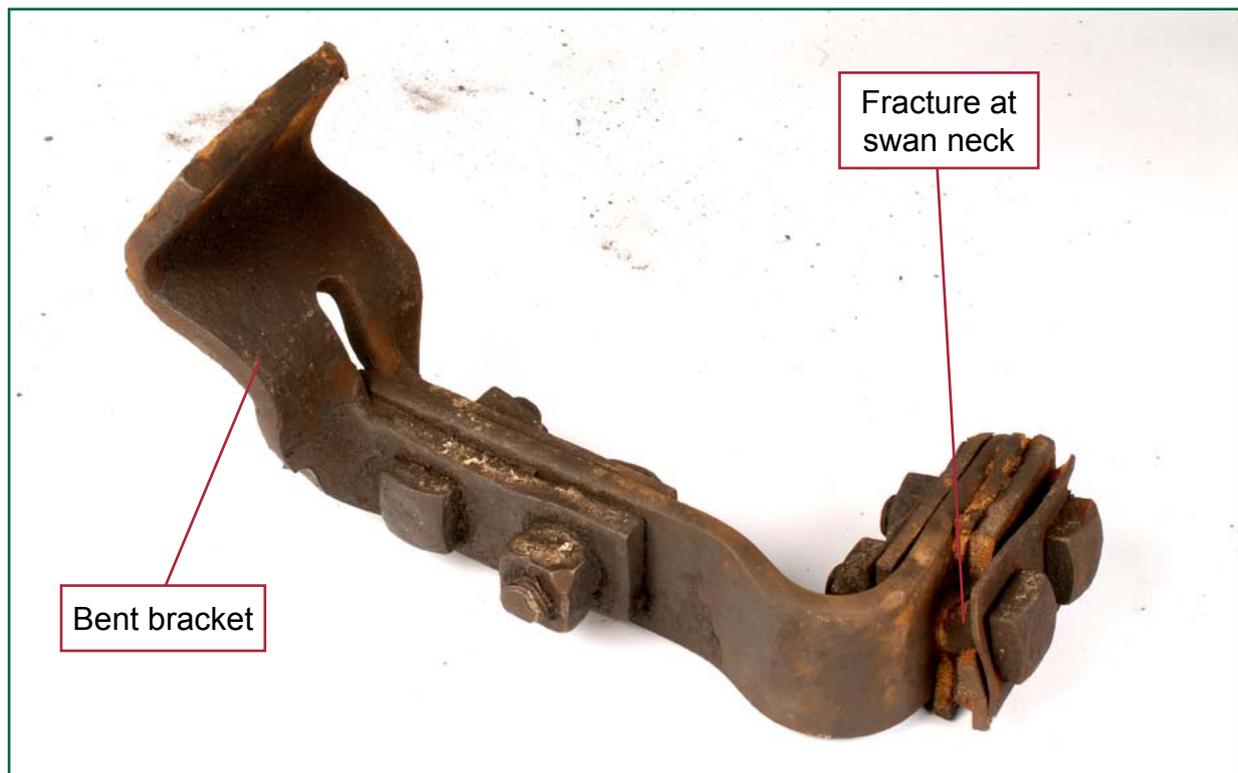
Figure 13: Short section of second permanent way stretcher bar

- The second permanent way stretcher bar was found to be missing from the points. All fastener components were present in the ballast in the vicinity of where the bar would have been, with the exception of the right-hand switch rail bolts which were still within the right-hand switch rail bolt holes. A short section (see paragraph 20) of a stretcher bar was found 50 metres towards Glasgow from the points. A long section was found on the embankment slope close to the train. The matching of length and fracture surfaces of these two sections indicates that it is most likely that they were the two sections of the second stretcher bar from 2B points (Figure 13). Metallurgical analysis shows that the two sections had failed by overload, and not by fatigue.

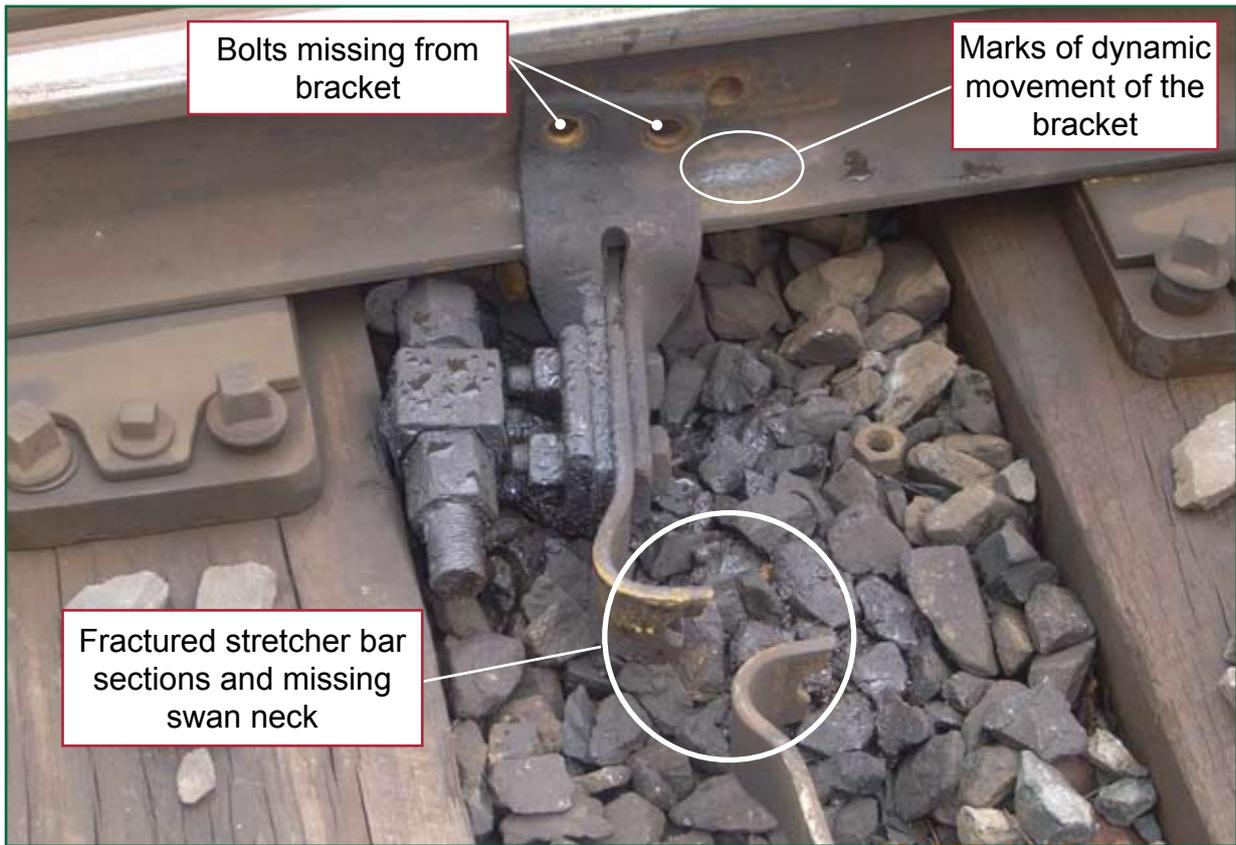
Figure 14: Failed third permanent way stretcher bar (25 February 2007)

- The third permanent way stretcher bar was found in place but broken (Figure 14). There were two points of fracture, both at vertical planes through the respective bolt holes between the short, right-hand end and the long, left-hand end within the *swan neck insulation* assembly. The fractured end of the swan neck insulation assembly was found in the *four-foot* on the third *bearer* before the third stretcher bar close to the left-hand *slide chair* (Figure 15). In addition, the bracket at the right-hand end of the bar was not connected to the switch rail (Figure 14). The bolts that had been fitted on 7 January 2007 were found in the ballast below the switch and stock rails, with the nuts and washers also in the same vicinity. The condition of the nuts and bolts (damaged from progressively working free from the bolt holes) indicates they had wound undone, and had neither broken nor had the nuts been pulled off the threads (Figure 16).

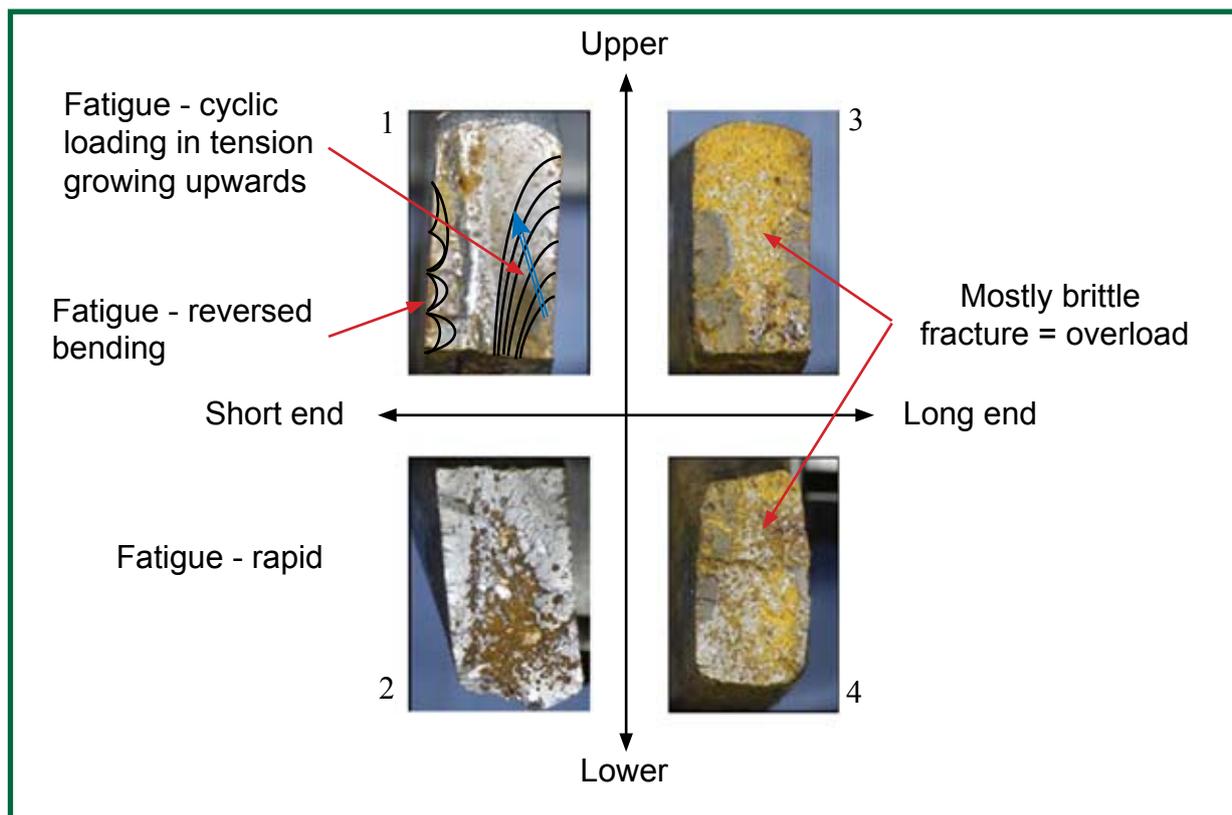
Figure 18: Fatigue failures on third stretcher bar swan neck attachment

- The failure of the right-hand side fasteners on the third permanent way stretcher bar allowed the left switch rail to relax towards its stock rail to such a degree that wheels passing through this gap were in flange back contact with the left switch rail with an interference of the order of 3 mm. As a result the left-hand switch rail was pushed over by 3 mm by every wheel that ran through the points. This repeated contact between the wheel-back and back of the switch rail generated a *cyclic loading* in the third stretcher bar which resulted in the completion of a *fatigue failure* of the short section of the third stretcher bar (Figure 18). The fracture surfaces show that a fatigue crack had been present to some extent for a long period of time and had been slow growing, but the rate of fatigue had accelerated rapidly in a very short period before final failure. Evidence from the SGT indicated that this fatigue failure of the stretcher bar had occurred by 12 February 2007.

- The consequent loss of integrity of the third stretcher bar allowed the left switch rail to relax further towards its stock rail, resulting in the free-wheel clearance now reducing from about 49 mm to 35 mm. This resulted in a more severe interference, with the left-hand switch rail pushed over by 21 mm by every wheel, which imposed higher cyclic loads on the remaining stretcher bars (two and one) and on the lock stretcher bar.

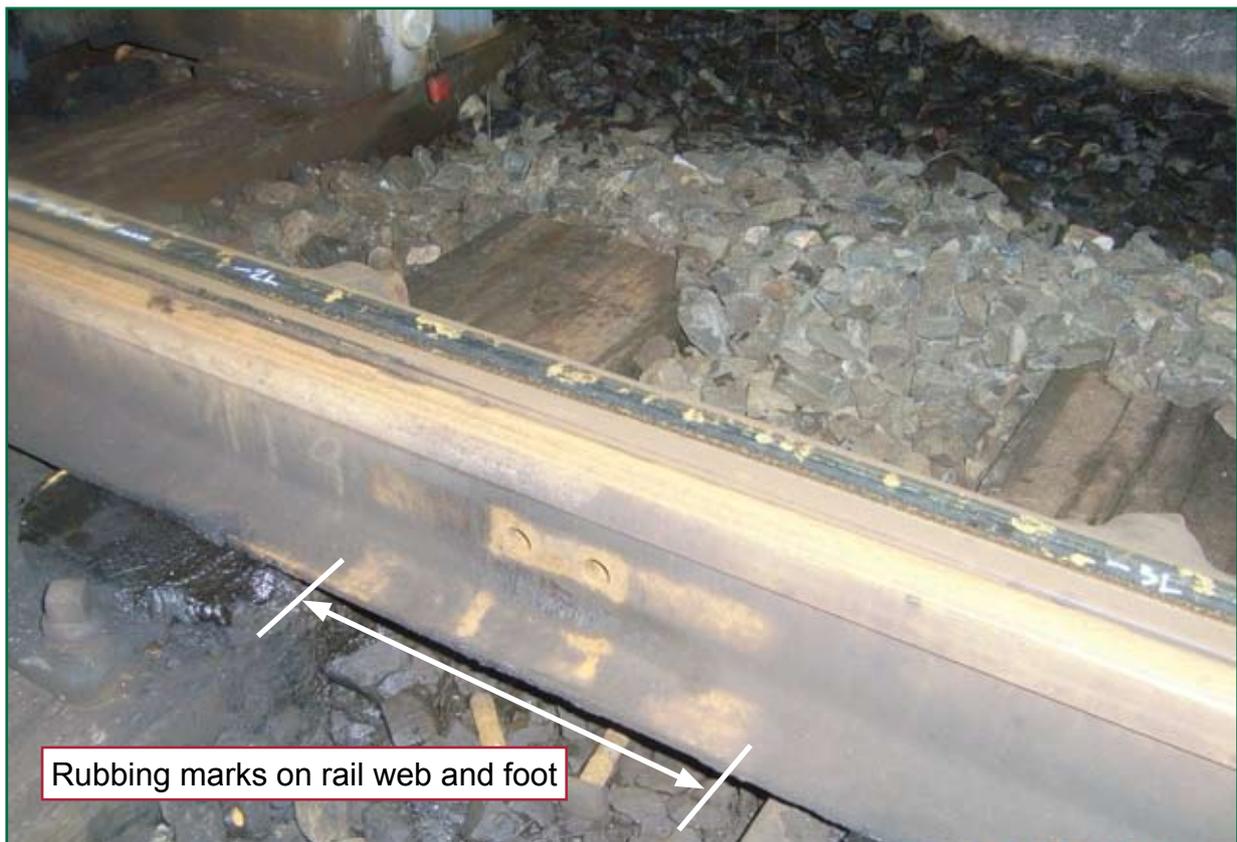
Figure 19: Marks on rails showing limits of movement of second stretcher bar

- It is believed that the brackets on both sides of the second stretcher bar became loose as a result of the loads and vibration induced by the repeated wheel strikes, and eventually this stretcher bar became detached from the rails. From the marks on the left and right-hand switch rails (Figure 19), it is likely that, once loose, it dropped and became caught between the switch rails until the subsequent passage of a train caused it to be squeezed up and carried along, fracturing into the two sections (see paragraph 69) which were deposited separately along the track. Evidence from the NMT indicated that this had occurred by 21 February 2007.

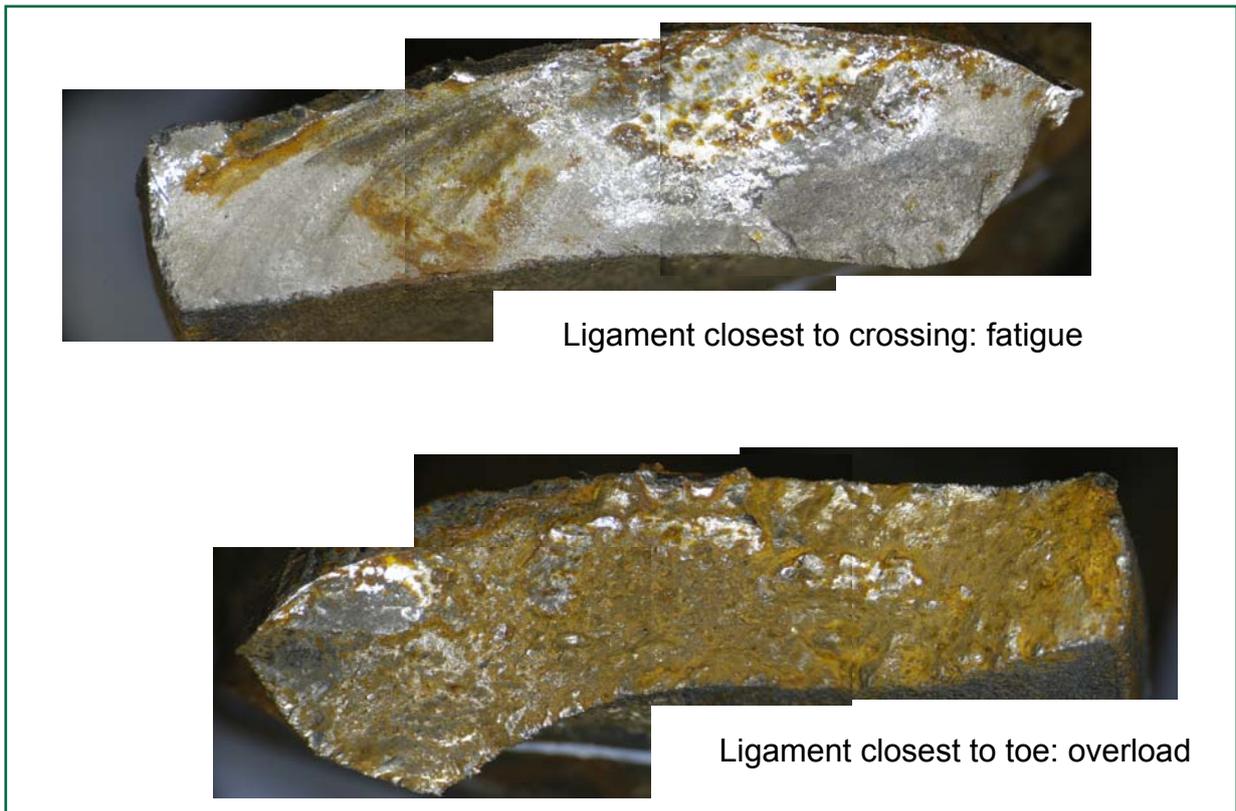
Figure 20: Fatigue and mechanical failure surfaces on ligaments of first stretcher bar bracket

- The loss of restraint by the second stretcher bar allowed the left switch rail to close further resulting in yet greater cyclic loading on the single remaining permanent way stretcher bar (the first stretcher bar) and the lock stretcher bar. This caused the ligament closest to the crossing on the left-hand first stretcher bar bracket to fail due to fatigue, which in turn caused the other ligament (closest to the switch toe) to fail by overload (Figure 20). The fracture surfaces are consistent with this analysis. During the period of time bounded by the second stretcher bar failing and the accident, the left-hand rail fasteners on both the first stretcher bar and the lock stretcher bar became loose with both of the lock stretcher bar fasteners and the fastener closest to the toe from stretcher bar one falling out of the bolt holes in the switch rail. One of the bolts from the lock stretcher bar fell between the switch rail and the stock rail, and remained there until after the derailment (Figure 21). The lock stretcher bar fasteners are longer than the permanent way stretcher bar fasteners. Despite extensive analysis of the bolts, grease marks showing where they fell out, and the fracture surfaces on the failed ligaments, it is not possible to be certain in which order the failures of the ligaments on the first stretcher bar and the fasteners on the lock stretcher bar occurred. However, it is certain that these were the two final failures.

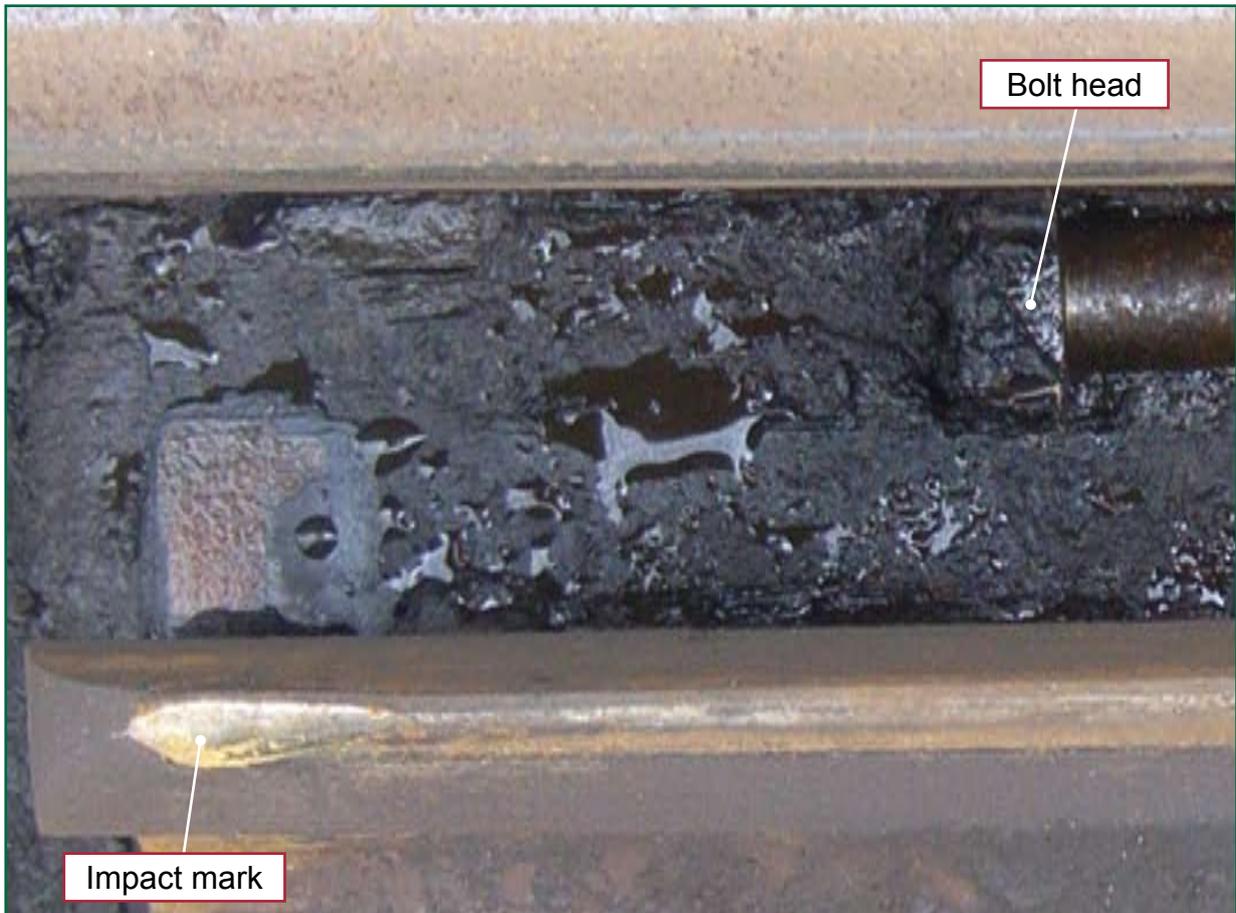
Figure 21: Bolt from lock stretcher bar lying between left-hand switch and stock rails - also shows damage from wheels striking switch toe (24 February 2007)

- The natural spring in the rail of the now unconstrained left-hand switch rail caused it to move so that it closed up to its adjacent stock rail as far as the bolt, trapped between the switch rail and its adjacent stock rail, would allow. This gave a toe opening of about 22 mm; sufficient for left-hand wheel flanges to pass to the right of the left-hand switch rail and be forced into derailment because of the narrowing gauge between the two switch rails.

- There were strike marks where the left-hand wheels of some wheelsets had struck the tip of the left-hand switch blade which had become free due to the failure of the stretcher bars. These wheels were then forced to follow the left-hand switch into the turnout route while the right-hand wheels proceeded along the right-hand switch blade of the down line. As the wheelsets encountered the reducing track gauge (as the switch rails converged), they were squeezed out of the track and into derailment (paragraph 33). Marks on the points showed that at least four wheelsets derailed at 2B points. Work is ongoing to establish which wheelsets derailed in this area.

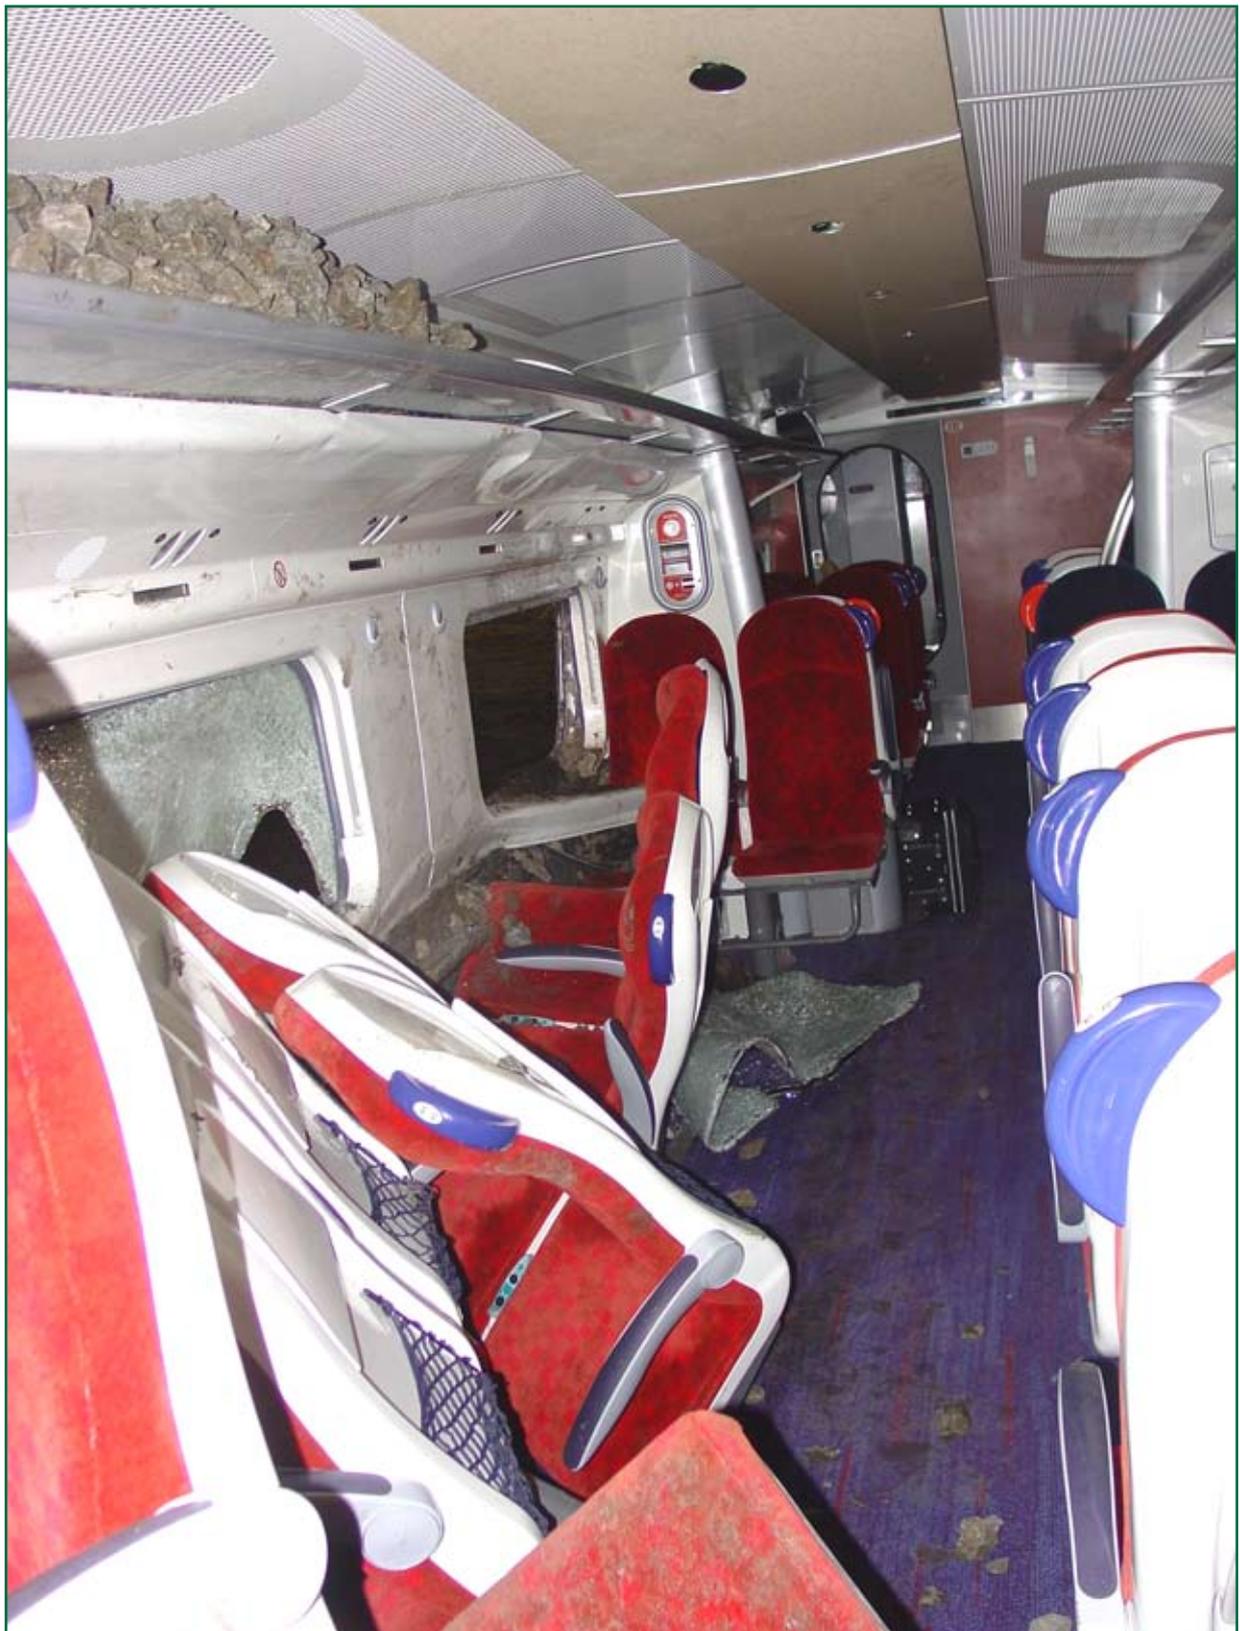
Figure 22: Dislodged seating in vehicle two

- With regard to the interior of the train, significant damage was limited to vehicles one and two and included six broken luggage rack lighting panels in vehicle one, detached seating units and some fractured table legs in both vehicles (the tables remained in place because the attachments to the side of the vehicle did not fail).
