Rail Accident Investigation: Interim Report

**Partial failure of a structure inside Balcombe
Tunnel**

23 September 2011

Report IR1/2013
January 2013

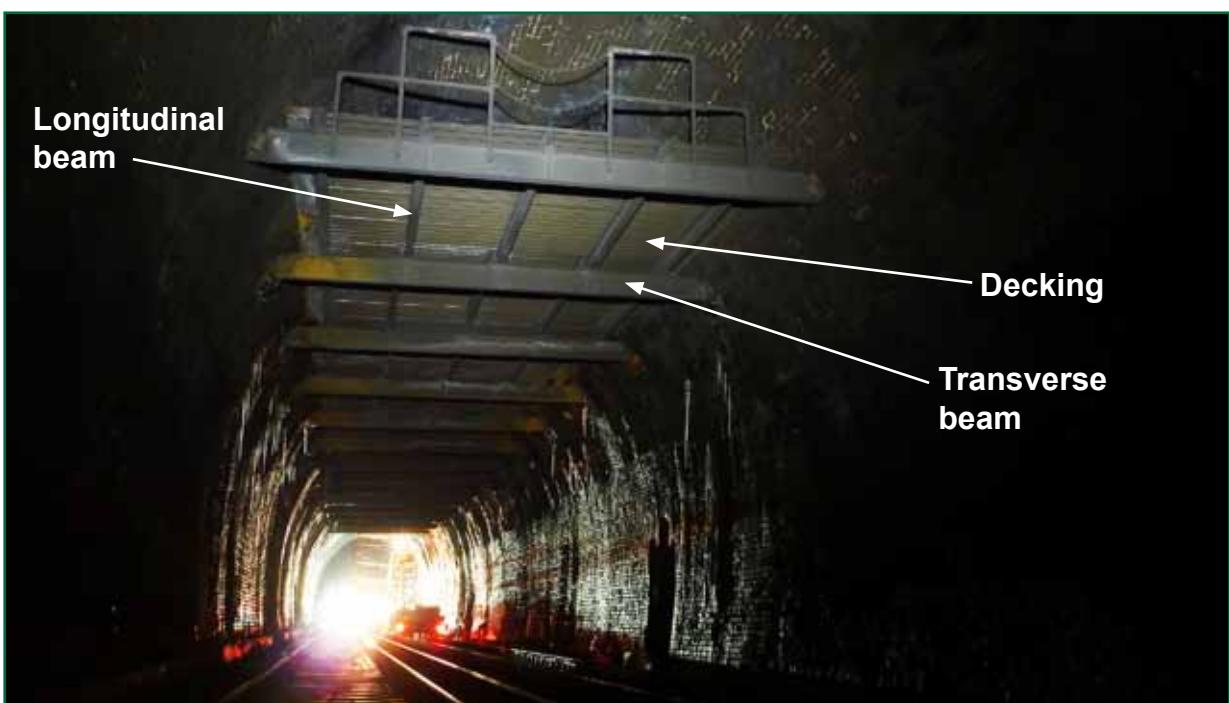
Figure 2: Water catchment tray structure

7 The water catchment tray involved in this incident (figure 2) was installed in 1998/99 and was 72 metres long. (It was shortened after the incident.) It comprises a deck, supported by longitudinal beams which in turn rest on transverse beams. The transverse beams are about six metres long and are located at four metre intervals. The beams are bolted to brackets supported by studs which are grouted⁴ into holes drilled in the tunnel brickwork, two on each side of the beam end (figure 3).

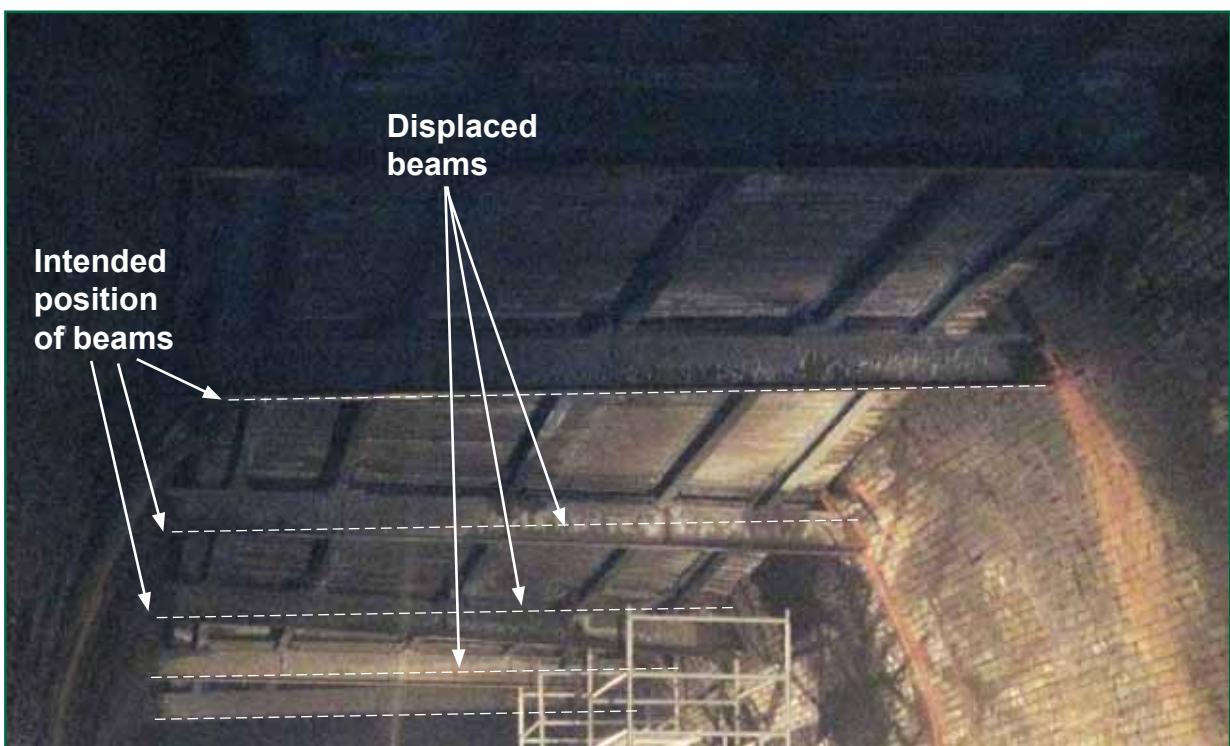
Figure 4: Deflected structure (photo courtesy of ORR)

- 8 Following the train crew's earlier report a Network Rail inspection on 23 September established that, on one side of the tunnel, three adjacent transverse beams were detached from the tunnel wall. At these locations, the beam ends had dropped about 0.5 metres (figure 4). The beams were not fouling the path of a train but there was risk of them moving until they did so. The beam ends had become detached because the four studs at each beam end (a total of 12 studs) had fallen from the tunnel wall.

- 10 It is probable that the studs were displaced as the structure vibrated due to the aerodynamic (wind) forces caused by passing trains. This was probably because, for reasons explained below, some studs were not adequately bonded to the brickwork by grout.
- 11 Post incident testing has shown that the grout used to fix the studs into the brickwork did not bond with the engineering bricks⁵ which form the innermost rings of brickwork (figure 3). This testing also showed that, in some locations, the grout was only poorly bonded to the remaining brickwork.
- 12 Witness evidence suggests that a volume of grout used around each stud had been pre-calculated. Post incident testing showed that
- grout was missing along parts of some studs;
 - some grout had escaped into gaps where mortar had been lost from the brickwork; and
 - some holes had been drilled longer than the nominal length.

- 23 Network Rail undertook emergency repairs to the defective part of the structure before train services resumed on 24 September 2011. Subsequently the defective part of the structure has been removed and additional support brackets have been installed under all similar water catchment trays in Balcombe tunnel. Network Rail has established that there are no other similar structures on their infrastructure.

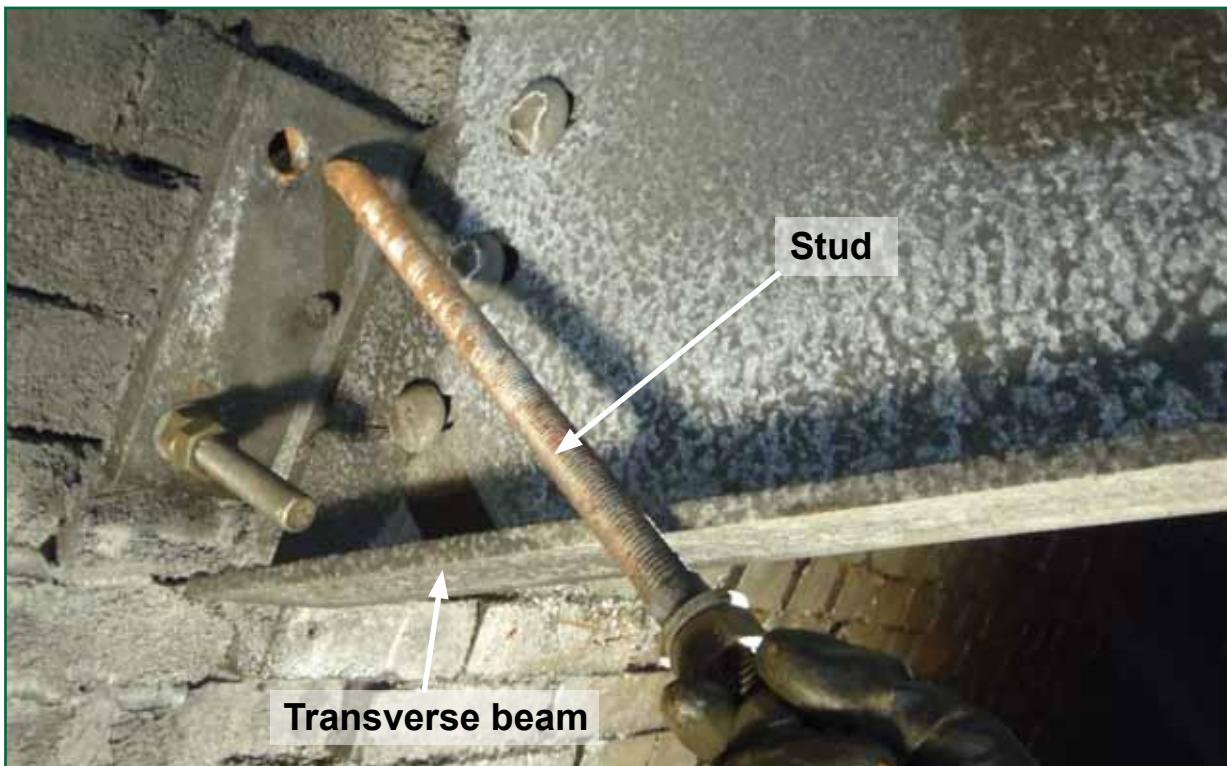
- 9 All similar beam ends supporting water catchment structures in the tunnel were also inspected on the 23 September with the exception of ten beam ends which could not be inspected because they were close to the displaced beams. This inspection showed that, in addition to the 12 studs missing at the detached beam ends, at least six other studs were missing, at least five were loose, and nuts were loose or missing on at least 29 other studs (figure 5).

Figure 5: Loose stud outside incident area removed by hand during inspection on 23 September 2011 (photo courtesy of Amey)
