## FLYER TO THE FISHING INDUSTRY

Fishing vessel *Enterprise* (PD147), fatal man overboard accident, 9 July 2015

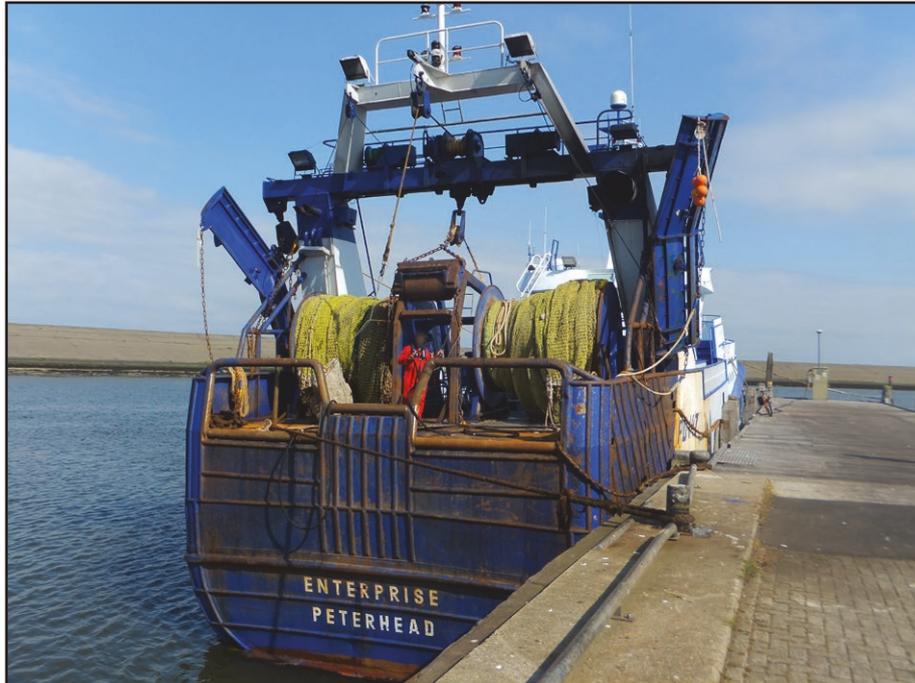
Figure 1: Fishing vessel *Enterprise*

*Enterprise* had been converted from a beam trawler into a twin rigged stern trawler in 2006. Following this conversion the unsafe nature of the deck-level openings created by the net shooting ports was not identified by the vessel's owners or in the vessel's risk assessment despite being clearly non-compliant with the relevant regulations requiring a minimum barrier height of 1m.

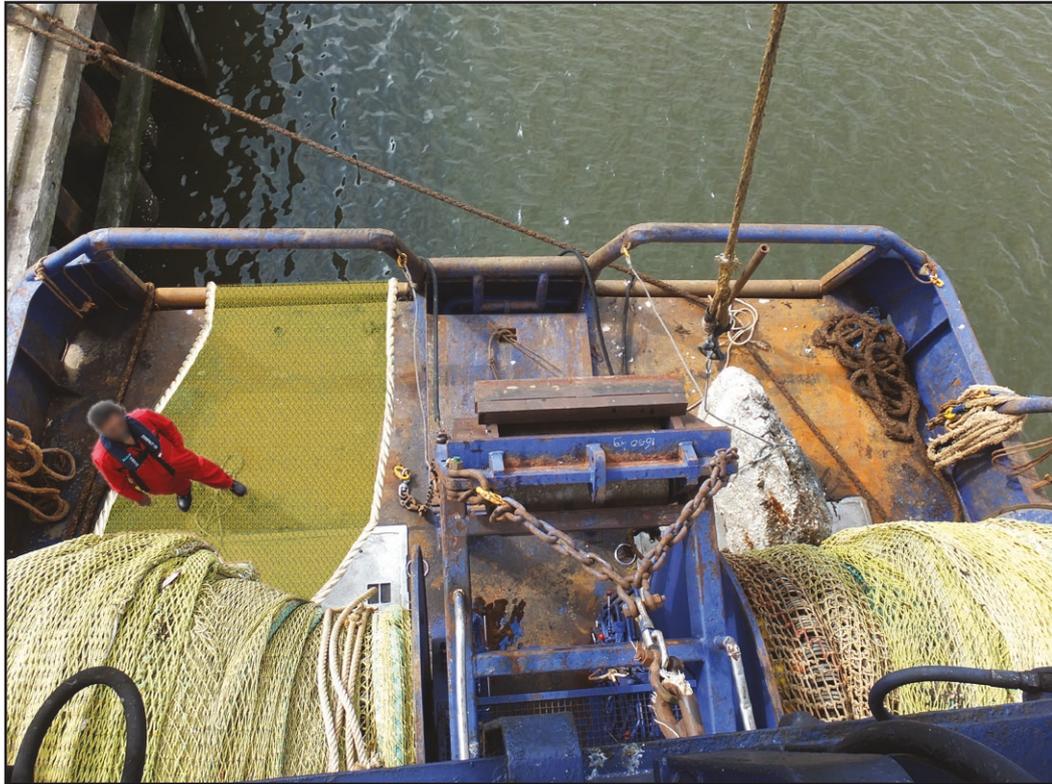
At about 0415 on 9 July 2015, the skipper of the fishing trawler *Enterprise* (**Figure 1**), fell overboard through one of the fishing net shooting ports while repairing a fishing net. The vessel was 16nm north of Dogger Bank in the North Sea and the skipper had been standing on the cod end that was laid out on the deck astern of the net drums (**Figure 2**). He had come down from the wheelhouse to where the crew were repairing the nets and was not wearing a lifejacket, oilskins or appropriate footwear. The sea was rough and there was a north-westerly gale force wind.

Standard practice on board was to repair the nets in the space aft of the net drums adjacent to the unguarded openings regardless of the weather conditions, even though there was sufficient space to conduct repairs forward of the net drums or on the main deck, either of which would have been safer. The crew's choice to work very close to the open ports, particularly when there were very heavy seas, exposed them to unacceptably high risks.

**Figure 2:** Illustration showing approximate position of the skipper just before the accident

1. Prevention is better than cure. Maintaining minimum bulwark heights, minimising exposure to unfenced openings, and adopting safe working practices can all reduce the risk of falling or being swept overboard.
