SAFETY FLYER TO THE FISHING INDUSTRY

Fishing vessel *St Apollo*, grounding and flooding, 24 August 2015

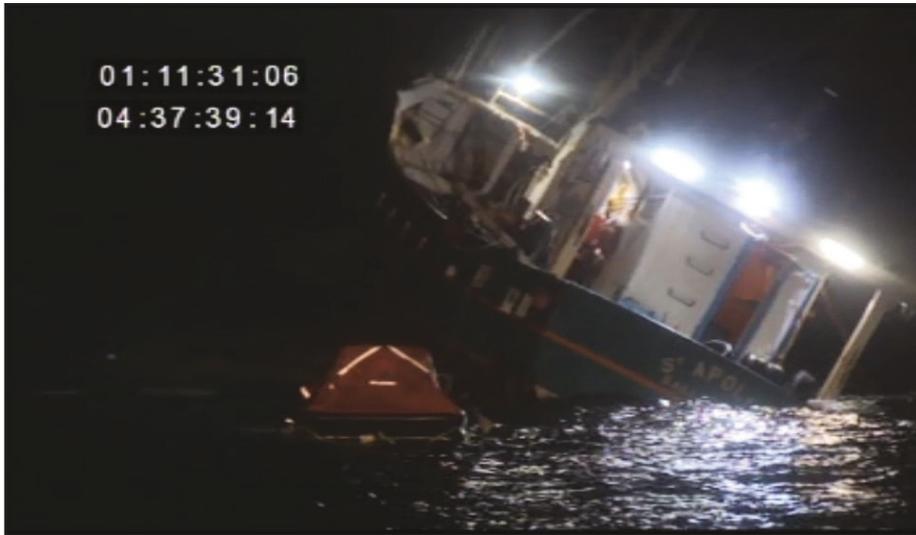
Crew abandoning *St Apollo*
