SAFETY FLYER TO THE FISHING INDUSTRY

Fishing vessel *Majestic* flooding and foundering off Shetland, 21 January 2016

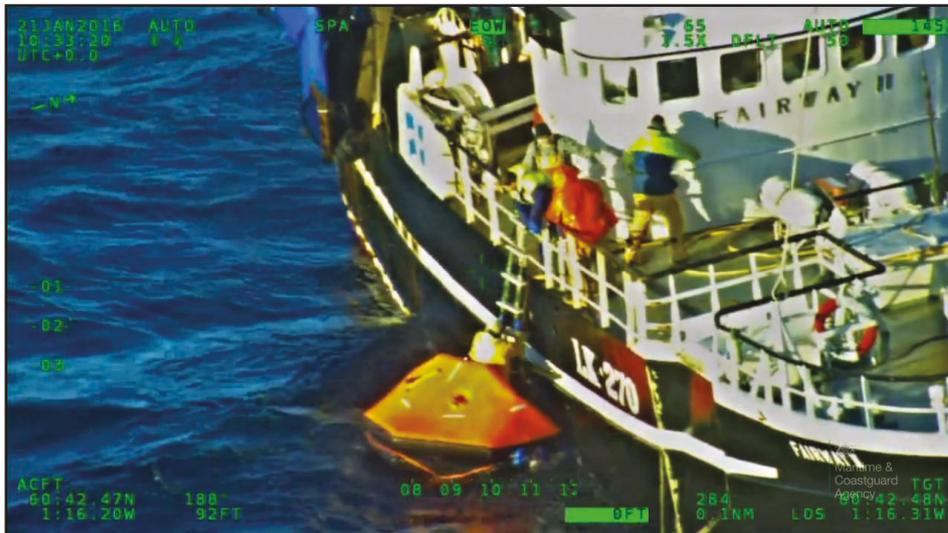
Photograph of crew boarding *Fairview II*
