# Rail Accident Report

## Overspeed at Fletton Junction, Peterborough 11 September 2015

Report 14/2016  
August 2016

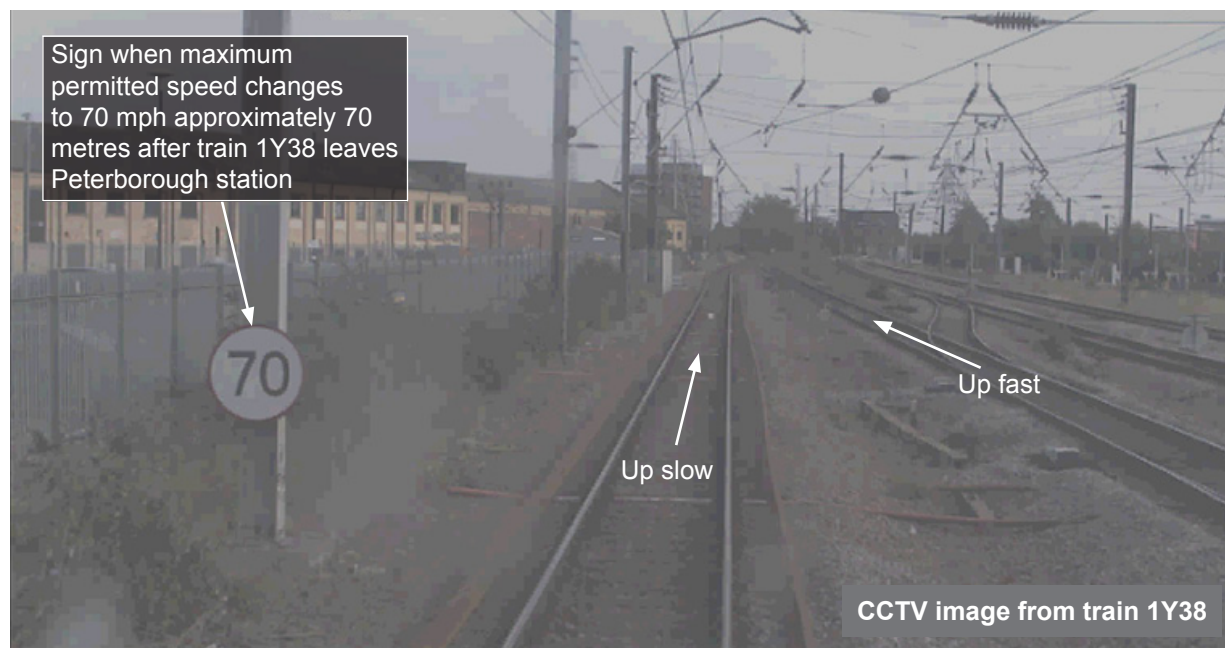
Figure 4: Speed limit sign at location where speed changes (courtesy VTEC)

- 15 Speed limit signs (referred to as *permissible speed indicators* in the railway rule book) are provided on both the up slow and up fast lines at the locations where a new maximum permitted speed applies (figure 4). A 115 mph sign is provided on the up main line, shortly after Fletton Junction, to advise drivers joining from the up slow line that they are now subject to the limit which already applies to trains travelling from the up fast line.

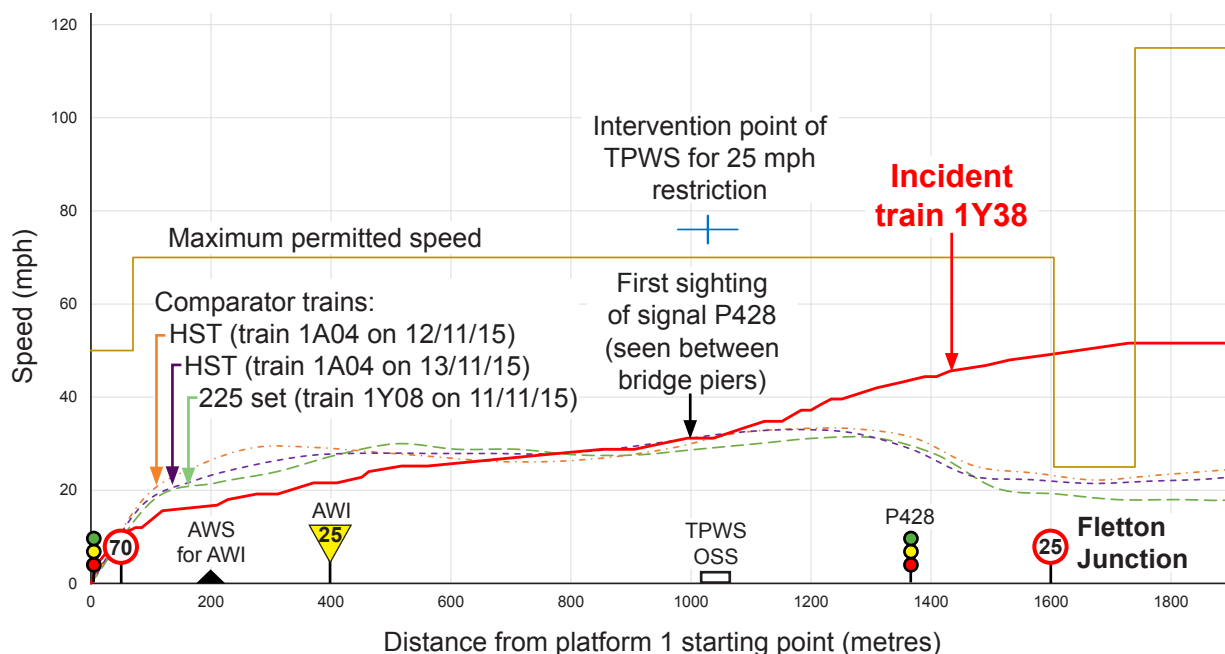
Figure 7: Speed profiles for trains on up slow line

- b. TPWS is not effective for trains which accelerate after they have passed the OSS loops. This is a normal condition for trains which start from platform 1 as demonstrated on figure 7 which shows that train 1Y38 and the sample of other trains were both accelerating as they passed the OSS.

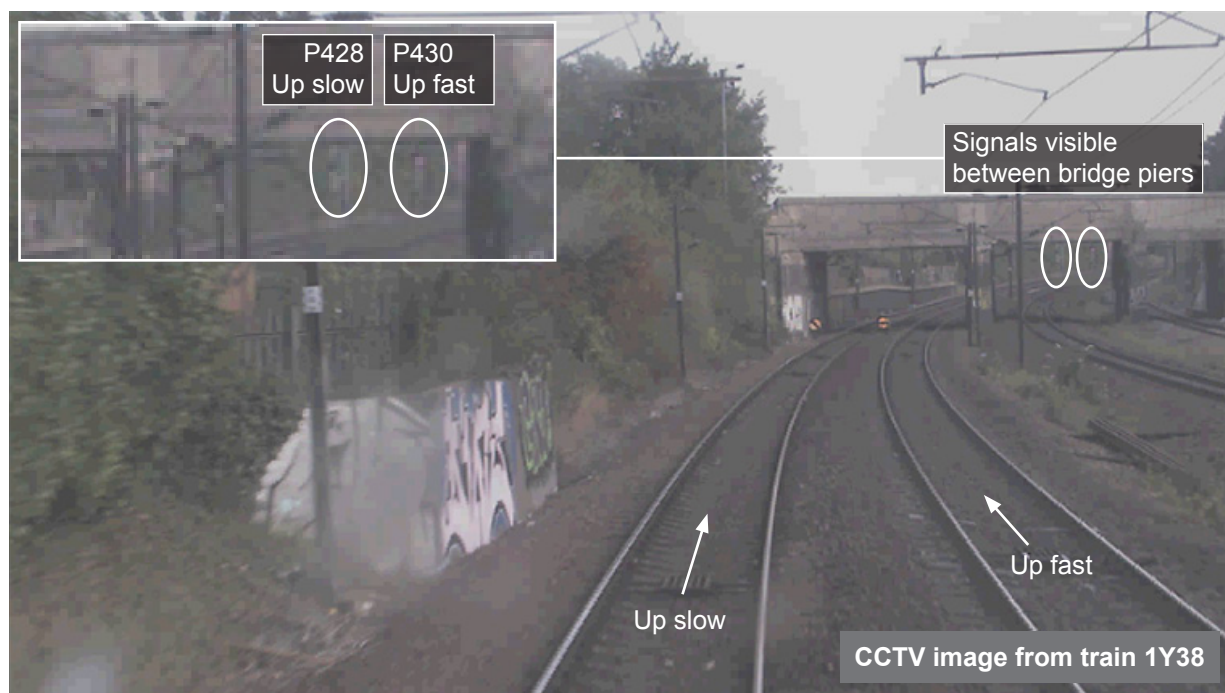
Figure 8: First sighting of signal P428 (courtesy VTEC)

- 37 The driver stated that he was using *commentary driving* between Peterborough and signal P428 to maintain an awareness of the need to stop at this signal if it was displaying a red aspect (this was a response to the yellow aspect of signal P436). Information collected by the *on train data recorder* (OTDR) is consistent with this style of driving and it was appropriate for the train to be driven on the basis of a possible red aspect at signal P428 until the driver saw the actual signal aspect. This means that his driving style before seeing signal P428 provides no indication of whether or not he was aware of the speed restriction at Fletton Junction.

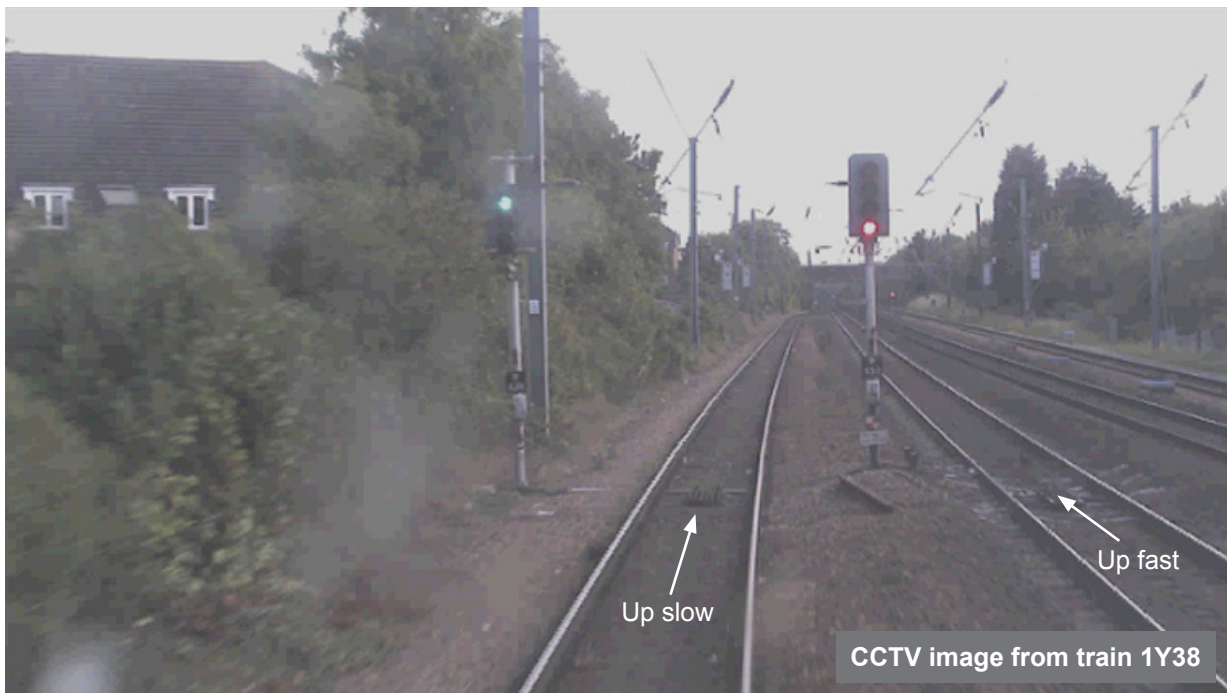
Figure 9: Passing between signals P428 and P430 (courtesy VTEC)

- b. When applying full power after sighting signals P428 and P430, signal P430 (the fast line signal) was displaying a red aspect which should have caused the driver to stop if he believed he was on the up fast line (table 1, 125 seconds, figure 8).

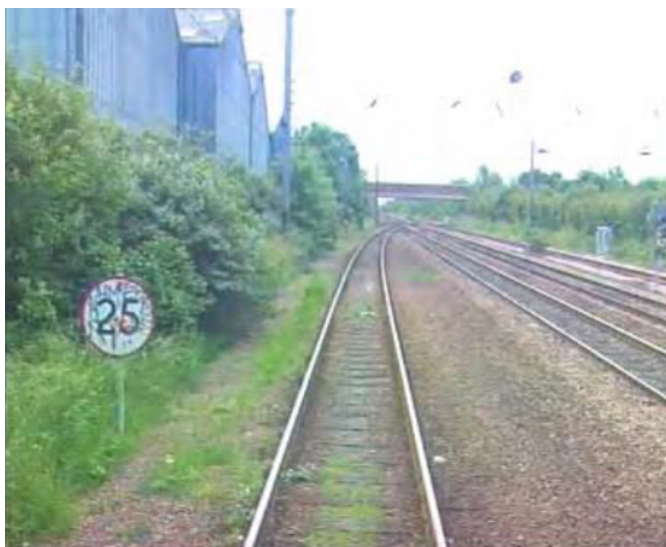
*Figure 11: Full-size permissible speed indicator at Fletton Junction in 2002 (image courtesy of Network Rail)*

- 87 **Network Rail's procedures did not identify that the speed restriction sign at Fletton Junction was smaller than required by its standards and this is a possible underlying factor.**
- 88 It is possible that a full-size permissible speed indicator at start of the 25 mph (40 km/h) speed restriction, rather than the miniature sign actually provided, would have caught the driver's attention and resulted in the driver reducing the train's speed before reaching Fletton Junction (paragraph 63).
- 89 A forward facing closed circuit television (CCTV) image taken on 18 June 2002 shows a full-size permissible speed indicator at Fletton Junction (figure 11). Network Rail has not been able to determine when the sign was replaced by the miniature sign, or why.
