Rail Accident Investigation Branch

Rail Accident Report

**Signal passed at danger on approach to
Wootton Bassett Junction, Wiltshire
7 March 2015**

Report 08/2016
May 2016

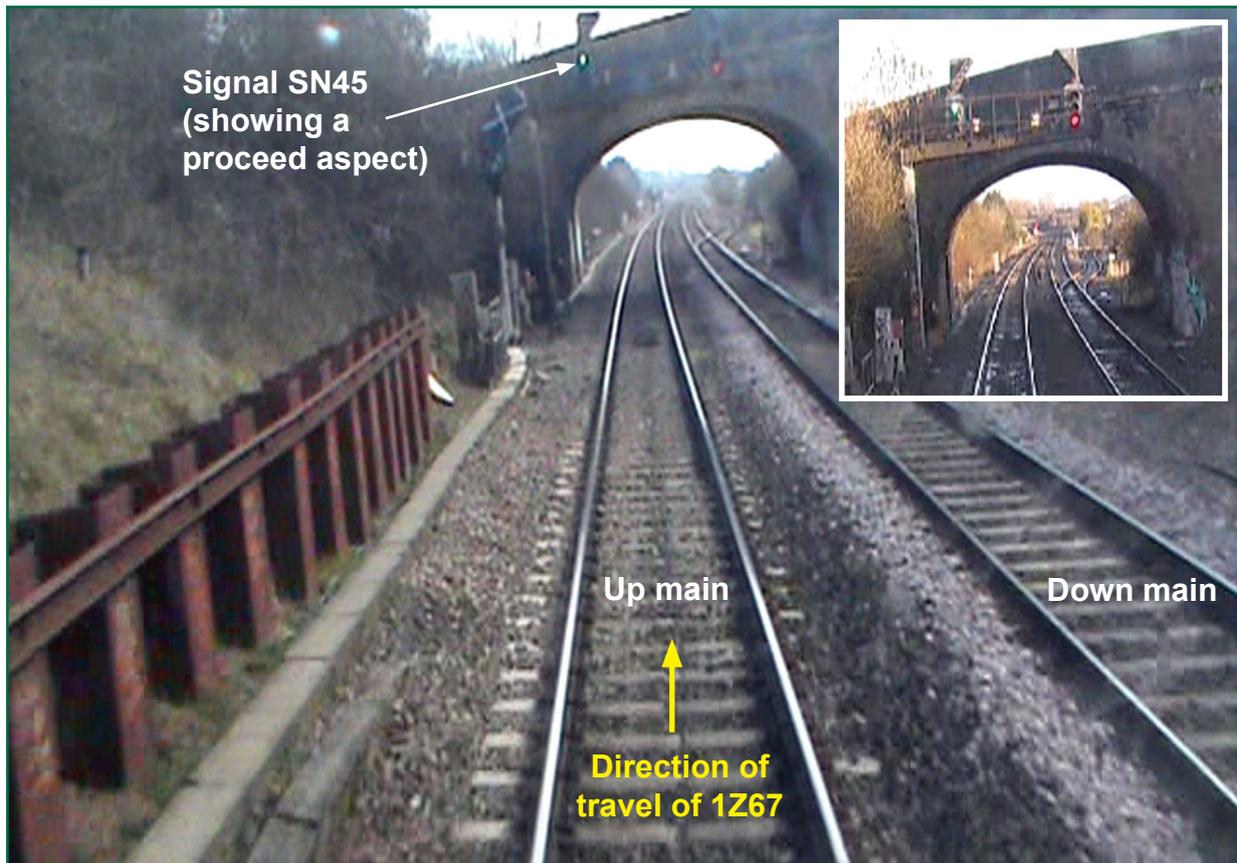
Figure 3: A video image of signal SN45 taken shortly after the incident. Inset figure shows an HD video image of the signal head taken in 2012 (images courtesy of Network Rail).

- 6 Wootton Bassett Junction is protected from trains approaching on the up main line from Chippenham by signal SN45, a *three-aspect colour light signal*, fitted with a *junction indicator* (figure 3). SN45 is mounted on a standard cantilever post which places the red aspect around 5 metres above the track and offset towards the cess by around 0.9 metres from the left-hand rail.

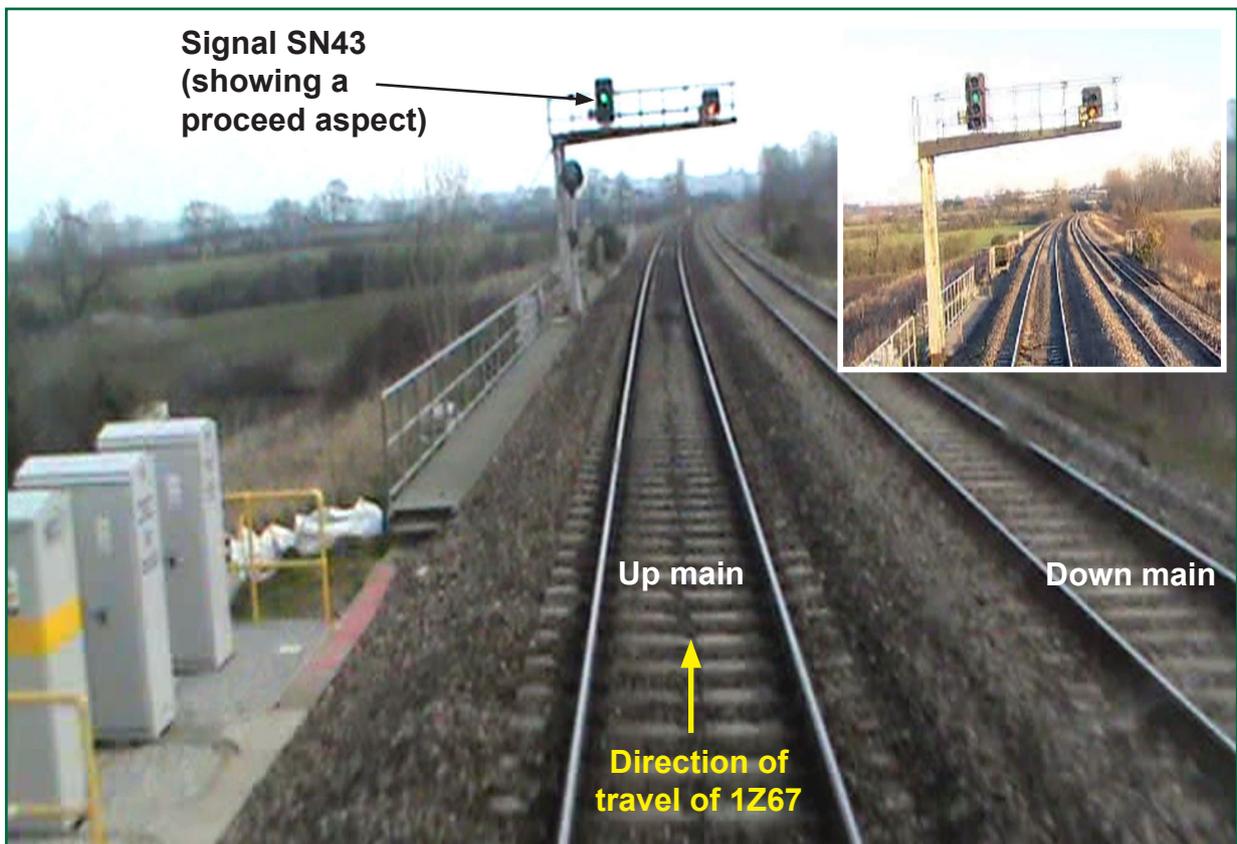
Figure 4: A video image of signal SN43 taken shortly after the incident. Inset figure shows an HD video image of the signal head taken in 2012 (images courtesy of Network Rail).

- 8 Signal SN45 is preceded on the up main line by signal SN43, a *four-aspect colour light signal* (figure 4). SN43 is mounted on a standard cantilever post and is also equipped with AWS and TPWS. The normal signalling sequence for a train approaching SN45 at danger is that SN43 signal shows a single yellow *caution* aspect and that the preceding signal, UM85, shows a green *proceed* aspect¹.

- 23 West Coast Railway Company Ltd. (trading as West Coast Railways) operates a variety of charter and other services on Network Rail managed infrastructure. West Coast Railways operated Tangmere on a lease and employed the drivers and firemen of trains 1Z21 and 1Z67 (paragraphs 29 and 40) and the *fitness-to-run examiner* who examined Tangmere prior to its entry into service on 7 March 2015.

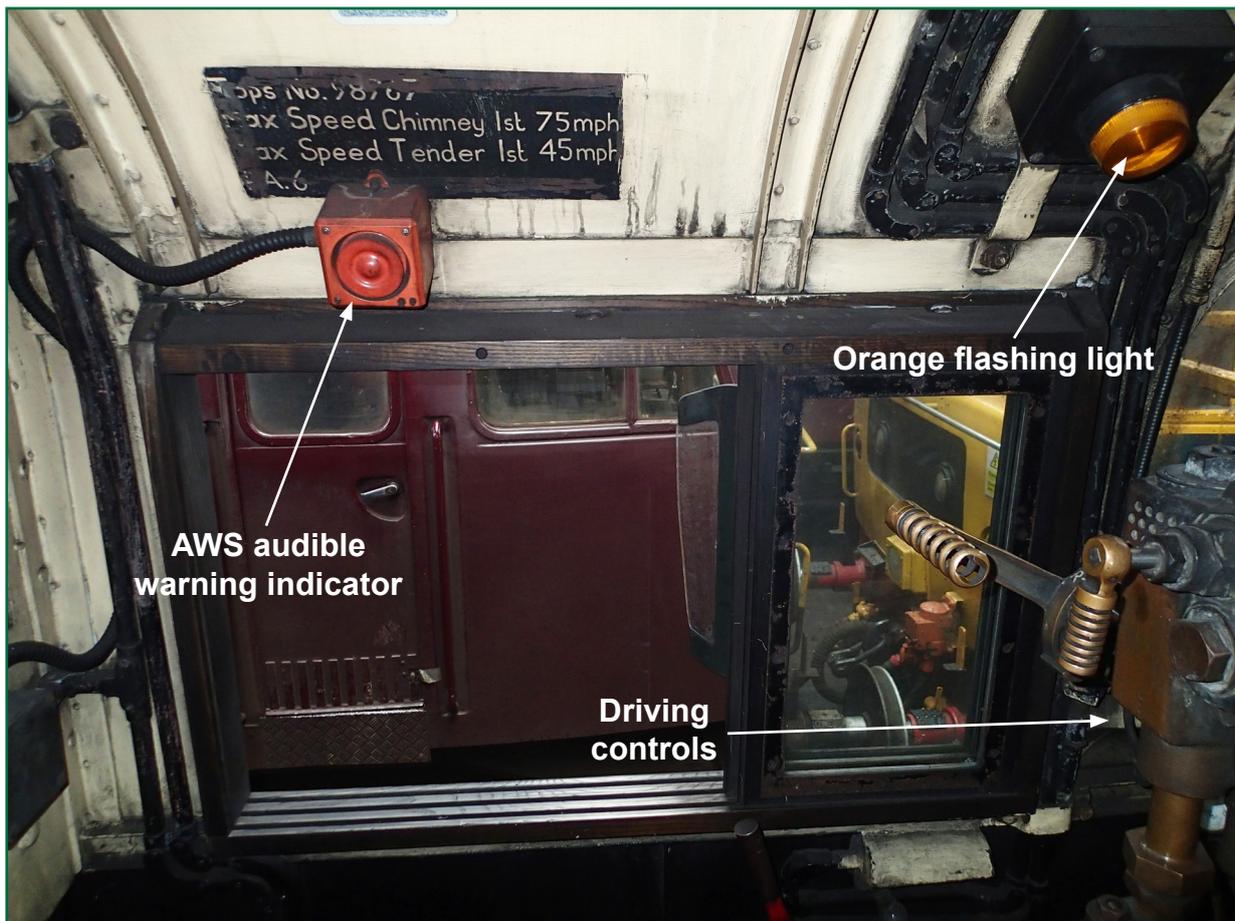
Figure 8: The position of the AWS audible warning indicator unit and flashing light on 7 March 2015

- 15 At the time of the incident, the AWS audible warning indicator on Tangmere was positioned on the inside of the cab roof, just above the *driving position* (which is on the left-hand side of this locomotive) and towards the rear of the driver's side window. The orange flashing light was also positioned on the inside of the cab roof, slightly higher than the audible warning indicator and to the front of the driver's side window (figures 8 and 9). The AWS visual indicator (commonly called the 'sunflower') is mounted in front of the driving position just above the main driving controls, with the TPWS display panel positioned directly above it (figure 9).

The sequence of events

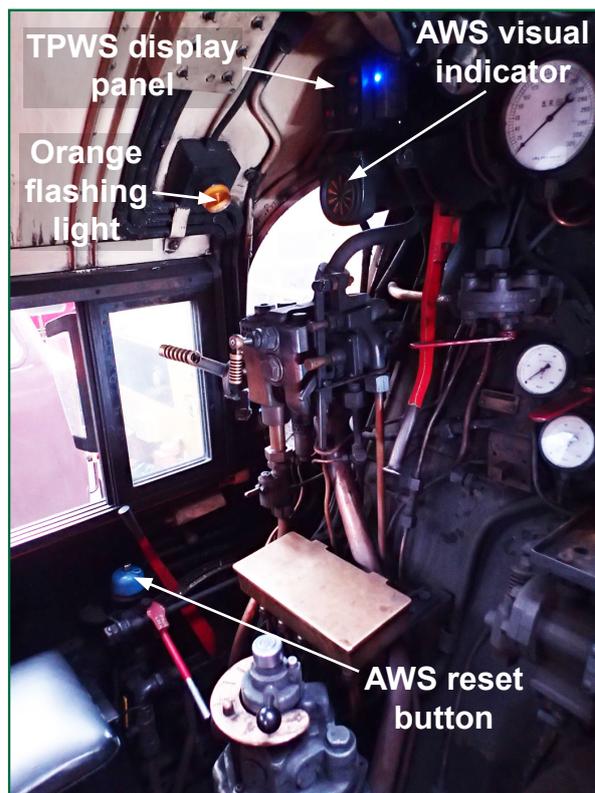
Figure 10: The position of the AWS flashing light, AWS visual indicator, AWS reset pushbutton and TPWS display panel on 7 March 2015

- 16 Drivers acknowledge AWS warnings on Tangmere by pressing and releasing the AWS reset pushbutton, which is located to the left of the driver's seat (figure 10). The *railway group standards* applicable at the time that Tangmere's AWS system was installed required that the driver be given a period of up to 2.7 seconds to acknowledge warnings. Should a driver not acknowledge an AWS warning within this time period, then the combined AWS/TPWS control unit will generate an AWS brake demand. The relevant standards required that AWS brake demands remain active until the driver acknowledged the warning and that any brake demand continue for at least 59 seconds after this had been done. In the event that an AWS brake demand occurs, the *Rule Book*⁴ requires drivers to immediately bring their trains to a stand and then to contact the signaller.

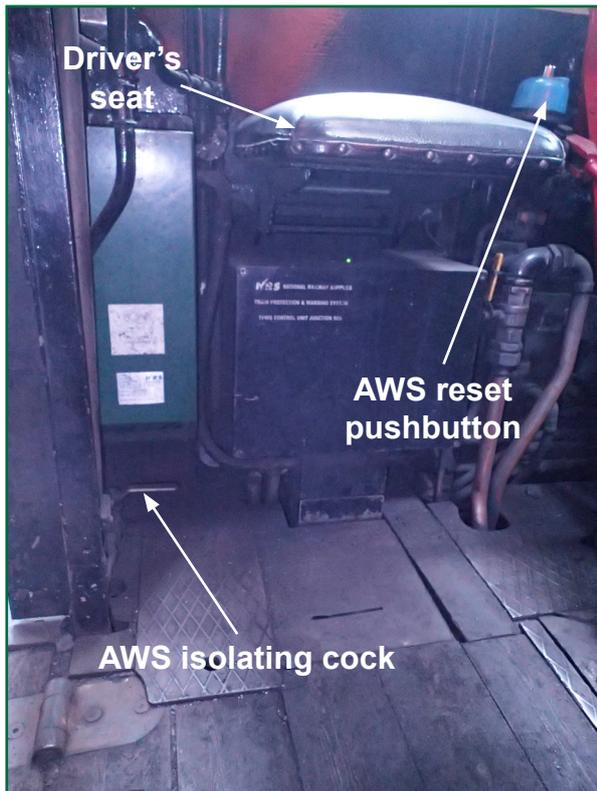
Figure 11: The AWS isolating cock shown in the open position

- 19 An AWS isolating cock is also situated to the rear of the driving position, close to the cab floor plates (figures 11 and 12). The AWS isolating cock is normally left closed in service; if opened it will admit air into the electro-pneumatic valve and lock it into the 'ISOLATED' position, regardless of whether it is energised or not. This means that, once the electro-pneumatic valve is locked in this position, de-energising it no longer has any effect on the air braking system and any brake demands generated by the combined AWS/TPWS control unit are rendered ineffective.

- 50 Despite these requirements, train 1Z67 was not brought to a stand and instead continued on its journey. OTDR data showed that the AWS brake demand ceased to be effective around 12 seconds after it was initiated and around 1.5 seconds before the train passed signal SN43. Before it was by-passed this brief brake application reduced the train's speed by a total of 8 mph (13 km/h). Witness evidence and OTDR data showed that the AWS isolating cock remained open during the remainder of the incident; this had the effect of making any subsequent AWS or TPWS brake demands ineffective (paragraph 19).

- 53 Train 1Z67 then passed over the second OSS at a speed of around 53 mph (85 km/h). This OSS has a set speed for passenger trains of 45 mph (72 km/h). The TPWS system on Tangmere correctly identified that train was travelling over the set speed and the combined control unit generated a brake demand. However, because the AWS isolating cock was still open, this demand had no effect on the train's braking systems (paragraph 19).

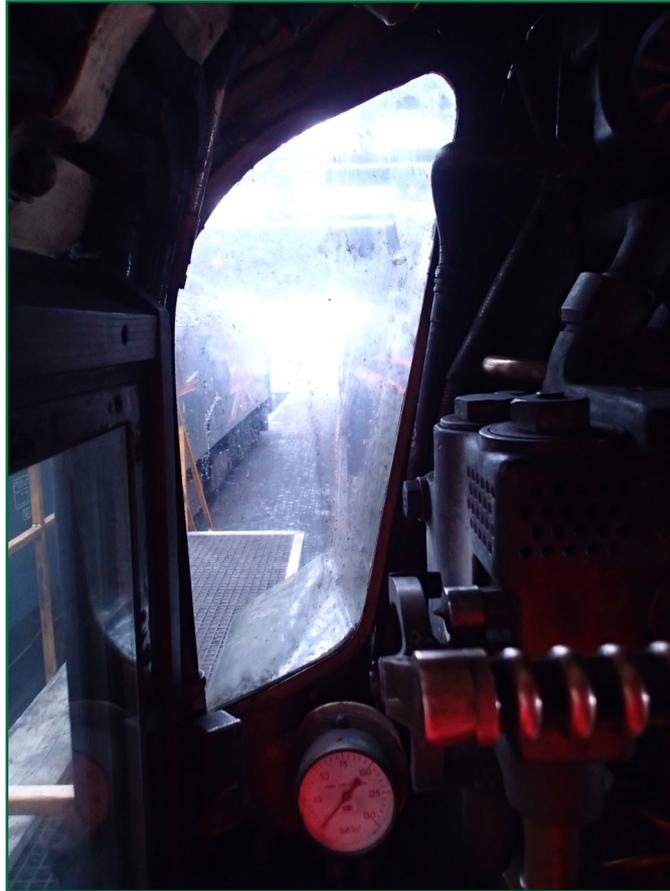
Figure 13: The driver's windscreen on Tangmere. Note that this photograph was taken with the train at a stand within a depot and does not show the driver's forward visibility on 7 March 2015

- 46 Train 1Z67 left Bristol Temple Meads at 16:38 hrs, around 3 minutes late. In addition to the driver and the fireman, two members of the locomotive's support crew were also present in the cab. Witness evidence suggested that the journey to Wootton Bassett Junction was uneventful, with the exception that the driver was experiencing poor visibility forwards through his windscreen. This was partly due to condensation on the windscreen from a steam leak (paragraph 40) but also because the locomotive's exhaust was being blown by the wind towards the left-hand side of the boiler, where it was accumulating and blocking his view. In order to improve his sighting, the driver decided to drive the train with his head positioned outside the driver's side window.

69 Because the driver's attention was focused inside the cab, neither the sighting of signal SN43 nor the poor forwards visibility from the driver's windscreen (paragraph 46) played a direct role in the driver's failure to observe the signal. Drivers are required by the Rule Book¹² to reduce speed if they cannot see signals or lineside indicators soon enough to react to them and there is no evidence that the driver of train 1Z67 felt that his visibility meant that he needed to reduce speed in order to observe this requirement. However, the driver stated that the poor visibility during the journey from Bristol had meant that he needed to focus more intently than usual on his driving tasks. Although the driver stated that this did not distract him, it was evident from witness accounts that the driver felt that there had been an increase in his workload because of the reduced visibility. This higher workload may have made it more likely that the driver would make an error during the journey.

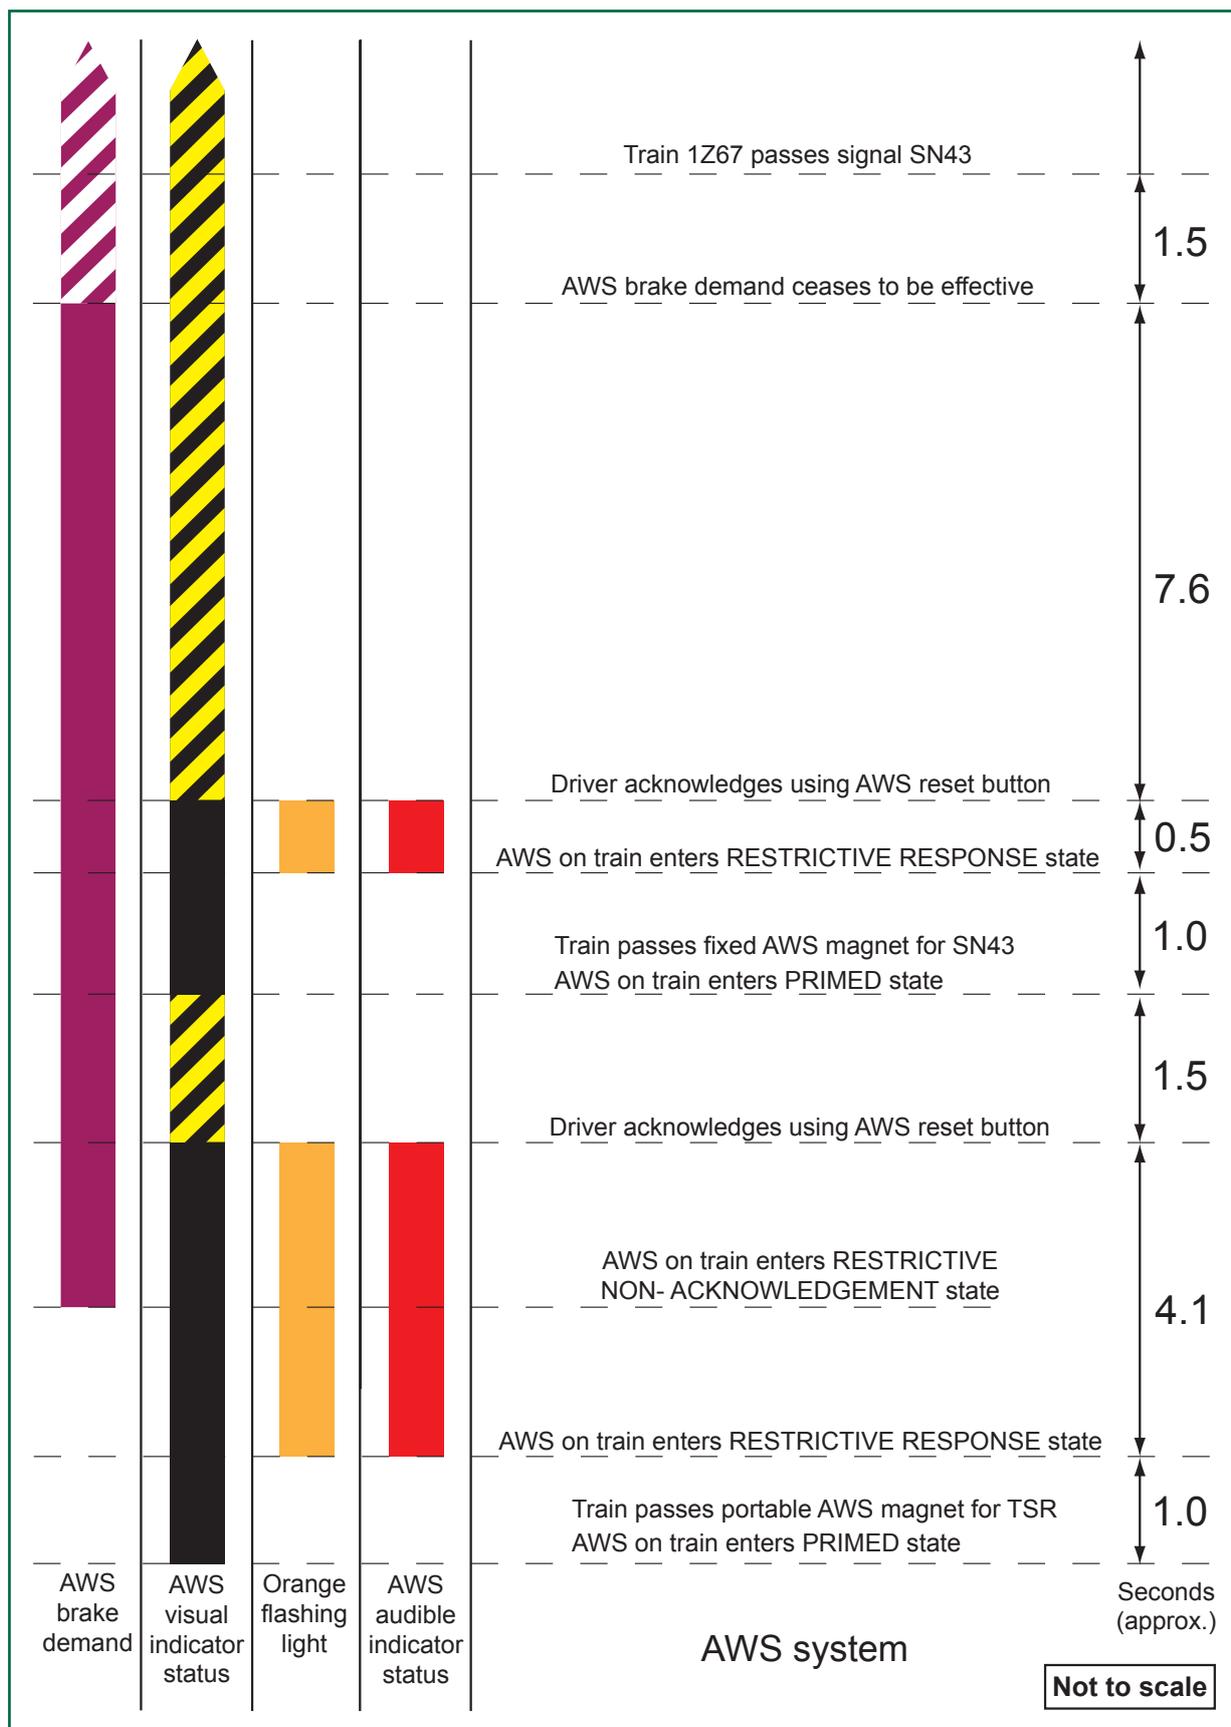
Figure 14: Timeline of events at signal SN43

- 47 At around 17:24 hrs, 1Z67 was approaching signal SN43 at 59 mph (95 km/h), when it passed over the portable AWS magnet associated with the TSR (paragraph 10). Around a second after this, an AWS warning occurred. OTDR data showed that it took the driver 4.1 seconds to acknowledge this warning, by which time the combined AWS/TPWS control unit had already generated an AWS brake demand (figure 14).
- 48 The driver indicated to the fireman that an AWS brake demand had occurred. His expectation was that the fireman would open the AWS isolating cock in order to by-pass the AWS brake demand and release the brakes. The fireman has stated that he believed that he was following the driver's instructions when he subsequently crossed the cab and opened the AWS isolating cock. The fireman stated that the AWS isolating cock was not sealed before he opened it.
