# ***AAIB Bulletin***

***8/2016***

Published: 11 August 2016

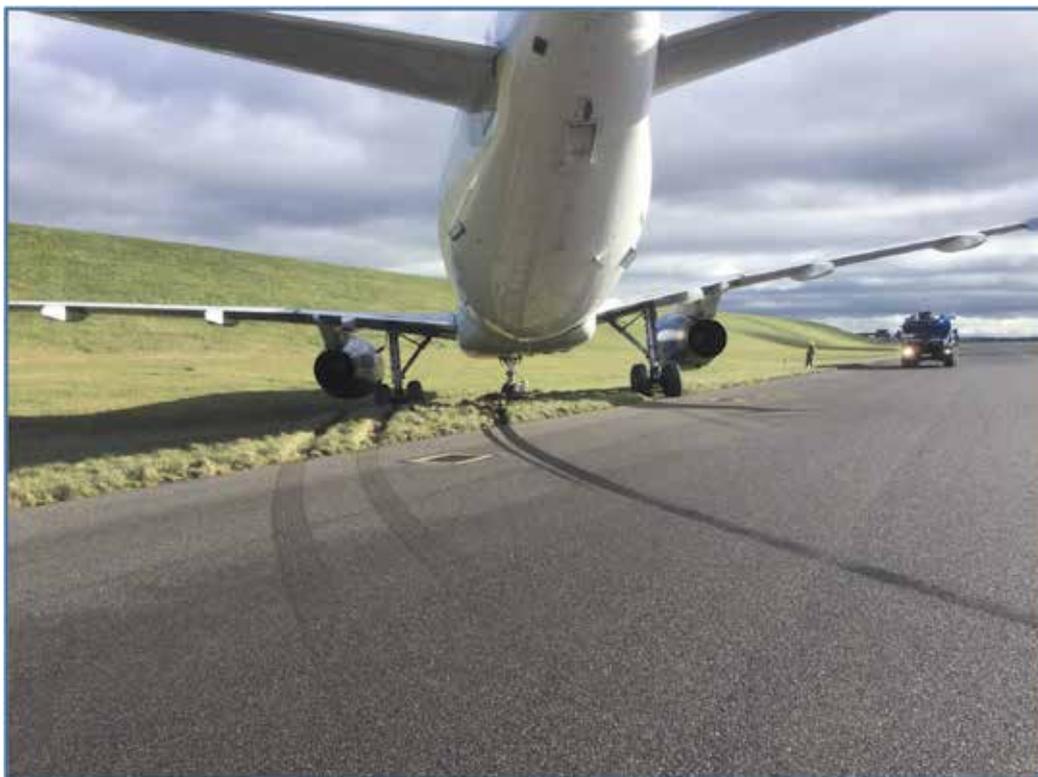
**Figure 1**

Photographs taken shortly after the incident confirm the commander's report that the taxiway surfaces were damp. There was a dry strip along the outer edge of Taxiway Alpha, across which could be seen moisture tracks left by the aircraft's mainwheel tyres (Figure 1).

From the distinctive nosewheel skid marks and furrows in the grass, it was clear that the nosewheels had begun to skid very soon after the turn started, and that it adopted, and remained at, a high angle of deflection.

Incident site immediately following excursion.  
Note nosewheel skid marks, mainwheel tracks, taxiway condition and nosewheel angle  
(*photo courtesy of Birmingham Airport*)

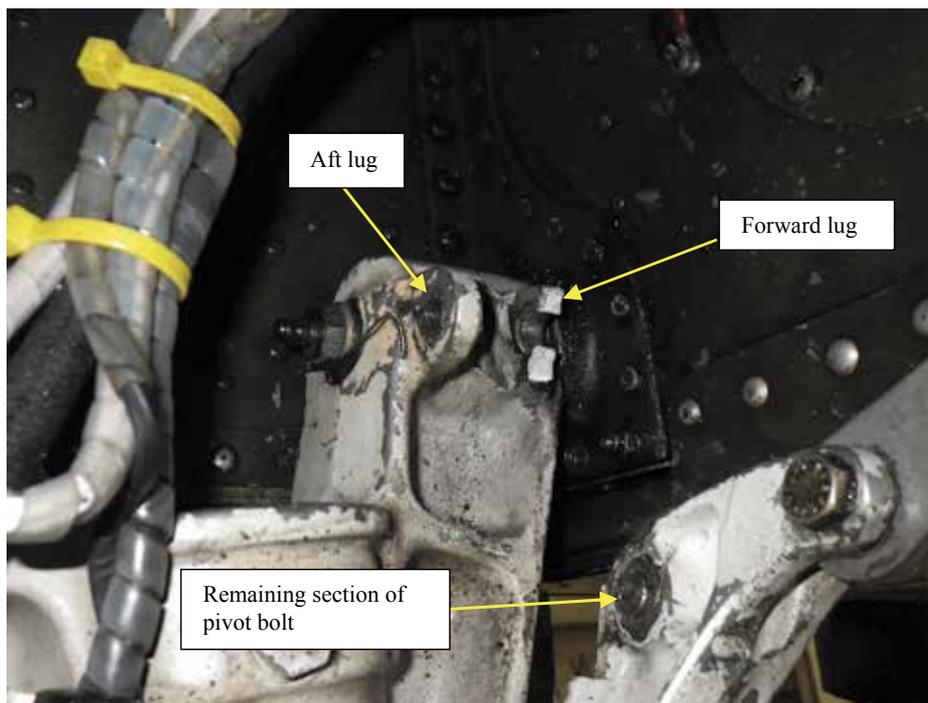
**Figure 3**  
Pivot bolt and mounting lugs

On the left landing gear, the head of the bellcrank pivot bolt was missing and the remainder of the bolt, which was still attached to the bellcrank, had moved forwards out of the aft mounting lug. The forward mounting lug had fractured across the bolt hole. The Airport Fire Service (AFS) recovered the outer section of the forward lug from the runway, Figure 3.

The fracture surfaces on the pivot bolt and the lugs on the bellcrank and landing gear were inspected by a metallurgist, who advised that the surfaces showed no evidence of a pre-existing crack and had all failed in overload. The lower forward lug had failed as a result of the lug bending forwards.

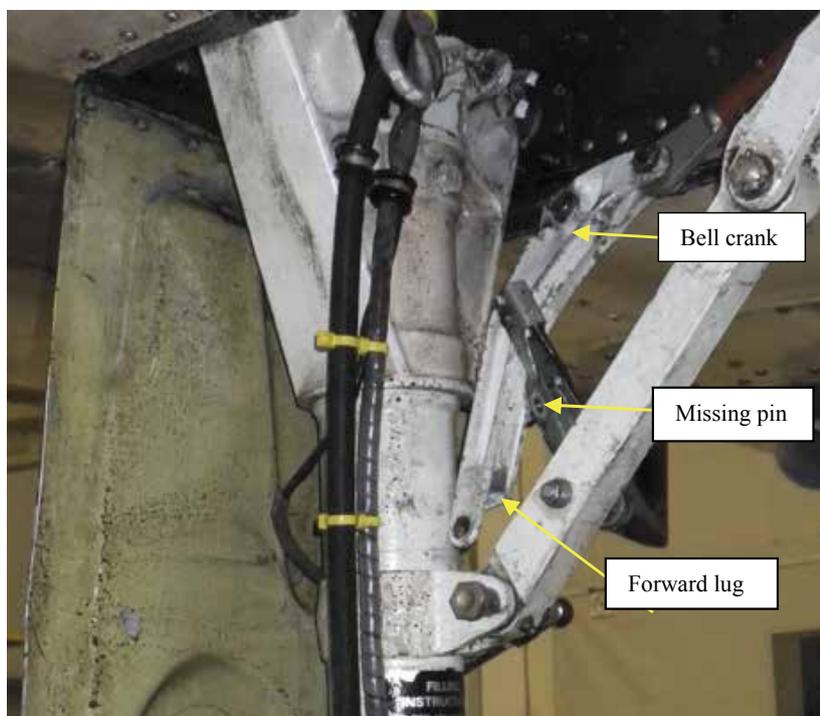
**Figure 4**  
Downlock link

The downlock pin and its associated bushes were missing. The forward lower lug on the bellcrank had fractured and was recovered from the runway by the AFS. The bolt hole on the rear lower lug, which remained attached to the bellcrank, was damaged. The spring which holds the downlock link in the over-centre position was still attached to the landing gear leg and the downlock link, Figure 4.

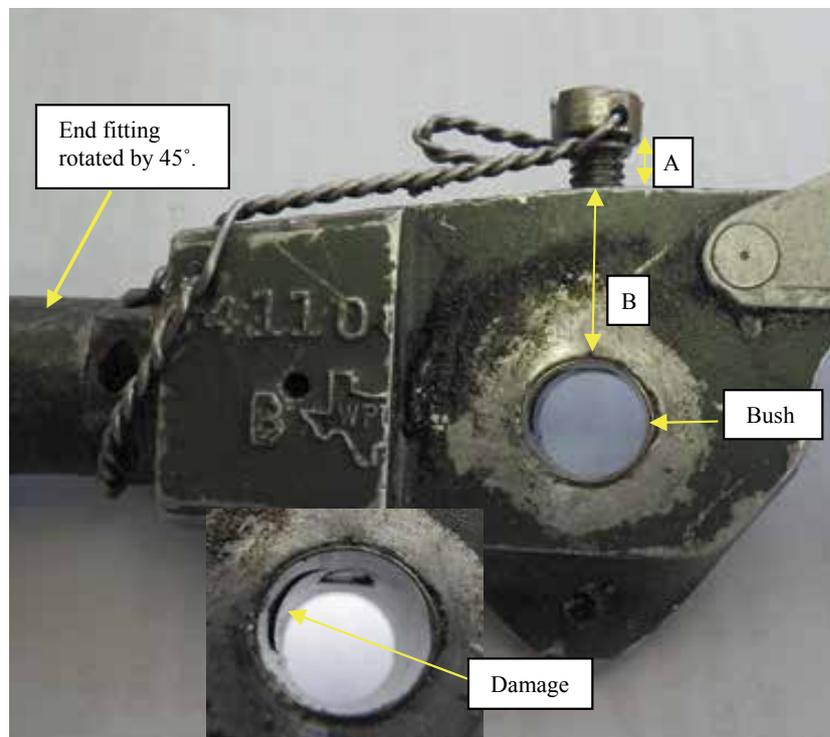
**Figure 5**  
Downlock link

Examination of the downlock link revealed that the end fitting that connects to the lower side brace had rotated clockwise by approximately 45°, Figure 5. The set screw was still wire locked to the casting and the head of the screw sat proud of the casting by 4 mm, with approximately five threads showing (Item A). The end of the set screw was flush with the wall of the bore in the casting and did not appear to have entered the hole in the bush. The bush had circumferential damage approximately 4 to 5 mm from the forward face of the downlock. The aft face of the downlock was undamaged, whereas the bore where it exited the forward face of the casting was distorted.

The measurements showed that with the head of the set screw 4 mm above the casting, the right downlock pin would have been locked in place, whereas the left downlock pin would have been free to move. The height of the set screws was checked on one of the operator's Cessna 310R aircraft where the clearance between the head of the screw and the casting was found to be approximately 2 mm (two threads).

The most likely explanation, therefore, is that the set screw had not been inserted a sufficient distance to secure the left downlock pin, which subsequently moved forward out of the aft lower fork on the bellcrank. The force through the retraction linkages would then have been taken by the lower forward fork on the bellcrank, causing it to splay outwards. As the downlock pin continued to migrate forward, damage would have occurred to the inside of the bore and the forward face of the downlock link. The eventual effect of the splaying of the fork would have been to shorten the bellcrank and downlink assembly such that the side brace was no longer over centre. As the left landing gear started to retract during the landing roll, the loads transmitted through the retraction mechanism would have caused the fork, mounting lugs and pivot bolt to fail in overload.

It is recommended that Textron Aviation informs operators of Cessna 300 and 400-series aircraft of the actions required to ensure that the set screw, which retains the main gear downlock pin, is properly installed in the side brace downlock link and, in addition, amends the aircraft maintenance manuals to include this information.

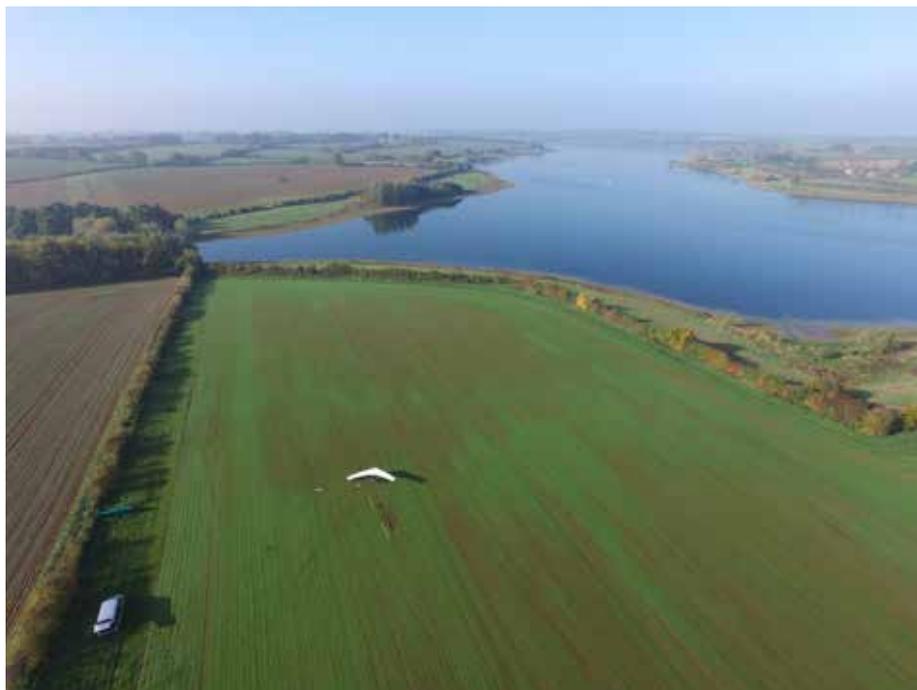
**Figure 2**

The aircraft crashed in a large field adjacent to Pitsford Water (Figure 2). The field was approximately 400 m long and 100 m wide, and the wreckage was found at the top of a gently sloping knoll. The ground was smooth and there was a grassy crop, approximately 1-2 cm high, growing in the field. The land owner had not been asked for permission to land in the field.

There were several ground marks all located within approximately 16 m from the nose of the aircraft. These marks were consistent with the nose wheel striking the ground heavily in a direction approximately parallel with the hedge running along the edge of the longest side of the field. The aircraft appeared to have performed a 'somersault', which resulted in two holes in the ground being made, first by the apex of the wing and then by the top of the mast, before the aircraft came to rest in an upright position. The ground marks were aligned on a bearing of between 240° and 245°T.

The accident site viewed in approximately the direction of the aircraft's travel

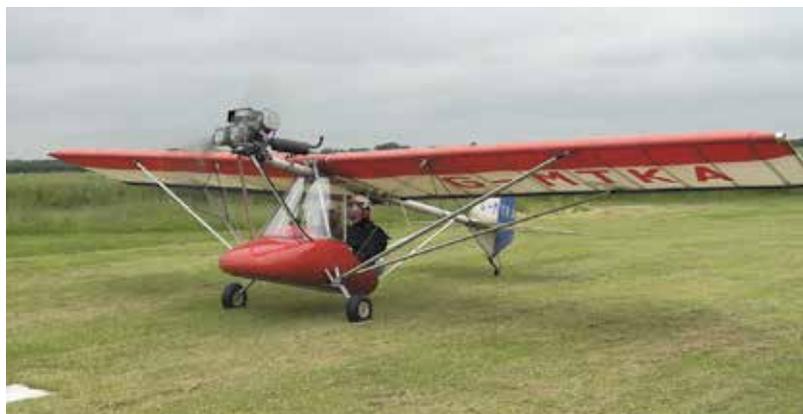
**Figure 1**  
Thruster TST Mk1, G-MTKA

When commencing takeoff on grass Runway 26L, the pilot believed there was a moderate crosswind from his right. As he reached flying speed, his rudder and aileron control inputs suddenly seemed ineffective. The right wing lifted and the aircraft (Figure 1) yawed quickly to the right through 90°. The left wheel dug into the ground and detached and the left wing then struck the runway. This caused the aircraft to yaw left, while pitching nose-down until the propeller made ground contact. The aircraft then fell back onto its tailwheel and right mainwheel and the two occupants vacated, without assistance.

Airport records indicated the wind direction that afternoon was predominantly northerly, at 10 kt or less but with occasional gusts of up to 15 kt. Approximately six minutes before the accident, it veered east of north and, before takeoff, the pilot was informed that the wind was from 030° at 7 kt. However, he recalled seeing no downwind component for Runway 26L on the windssock situated nearest the threshold. Immediately after the accident, he sensed the wind was extremely variable and suspected a sudden wind shift caused the loss of control.
