## SAFETY FLYER TO THE FISHING INDUSTRY

### *Aquarius*: Fatal man overboard on 17 August 2015

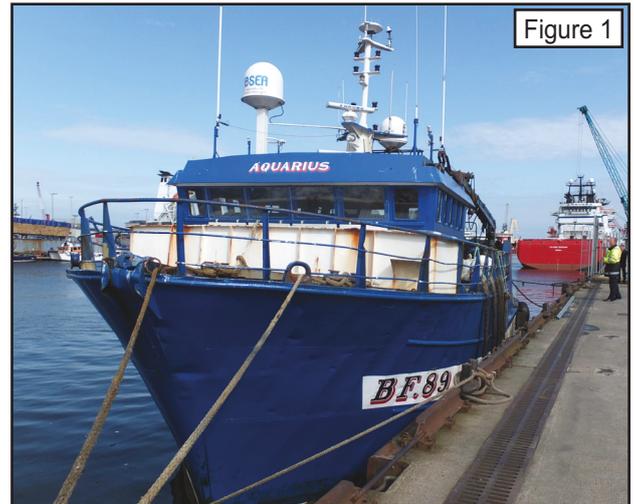
In the early hours of the morning on 17 August 2015, a fisherman on board the 20.8m twin rig trawler *Aquarius* (**Figure 1**) was thrown overboard violently when a rope stopper parted. The vessel had just cleared the port of Aberdeen, Scotland, and its crew were attempting to re-mark the trawl warps when the accident happened. The skipper reacted quickly to stop the vessel, and the crew threw lifebuoys to the casualty. However, the recovery attempt was unsuccessful and, about 10 minutes later, the casualty sank out of view. The skipper then raised the alarm but, despite a search involving numerous vessels and a helicopter, the casualty's body was not recovered.

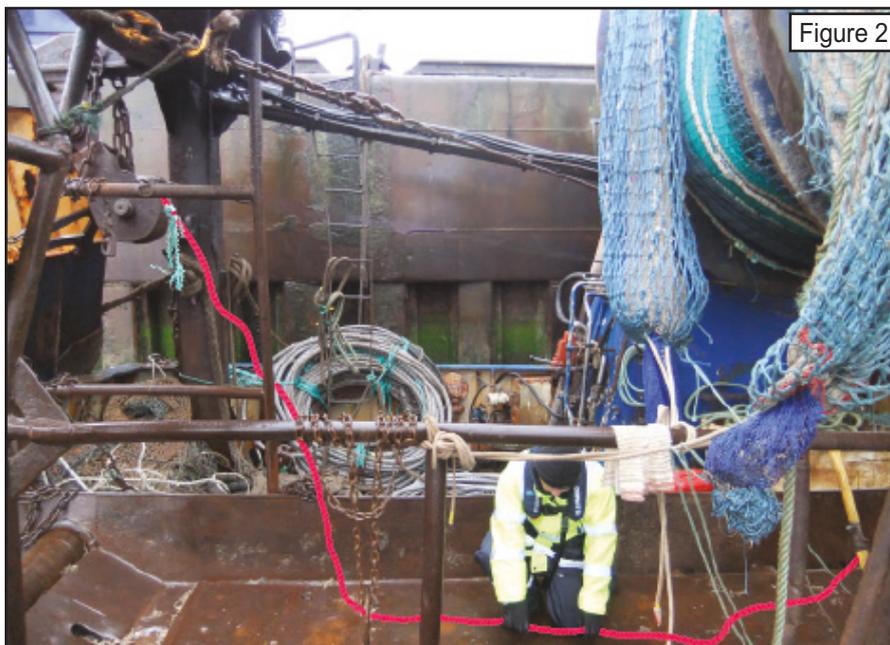
In order to mark the steel wire warp, the crew had streamed it over the stern. The stopper was used to take the strain of the trailing warp so that the crew could lower its inboard section on to the deck (**Figure 2**). The MAIB investigation established that:

- The stopper parted under tension because a man-made fibre rope had been used instead of a chain, and a proper stopper hitch had not been applied.
- The casualty was thrown overboard because he had positioned himself within the bight of the slackened trawl warp.

- The method used to mark the trawl warp was unnecessarily hazardous and the outcome was entirely foreseeable.
- The crew were unable to recover the casualty back on board because neither they, nor their vessel had been adequately prepared to deal with such emergency situations.
  - The vessel did not carry a dedicated means of recovering a person from the water.
  - The crew did not conduct periodic emergency drills.
- The casualty sank and his body was not recovered because he was not wearing a lifejacket or other type of personal flotation device while working on the vessel's open deck.
- *Aquarius* had been poorly operated; its safety equipment was not properly maintained, hazardous activities had not been risk assessed and its crew worked prolonged hours and did not receive the minimum amount of rest or leave required by UK legislation.

- Fishing vessel owners and skippers must make every effort to promote a strong safety culture on board their vessels; hazardous activities should be properly planned and safe systems of work developed. This is particularly important when carrying out non-standard or one-off tasks.

- The dangers of standing in the bight of a rope, or over a slacked warp should be well understood by all seafarers and, in accordance with basic seamanship good practice, must be avoided at all times.
