Rail Accident Investigation Branch

Rail Accident Report

Overspeed at Queen's Park, London 5 January 2016

Report 19/2016
October 2016

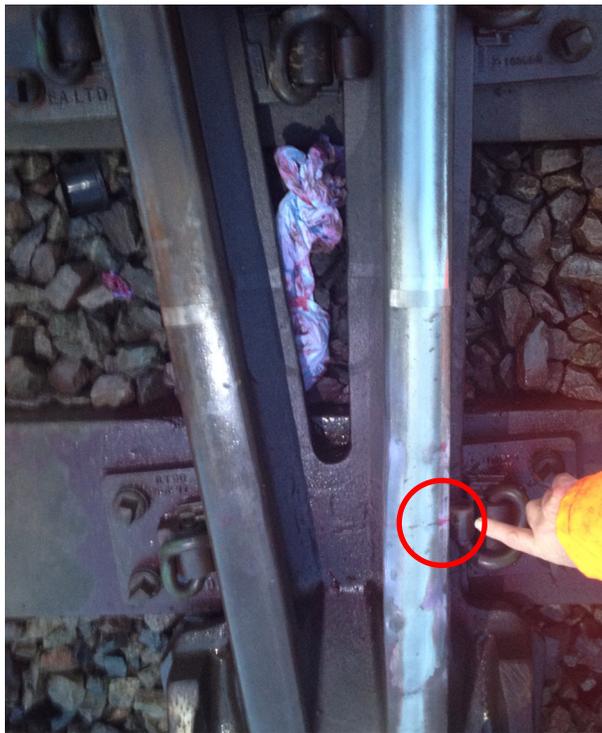
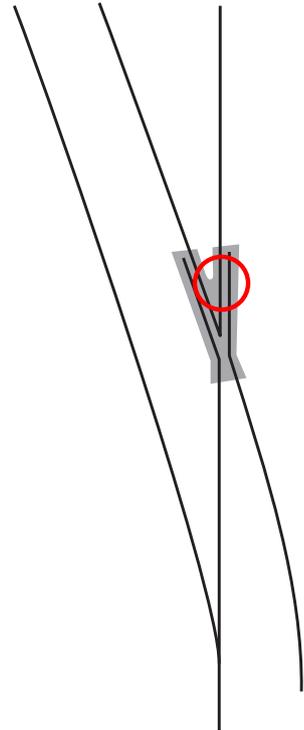
Figure 4: Defect at 2322B points

- 29 In the early hours of 5 January 2016, a Network Rail permanent way team, inspecting the *plain line* in the Queen's Park area, noticed a crack in the crossing of 2322B points. This was reported to Network Rail control at 03:10 hrs. The track maintenance staff arranged for a *dye penetrant inspection* to be carried out and for an emergency speed restriction to be applied in accordance with Network Rail standards. They also appointed a watchman who was required to monitor the crossing's condition until the fault was repaired.

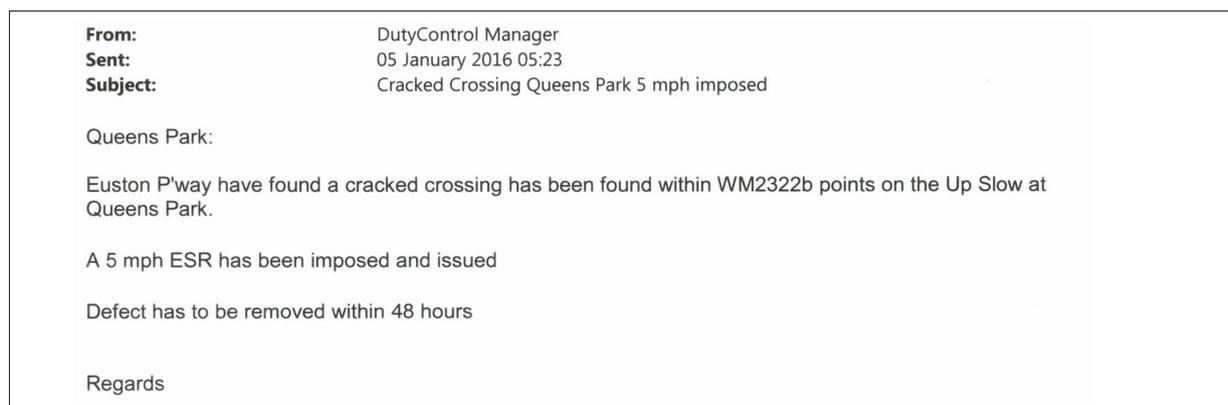
Figure 5: Email sent at 05:23 hrs by the London Midland duty control manager

- a. the driver misunderstood an email sent at 05:23 hrs by the London Midland duty control manager advising London Midland managers that a cracked crossing required a 5 mph (8 km/h) emergency speed restriction;

- 49 The driver first learnt of the emergency speed restriction from an email sent at 05:23 hrs which he read in between arriving at Bletchley at about 07:00 hrs and going to the booking-on point. This email was intended to advise London Midland managers that a cracked crossing required a 5 mph (8 km/h) emergency speed restriction (figure 5). It had the heading 'Cracked Crossing Queens Park 5 mph imposed'. The driver understood 'crossing' to be the line linking the up slow line to the up and down goods loop. He therefore incorrectly believed that the speed restriction applied only to trains entering or leaving the loop, and not to trains passing on the up slow line.

- 2 *The intent of this recommendation is to ensure that safety critical information is easily and unambiguously seen in late notices and other communications.*

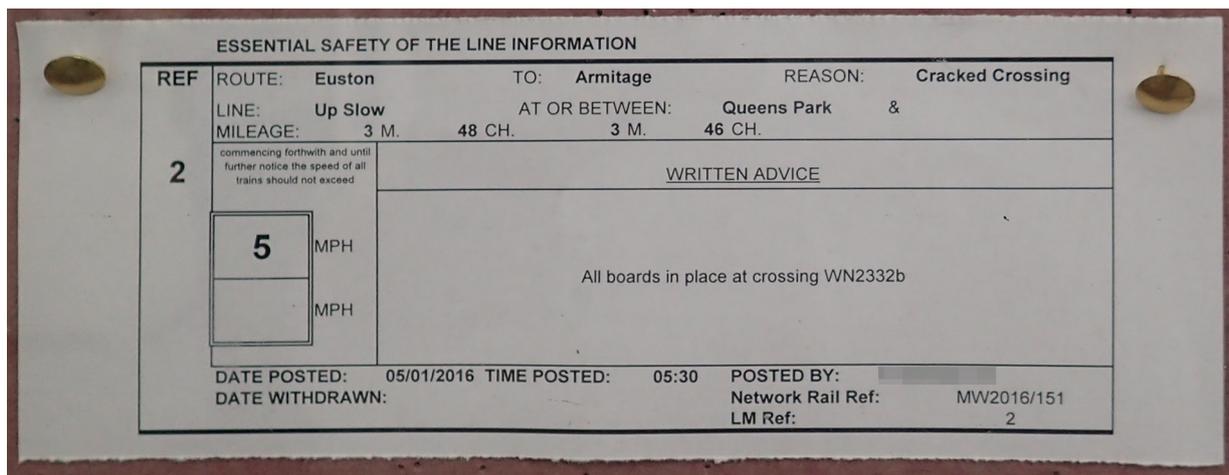
Figure 7: Notice posted in Bletchley late notice case

- c. a notice posted in the Bletchley late notice case did not correct the misunderstanding; and
 - d. the lineside signage did not correct the driver's misunderstanding.

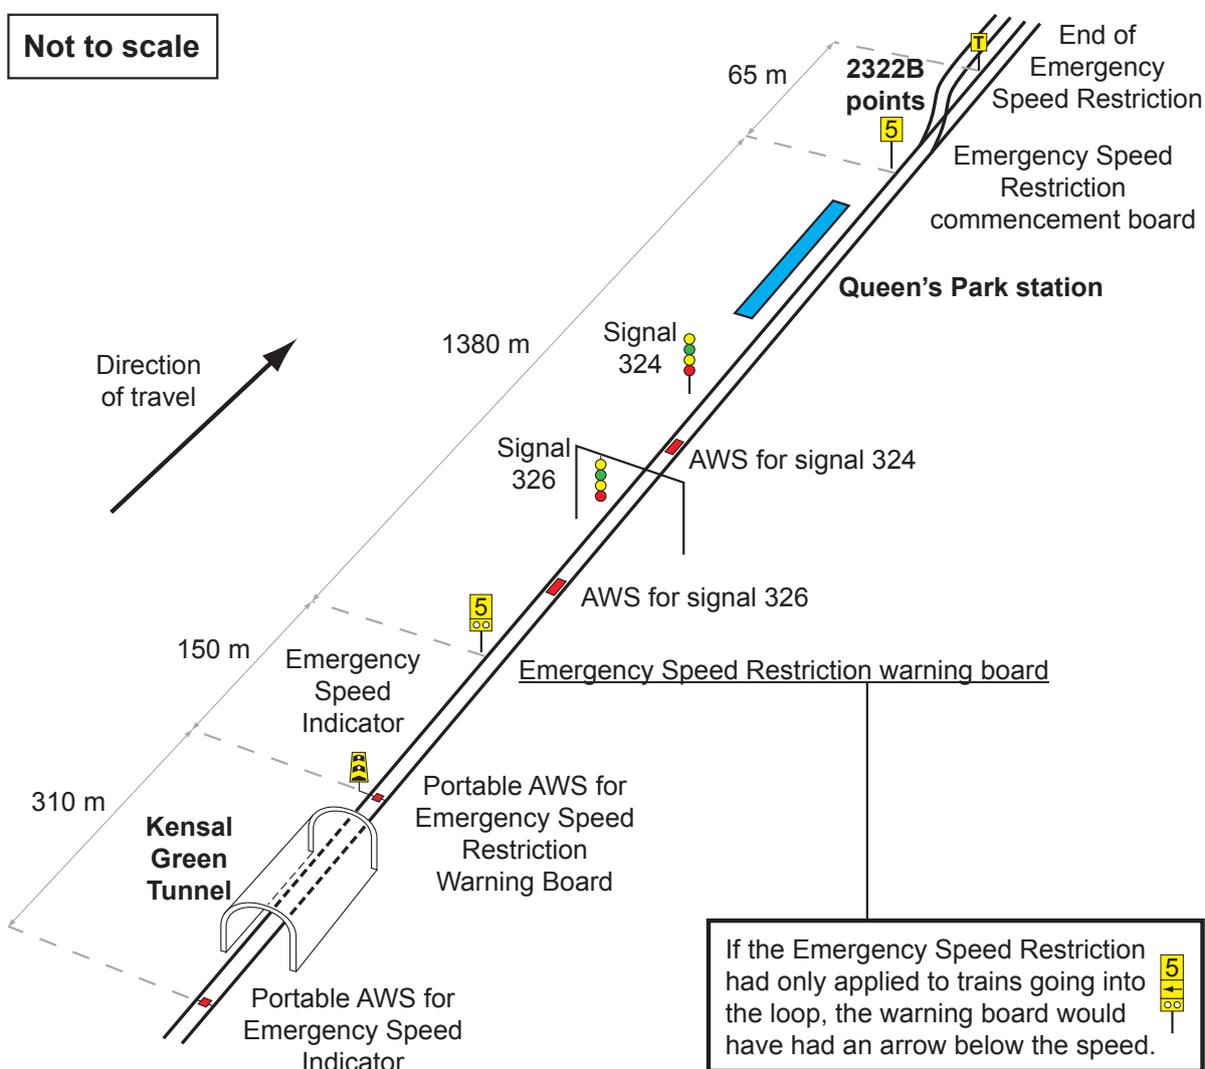
Figure 8: Layout of signs at Queen's Park

- 54 The lineside signage did not correct the driver's misunderstanding as he was already convinced that the emergency speed restriction did not apply to his train. The driver recalled being able to see the emergency warning indicator before reaching the AWS magnet at the entrance to Kensal Green tunnel and that this indicator remained visible until his train passed it. He does not recall seeing any of the other emergency speed restriction signs.

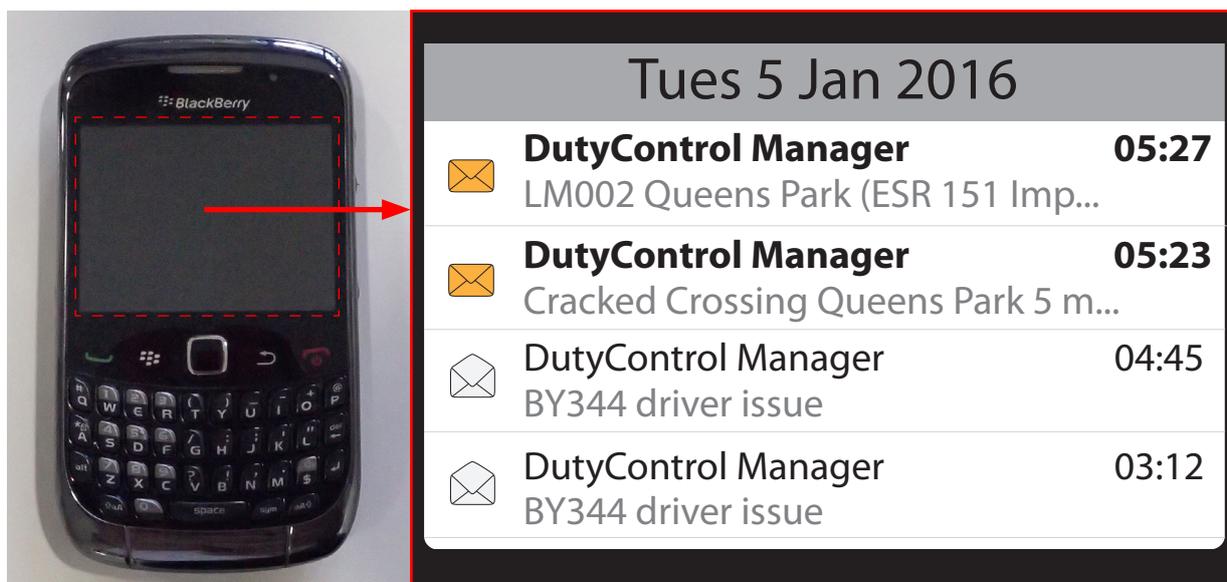
Figure 9: Email headers on Blackberry™ screen

- d. the assessor was probably unaware of the emergency speed restriction warnings.
- 59 The assessor first became aware of the emergency speed restrictions when he read the headings of the two emails while he was having breakfast at home (paragraph 33). The headings (figure 9) made the assessor aware that a speed restriction had been introduced and its approximate location. The headings did not identify the line affected or the precise location, so did not contain enough information to brief him should he have been driving a train.
