## Fatal accident while manoeuvring *Svitzer Moira* alongside an unmanned tug Royal Portbury Dock, Bristol 29 December 2015

### SUMMARY

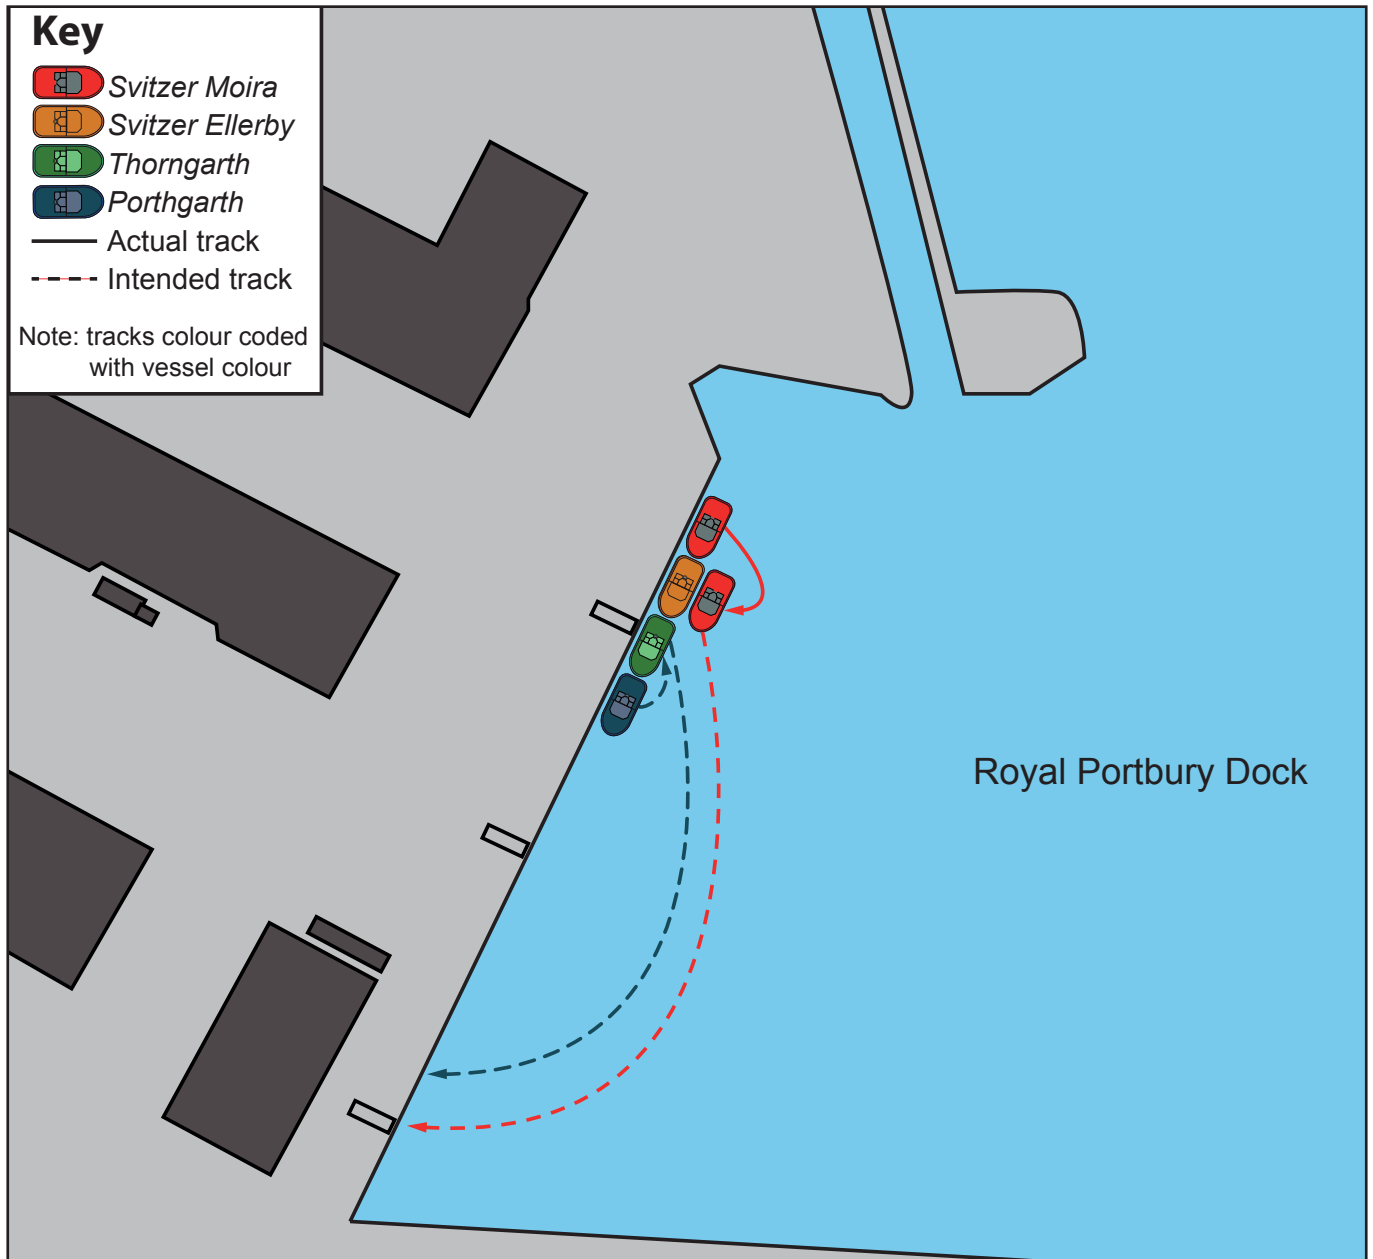
**Figure 2:** Svitzer Moira's intended manoeuvre

*Svitzer Moira* departed its berth and was manoeuvred approximately 40 metres ahead until it was abeam of *Svitzer Ellerby*, a sister vessel that was moored alongside the same quay (**Figure 2**). *Svitzer Ellerby* was unmanned and unlit.

As *Svitzer Moira* came alongside *Svitzer Ellerby*, the deckhand, who was positioned forward, lassoed a bitt on *Svitzer Ellerby* with the eye of a mooring rope. Using his portable radio, he requested some minor adjustments to the vessel's relative fore and aft position to *Svitzer Ellerby*. He then made the rope fast and began running a second rope.

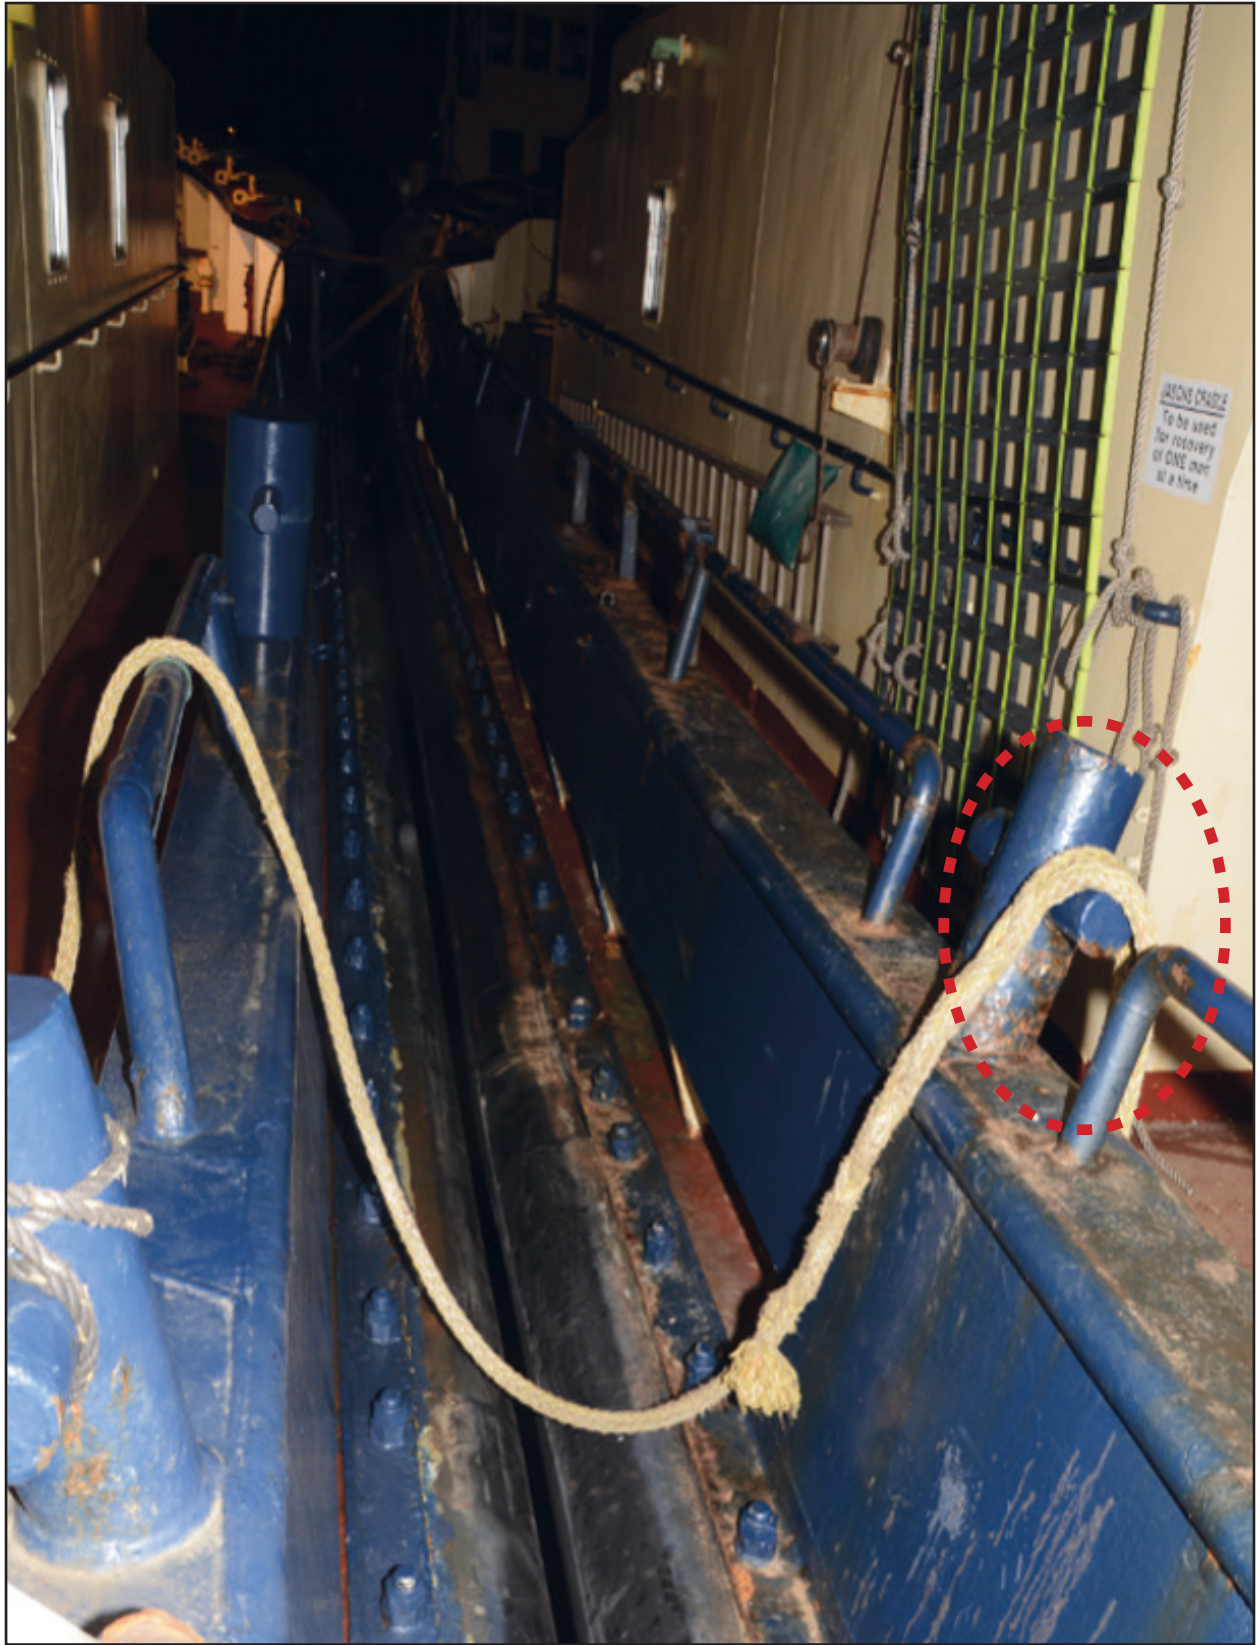
**Figure 3:** Amidships mooring rope as found following accident (reconstruction)

The master left the wheelhouse to get a better view of the aft deck. He could not see the engineer so went down to the aft deck and called to the deckhand, who was now making his way aft having made the second forward rope fast. The deckhand did not know the whereabouts of the engineer, who normally secured the amidships rope and the stern rope. The deckhand noticed that neither rope had been made fast and that the eye of the amidships rope was lying slack over *Svitzer Ellerby*'s bulwark (**Figure 3**). The deckhand straddled the bulwark with the intention of boarding *Svitzer Ellerby* to make the amidships rope fast. He then saw the engineer lying on and partly trapped between the longitudinal fendering of the two tugs, in a position forward of *Svitzer Moira*'s bulwark gate, which was open.

The status of the amidships mooring rope indicates that the engineer had made an attempt to pass the eye of the rope over the corresponding bitts on *Svitzer Ellerby* but was unsuccessful. The open bulwark gate suggests that the engineer had opened it, to transfer to the unmanned tug in order to place the rope correctly over the bitt.

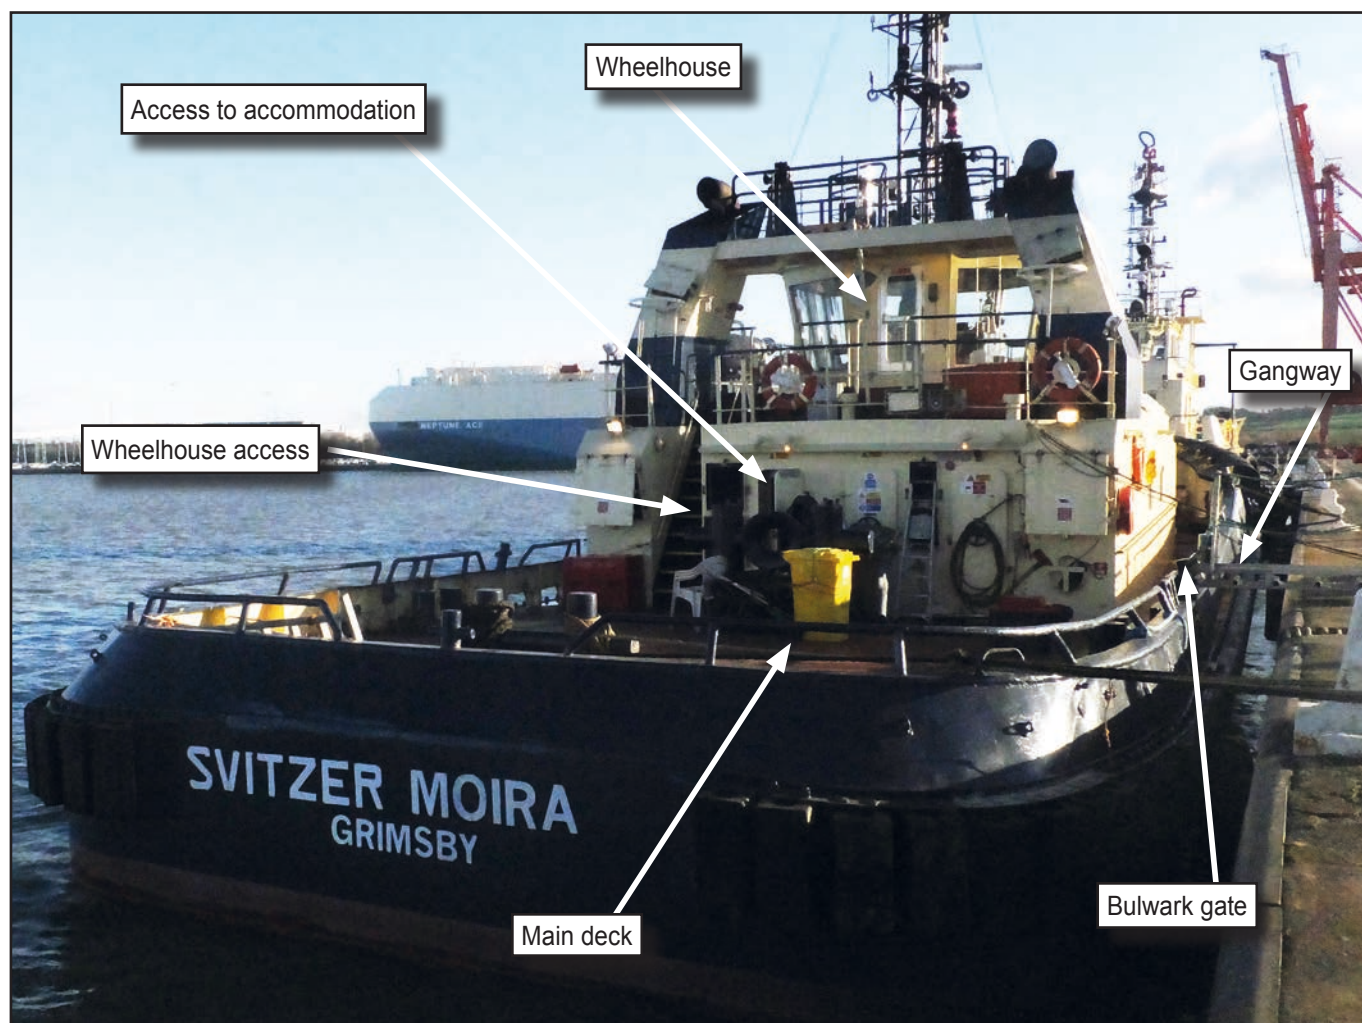
**Figure 4:** *Svitzer Moira*

On the starboard side of the main deck was a permanently attached gangway with a pivot that enabled it to be raised or lowered as required. A bulwark gate was located aft of the gangway (**Figure 4**).

From within *Svitzer Moira's* wheelhouse visibility of the starboard side of the aft deck was obstructed by the funnels, and the amidships mooring bitt and the bulwark gate could not be seen.

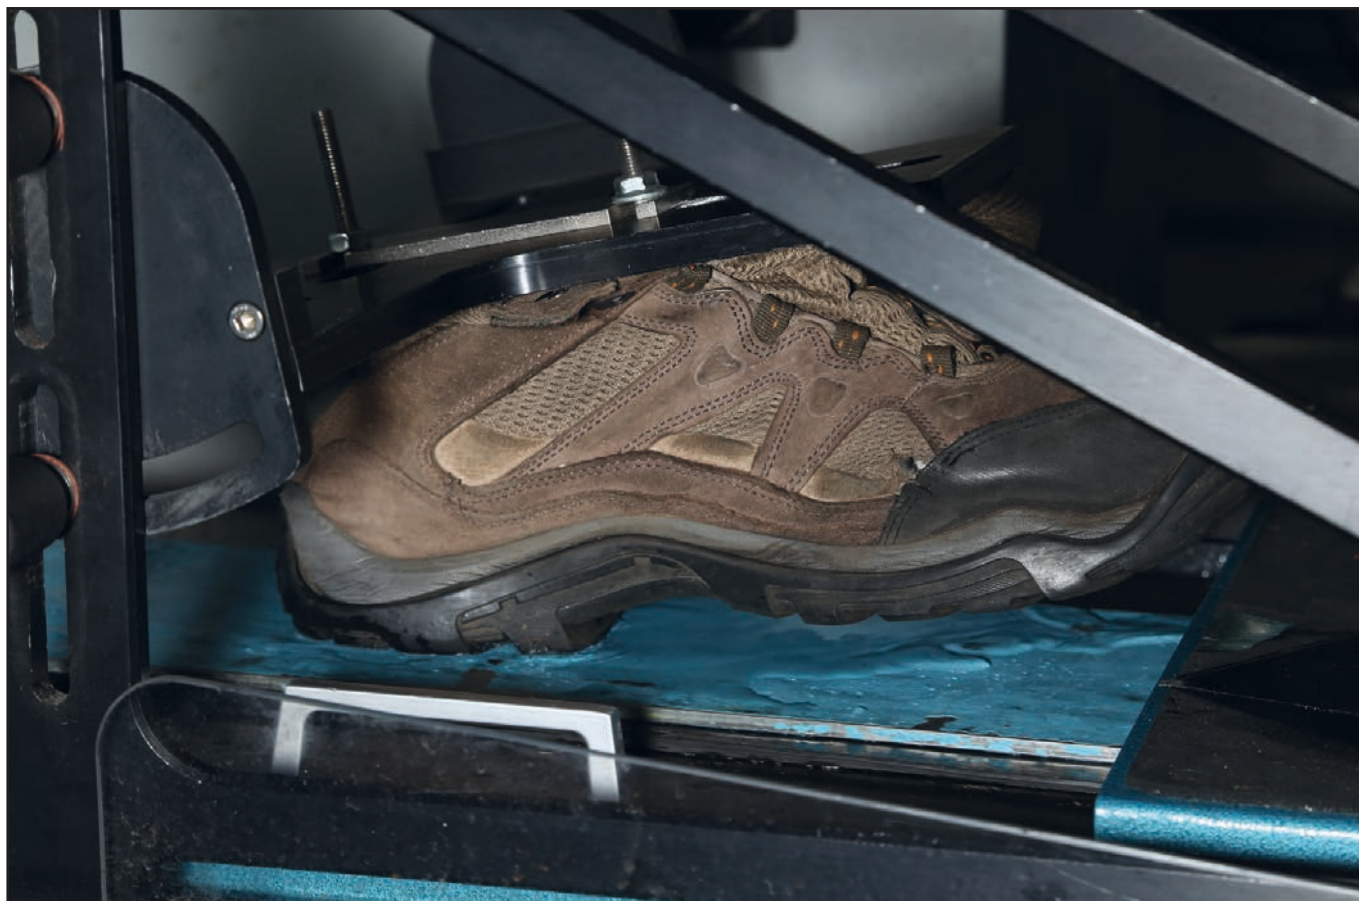
**Figure 5:** Walking boot undergoing slip resistance testing

Independent comparative slip resistance tests were conducted on the walking boots the engineer was wearing at the time of the accident and a new pair of safety boots of the type supplied to him by the company (**Figure 5**). The tests concluded:

*'The worn boots are clearly not in a condition that would be recommended for wearing in the work place due to the general state of wear of the upper, sole and construction. The integrity of the construction in particular is of concern with the shoe bottom coming away from the upper presenting a safety risk. The outsole itself is also in need of replacing being materially changed from its original design and the wearing face breaking down.'*

*Notwithstanding the above, however, there is no indication from the slip resistance testing completed and reported here, that the worn boots would have been expected to have a significantly different level of slip resistance performance in wear on wet and otherwise contaminated surface from the new boots.*

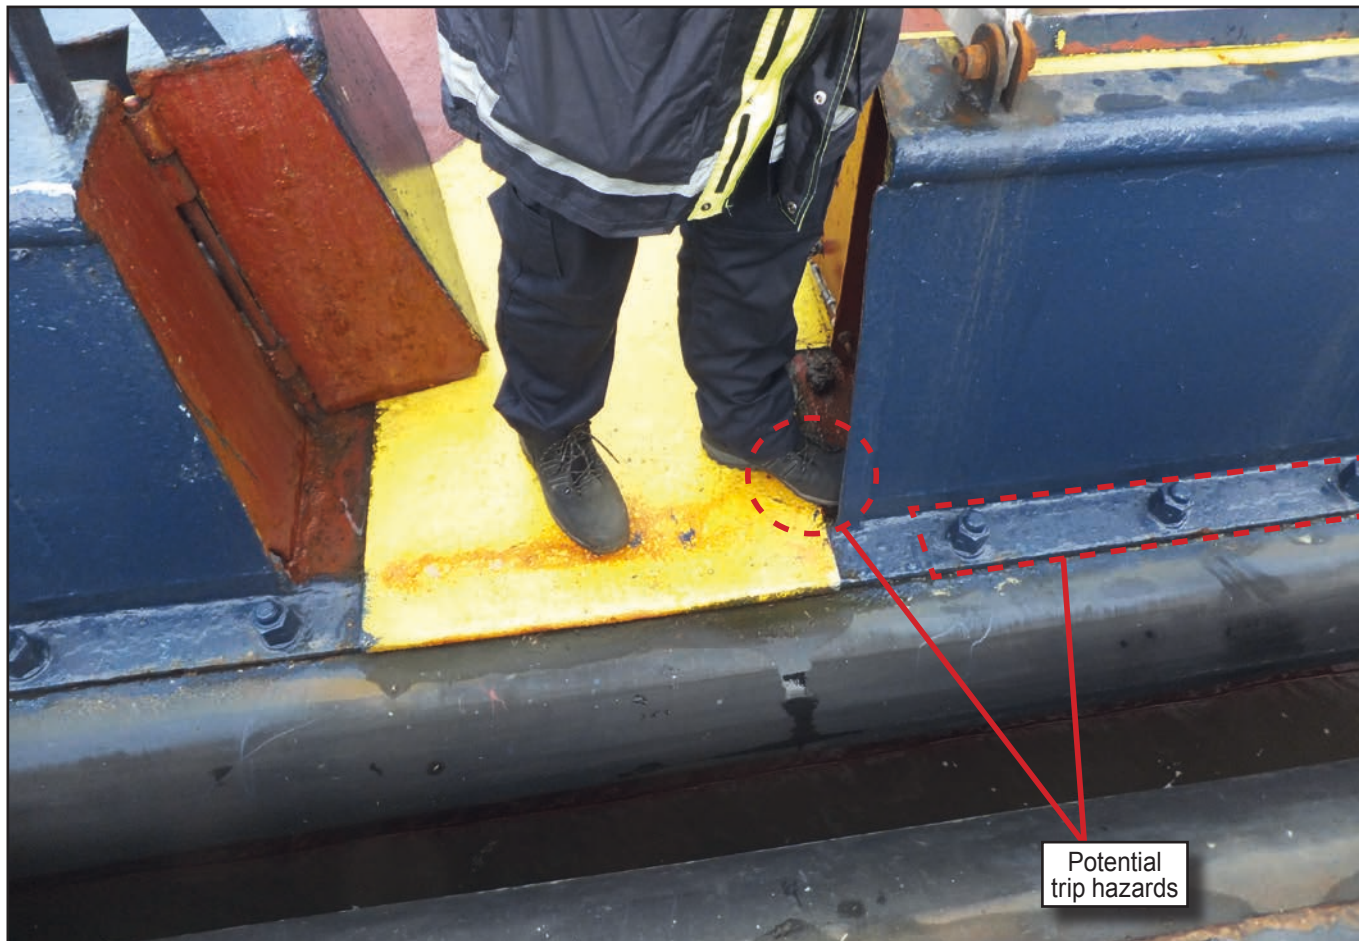
**Figure 6:** Bulwark structure, fendering and securing bolts

There were several trip hazards in the vicinity of the bulwark gate. These included the bulwark structure and the bolts used to secure the fendering in position (**Figure 6**). *Svitzer Moira* was well illuminated but *Svitzer Ellerby* was in darkness, giving rise to an increased risk of tripping (**Figure 7**).

It is probable that the engineer fell forward, possibly as a result of slipping or tripping as he exited through the bulwark gateway in an attempt to pass between the two tugs. As he fell he might have extended his right arm for protection, and possibly struck his head against something, rendering him unconscious.

- *'When a tug is underway, crew members must always stay inside the tug's bulwarks until the Master has indicated that the tug is safely alongside the quay or another vessel and that it is safe for the crew member to move outside of the bulwark.'*
- *'Safe access/egress must always be established and confirmed prior to any crewmember moving between vessels or between a vessel and the quayside.'*

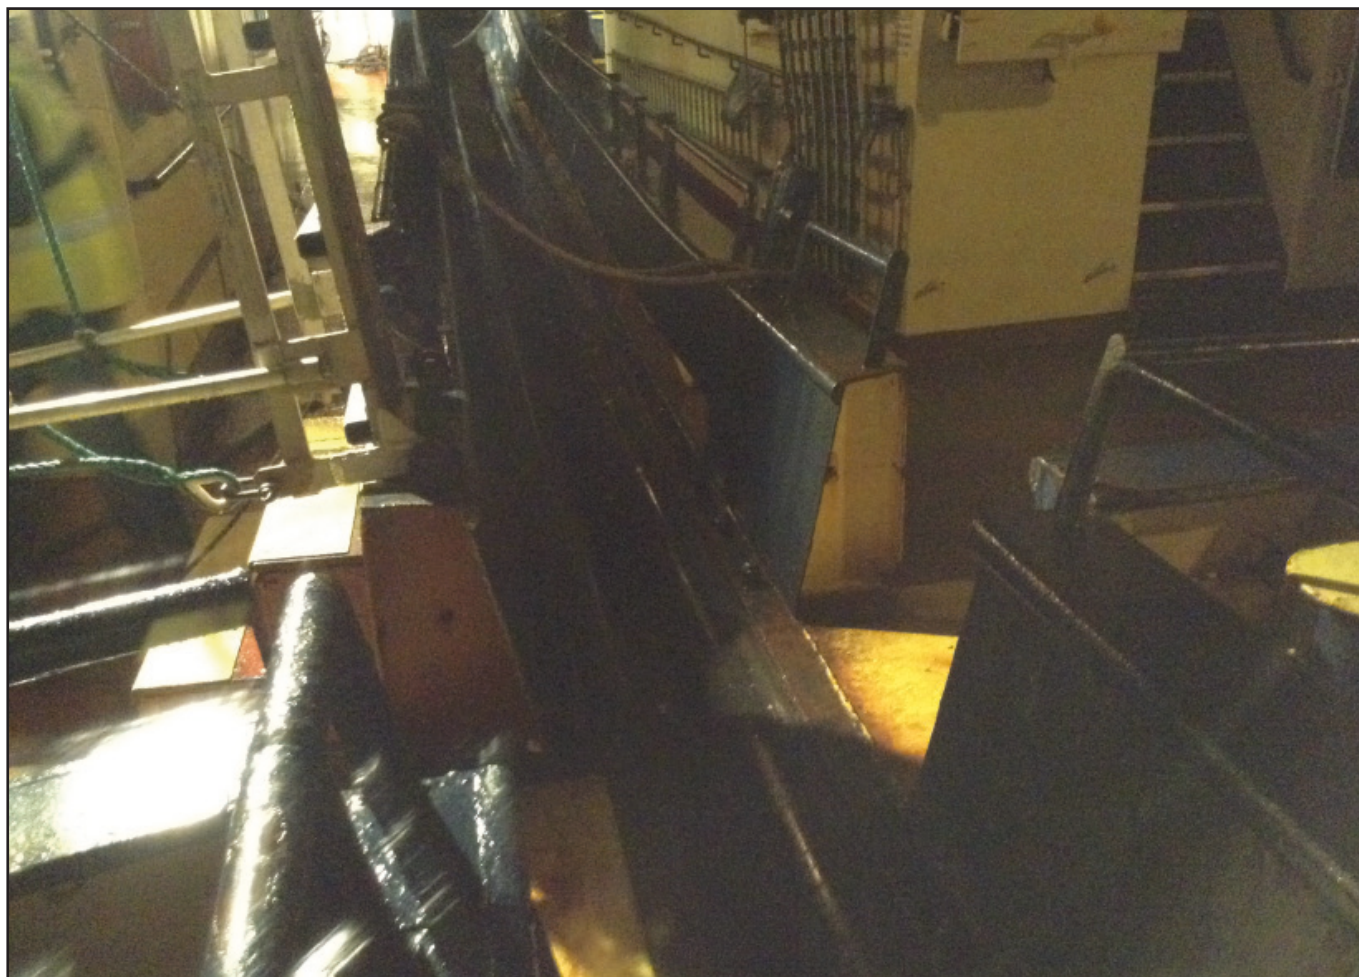
**Figure 7:** *Svitzer Moira* (left) alongside *Svitzer Ellerby* (right) at night

From *Svitzer Moira*'s wheelhouse the master had limited visibility of the aft deck where the engineer was working and, in the dark conditions, he was restricted in his ability to see what he was doing or assure himself that the engineer was wearing the correct PPE. However, he also did not anticipate communicating with the engineer, made no attempt to do so, and expected that the engineer would not cross to the other vessel until he considered it safe to do so.
