Published 13 October 2016

## ACCIDENT

<b>Aircraft Type and Registration:</b>	Beech B200 Super King Air, G-BYCP	
<b>No &amp; Type of Engines:</b>	2 Pratt & Whitney Canada PT6A-42 turboprop engines	
<b>Year of Manufacture:</b>	1981 (Serial no: BB-966)	
<b>Date &amp; Time (UTC):</b>	3 October 2015 at 0920 hrs	
<b>Location:</b>	Near Chigwell, Essex	
<b>Type of Flight:</b>	Non-commercial	
<b>Persons on Board:</b>	Crew - 1	Passengers - 1
<b>Injuries:</b>	Crew - 1 (Fatal)	Passengers - 1 (Fatal)
<b>Nature of Damage:</b>	Aircraft destroyed	
<b>Commander's Licence:</b>	Commercial Pilot's Licence	
<b>Commander's Age:</b>	40 years	
<b>Commander's Flying Experience:</b>	1,941 hours (of which 162 hours were on type) Last 90 days - 61 hours Last 28 days - 50 hours	
<b>Information Source:</b>	AAIB Field Investigation

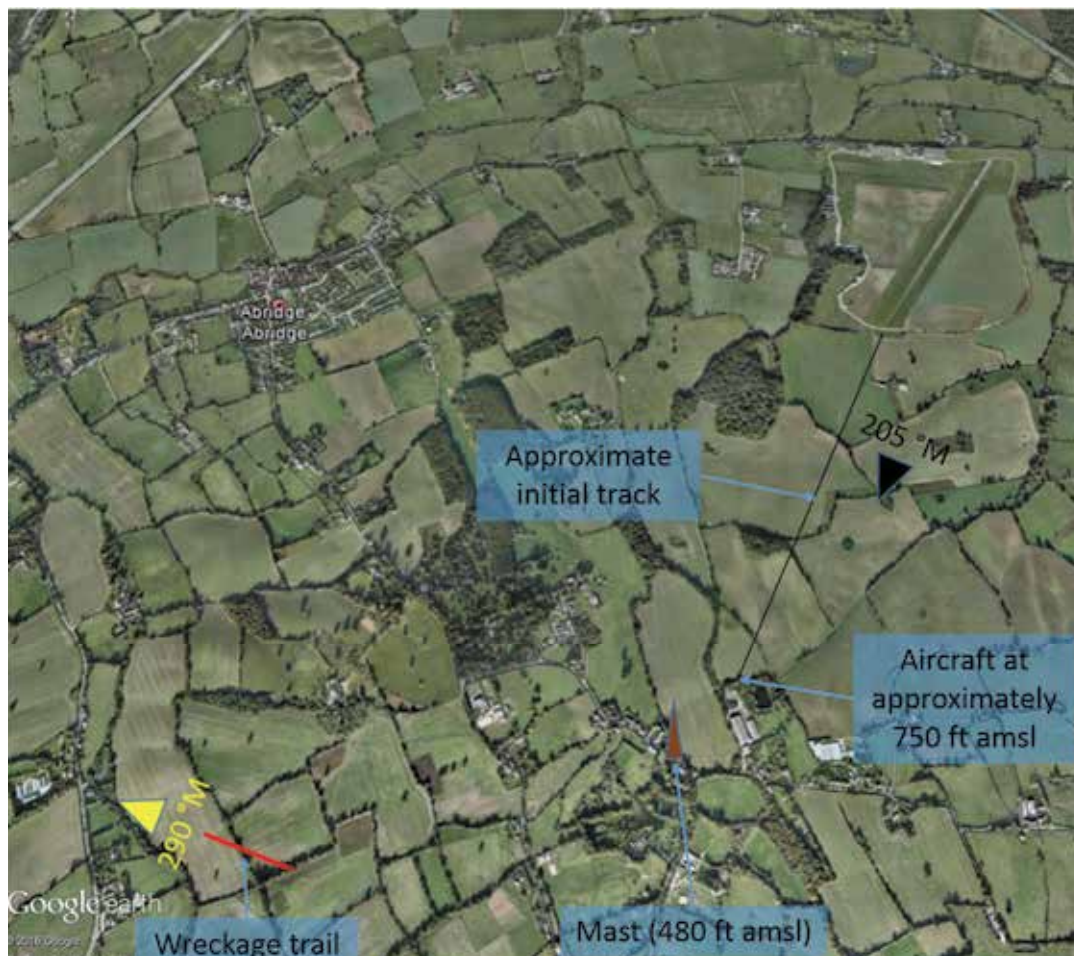
**Figure 3**

Initial track and wreckage trail

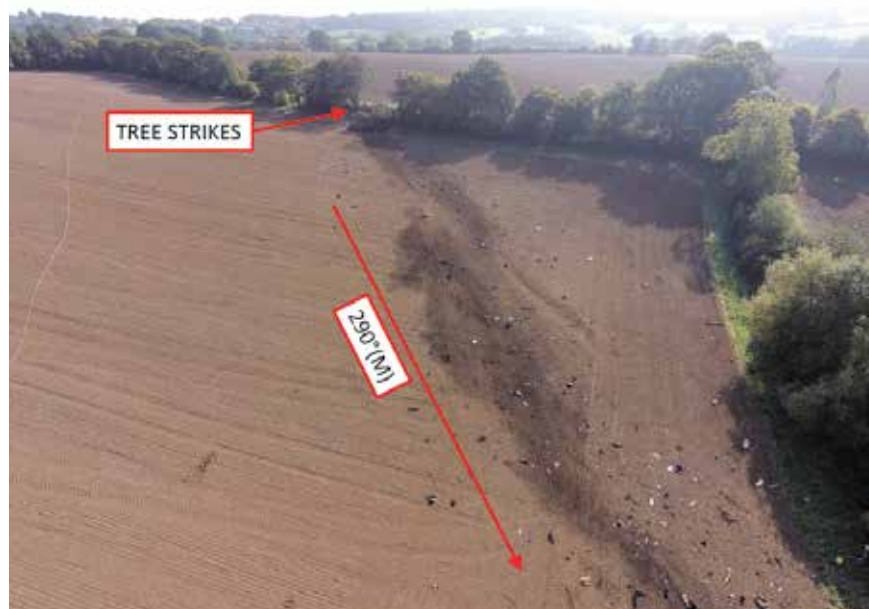
**Figure 6**

The accident site was located in an area of open farmland 1.8 nm southwest of Stapleford Aerodrome, at an elevation of 220 ft amsl. The aircraft had struck a line of oak trees in a shallow pitch attitude and at high speed, causing the aircraft to break up into a large number of fragments and distributing the wreckage along a trail approximately 300 m in length, oriented on a heading of 290°M. Measurement of the angle of strikes to the tree line indicated that the aircraft had impacted with a roll attitude of approximately 12° right wing low. There was a strong smell of unburned fuel within the debris trail and scorching of wreckage lying on the field surface indicated that an intense, short-duration, fuel fire had occurred shortly after the aircraft had struck the trees. All major components of the aircraft were identified at the accident site, prior to wreckage recovery.

Aerial view of the accident site, looking south-east

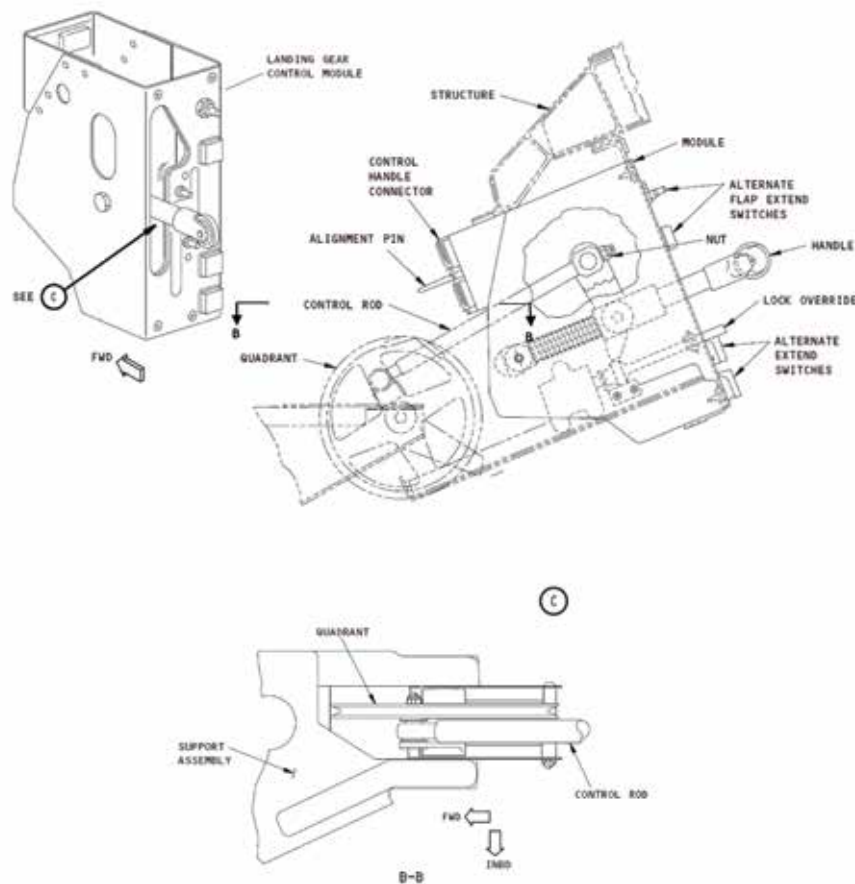
**Figure 1**

Landing Gear Control Module showing handle and control rod

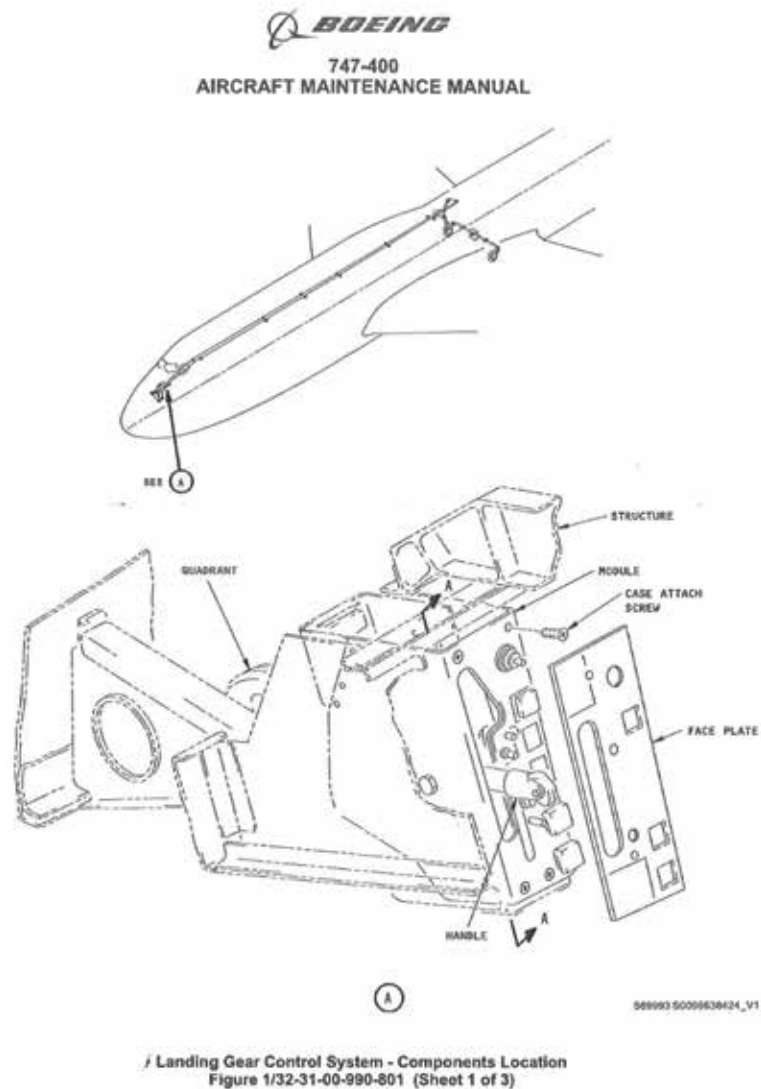
**Figure 2**

Landing Gear Control Module and cable runs

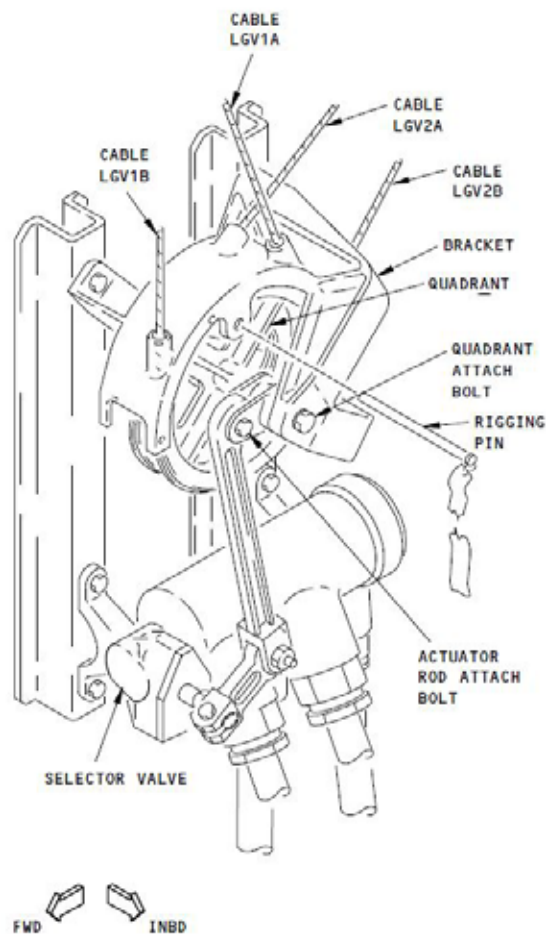
**Figure 3**

The quadrant in each wheel well is connected to a selector valve by a mechanical lever. When a replacement LGCM is installed, it is a requirement in the Aircraft Maintenance Manual (AMM) to insert a rig pin in the selector valve quadrant (Figure 3).

Wing Gear Selector Valve Installation - note rig pin  
(Nose/Body Gear Selector Valve Installation similar)

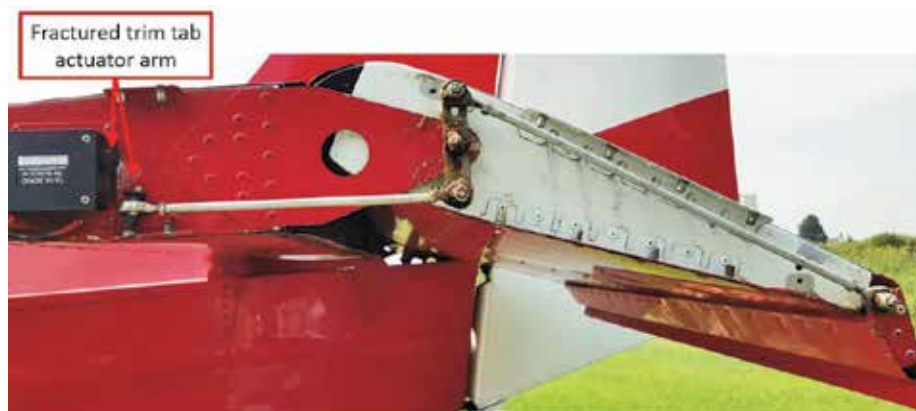
**Figure 1**

Fractured elevator anti-balance trim tab servo arm

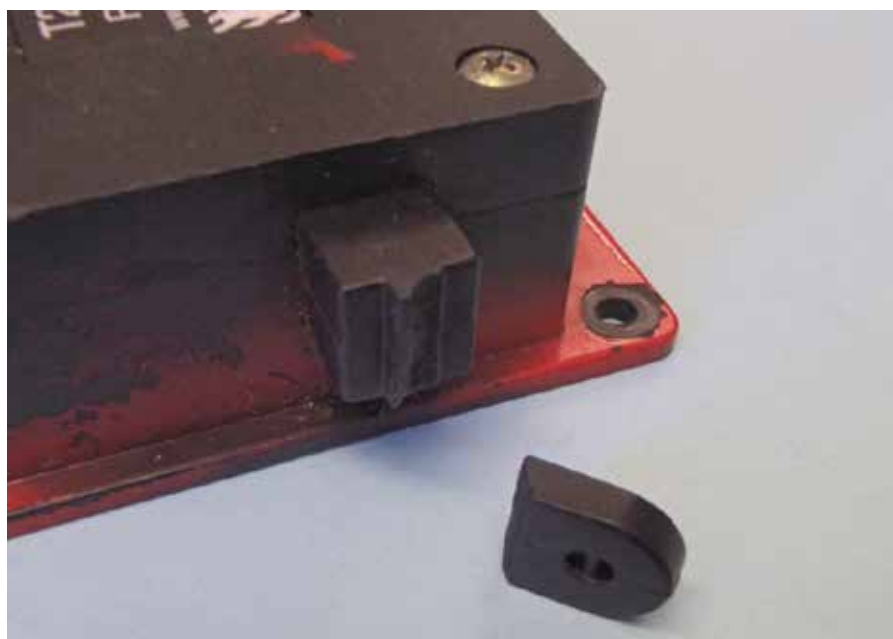
**Figure 2**

The Savannah VG pitch trim system consists of two anti-balance trim tabs, one fitted to the trailing edge of each elevator. Each tab is separately moved for trim by an electric trim servo mounted on the tailplane tip rib, via a system of pushrods and a lever. As the elevator rotates, the anti-balance tab gearing provides an increase in elevator forces. The neutral position of the anti-balance tab is adjusted via the trim servo to provide pitch trim. Figure 1 shows the left elevator anti-balance tab and trim system, following the precautionary landing, with the elevator tip fairing removed for clarity. The electric trim actuator arm, manufactured from a toughened thermoplastic material, had fractured in downward bending overload and there was no evidence of fatigue or progressive failure (Figure 2).

Bending failure of the trim tab servo arm
